Profile/Photo Observation Report

Date:	05/02/2018	Weather:		Coding:	PACP 6.0
Pipe Length (ft):		Owner:	City of Hobart	Pre Clean:	No Pre-Cleaning
P.O.#:	159	Surveyor:	M. Pielacha	PSR:	
Customer:	City of Hobart	Clean Date:		Shape:	C

Street:	Main Street	Flow Control:	Not Controlled
City:	Hobart, IN	Year Renewed:	
Location:	Light Highway	Tape/Media #:	DEP 159
Purpose:	Routine Assessment	Dia/Height:	18"
Use:	Sanitary	Material:	VCP
Drain Area:		Lining:	
Category:	NA		
Comment:	5-21-2018		
Location Details:		Direction of Survey:	Upstream
US MH:	M-705-024.1	DS MH:	M-705-024
		Total Length Surveyed (ft):	45.9

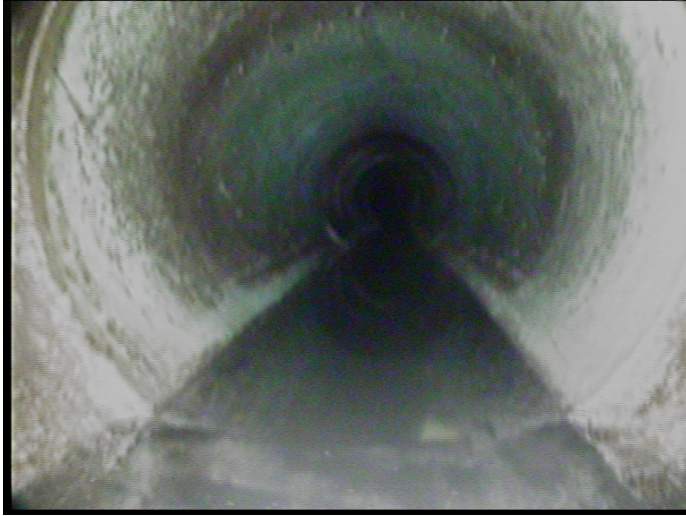
Code:	AMH
Description:	Manhole
Distance (ft):	.0
Structural Grade:	0
O&M Grade:	0
Clock Start/From:	
Clock To:	
1st Value:	
2nd Value:	
Value Percent:	
Continuous Index:	
Within 8" of Joint:	NO
Remarks:	M-705-024.1

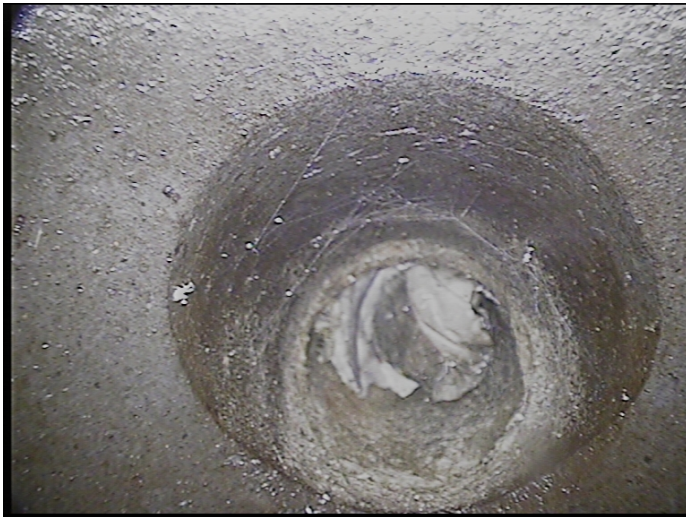
Code: **MWL**
Description: **Water Level**

Distance (ft): **.0**
Structural Grade: **0**
O&M Grade: **0**
Clock Start/From:
Clock To:
1st Value:
2nd Value:
Value Percent: **10.000**
Continuous Index:
Within 8" of Joint: **NO**
Remarks:

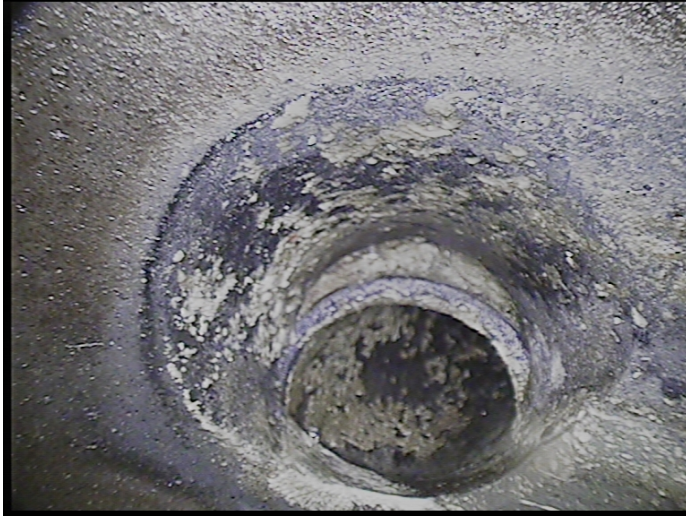
Code: **TF**
Description: **Tap Factory**

Distance (ft): **15.8**
Structural Grade: **0**
O&M Grade: **0**
Clock Start/From: **11**
Clock To:
1st Value: **4.000**
2nd Value:
Value Percent:
Continuous Index:
Within 8" of Joint: **NO**
Remarks:

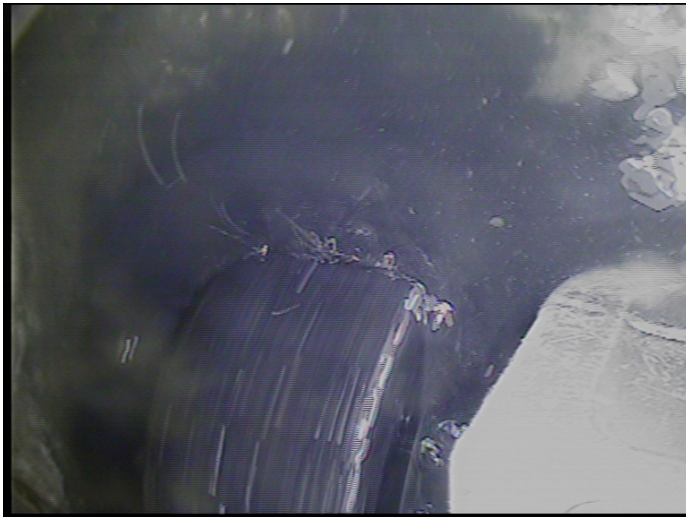
Code: **TF**
Description: **Tap Factory**

Distance (ft): **18.8**
Structural Grade: **0**
O&M Grade: **0**
Clock Start/From: **2**
Clock To:
1st Value: **4.000**
2nd Value:
Value Percent:
Continuous Index:
Within 8" of Joint: **NO**
Remarks:

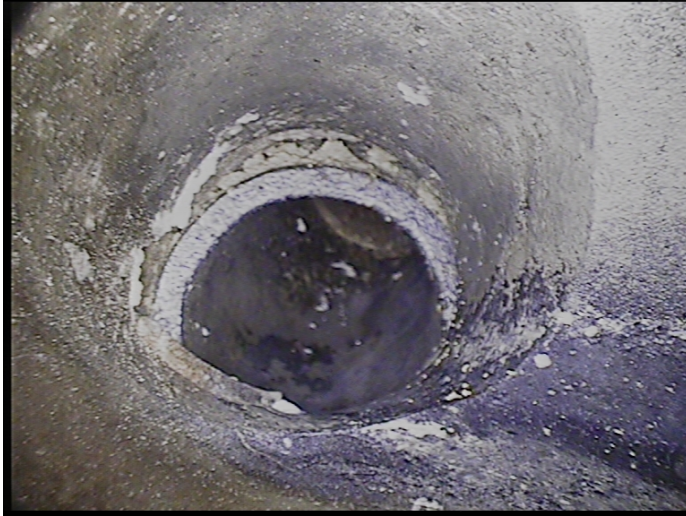
Code: **DSF**
Description: **Deposits Settled Fine**

Distance (ft): **27.8**
Structural Grade: **0**
O&M Grade: **3**
Clock Start/From: **4**
Clock To: **8**
1st Value:
2nd Value:
Value Percent: **15.000**
Continuous Index: **S01**
Within 8" of Joint: **YES**
Remarks:

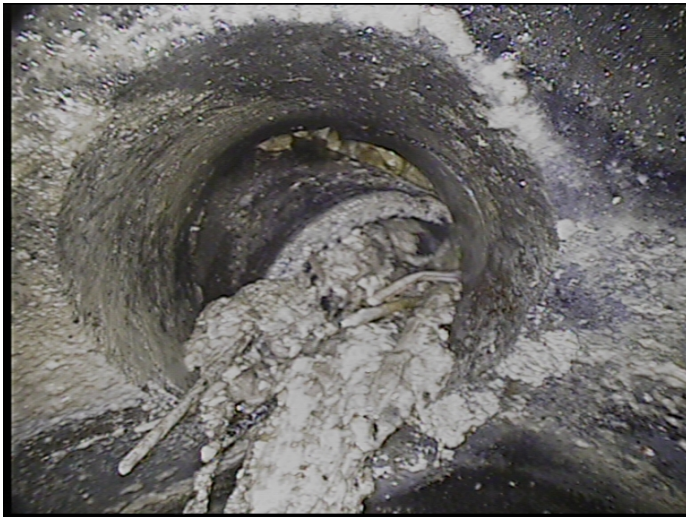
Code: **TF**
Description: **Tap Factory**

Distance (ft): **40.1**
Structural Grade: **0**
O&M Grade: **0**
Clock Start/From: **2**
Clock To:
1st Value: **4.000**
2nd Value:
Value Percent:
Continuous Index:
Within 8" of Joint: **NO**
Remarks:

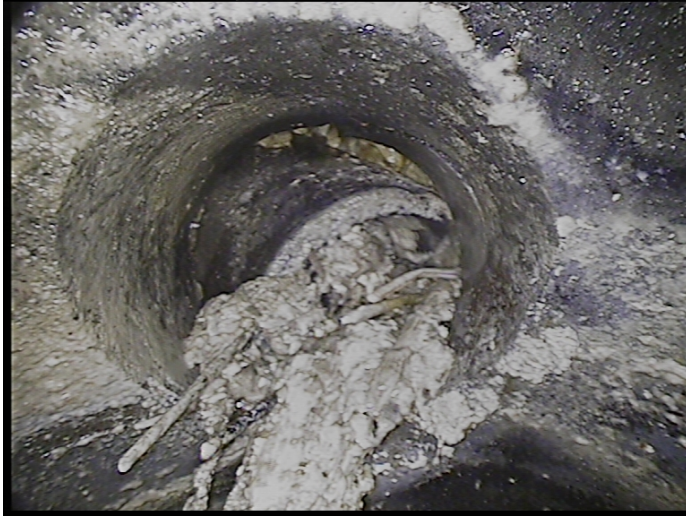
Code: **TFD**
Description: **Tap Factory Defective**

Distance (ft): **43.1**
Structural Grade: **0**
O&M Grade: **2**
Clock Start/From: **10**
Clock To:
1st Value: **4.000**
2nd Value:
Value Percent:
Continuous Index:
Within 8" of Joint: **NO**
Remarks: **Defective**

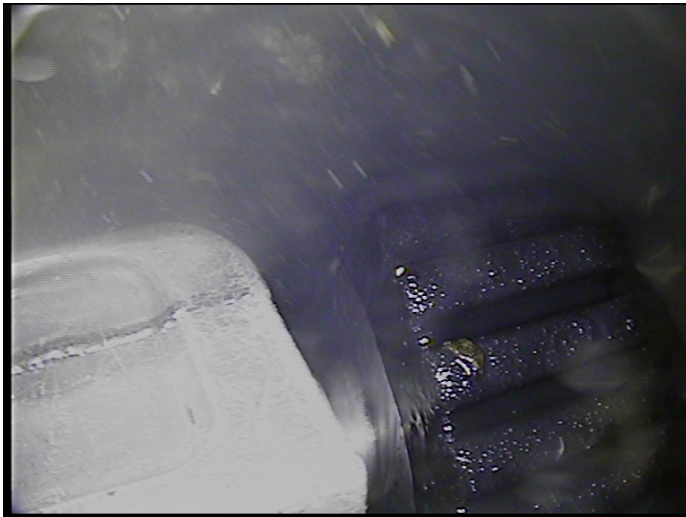
Code:	DAE
Description:	Deposits Attached Encrustation
Distance (ft):	43.1
Structural Grade:	0
O&M Grade:	2
Clock Start/From:	11
Clock To:	
1st Value:	
2nd Value:	
Value Percent:	10.000
Continuous Index:	
Within 8" of Joint:	YES
Remarks:

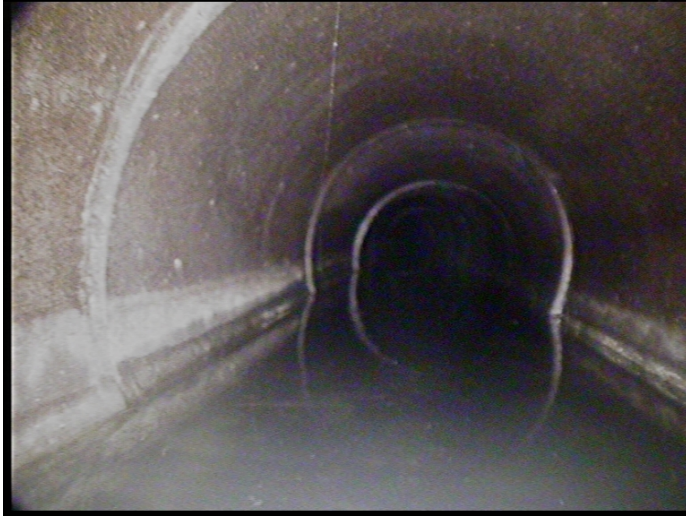
Code:	DSF
Description:	Deposits Settled Fine
Distance (ft):	45.7
Structural Grade:	0
O&M Grade:	3
Clock Start/From:	4
Clock To:	8
1st Value:	
2nd Value:	
Value Percent:	15.000
Continuous Index:	F01
Within 8" of Joint:	NO
Remarks:
