Profile/Photo Observation Report

Date:	05/02/2018	Weather:		Coding:	PACP 6.0
Pipe Length (ft):		Owner:	City of Hobart	Pre Clean:	No Pre-Cleaning
P.O.#:	158	Surveyor:	M. Pielacha	PSR:	P-705-024-025
Customer:	City of Hobart	Clean Date:		Shape:	C

Street:	Main Street	Flow Control:	Not Controlled
City:	Hobart, IN	Year Renewed:	
Location:	Light Highway	Tape/Media #:	DEP 158
Purpose:	Routine Assessment	Dia/Height:	18"
Use:	Sanitary	Material:	VCP
Drain Area:		Lining:	
Category:	NA		
Comment:	5-21-2018		
Location Details:		Direction of Survey:	Downstream
US MH:	M-705-025	DS MH:	M-705-024
		Total Length Surveyed (ft):	10.6

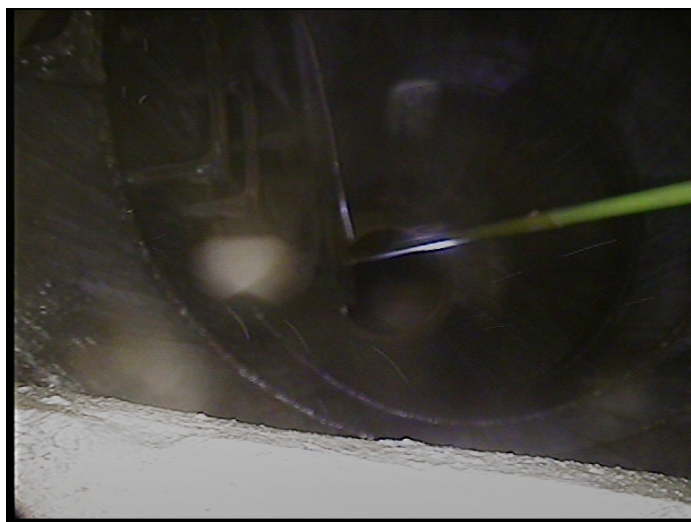
Code: **AMH**
Description: **Manhole**

Distance (ft): **.0**
Structural Grade: **0**
O&M Grade: **0**
Clock Start/From:
Clock To:
1st Value:
2nd Value:
Value Percent:
Continuous Index:
Within 8" of Joint: **NO**
Remarks: **M-705-024**

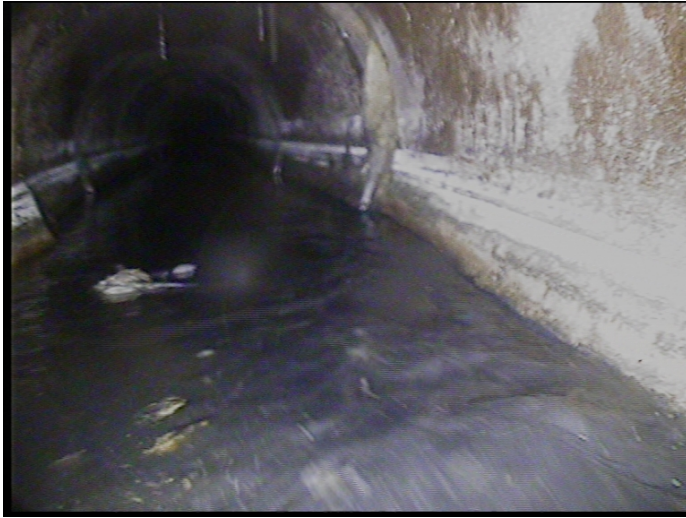
Code: **MWL**
Description: **Water Level**

Distance (ft): **.0**
Structural Grade: **0**
O&M Grade: **0**
Clock Start/From:
Clock To:
1st Value:
2nd Value:
Value Percent: **10.000**
Continuous Index:
Within 8" of Joint: **NO**
Remarks:

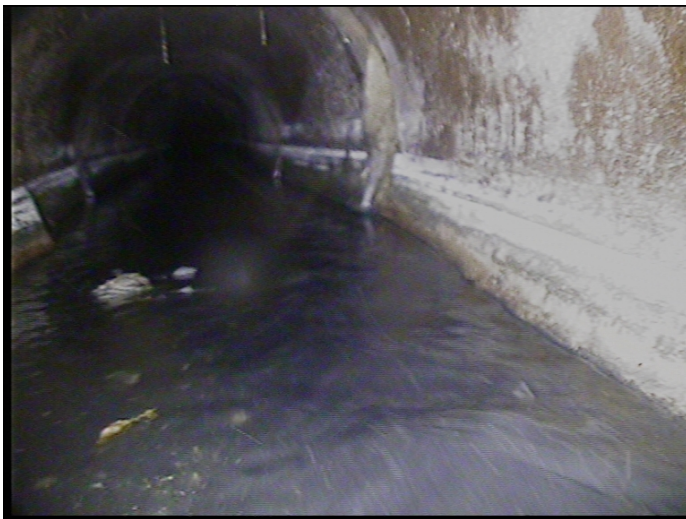
Code: **DSF**
Description: **Deposits Settled Fine**

Distance (ft): **.0**
Structural Grade: **0**
O&M Grade: **3**
Clock Start/From: **4**
Clock To: **8**
1st Value:
2nd Value:
Value Percent: **15.000**
Continuous Index: **S01**
Within 8" of Joint: **YES**
Remarks:

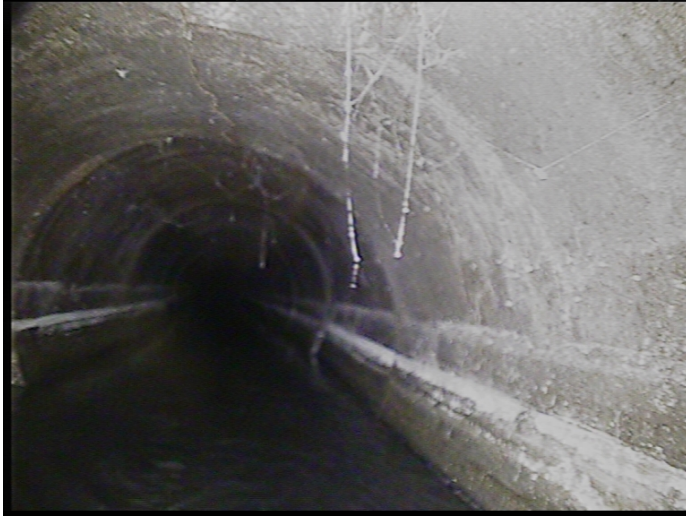
Code: **DSF**
Description: **Deposits Settled Fine**

Distance (ft): **10.5**
Structural Grade: **0**
O&M Grade: **3**
Clock Start/From: **4**
Clock To: **8**
1st Value:
2nd Value:
Value Percent: **20.000**
Continuous Index: **F01**
Within 8" of Joint: **NO**
Remarks:

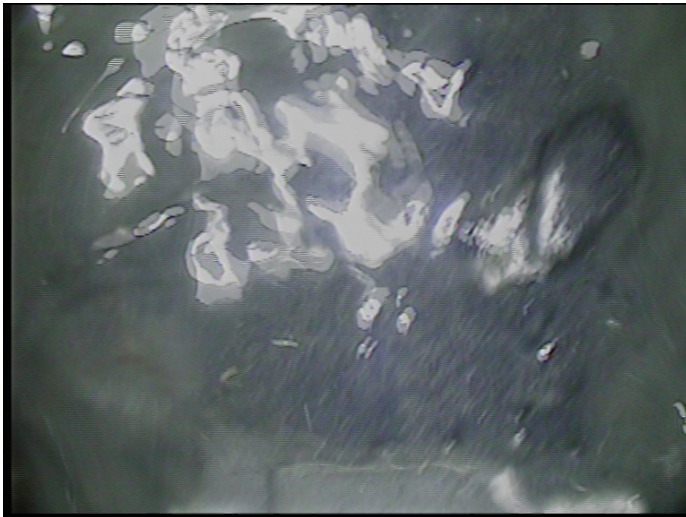
Code: **MSA**
Description: **Abandoned Survey**

Distance (ft): **10.6**
Structural Grade: **0**
O&M Grade: **0**
Clock Start/From:
Clock To:
1st Value:
2nd Value:
Value Percent:
Continuous Index:
Within 8" of Joint: **NO**
Remarks: **sediment**
