Profile/Photo Observation Report

Street:	Main Street	Flow Control:	
City:	Hobart, IN	Year Renewed:	
Location:	Light Highway	Tape/Media #:	952
Purpose:	Routine Assessment	Dia/Height:	10"
Use:	Sanitary	Material:	PVC
Drain Area:		Lining:	
Category:	NA		
Comment:

Location Details:		Direction of Survey:	Upstream
US MH:	M-705-25	DS MH:	M-705-87
		Total Length Surveyed (ft):	29.6

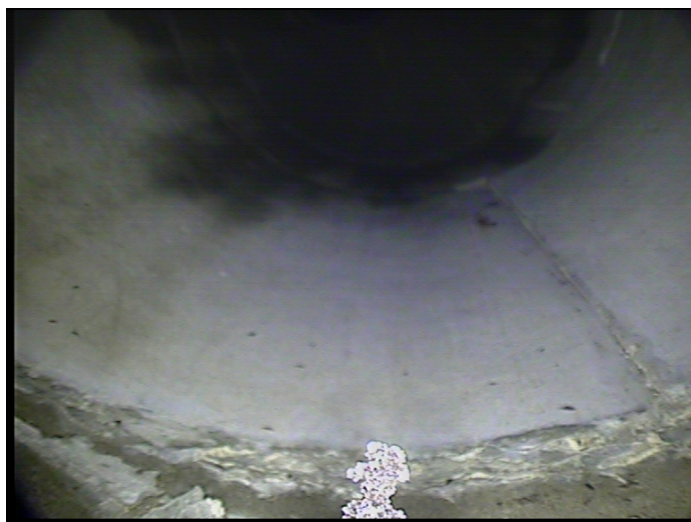
Code: **AMH**
Description: **Manhole**

Distance (ft): **.0**
Structural Grade: **0**
O&M Grade: **0**
Clock Start/From:
Clock To:
1st Value:
2nd Value:
Value Percent:
Continuous Index:
Within 8" of Joint: **NO**
Remarks: **M-705-87**

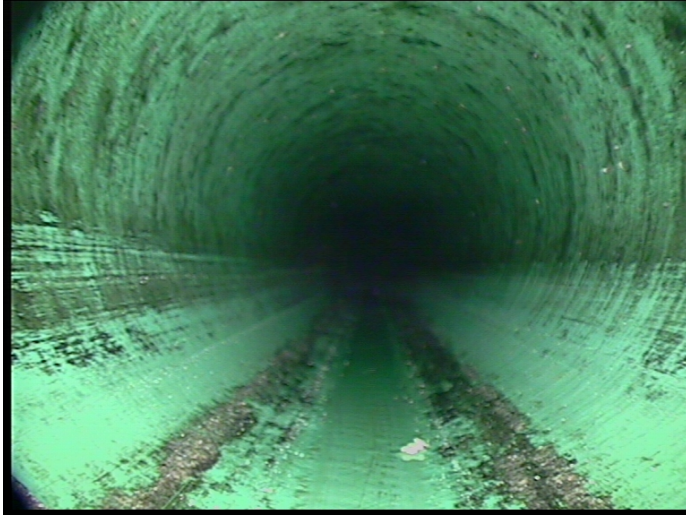
Code: **MWL**
Description: **Water Level**

Distance (ft): **.0**
Structural Grade: **0**
O&M Grade: **0**
Clock Start/From:
Clock To:
1st Value:
2nd Value:
Value Percent: **5.000**
Continuous Index:
Within 8" of Joint: **NO**
Remarks:

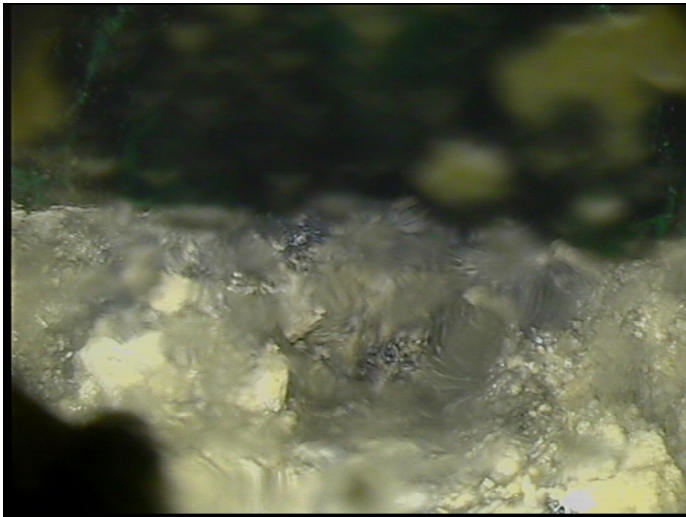
Code: **DSF**
Description: **Deposits Settled Fine**

Distance (ft): **28.3**
Structural Grade: **0**
O&M Grade: **3**
Clock Start/From: **4**
Clock To: **8**
1st Value:
2nd Value:
Value Percent: **20.000**
Continuous Index:
Within 8" of Joint: **NO**
Remarks:

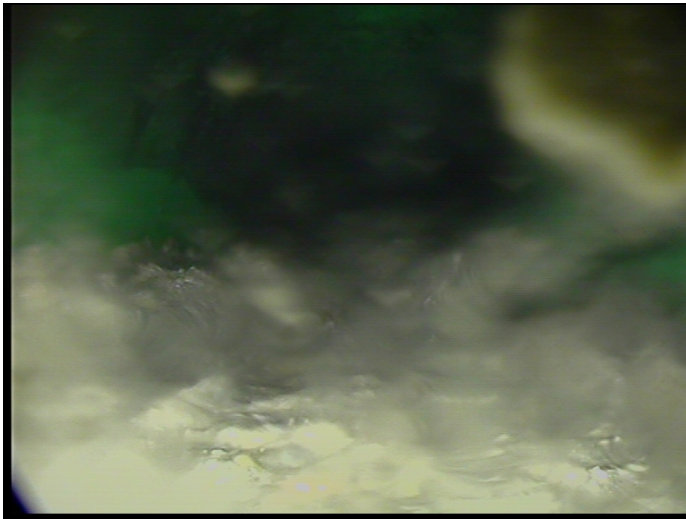
Code:	MSA
Description:	Abandoned Survey
Distance (ft):	29.6
Structural Grade:	0
O&M Grade:	0
Clock Start/From:	
Clock To:	
1st Value:	
2nd Value:	
Value Percent:	
Continuous Index:	
Within 8" of Joint:	NO
Remarks:	debris
