Profile/Photo Observation Report

Street:	3rd Street	Flow Control:	
City:	Hobart, IN	Year Renewed:	
Location:	Light Highway	Tape/Media #:	958
Purpose:	Reversal	Dia/Height:	10"
Use:	Sanitary	Material:	PVC
Drain Area:		Lining:	
Category:	NA		
Comment:

Location Details:		Direction of Survey:	Downstream
US MH:	M-705-25	DS MH:	M-705-87
		Total Length Surveyed (ft):	240.3

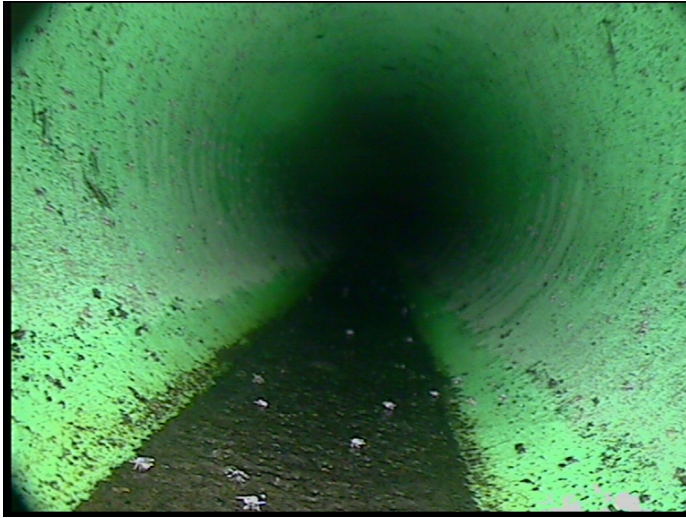
Code:	MWL
Description:	Water Level
Distance (ft):	.0
Structural Grade:	0
O&M Grade:	0
Clock Start/From:	
Clock To:	
1st Value:	
2nd Value:	
Value Percent:	5.000
Continuous Index:	
Within 8" of Joint:	NO
Remarks:

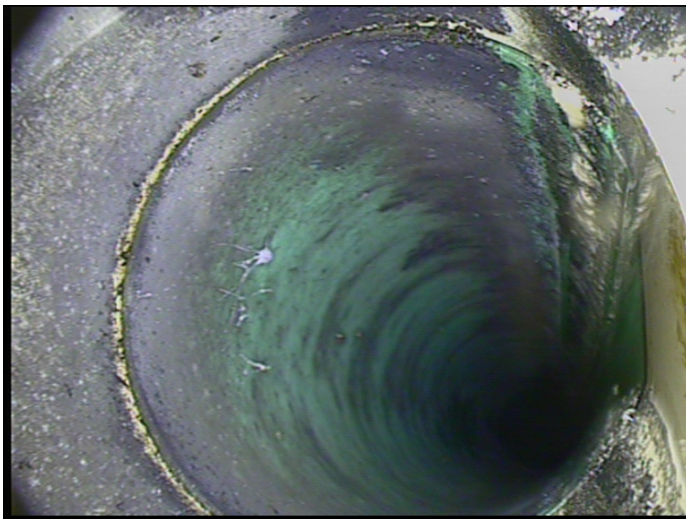
Code:	TF
Description:	Tap Factory
Distance (ft):	22.4
Structural Grade:	0
O&M Grade:	0
Clock Start/From:	3
Clock To:	
1st Value:	4.000
2nd Value:	
Value Percent:	
Continuous Index:	
Within 8" of Joint:	NO
Remarks:

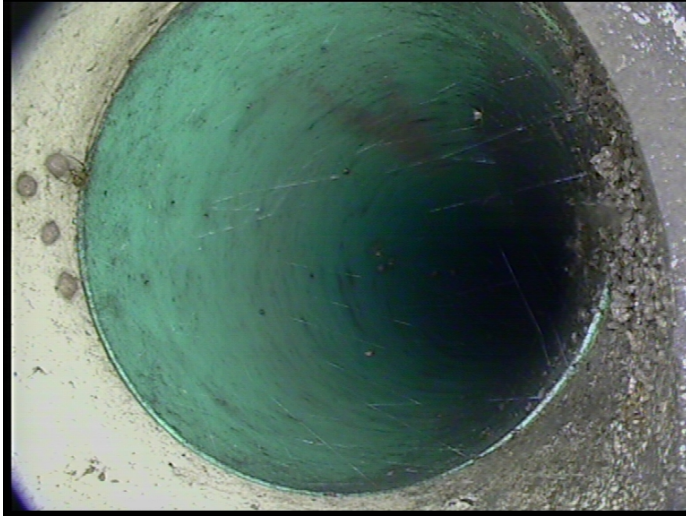
Code: **TF**
Description: **Tap Factory**

Distance (ft): **30.7**
Structural Grade: **0**
O&M Grade: **0**
Clock Start/From: **3**
Clock To:
1st Value: **4.000**
2nd Value:
Value Percent:
Continuous Index:
Within 8" of Joint: **NO**
Remarks:

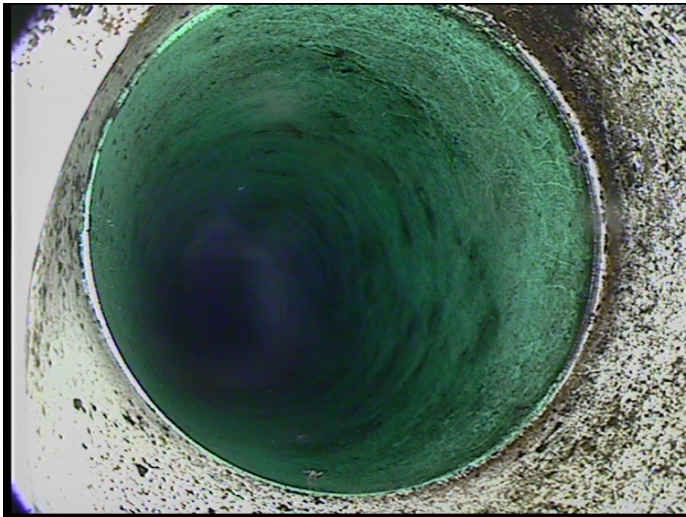
Code: **TF**
Description: **Tap Factory**

Distance (ft): **190.9**
Structural Grade: **0**
O&M Grade: **0**
Clock Start/From: **9**
Clock To:
1st Value: **4.000**
2nd Value:
Value Percent:
Continuous Index:
Within 8" of Joint: **NO**
Remarks:

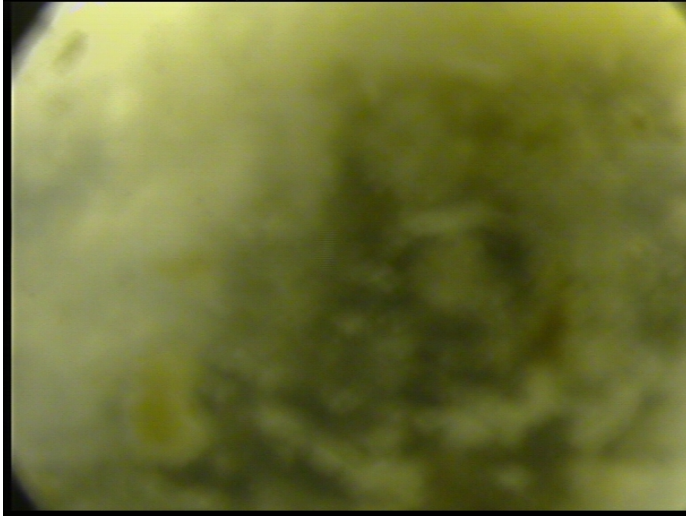
Code: **OBZ**
Description: **Obstacle Other**

Distance (ft): **240.3**
Structural Grade: **0**
O&M Grade: **2**
Clock Start/From: **6**
Clock To:
1st Value:
2nd Value:
Value Percent: **10.000**
Continuous Index:
Within 8" of Joint: **NO**
Remarks: **under water debris**

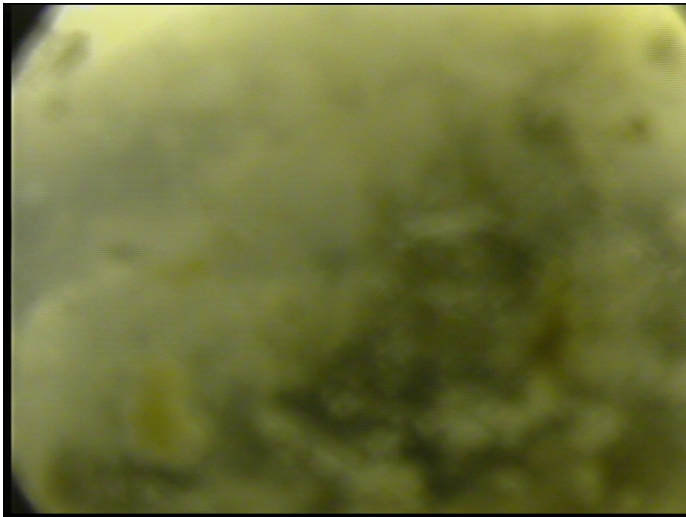
Code: **MSA**
Description: **Abandoned Survey**

Distance (ft): **240.3**
Structural Grade: **0**
O&M Grade: **0**
Clock Start/From:
Clock To:
1st Value:
2nd Value:
Value Percent:
Continuous Index:
Within 8" of Joint: **NO**
Remarks: **MSA due to debris; Reverse is complete**
