Date: Pipe Length (ft	<b>10/22/2021</b>	Weather: Owner:	Hobart, IN	Coding: Pre Clean:	PACP 6.0 Not Known
P.O.#:	951_1	Surveyor:	M. Pielacha	PSR:	P-705-033-025
Customer:	Hobart, IN	Clean Date:		Shape:	C
Street:	Main Street		Flow Control:		
City:	Hobart, IN		Year Renewed:		
Location:	Light Highway		Tape/Media #:	951	
Purpose:	Routine Assessment		Dia/Height:	10"	
Use:	Sanitary		Material:	VCP	
Drain Area:			Lining:		
Category:	NA				
Comment:					
Location Detail	s:		Direction of Surve	y: Upstream	
US MH:	M-705-33	DS MH:	M-705-25	Total Length Surveyed (ft):	105.8
0&M Index:	2.00	O&M Quick:	2500	O&M Rating:	10.00
Structural Index:	0.00	 Structural Qu	uick: 0000	Structural Rating:	0.00
Overall Index:	2.00	Overall Quick	2500	Overall Rating:	10.00

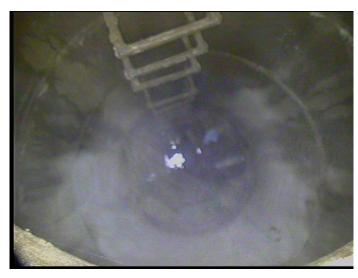
Code: Description:	AMH Manhole
Distance (ft):	.0
Structural Grade:	0
O&M Grade:	0
Clock Start/From:	
Clock To:	
1st Value:	
2nd Value:	
Value Percent:	
Continuous Index:	
Within 8" of Joint:	NO
Remarks:	M-705-25

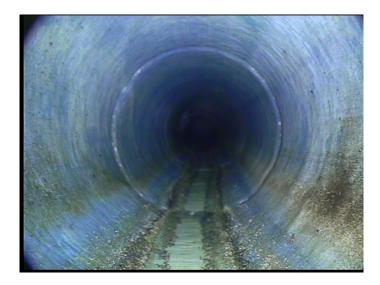
Code:	MWL
Description:	Water Level
	•
Distance (ft):	.0
Structural Grade:	0
O&M Grade:	0
Clock Start/From:	
Clock To:	
1st Value:	
2nd Value:	
Value Percent:	5.000
Continuous Index:	
Within 8" of Joint:	NO
Remarks:

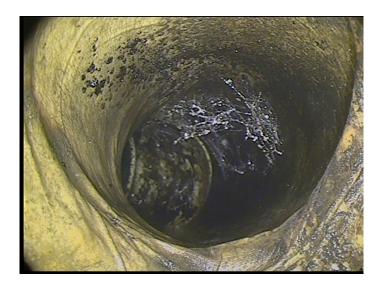
Code: Description:	TF Tap Factory
Distance (ft):	77.9
Structural Grade:	0
O&M Grade:	0
Clock Start/From:	10
Clock To:	
1st Value:	4.000
2nd Value:	
Value Percent:	
Continuous Index:	
Within 8" of Joint:	NO
Remarks:

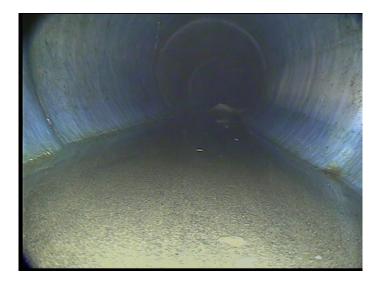
Code:	DSF
Description:	<b>Deposits Settled Fine</b>
Distance (ft):	80.3
Structural Grade:	0
O&M Grade:	2
Clock Start/From:	4
Clock To:	8
1st Value:	
2nd Value:	
Value Percent:	10.000
Continuous Index:	S01
Within 8" of Joint:	YES
Remarks:

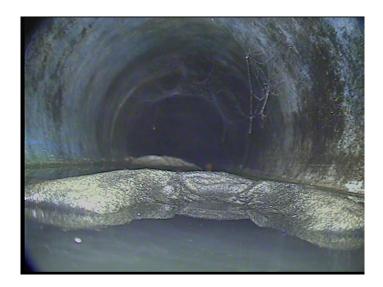
Code: Description:	DSF Deposits Settled Fine
Distance (ft): Structural Grade: O&M Grade: Clock Start/From: Clock To: 1st Value: 2nd Value: Value Percent: Continuous Index: Within 8" of Joint: Remarks:	105.5 0 3 4 8 20.000 F01 NO

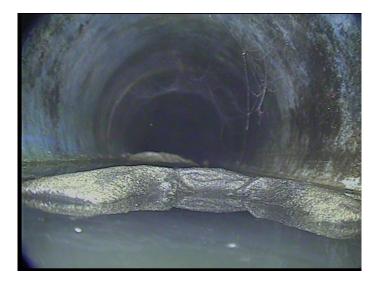
Code: MSA Description: Abandoned Survey Distance (ft): 105.5 Structural Grade: 0 O&M Grade: 0 Clock Start/From: Clock To: 1st Value: 2nd Value: Value Percent: Continuous Index: Within 8" of Joint: NO Remarks: deep sediment
