Profile/Photo Observation Report

Date:	10/22/2021	Weather:		Coding:	PACP 6.0
Pipe Length (ft):		Owner:	Hobart, IN	Pre Clean:	Not Known
P.O.#:	953_1	Surveyor:	M. Pielacha	PSR:	P-705-033-025
Customer:	Hobart, IN	Clean Date:		Shape:	C

Street:	3rd Street	Flow Control:	
City:	Hobart, IN	Year Renewed:	
Location:	Light Highway	Tape/Media #:	953
Purpose:	Reversal	Dia/Height:	10"
Use:	Sanitary	Material:	VCP
Drain Area:		Lining:

US MH: **M-705-33** DS MH: **M-705-25** Total Length Surveyed (ft): **161.5**

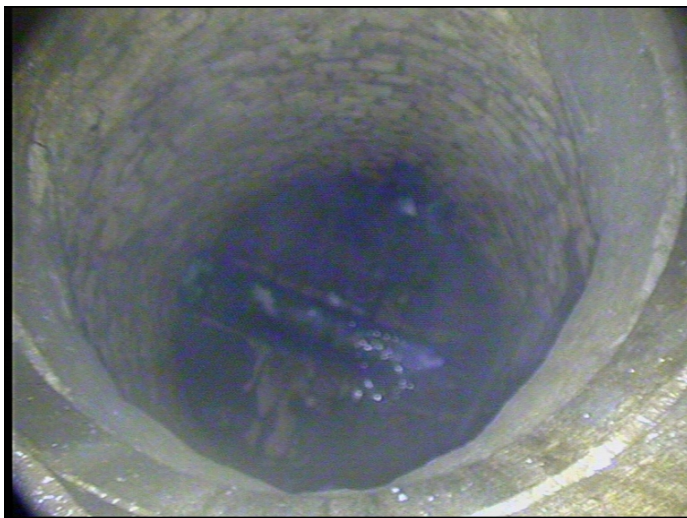
Code: **AMH**
 Description: **Manhole**

Distance (ft): **.0**
 Structural Grade: **0**
 O&M Grade: **0**
 Clock Start/From:
 Clock To:
 1st Value:
 2nd Value:
 Value Percent:
 Continuous Index:
 Within 8" of Joint: **NO**
 Remarks: **M-705-33**

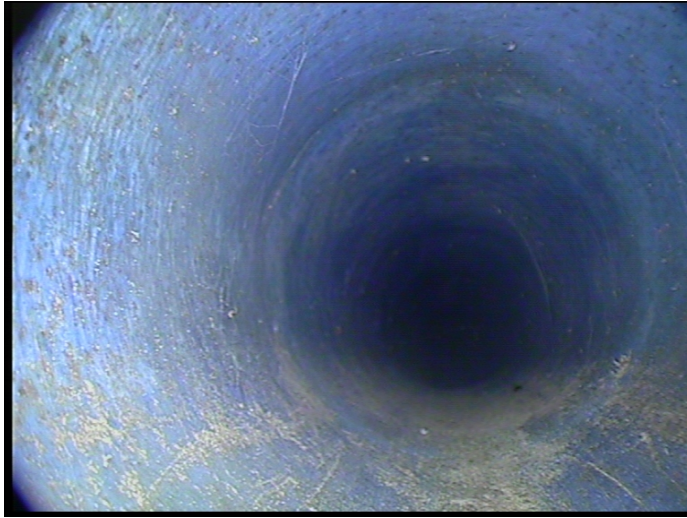
Code: **MWL**
Description: **Water Level**

Distance (ft): **.0**
Structural Grade: **0**
O&M Grade: **0**
Clock Start/From:
Clock To:
1st Value:
2nd Value:
Value Percent: **5.000**
Continuous Index:
Within 8" of Joint: **NO**
Remarks:

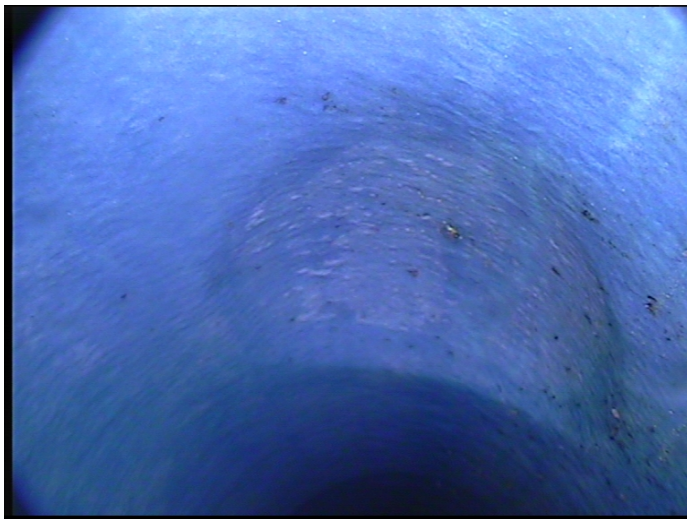
Code: **LFAC**
Description: **Lining Failure Abandoned Connection**

Distance (ft): **40.7**
Structural Grade: **0**
O&M Grade: **0**
Clock Start/From: **2**
Clock To:
1st Value:
2nd Value:
Value Percent:
Continuous Index:
Within 8" of Joint: **NO**
Remarks:

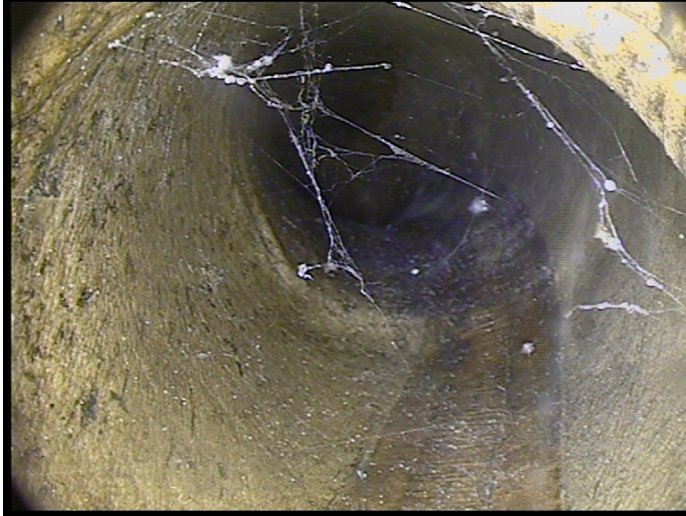
Code: **TF**
Description: **Tap Factory**

Distance (ft): **45.4**
Structural Grade: **0**
O&M Grade: **0**
Clock Start/From: **9**
Clock To:
1st Value: **4.000**
2nd Value:
Value Percent:
Continuous Index:
Within 8" of Joint: **NO**
Remarks:

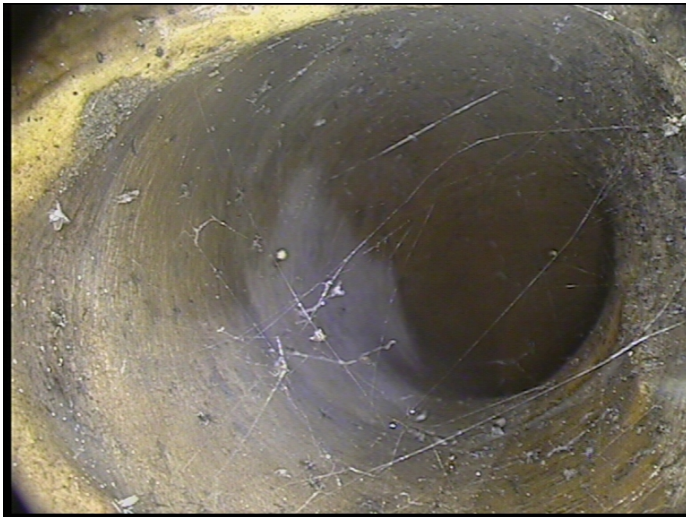
Code: **TF**
Description: **Tap Factory**

Distance (ft): **71.7**
Structural Grade: **0**
O&M Grade: **0**
Clock Start/From: **3**
Clock To:
1st Value: **4.000**
2nd Value:
Value Percent:
Continuous Index:
Within 8" of Joint: **NO**
Remarks:

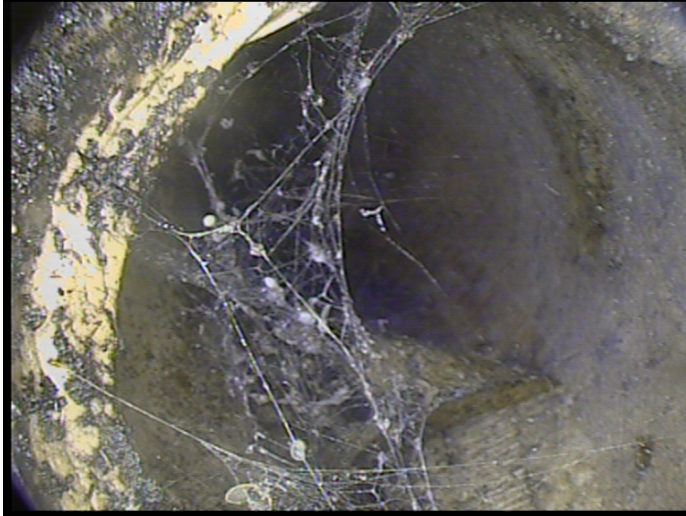
Code: **TF**
Description: **Tap Factory**

Distance (ft): **75.8**
Structural Grade: **0**
O&M Grade: **0**
Clock Start/From: **9**
Clock To:
1st Value: **4.000**
2nd Value:
Value Percent:
Continuous Index:
Within 8" of Joint: **NO**
Remarks:

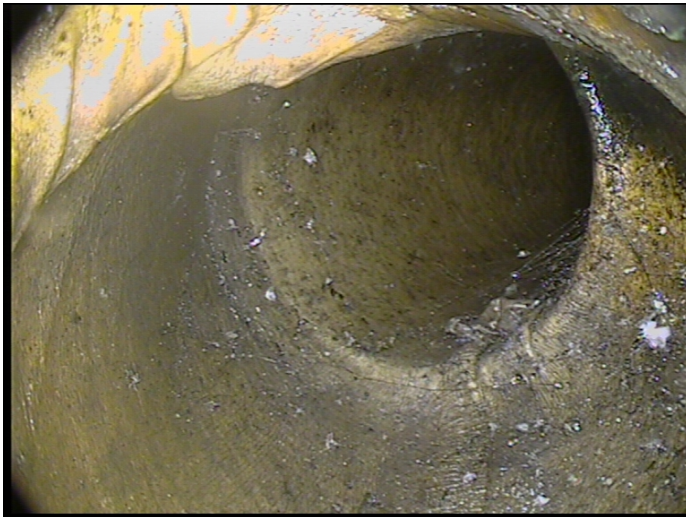
Code: **TF**
Description: **Tap Factory**

Distance (ft): **92.0**
Structural Grade: **0**
O&M Grade: **0**
Clock Start/From: **3**
Clock To:
1st Value: **4.000**
2nd Value:
Value Percent:
Continuous Index:
Within 8" of Joint: **NO**
Remarks:

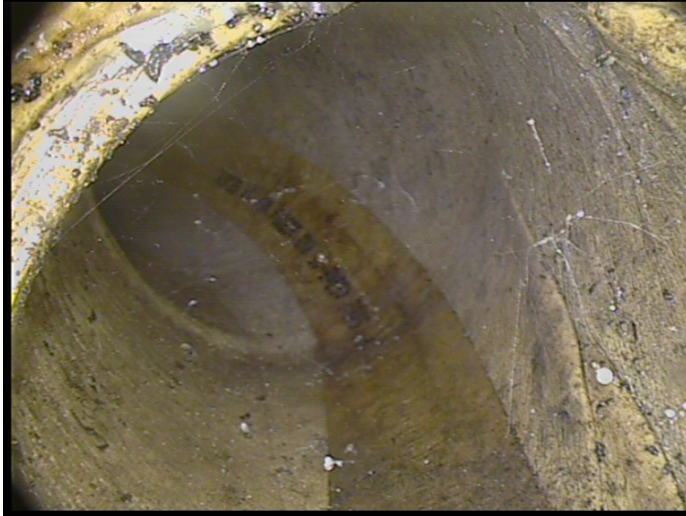
Code: **TF**
Description: **Tap Factory**

Distance (ft): **100.4**
Structural Grade: **0**
O&M Grade: **0**
Clock Start/From: **10**
Clock To:
1st Value: **4.000**
2nd Value:
Value Percent:
Continuous Index:
Within 8" of Joint: **NO**
Remarks:

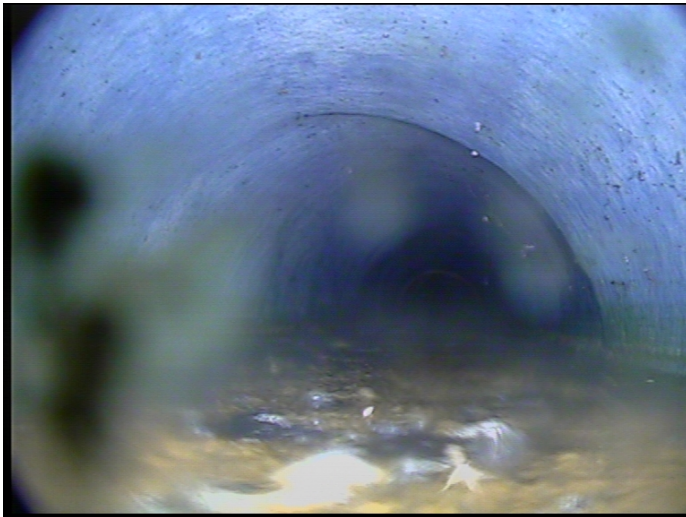
Code: **MWL**
Description: **Water Level**

Distance (ft): **116.1**
Structural Grade: **0**
O&M Grade: **0**
Clock Start/From:
Clock To:
1st Value:
2nd Value:
Value Percent: **30.000**
Continuous Index:
Within 8" of Joint: **NO**
Remarks:

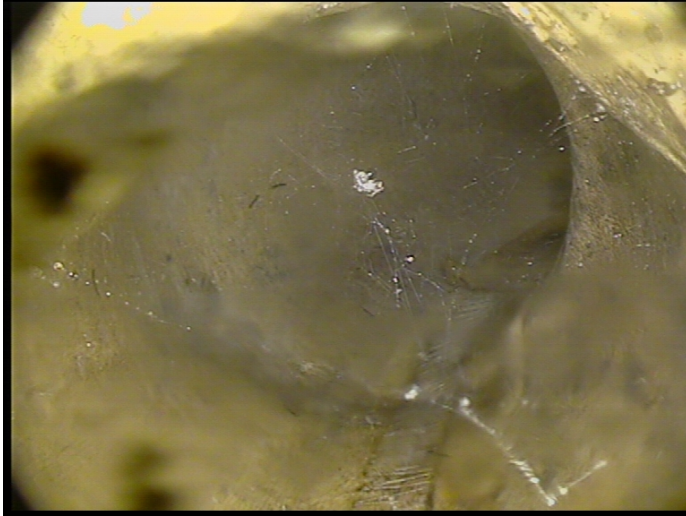
Code: **TF**
Description: **Tap Factory**

Distance (ft): **124.9**
Structural Grade: **0**
O&M Grade: **0**
Clock Start/From: **2**
Clock To:
1st Value: **4.000**
2nd Value:
Value Percent:
Continuous Index:
Within 8" of Joint: **NO**
Remarks:

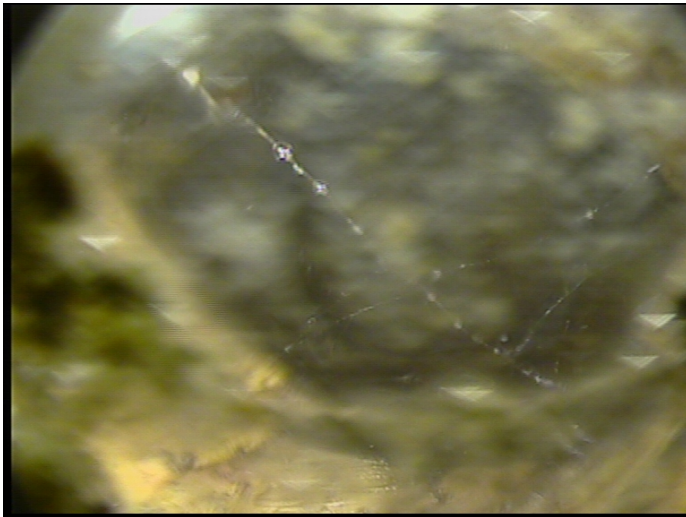
Code: **TFA**
Description: **Tap Factory Active**

Distance (ft): **129.3**
Structural Grade: **0**
O&M Grade: **0**
Clock Start/From: **10**
Clock To:
1st Value: **4.000**
2nd Value:
Value Percent:
Continuous Index:
Within 8" of Joint: **NO**
Remarks:

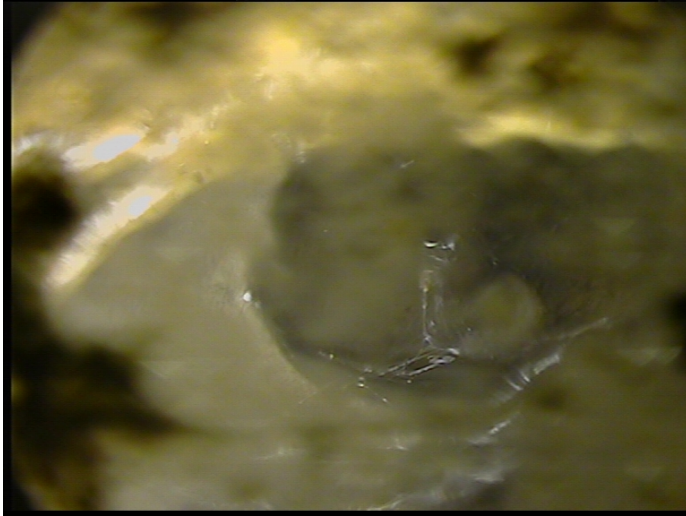
Code: **TF**
Description: **Tap Factory**

Distance (ft): **144.9**
Structural Grade: **0**
O&M Grade: **0**
Clock Start/From: **3**
Clock To:
1st Value: **4.000**
2nd Value:
Value Percent:
Continuous Index:
Within 8" of Joint: **NO**
Remarks:

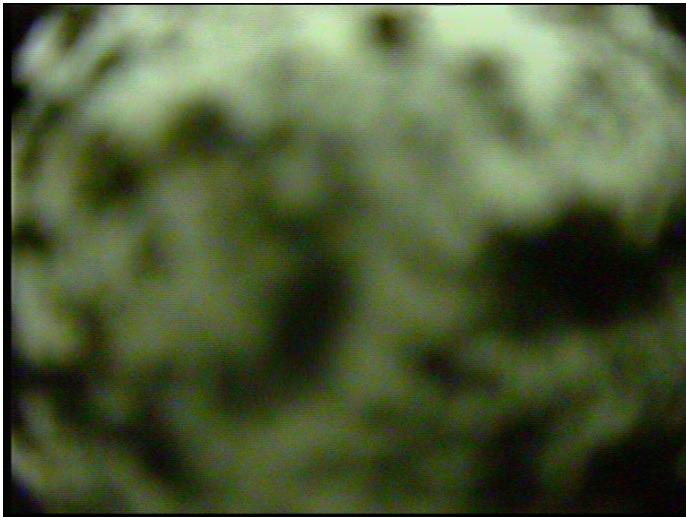
Code: **OBZ**
Description: **Obstacle Other**

Distance (ft): **161.4**
Structural Grade: **0**
O&M Grade: **2**
Clock Start/From: **6**
Clock To:
1st Value:
2nd Value:
Value Percent: **10.000**
Continuous Index:
Within 8" of Joint: **NO**
Remarks: **under water debris**

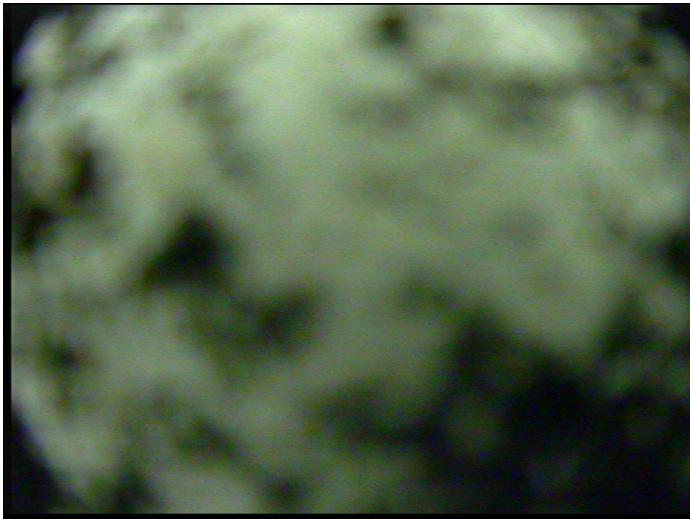
Code:	MSA
Description:	Abandoned Survey
Distance (ft):	161.5
Structural Grade:	0
O&M Grade:	0
Clock Start/From:	
Clock To:	
1st Value:	
2nd Value:	
Value Percent:	
Continuous Index:	
Within 8" of Joint:	NO
Remarks:	camera under water and debris
