Profile/Photo Observation Report

Date:	09/17/2022	Weather:		Coding:	PACP 7.0
Pipe Length (ft):	187.3	Owner:	City of Hobart	Pre Clean:	No Pre-Cleaning
P.O.#:	YES502259	Surveyor:	S. Bucklin	PSR:	M-705-033-M-705-032
Customer:	City of Hobart	Clean Date:		Shape:	C

Street:	Center Street	Flow Control:	Not Controlled
City:	Hobart, IN	Year Renewed:	
Location:	Local rural streets with light traffic, t	Tape/Media #:	
Purpose:	Routine Assessment	Dia/Height:	8"
Use:	Sanitary Sewage Pipe	Material:	PVC
Drain Area:		Lining:	None
Category:	NA

US MH: **M-705-033** DS MH: **M-705-032** Total Length Surveyed (ft): **142.5**

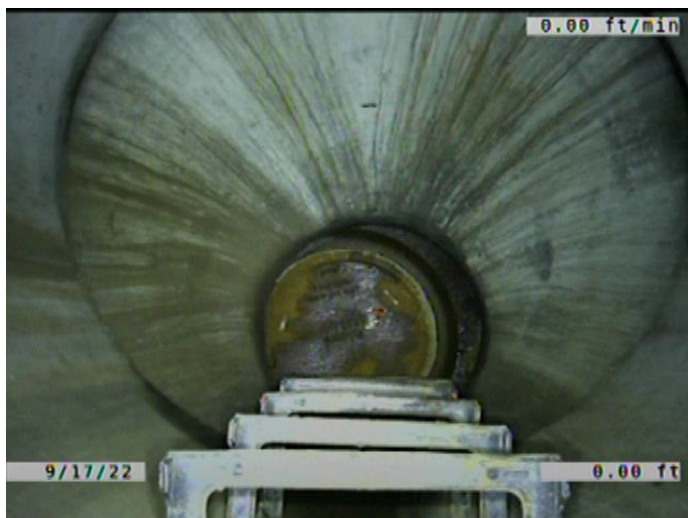
Code: **AMH**
 Description: **Manhole**

Distance (ft): **.0**
 Structural Grade: **0**
 O&M Grade: **0**
 Clock Start/From:
 Clock To:
 1st Value:
 2nd Value:
 Value Percent:
 Continuous Index:
 Within 8" of Joint: **NO**
 Remarks: **M-705-033**

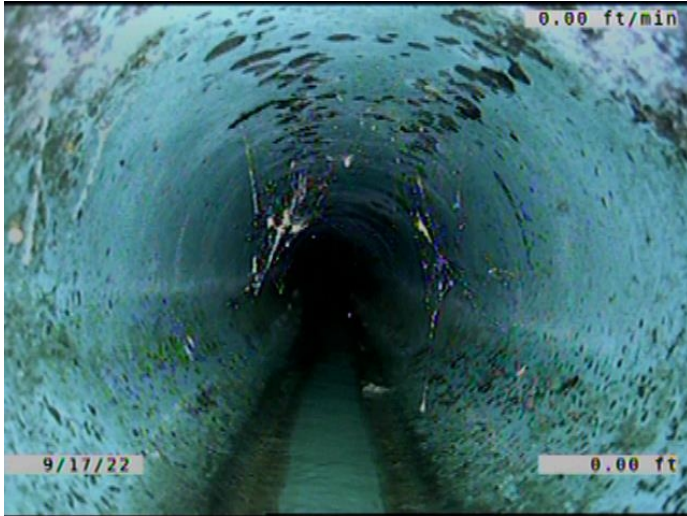
Code: **MWL**
Description: **Miscellaneous Water Level**

Distance (ft): **.0**
Structural Grade: **0**
O&M Grade: **0**
Clock Start/From:
Clock To:
1st Value:
2nd Value:
Value Percent: **5.000**
Continuous Index:
Within 8" of Joint: **NO**
Remarks:

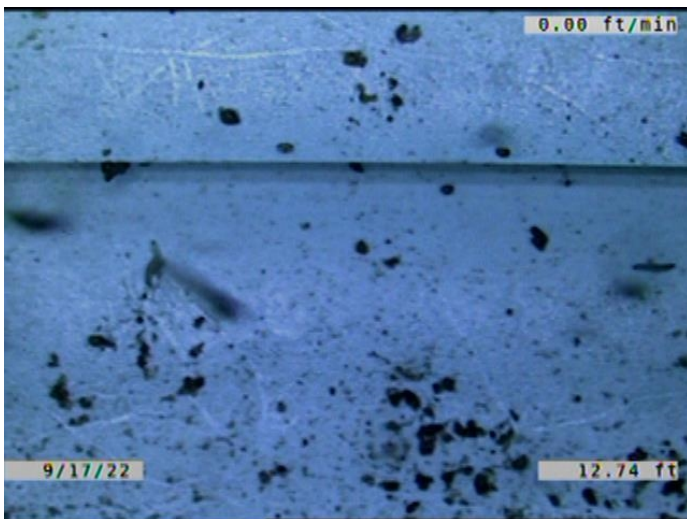
Code: **MGO**
Description: **Miscellaneous General Observation**

Distance (ft): **12.7**
Structural Grade: **0**
O&M Grade: **0**
Clock Start/From:
Clock To:
1st Value:
2nd Value:
Value Percent:
Continuous Index:
Within 8" of Joint: **NO**
Remarks: **JOINT/ PIPES NOT PUSHED ALL THE WAY TOGETHER WHEN INSTALLED**

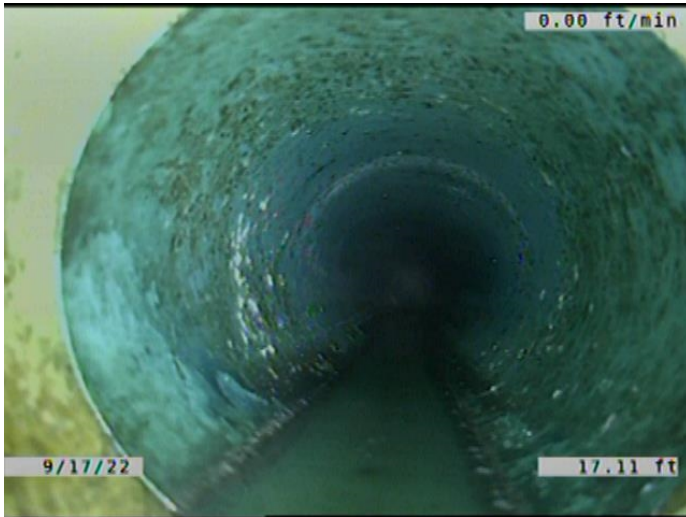
Code: **LR**
Description: **Line Right**

Distance (ft): **17.1**
Structural Grade: **0**
O&M Grade: **1**
Clock Start/From:
Clock To:
1st Value:
2nd Value:
Value Percent: **5.000**
Continuous Index:
Within 8" of Joint: **NO**
Remarks:

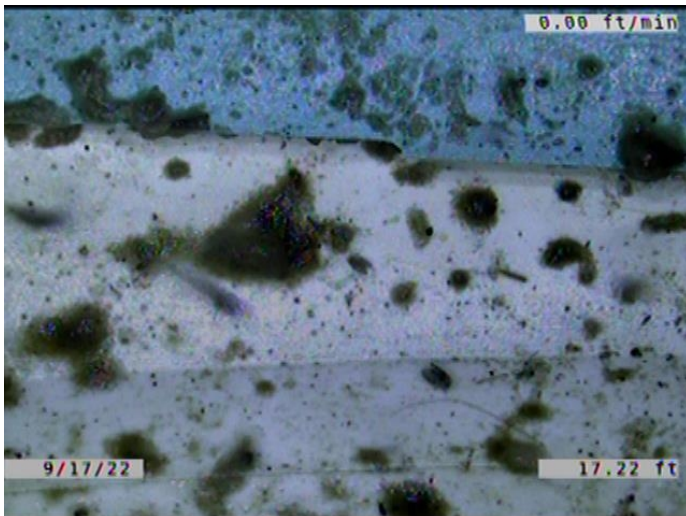
Code: **MGO**
Description: **Miscellaneous General Observation**

Distance (ft): **17.2**
Structural Grade: **0**
O&M Grade: **0**
Clock Start/From:
Clock To:
1st Value:
2nd Value:
Value Percent:
Continuous Index:
Within 8" of Joint: **NO**
Remarks: **JOINT/ PIPES NOT PUSHED ALL THE WAY TOGETHER WHEN INSTALLED**

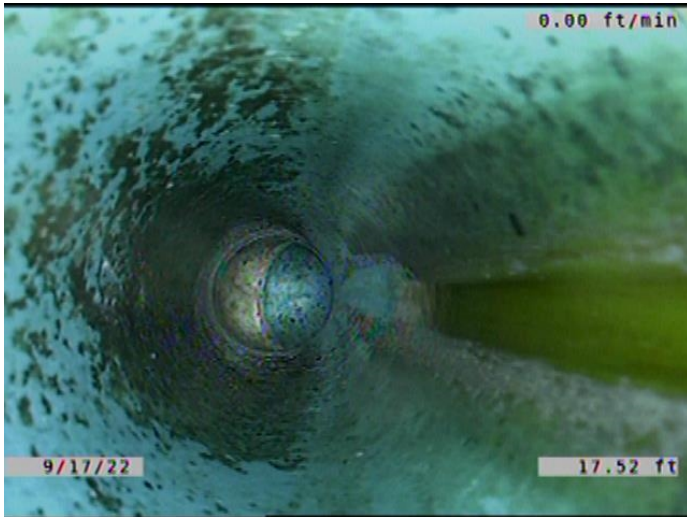
Code: **TFA**
 Description: **Tap Factory Activity**

Distance (ft): **17.5**
 Structural Grade: **0**
 O&M Grade: **0**
 Clock Start/From: **2**
 Clock To:
 1st Value: **6.000**
 2nd Value:
 Value Percent:
 Continuous Index:
 Within 8" of Joint: **YES**
 Remarks:

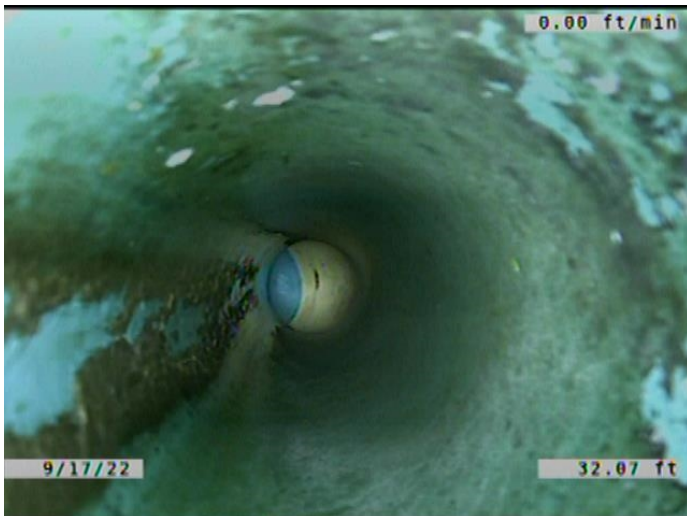
Code: **TF**
 Description: **Tap Factory**

Distance (ft): **32.1**
 Structural Grade: **0**
 O&M Grade: **0**
 Clock Start/From: **11**
 Clock To:
 1st Value: **6.000**
 2nd Value:
 Value Percent:
 Continuous Index:
 Within 8" of Joint: **YES**
 Remarks: **CONSTANTLY RUNNING WATER.**

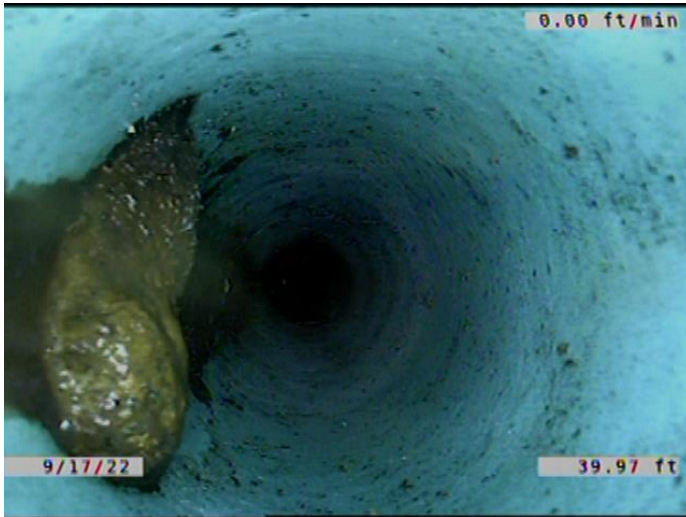
Code: **TF**
Description: **Tap Factory**

Distance (ft): **40.0**
Structural Grade: **0**
O&M Grade: **0**
Clock Start/From: **9**
Clock To:
1st Value: **6.000**
2nd Value:
Value Percent:
Continuous Index:
Within 8" of Joint: **YES**
Remarks:

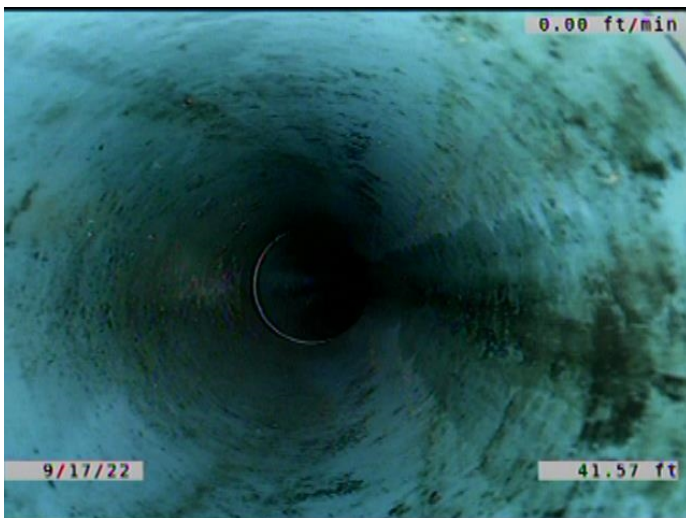
Code: **TF**
Description: **Tap Factory**

Distance (ft): **41.6**
Structural Grade: **0**
O&M Grade: **0**
Clock Start/From: **3**
Clock To:
1st Value: **6.000**
2nd Value:
Value Percent:
Continuous Index:
Within 8" of Joint: **YES**
Remarks:

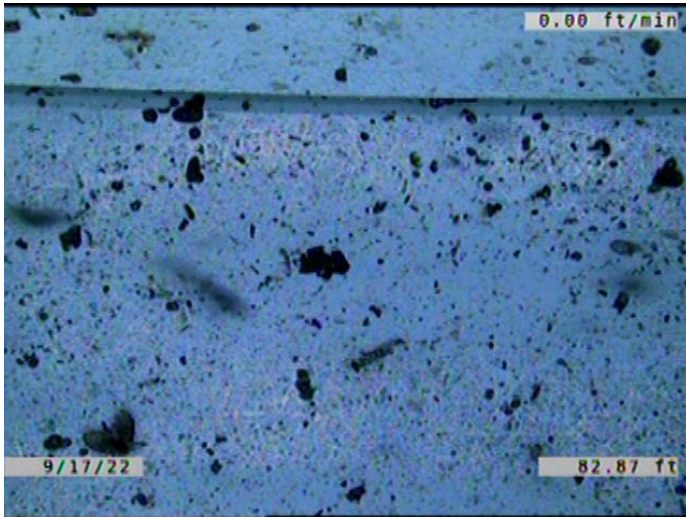
Code: **MGO**
 Description: **Miscellaneous General Observation**

Distance (ft): **82.9**
 Structural Grade: **0**
 O&M Grade: **0**
 Clock Start/From:
 Clock To:
 1st Value:
 2nd Value:
 Value Percent:
 Continuous Index:
 Within 8" of Joint: **NO**
 Remarks: **JOINT/ PIPES NOT PUSHED ALL THE WAY TOGETHER WHEN INSTALLED**

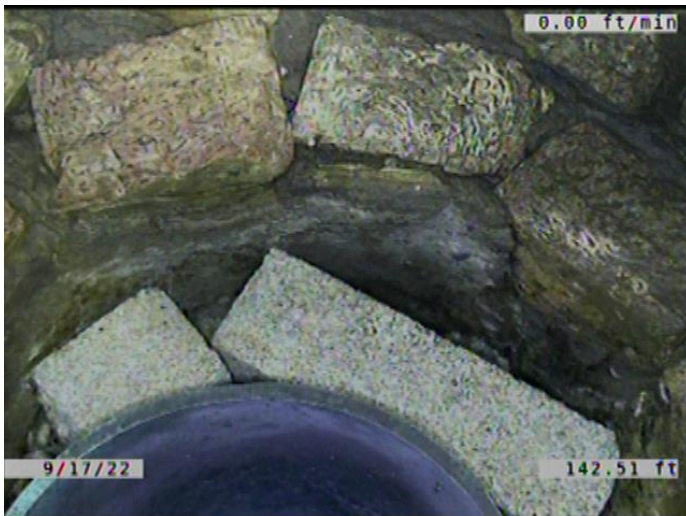
Code: **VC**
 Description: **Vermin Cockroach**

Distance (ft): **142.5**
 Structural Grade: **0**
 O&M Grade: **1**
 Clock Start/From:
 Clock To:
 1st Value:
 2nd Value:
 Value Percent:
 Continuous Index:
 Within 8" of Joint: **YES**
 Remarks:

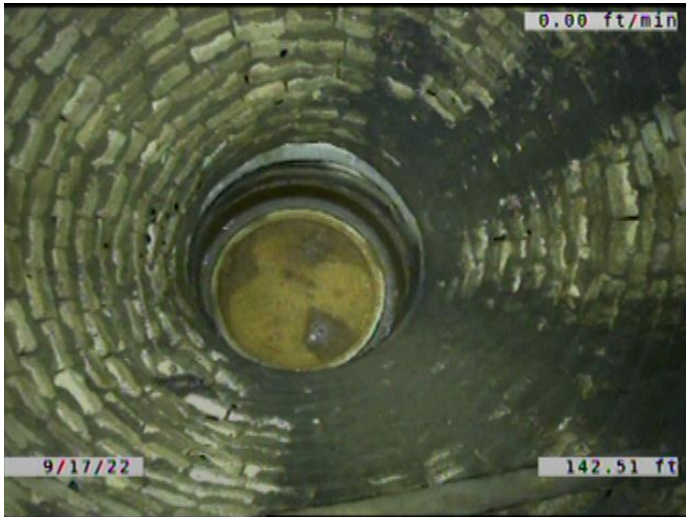
Code:	AMH
Description:	Manhole
Distance (ft):	142.5
Structural Grade:	0
O&M Grade:	0
Clock Start/From:	
Clock To:	
1st Value:	
2nd Value:	
Value Percent:	
Continuous Index:	
Within 8" of Joint:	NO
Remarks:	M-705-032
