Profile/Photo Observation Report

| P.O.#: | 912_1 | Surveyor: | M. Pielacha | PSR: | P-705-032-033 |

| Street: | Center Street | Flow Control: | |

| US MH: | M-705-33 | DS MH: | M-705-32 |

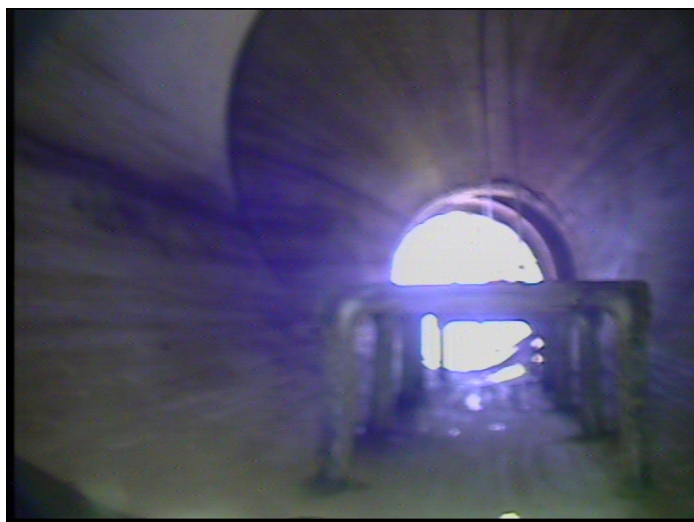
Code: **AMH**
 Description: **Manhole**

Distance (ft): **.0**
 Structural Grade: **0**
 O&M Grade: **0**
 Clock Start/From:
 Clock To:
 1st Value:
 2nd Value:
 Value Percent:
 Continuous Index:
 Within 8" of Joint: **NO**
 Remarks: **M-705-33**

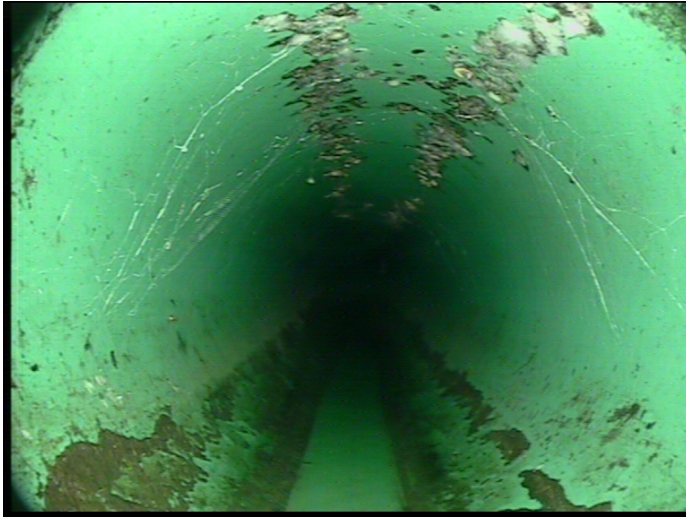
| Code: | MWL |
| Description: | Water Level |
| Distance (ft): | .0 |
| Value Percent: | 5.000 |

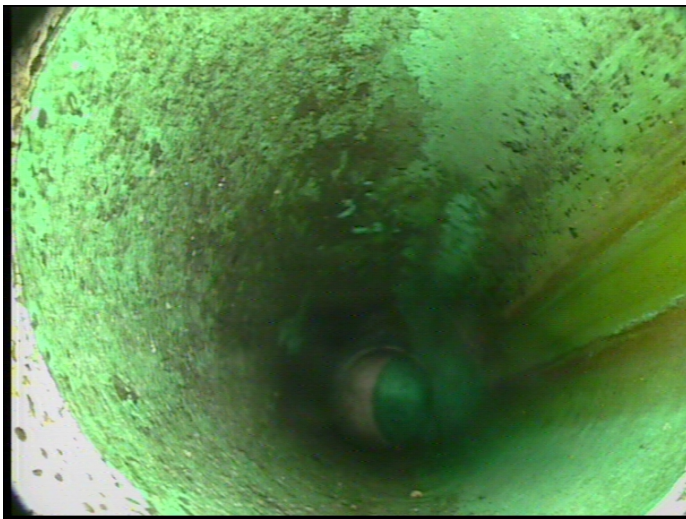
| Code: | TF |
| Description: | Tap Factory |
| Distance (ft): | 19.6 |
| Clock Start/From: | 2 |
| 1st Value: | 4.000 |

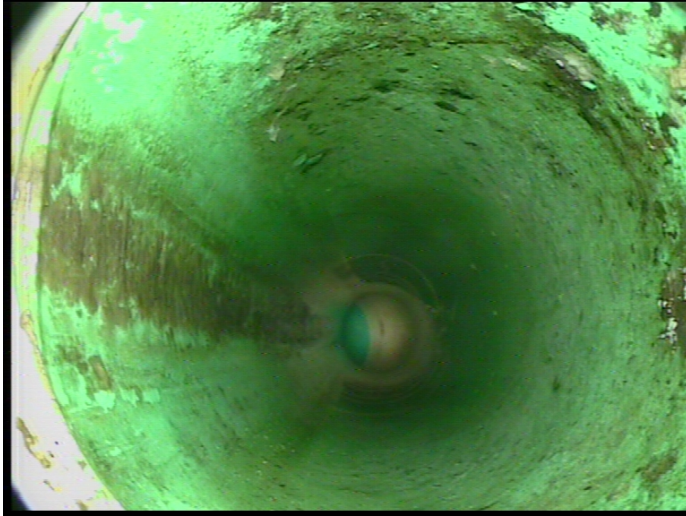
| Code: | TF |
| Description: | Tap Factory |
| Distance (ft): | 34.5 |
| Clock Start/From: | 10 |
| 1st Value: | 4.000 |

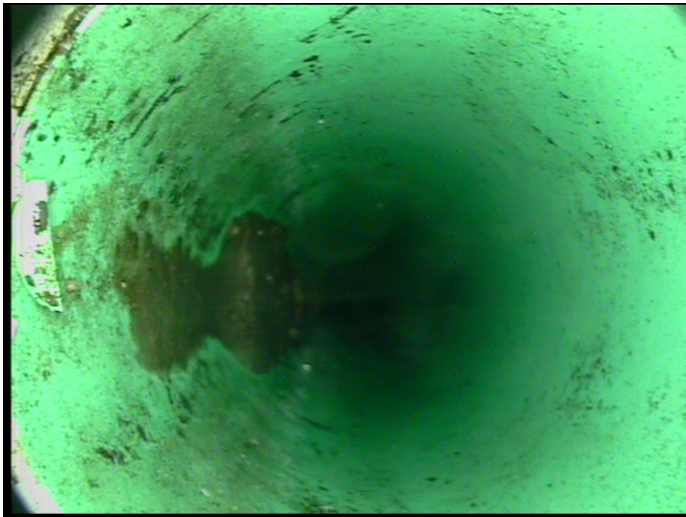
| Code: | TF |
| Description: | Tap Factory |
| Distance (ft): | 41.4 |
| Clock Start/From: | 9 |
| 1st Value: | 4.000 |

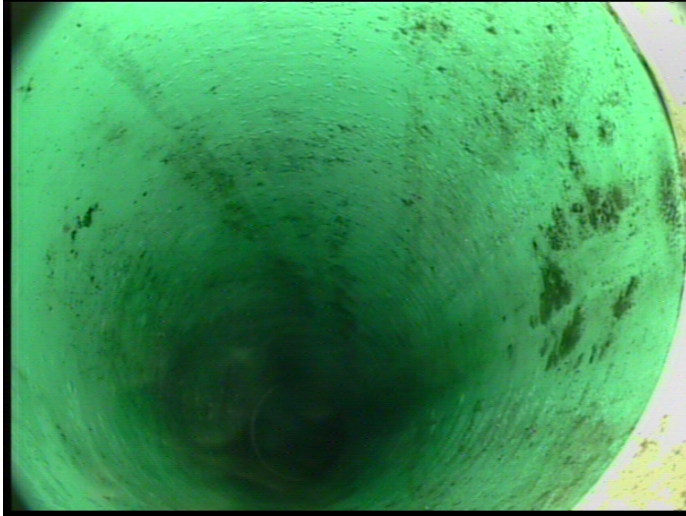
Code: **TF**
Description: **Tap Factory**

Distance (ft): **42.7**
Structural Grade: **0**
O&M Grade: **0**
Clock Start/From: **3**
Clock To:
1st Value: **4.000**
2nd Value:
Value Percent:
Continuous Index:
Within 8" of Joint: **NO**
Remarks:

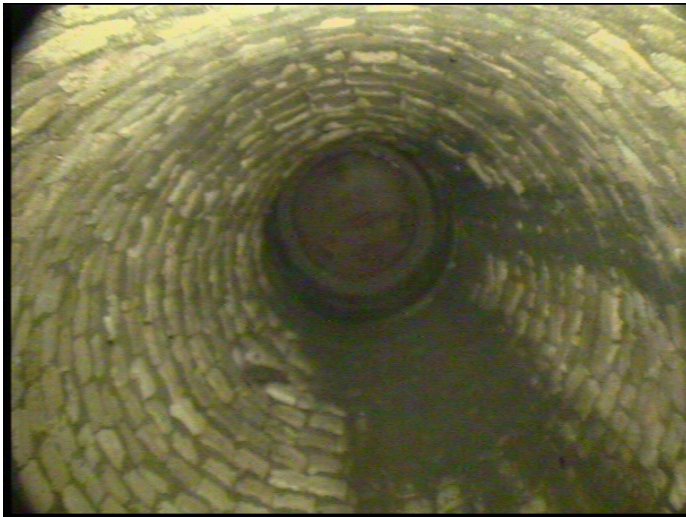
Code: **AMH**
Description: **Manhole**

Distance (ft): **140.5**
Structural Grade: **0**
O&M Grade: **0**
Clock Start/From:
Clock To:
1st Value:
2nd Value:
Value Percent:
Continuous Index:
Within 8" of Joint: **NO**
Remarks: **M-705-32**
