## Profile/Photo Observation Report

Date:	<b>04/30/2018</b>	Weather:		Coding:	<b>PACP 6.0</b>
Pipe Length (ft):		Owner:	<b>City of Hobart</b>	Pre Clean:	<b>No Pre-Cleaning</b>
P.O.#:	<b>146</b>	Surveyor:	<b>M. Pielacha</b>	PSR:	<b>P-705-047-035</b>
Customer:	<b>City of Hobart</b>	Clean Date:		Shape:	<b>C</b>

Street:	<b>East Street</b>	Flow Control:	<b>Not Controlled</b>
City:	<b>Hobart, IN</b>	Year Renewed:	
Location:	<b>Light Highway</b>	Tape/Media #:	<b>DEP 146</b>
Purpose:	<b>Routine Assessment</b>	Dia/Height:	<b>18"</b>
Use:	<b>Sanitary</b>	Material:	<b>VCP</b>
Drain Area:		Lining:	
Category:	<b>NA</b>		
Comment:	<b>5-21-2018</b>		
Location Details:		Direction of Survey:	<b>Downstream</b>
US MH:	<b>M-705-035</b>	DS MH:	<b>M-705-047</b>
		Total Length Surveyed (ft):	<b>40.1</b>

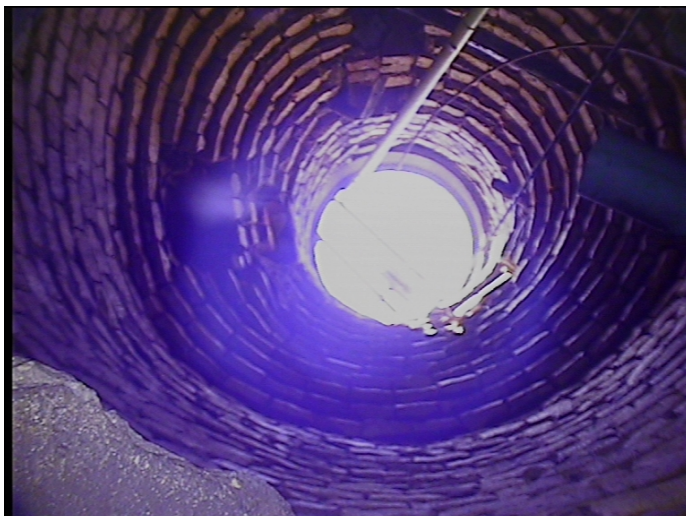
Code: **AMH**  
 Description: **Manhole**

Distance (ft): **.0**  
 Structural Grade: **0**  
 O&M Grade: **0**  
 Clock Start/From:  
 Clock To:  
 1st Value:  
 2nd Value:  
 Value Percent:  
 Continuous Index:  
 Within 8" of Joint: **NO**  
 Remarks: **M-75-047**

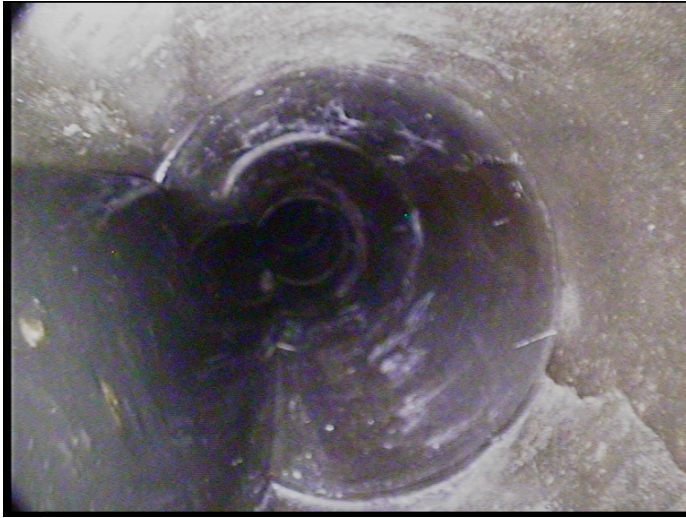
Code: **MWL**  
Description: **Water Level**

Distance (ft): **.0**  
Structural Grade: **0**  
O&M Grade: **0**  
Clock Start/From:  
Clock To:  
1st Value:  
2nd Value:  
Value Percent: **10.000**  
Continuous Index:  
Within 8" of Joint: **NO**  
Remarks:

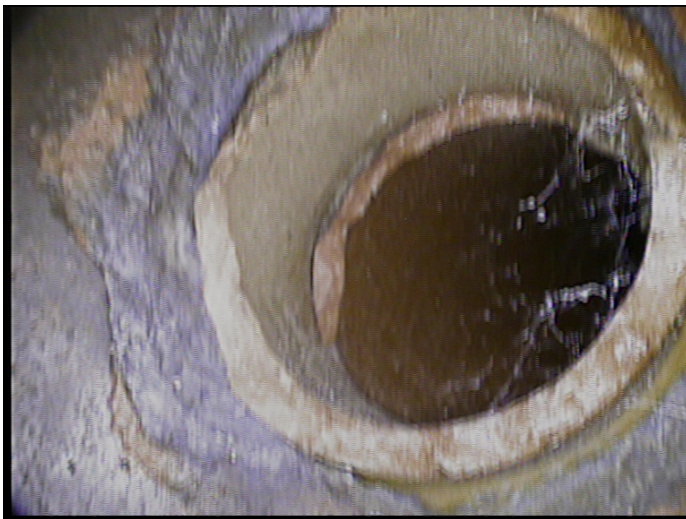
Code: **TB**  
Description: **Tap Break-in**

Distance (ft): **.0**  
Structural Grade: **0**  
O&M Grade: **0**  
Clock Start/From: **2**  
Clock To:  
1st Value: **4.000**  
2nd Value:  
Value Percent:  
Continuous Index:  
Within 8" of Joint: **NO**  
Remarks:

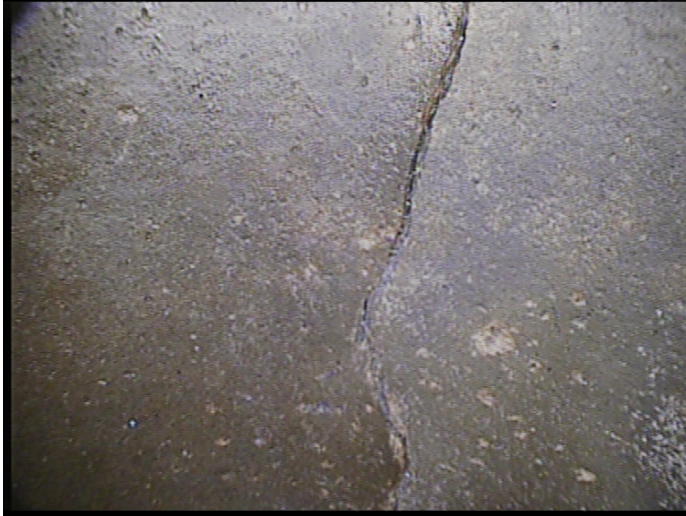
Code:	<b>FL</b>
Description:	<b>Fracture Longitudinal</b>
Distance (ft):	<b>.0</b>
Structural Grade:	<b>3</b>
O&M Grade:	<b>0</b>
Clock Start/From:	<b>2</b>
Clock To:	
1st Value:	
2nd Value:	
Value Percent:	
Continuous Index:	
Within 8" of Joint:	<b>YES</b>
Remarks:

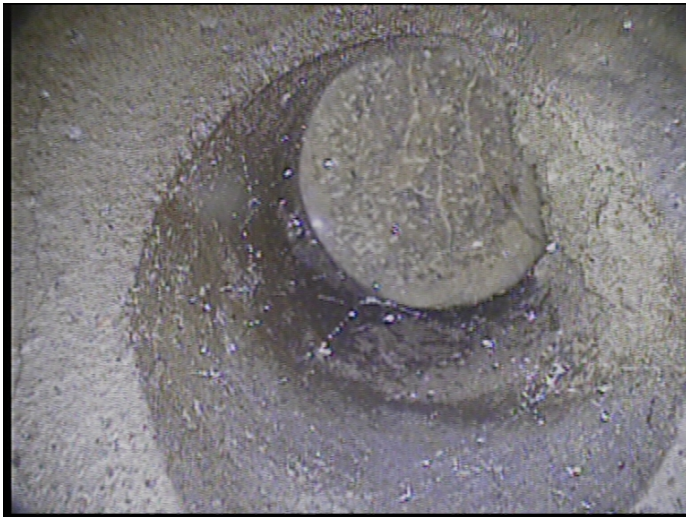
Code:	<b>TFC</b>
Description:	<b>Tap Factory Capped</b>
Distance (ft):	<b>28.3</b>
Structural Grade:	<b>0</b>
O&M Grade:	<b>0</b>
Clock Start/From:	<b>2</b>
Clock To:	
1st Value:	<b>4.000</b>
2nd Value:	
Value Percent:	
Continuous Index:	
Within 8" of Joint:	<b>NO</b>
Remarks:

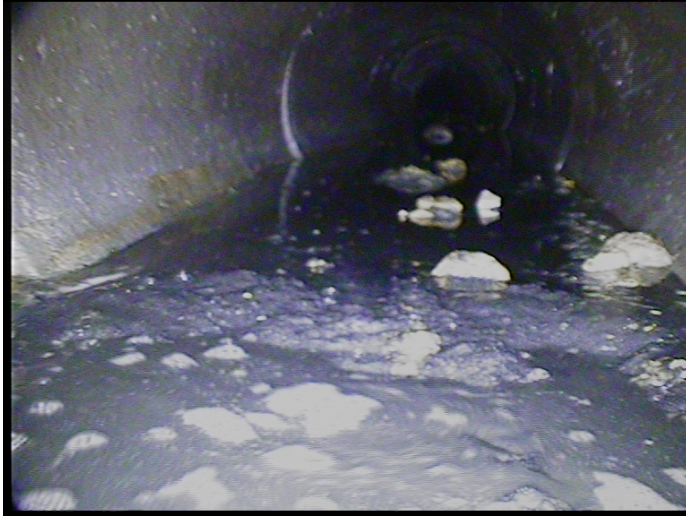
Code: **DSF**  
Description: **Deposits Settled Fine**

Distance (ft): **34.6**  
Structural Grade: **0**  
O&M Grade: **3**  
Clock Start/From: **4**  
Clock To: **8**  
1st Value:  
2nd Value:  
Value Percent: **15.000**  
Continuous Index: **S01**  
Within 8" of Joint: **YES**  
Remarks:

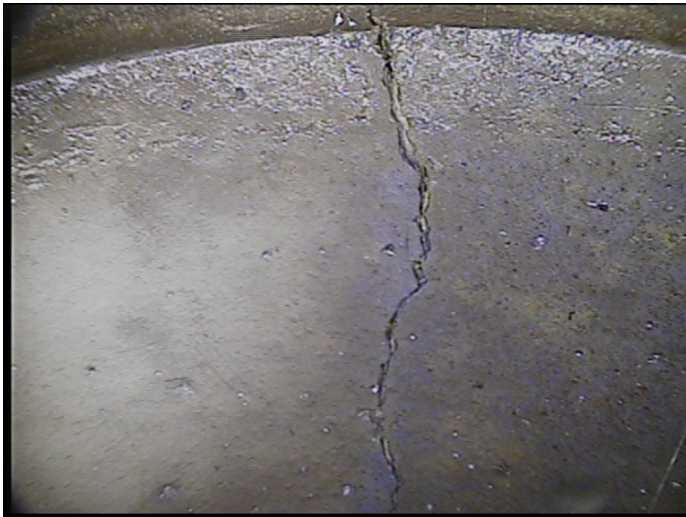
Code: **FL**  
Description: **Fracture Longitudinal**

Distance (ft): **35.9**  
Structural Grade: **3**  
O&M Grade: **0**  
Clock Start/From: **12**  
Clock To:  
1st Value:  
2nd Value:  
Value Percent:  
Continuous Index:  
Within 8" of Joint: **YES**  
Remarks:

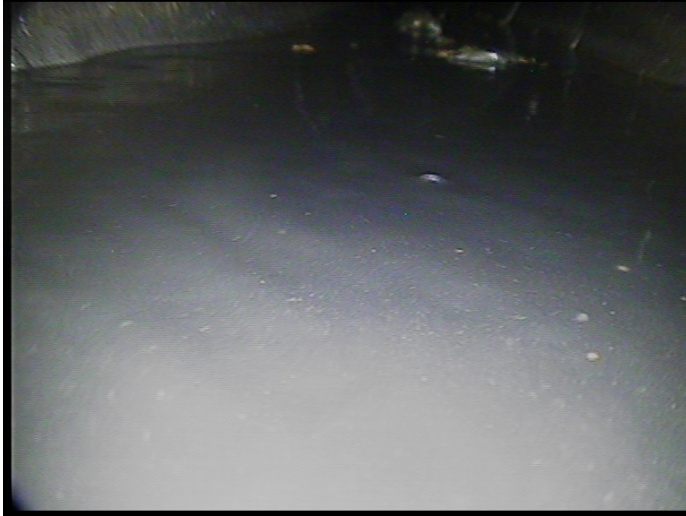
Code: **DSF**  
Description: **Deposits Settled Fine**

Distance (ft): **37.9**  
Structural Grade: **0**  
O&M Grade: **3**  
Clock Start/From: **4**  
Clock To: **8**  
1st Value:  
2nd Value:  
Value Percent: **20.000**  
Continuous Index: **F01**  
Within 8" of Joint: **NO**  
Remarks:

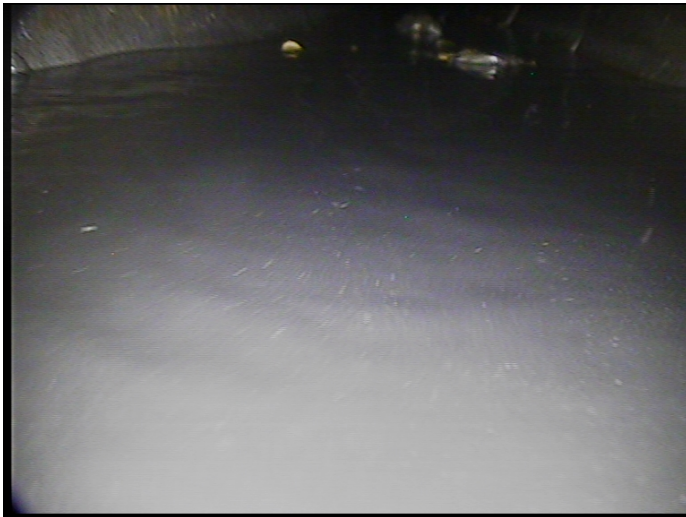
Code: **MSA**  
Description: **Abandoned Survey**

Distance (ft): **37.9**  
Structural Grade: **0**  
O&M Grade: **0**  
Clock Start/From:  
Clock To:  
1st Value:  
2nd Value:  
Value Percent:  
Continuous Index:  
Within 8" of Joint: **NO**  
Remarks: **sediment**
