Profile/Photo Observation Report

| Street: | 2nd Street | Flow Control: | Not Controlled |
| US MH: | M-705-035 | DS MH: | M-705-047 |

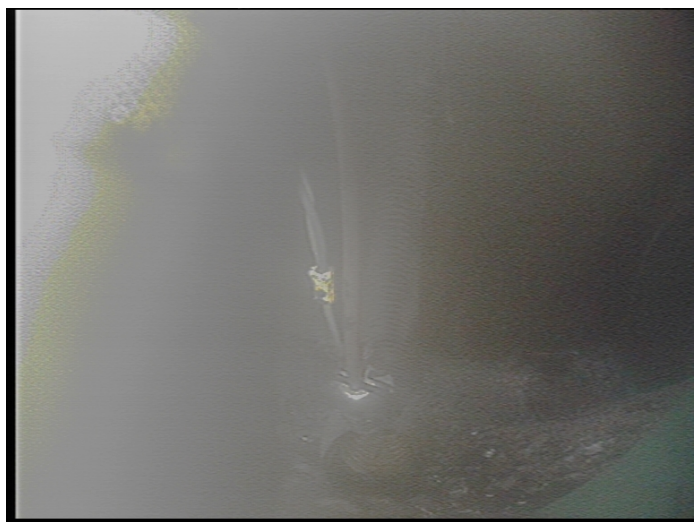
Code: **AMH**
Description: **Manhole**

Distance (ft): **.0**
Structural Grade: **0**
O&M Grade: **0**
Clock Start/From:
Clock To:
1st Value:
2nd Value:
Value Percent:
Continuous Index:
Within 8" of Joint: **NO**
Remarks: **M-705-035**

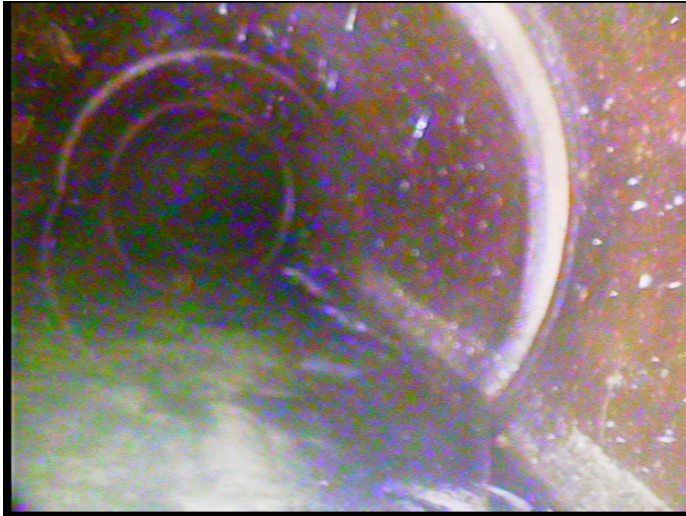
Code: **MWL**
Description: **Water Level**

Distance (ft): **.0**
Structural Grade: **0**
O&M Grade: **0**
Clock Start/From:
Clock To:
1st Value:
2nd Value:
Value Percent: **10.000**
Continuous Index:
Within 8" of Joint: **NO**
Remarks:

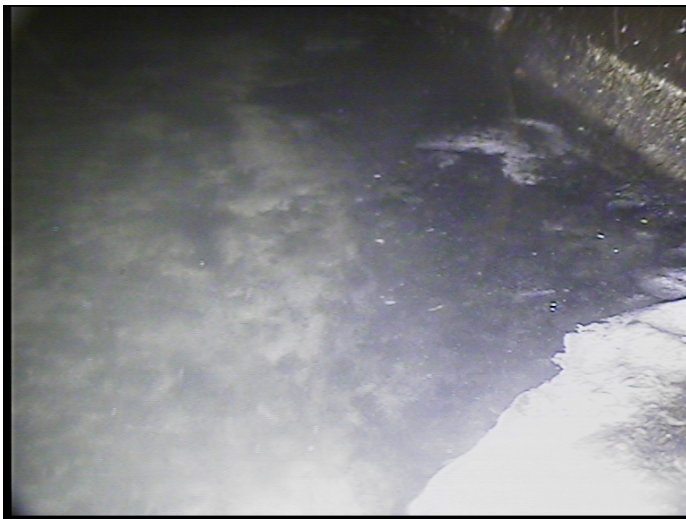
Code: **DSF**
Description: **Deposits Settled Fine**

Distance (ft): **.0**
Structural Grade: **0**
O&M Grade: **3**
Clock Start/From: **4**
Clock To: **8**
1st Value:
2nd Value:
Value Percent: **15.000**
Continuous Index: **S01**
Within 8" of Joint: **YES**
Remarks:

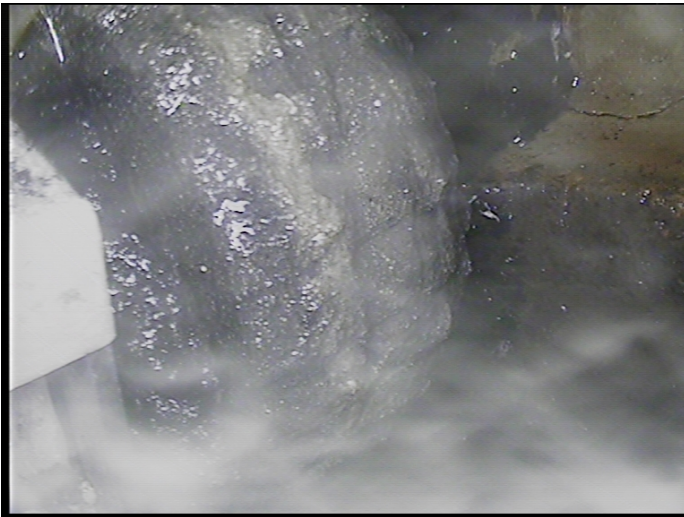
Code: **DSF**
Description: **Deposits Settled Fine**

Distance (ft): **6.4**
Structural Grade: **0**
O&M Grade: **3**
Clock Start/From: **4**
Clock To: **8**
1st Value:
2nd Value:
Value Percent: **15.000**
Continuous Index: **F01**
Within 8" of Joint: **NO**
Remarks:

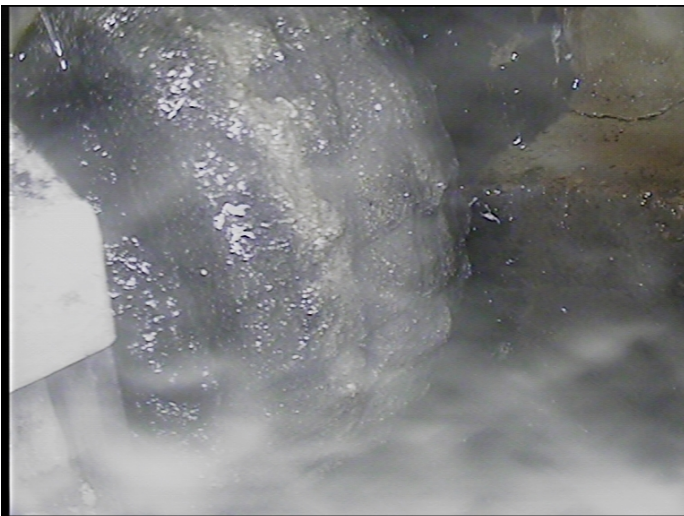
Code: **MSA**
Description: **Abandoned Survey**

Distance (ft): **6.4**
Structural Grade: **0**
O&M Grade: **0**
Clock Start/From:
Clock To:
1st Value:
2nd Value:
Value Percent:
Continuous Index:
Within 8" of Joint: **NO**
Remarks: **sediment**
