Profile/Photo Observation Report

Date:	08/11/2022	Weather:		Coding:	PACP 7.0
Pipe Length (ft):	334.0	Owner:	City of Hobart	Pre Clean:	Heavy Cleaning
P.O.#:	YES502259	Surveyor:	S. Bucklin	PSR:	P-705-047-035
Customer:	City of Hobart	Clean Date:	08/03/2022	Shape:	C

Street:	2nd Street	Flow Control:	Not Controlled
City:	Hobart, IN	Year Renewed:	
Location:	Local rural streets with light traffic, t	Tape/Media #:	
Purpose:	Routine Assessment	Dia/Height:	18"
Use:	Sanitary Sewage Pipe	Material:	VCP
Drain Area:		Lining:	None
Category:	NA		
Comment:			
Location Details:		Direction of Survey:	Downstream
US MH:	M-705-035	DS MH:	M-705-047
		Total Length Surveyed (ft):	331.2

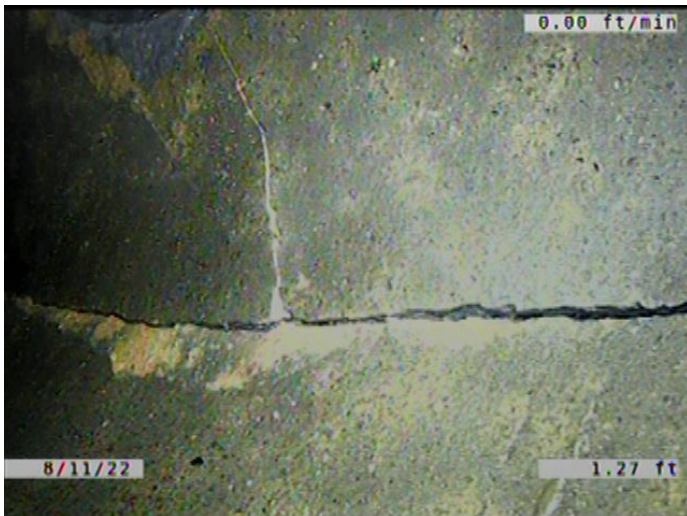
Code: **B**
 Description: **Broken**

Distance (ft): **1.3**
 Structural Grade: **4**
 O&M Grade: **0**
 Clock Start/From: **7**
 Clock To: **5**
 1st Value:
 2nd Value:
 Value Percent:
 Continuous Index: **S01**
 Within 8" of Joint: **YES**
 Remarks:

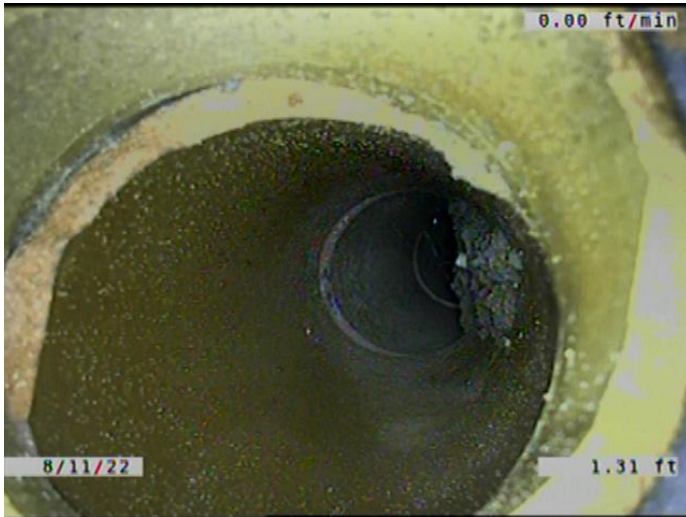
Code: **TBI**
 Description: **Tap Break-in Intruding**

Distance (ft): **1.3**
 Structural Grade: **0**
 O&M Grade: **2**
 Clock Start/From: **2**
 Clock To:
 1st Value: **6.000**
 2nd Value: **1.000**
 Value Percent:
 Continuous Index:
 Within 8" of Joint: **NO**
 Remarks:

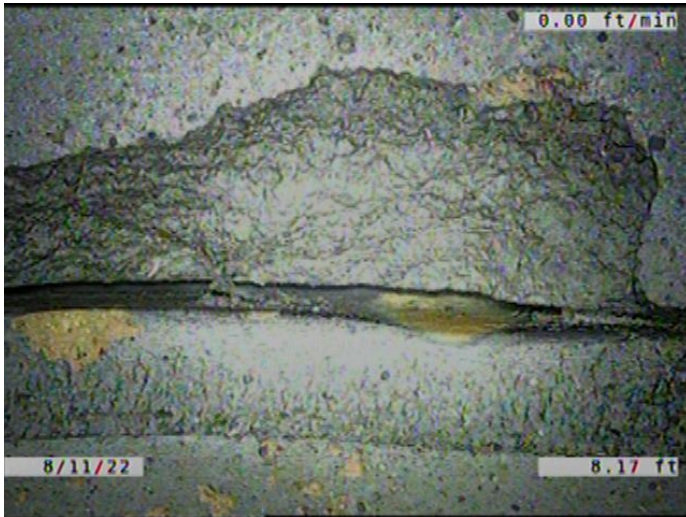
Code:	SZ
Description:	Surface Damage Other
Distance (ft):	8.2
Structural Grade:	0
O&M Grade:	0
Clock Start/From:	11
Clock To:	1
1st Value:	
2nd Value:	
Value Percent:	
Continuous Index:	
Within 8" of Joint:	YES
Remarks:	A PIECE CHIPPED AWAY FROM THE JOINT.

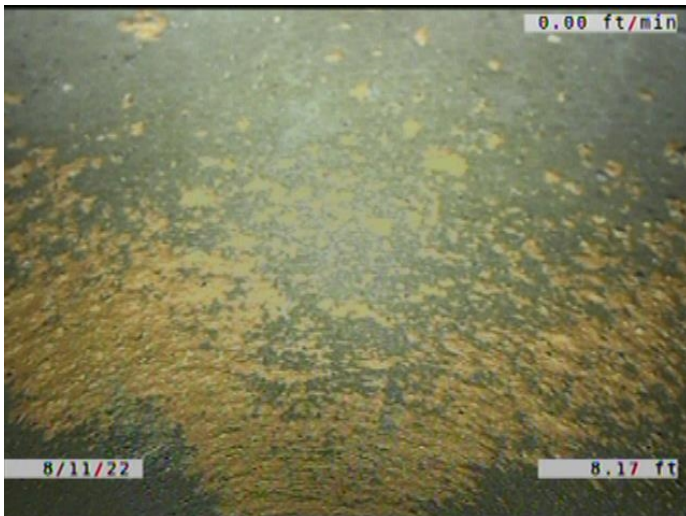
Code:	SSC
Description:	Surface Spalling of Damage Coating
Distance (ft):	8.2
Structural Grade:	1
O&M Grade:	0
Clock Start/From:	9
Clock To:	3
1st Value:	
2nd Value:	
Value Percent:	
Continuous Index:	S02
Within 8" of Joint:	YES
Remarks:

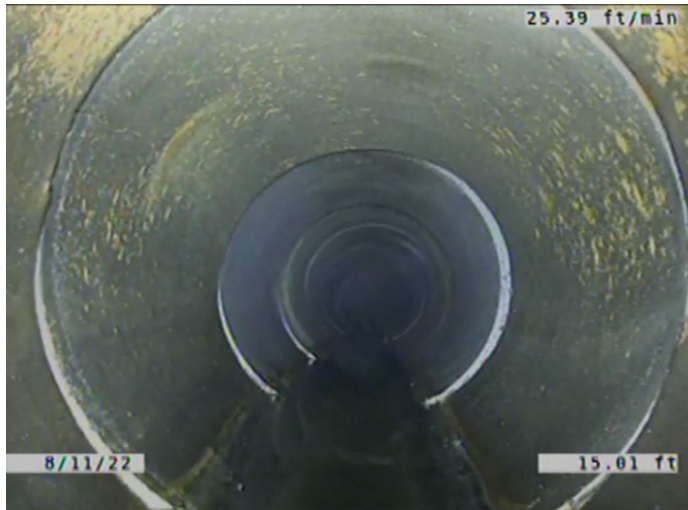
Code: **CL**
Description: **Crack Longitudinal**

Distance (ft): **15.0**
Structural Grade: **2**
O&M Grade: **0**
Clock Start/From: **10**
Clock To:
1st Value:
2nd Value:
Value Percent:
Continuous Index:
Within 8" of Joint: **YES**
Remarks:

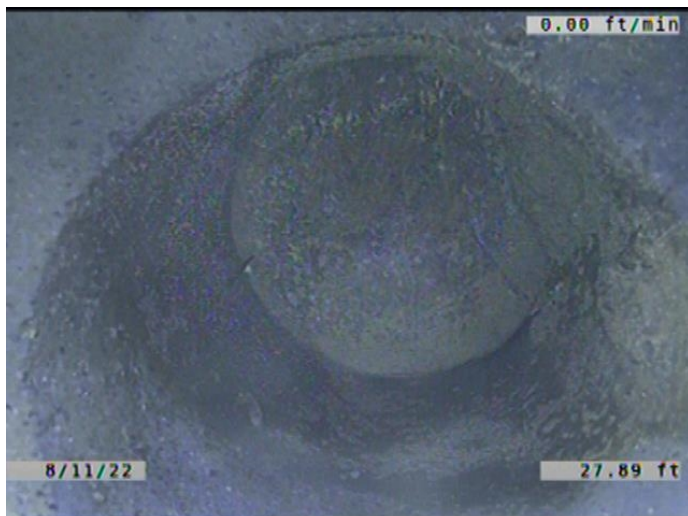
Code: **TFC**
Description: **Tap Factory Capped**

Distance (ft): **27.9**
Structural Grade: **0**
O&M Grade: **0**
Clock Start/From: **1**
Clock To:
1st Value: **6.000**
2nd Value:
Value Percent:
Continuous Index:
Within 8" of Joint: **YES**
Remarks: **CAP CRACKED.**

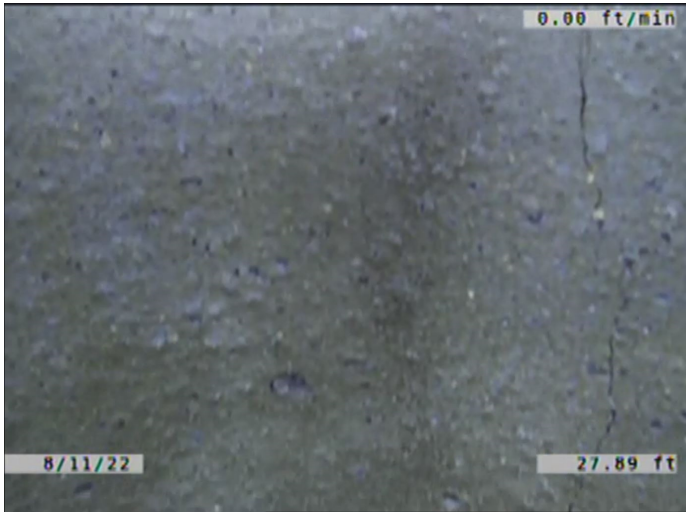
Code: **CL**
Description: **Crack Longitudinal**

Distance (ft): **27.9**
Structural Grade: **2**
O&M Grade: **0**
Clock Start/From: **1**
Clock To:
1st Value:
2nd Value:
Value Percent:
Continuous Index:
Within 8" of Joint: **NO**
Remarks:

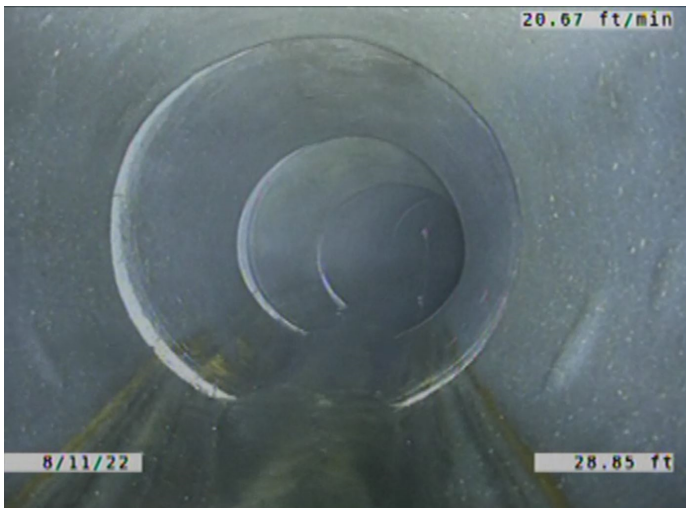
Code: **SZ**
Description: **Surface Damage Other**

Distance (ft): **28.9**
Structural Grade: **0**
O&M Grade: **0**
Clock Start/From: **8**
Clock To: **4**
1st Value:
2nd Value:
Value Percent:
Continuous Index:
Within 8" of Joint: **NO**
Remarks: **Indentations, Factory Defect**

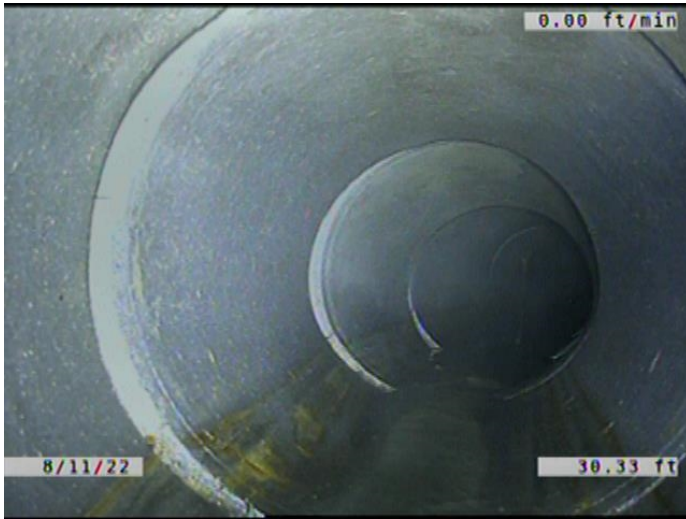
Code: **SSC**
Description: **Surface Spalling of Damage Coating**

Distance (ft): **30.3**
Structural Grade: **1**
O&M Grade: **0**
Clock Start/From: **9**
Clock To: **3**
1st Value:
2nd Value:
Value Percent:
Continuous Index: **F02**
Within 8" of Joint: **YES**
Remarks:

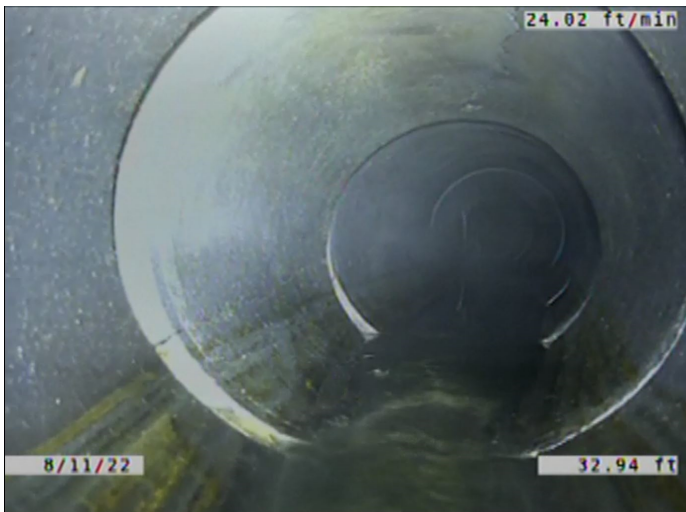
Code: **FH3**
Description: **Fracture Longitudinal Hinge, 3**

Distance (ft): **32.9**
Structural Grade: **4**
O&M Grade: **0**
Clock Start/From: **9**
Clock To: **3**
1st Value:
2nd Value:
Value Percent:
Continuous Index:
Within 8" of Joint: **YES**
Remarks:

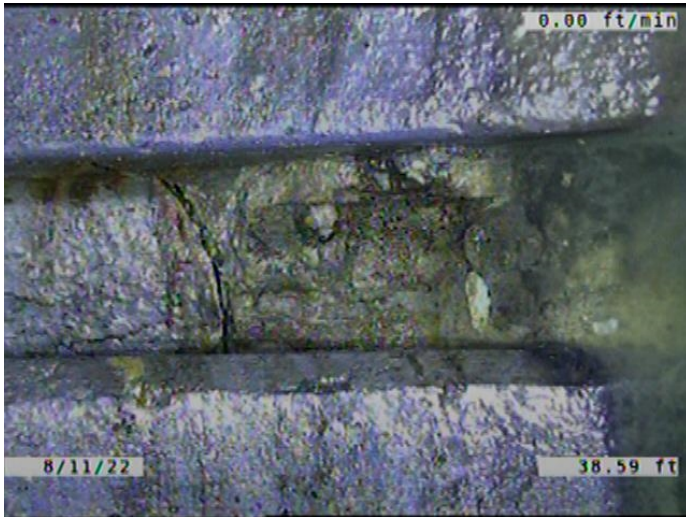
Code: **JAM**
 Description: **Joint Angular Medium**

Distance (ft): **38.6**
 Structural Grade: **3**
 O&M Grade: **0**
 Clock Start/From:
 Clock To:
 1st Value:
 2nd Value:
 Value Percent:
 Continuous Index:
 Within 8" of Joint: **NO**
 Remarks:

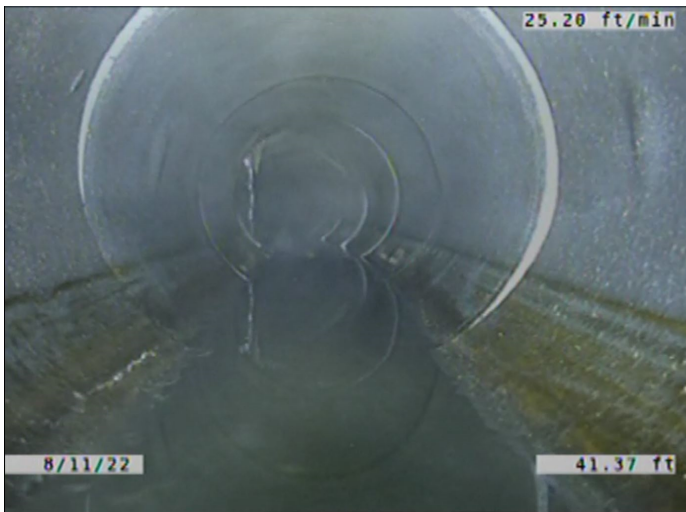
Code: **SZ**
 Description: **Surface Damage Other**

Distance (ft): **41.4**
 Structural Grade: **0**
 O&M Grade: **0**
 Clock Start/From: **9**
 Clock To: **3**
 1st Value:
 2nd Value:
 Value Percent:
 Continuous Index:
 Within 8" of Joint: **NO**
 Remarks: **Indentations, Factory Defect**

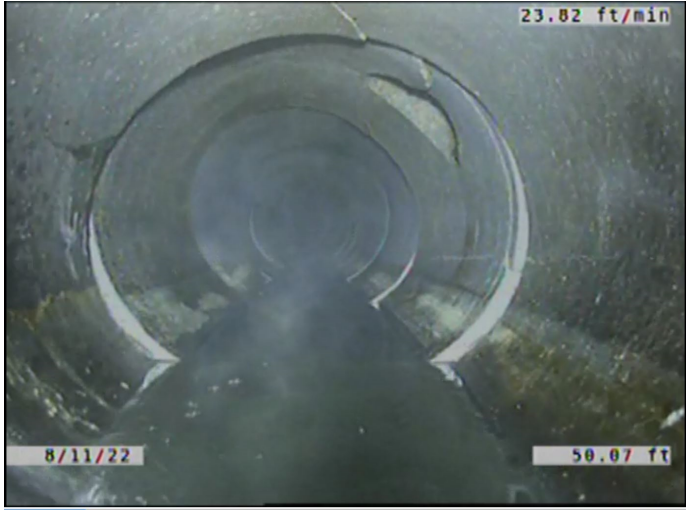
Code: **B**
Description: **Broken**

Distance (ft): **50.1**
Structural Grade: **4**
O&M Grade: **0**
Clock Start/From: **7**
Clock To: **3**
1st Value:
2nd Value:
Value Percent:
Continuous Index: **S08**
Within 8" of Joint: **YES**
Remarks:

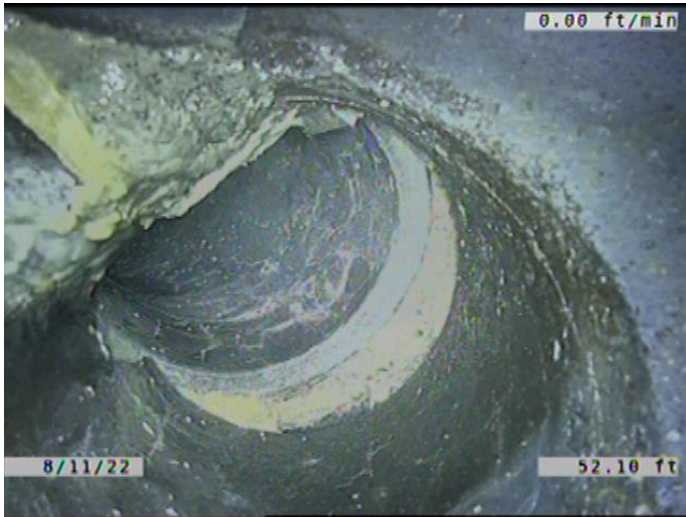
Code: **TFD**
Description: **Tap Factory Defective**

Distance (ft): **52.1**
Structural Grade: **0**
O&M Grade: **3**
Clock Start/From: **11**
Clock To:
1st Value: **6.000**
2nd Value:
Value Percent:
Continuous Index:
Within 8" of Joint: **YES**
Remarks: **TAP BROKEN. SERVICE OFFSET. SOIL VISIBLE. CONSTANTLY RUNNING WA**

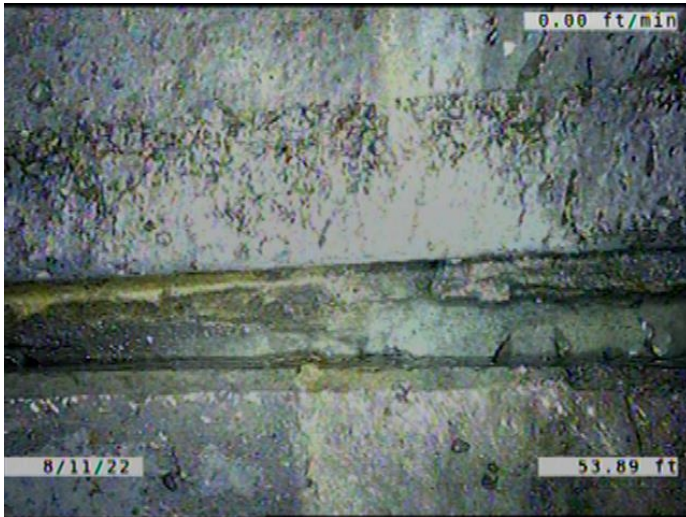
Code: **IRJ**
 Description: **Infiltration Runner Joint**

Distance (ft): **53.9**
 Structural Grade: **0**
 O&M Grade: **4**
 Clock Start/From: **8**
 Clock To:
 1st Value:
 2nd Value:
 Value Percent:
 Continuous Index:
 Within 8" of Joint: **YES**
 Remarks:

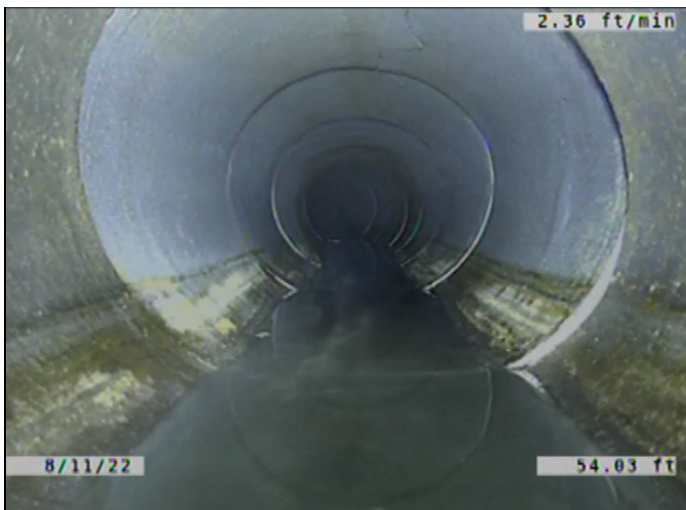
Code: **FM**
 Description: **Fracture Multiple**

Distance (ft): **54.0**
 Structural Grade: **4**
 O&M Grade: **0**
 Clock Start/From: **11**
 Clock To: **1**
 1st Value:
 2nd Value:
 Value Percent:
 Continuous Index: **S09**
 Within 8" of Joint: **YES**
 Remarks:

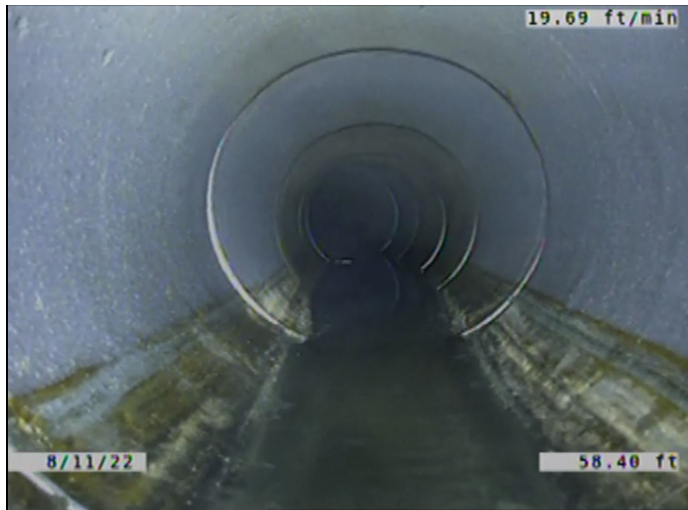
Code: **B**
Description: **Broken**

Distance (ft): **58.4**
Structural Grade: **4**
O&M Grade: **0**
Clock Start/From: **7**
Clock To: **3**
1st Value:
2nd Value:
Value Percent:
Continuous Index: **F08**
Within 8" of Joint: **YES**
Remarks:

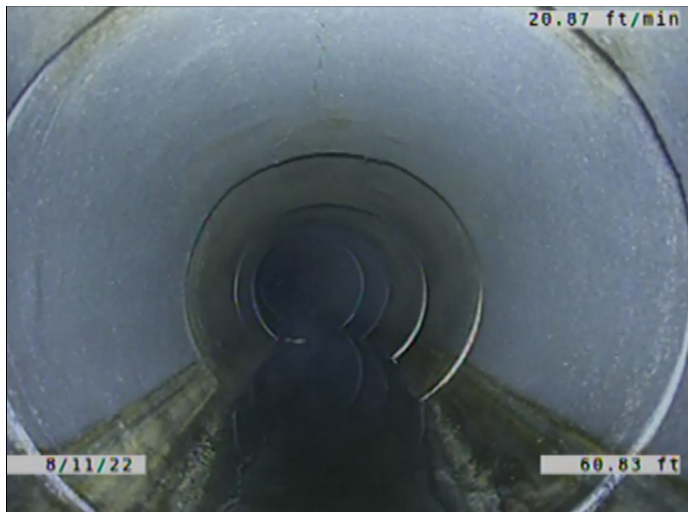
Code: **FM**
Description: **Fracture Multiple**

Distance (ft): **60.8**
Structural Grade: **4**
O&M Grade: **0**
Clock Start/From: **11**
Clock To: **1**
1st Value:
2nd Value:
Value Percent:
Continuous Index: **F09**
Within 8" of Joint: **YES**
Remarks:

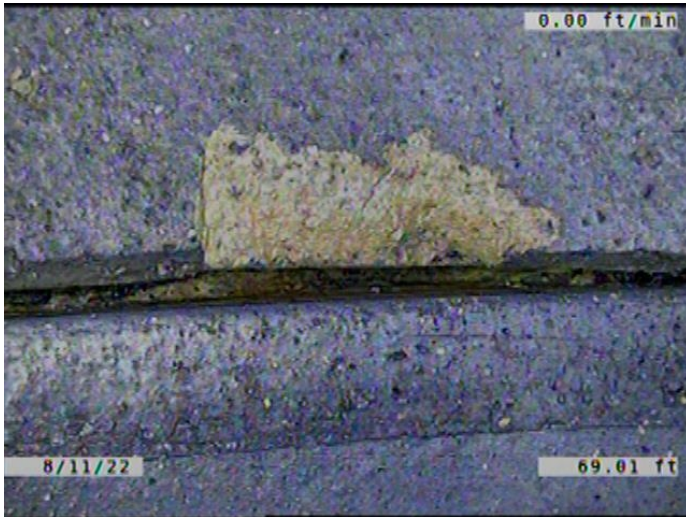
Code:	SZ
Description:	Surface Damage Other
Distance (ft):	69.0
Structural Grade:	0
O&M Grade:	0
Clock Start/From:	9
Clock To:	
1st Value:	
2nd Value:	
Value Percent:	
Continuous Index:	
Within 8" of Joint:	YES
Remarks:	A PIECE CHIPPED AWAY FROM THE JOINT.

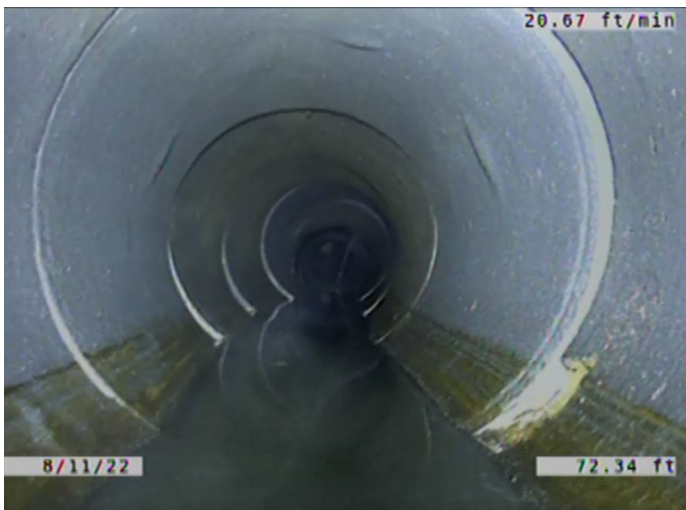
Code:	SZ
Description:	Surface Damage Other
Distance (ft):	72.3
Structural Grade:	0
O&M Grade:	0
Clock Start/From:	9
Clock To:	3
1st Value:	
2nd Value:	
Value Percent:	
Continuous Index:	S10
Within 8" of Joint:	NO
Remarks:	Indentations, factory defect. Wandering.

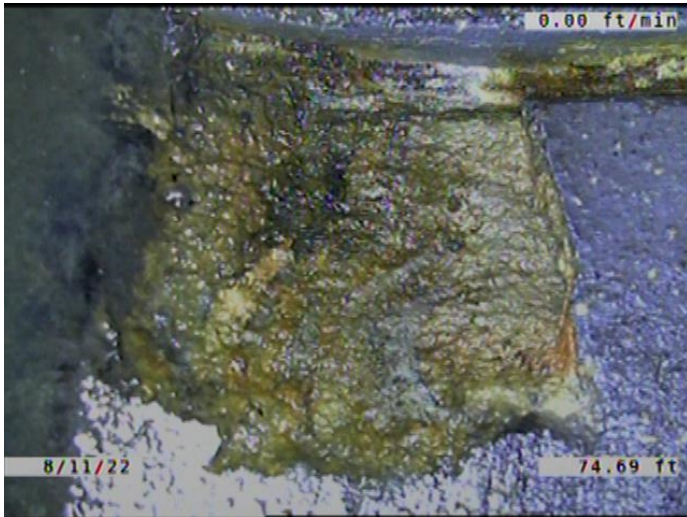
Code: **SSS**
 Description: **Surface Damage Surface Spalling**

Distance (ft): **74.7**
 Structural Grade: **2**
 O&M Grade: **0**
 Clock Start/From: **4**
 Clock To: **5**
 1st Value:
 2nd Value:
 Value Percent:
 Continuous Index:
 Within 8" of Joint: **YES**
 Remarks:

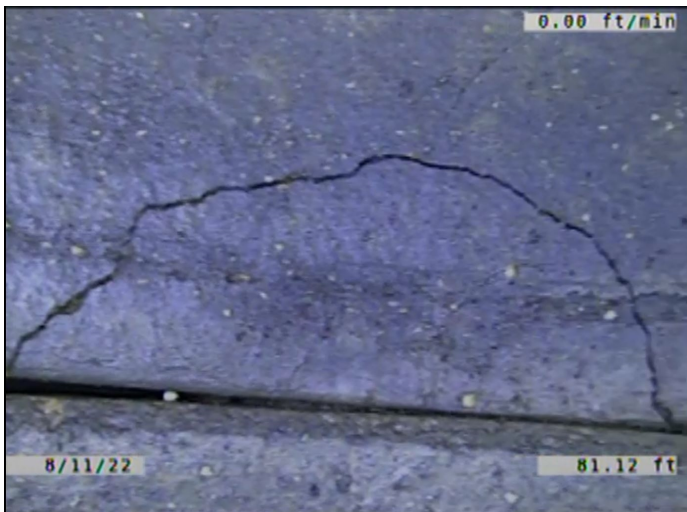
Code: **B**
 Description: **Broken**

Distance (ft): **81.1**
 Structural Grade: **4**
 O&M Grade: **0**
 Clock Start/From: **3**
 Clock To: **4**
 1st Value:
 2nd Value:
 Value Percent:
 Continuous Index:
 Within 8" of Joint: **YES**
 Remarks:

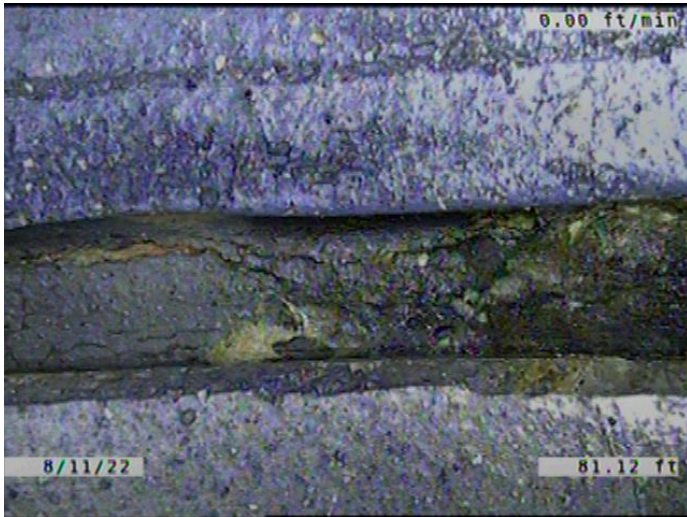
Code: **JAM**
 Description: **Joint Angular Medium**

Distance (ft): **81.1**
 Structural Grade: **3**
 O&M Grade: **0**
 Clock Start/From:
 Clock To:
 1st Value:
 2nd Value:
 Value Percent:
 Continuous Index:
 Within 8" of Joint: **NO**
 Remarks:

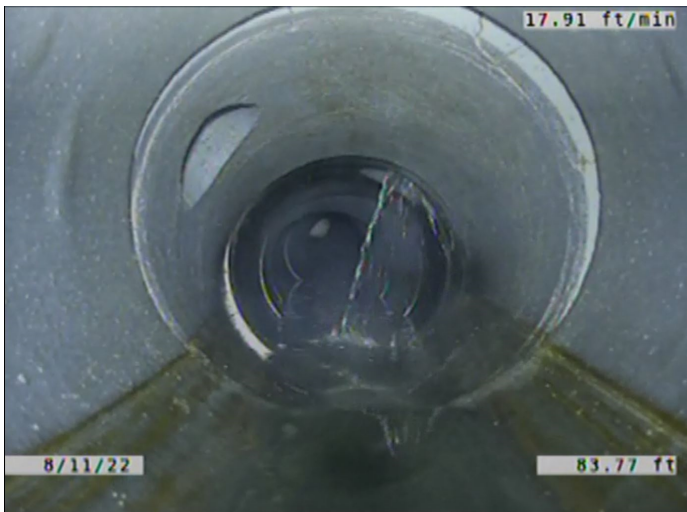
Code: **B**
 Description: **Broken**

Distance (ft): **83.8**
 Structural Grade: **4**
 O&M Grade: **0**
 Clock Start/From: **11**
 Clock To: **3**
 1st Value:
 2nd Value:
 Value Percent:
 Continuous Index:
 Within 8" of Joint: **YES**
 Remarks:

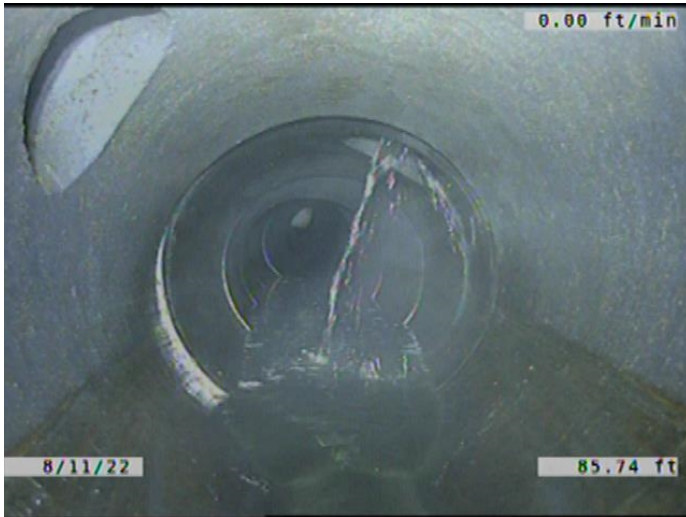
Code: **LD**
Description: **Line Down**

Distance (ft): **85.7**
Structural Grade: **0**
O&M Grade: **1**
Clock Start/From:
Clock To:
1st Value:
2nd Value:
Value Percent: **5.000**
Continuous Index:
Within 8" of Joint: **NO**
Remarks:

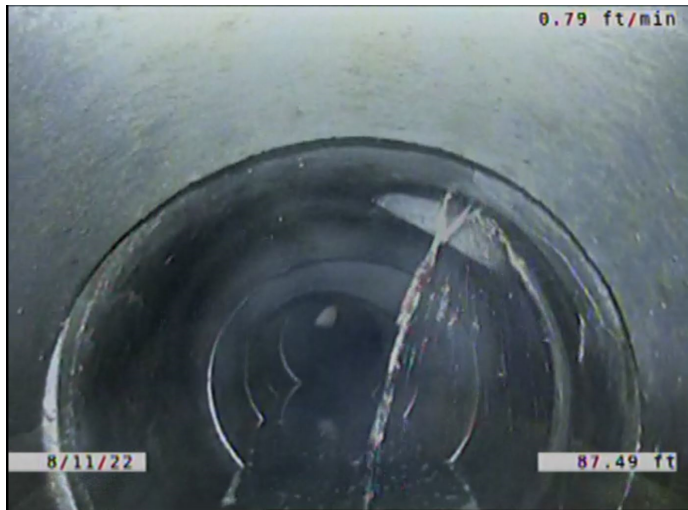
Code: **B**
Description: **Broken**

Distance (ft): **87.5**
Structural Grade: **4**
O&M Grade: **0**
Clock Start/From: **1**
Clock To: **3**
1st Value:
2nd Value:
Value Percent:
Continuous Index:
Within 8" of Joint: **YES**
Remarks:

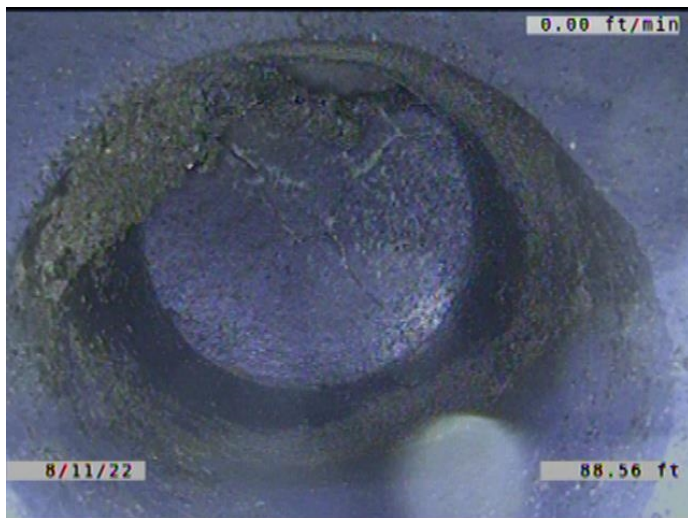
Code: **TFD**
Description: **Tap Factory Defective**

Distance (ft): **88.6**
Structural Grade: **0**
O&M Grade: **3**
Clock Start/From: **10**
Clock To:
1st Value: **6.000**
2nd Value:
Value Percent:
Continuous Index:
Within 8" of Joint: **YES**
Remarks: **CAPPED. CAP BROKEN.**

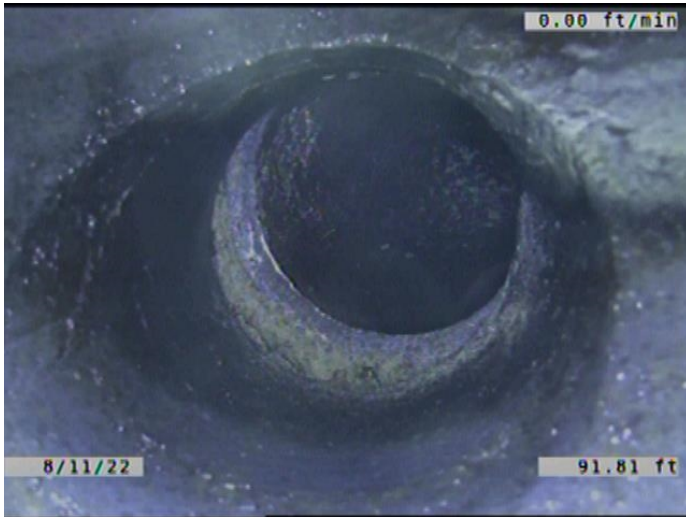
Code:	TFD
Description:	Tap Factory Defective
Distance (ft):	91.8
Structural Grade:	0
O&M Grade:	3
Clock Start/From:	1
Clock To:	
1st Value:	6.000
2nd Value:	
Value Percent:	
Continuous Index:	
Within 8" of Joint:	YES
Remarks:	ACTIVITY. TAP BROKEN. SERVICE OFFSET. SOIL VISIBLE.

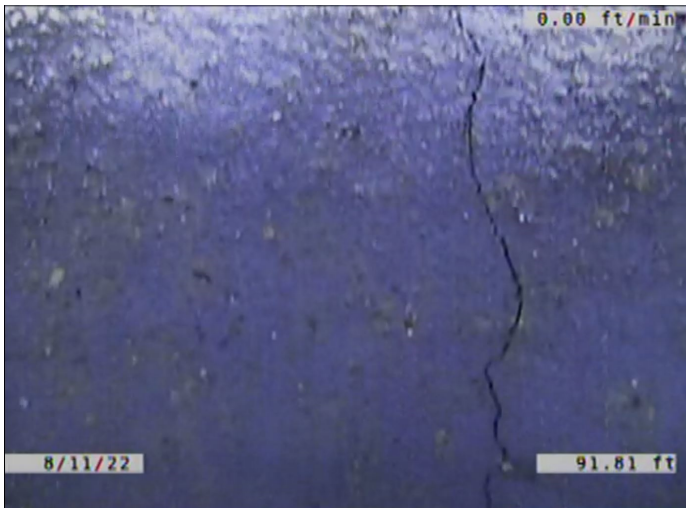
Code:	CL
Description:	Crack Longitudinal
Distance (ft):	91.8
Structural Grade:	2
O&M Grade:	0
Clock Start/From:	12
Clock To:	
1st Value:	
2nd Value:	
Value Percent:	
Continuous Index:	S11
Within 8" of Joint:	YES
Remarks:

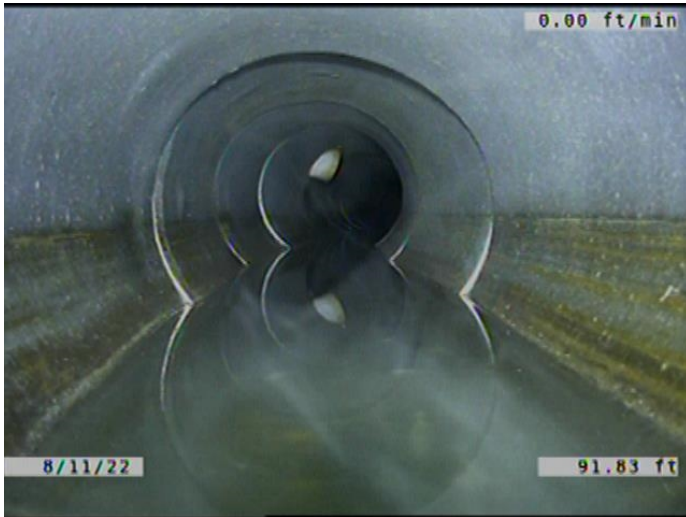
Code: **MWLS**
Description: **Miscellaneous Water Level Sag**

Distance (ft): **91.8**
Structural Grade: **2**
O&M Grade: **0**
Clock Start/From:
Clock To:
1st Value:
2nd Value:
Value Percent: **15.000**
Continuous Index: **S03**
Within 8" of Joint: **NO**
Remarks:

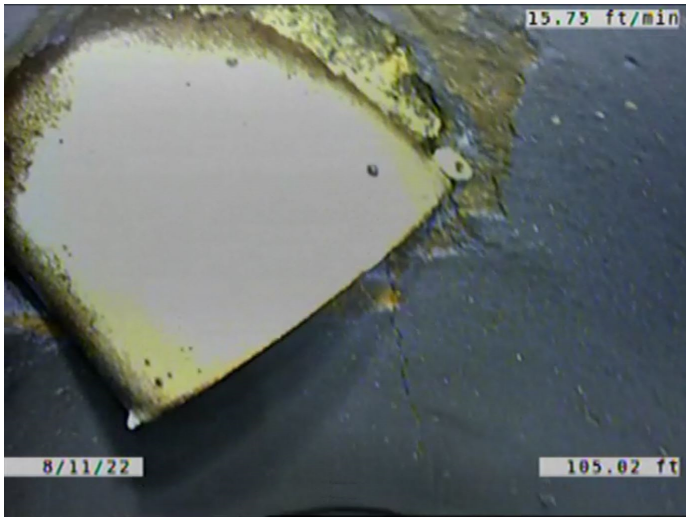
Code: **FM**
 Description: **Fracture Multiple**

Distance (ft): **105.0**
 Structural Grade: **4**
 O&M Grade: **0**
 Clock Start/From: **10**
 Clock To: **11**
 1st Value:
 2nd Value:
 Value Percent:
 Continuous Index:
 Within 8" of Joint: **NO**
 Remarks:

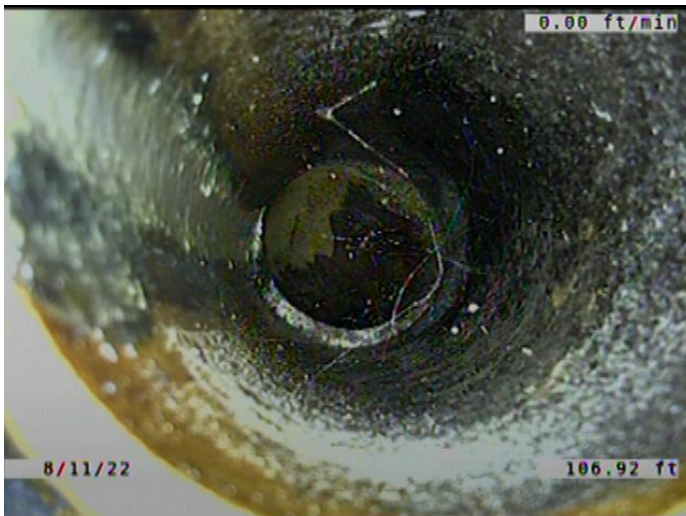
Code: **TBI**
 Description: **Tap Break-in Intruding**

Distance (ft): **106.9**
 Structural Grade: **0**
 O&M Grade: **2**
 Clock Start/From: **10**
 Clock To:
 1st Value: **6.000**
 2nd Value: **4.000**
 Value Percent:
 Continuous Index:
 Within 8" of Joint: **YES**
 Remarks:

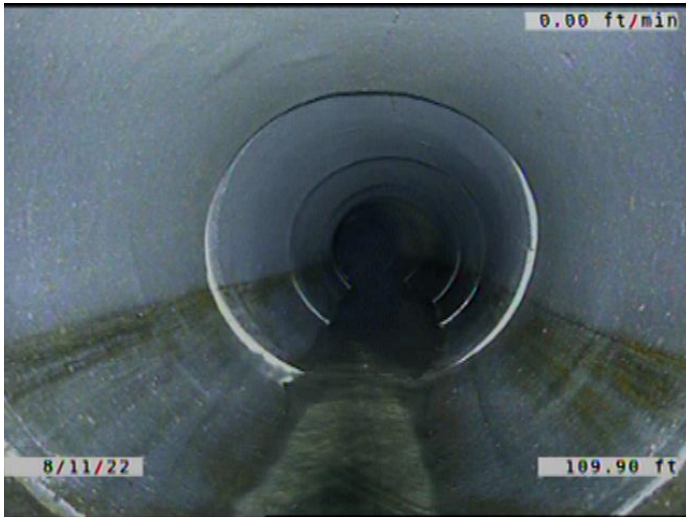
Code: **MWLS**
Description: **Miscellaneous Water Level Sag**

Distance (ft): **109.9**
Structural Grade: **2**
O&M Grade: **0**
Clock Start/From:
Clock To:
1st Value:
2nd Value:
Value Percent: **15.000**
Continuous Index: **F03**
Within 8" of Joint: **NO**
Remarks:

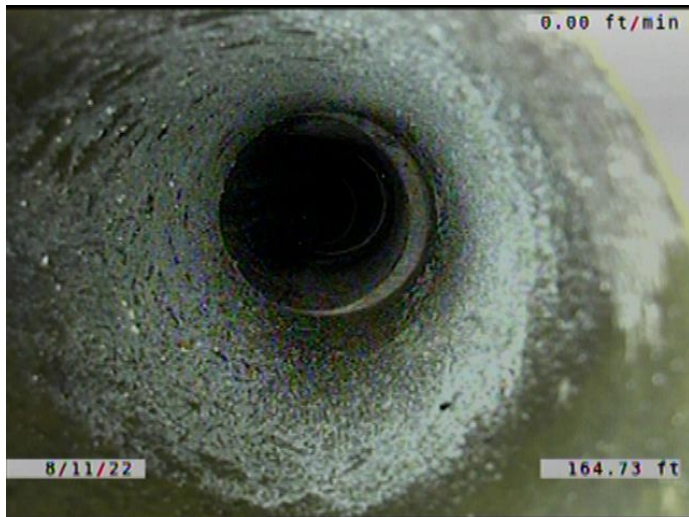
Code: **TBI**
Description: **Tap Break-in Intruding**

Distance (ft): **164.7**
Structural Grade: **0**
O&M Grade: **2**
Clock Start/From: **11**
Clock To:
1st Value: **6.000**
2nd Value: **1.000**
Value Percent:
Continuous Index:
Within 8" of Joint: **YES**
Remarks:

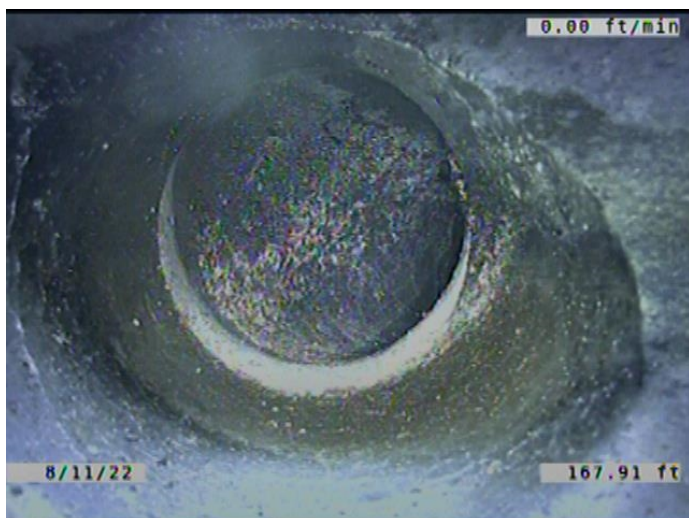
Code: **TFD**
Description: **Tap Factory Defective**

Distance (ft): **167.9**
Structural Grade: **0**
O&M Grade: **3**
Clock Start/From: **1**
Clock To:
1st Value: **6.000**
2nd Value:
Value Percent:
Continuous Index:
Within 8" of Joint: **YES**
Remarks: **TAP CRACKED.**

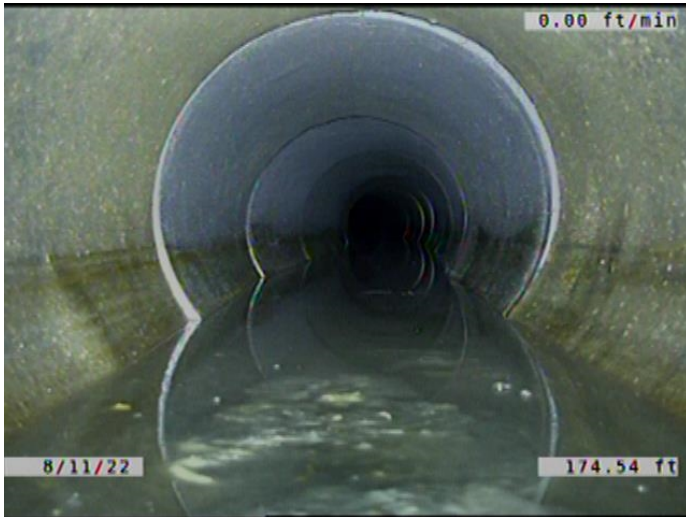
Code: **DSF**
Description: **Deposits Settled Fine**

Distance (ft): **174.5**
Structural Grade: **0**
O&M Grade: **2**
Clock Start/From: **5**
Clock To: **7**
1st Value:
2nd Value:
Value Percent: **5.000**
Continuous Index: **S04**
Within 8" of Joint: **YES**
Remarks:

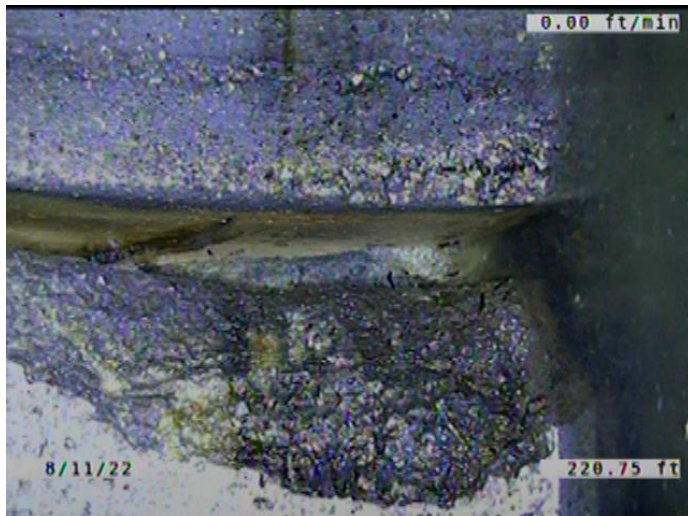
Code: **SZ**
 Description: **Surface Damage Other**

Distance (ft): **220.8**
 Structural Grade: **0**
 O&M Grade: **0**
 Clock Start/From: **7**
 Clock To: **8**
 1st Value:
 2nd Value:
 Value Percent:
 Continuous Index:
 Within 8" of Joint: **YES**
 Remarks: **A PIECE CHIPPED AWAY FROM THE JOINT.**

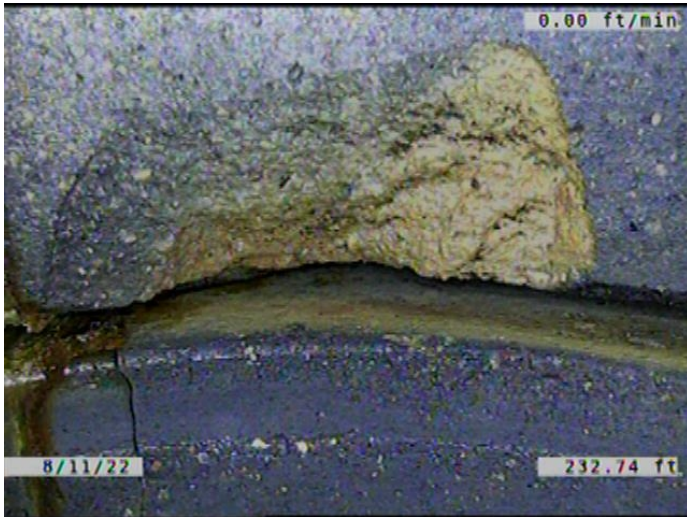
Code: **SZ**
 Description: **Surface Damage Other**

Distance (ft): **232.7**
 Structural Grade: **0**
 O&M Grade: **0**
 Clock Start/From: **9**
 Clock To: **10**
 1st Value:
 2nd Value:
 Value Percent:
 Continuous Index:
 Within 8" of Joint: **YES**
 Remarks: **A PIECE CHIPPED AWAY FROM THE JOINT.**

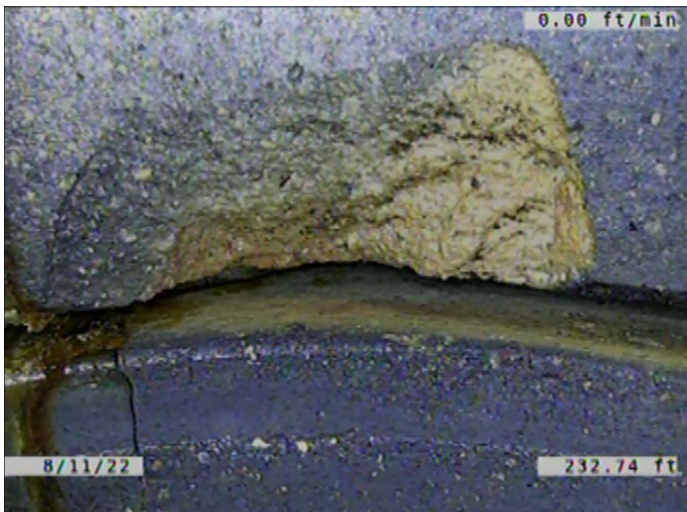
Code: **CL**
 Description: **Crack Longitudinal**

Distance (ft): **232.7**
 Structural Grade: **2**
 O&M Grade: **0**
 Clock Start/From: **8**
 Clock To:
 1st Value:
 2nd Value:
 Value Percent:
 Continuous Index:
 Within 8" of Joint: **YES**
 Remarks:

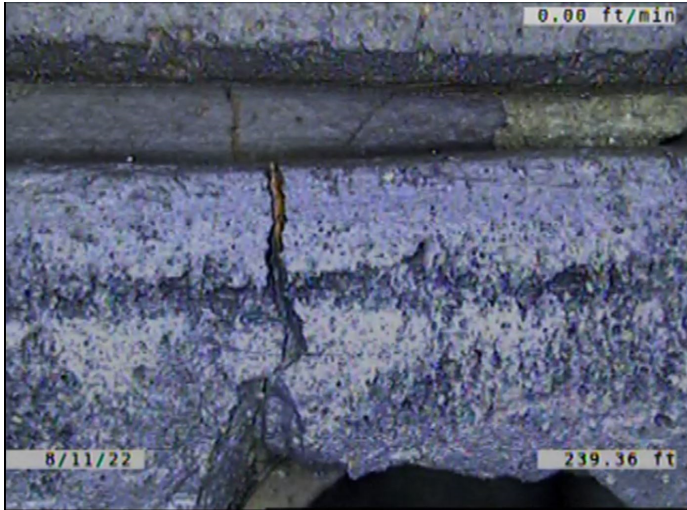
Code: **FM**
Description: **Fracture Multiple**

Distance (ft): **239.4**
Structural Grade: **4**
O&M Grade: **0**
Clock Start/From: **12**
Clock To: **1**
1st Value:
2nd Value:
Value Percent:
Continuous Index:
Within 8" of Joint: **YES**
Remarks:

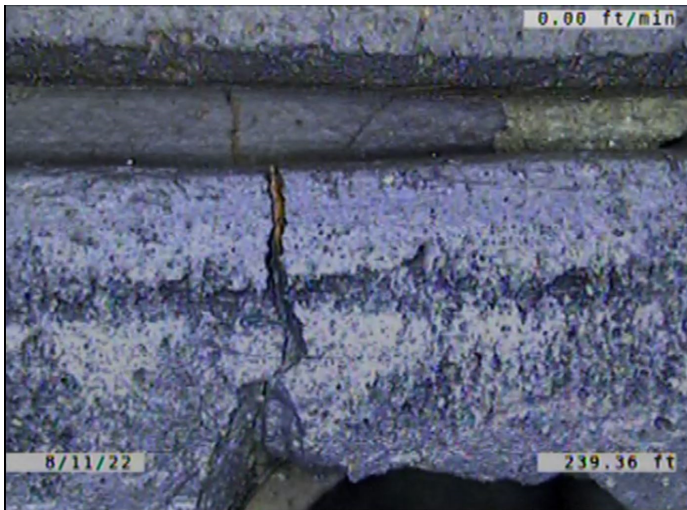
Code: **CL**
Description: **Crack Longitudinal**

Distance (ft): **239.4**
Structural Grade: **2**
O&M Grade: **0**
Clock Start/From: **12**
Clock To:
1st Value:
2nd Value:
Value Percent:
Continuous Index: **F11**
Within 8" of Joint: **NO**
Remarks:

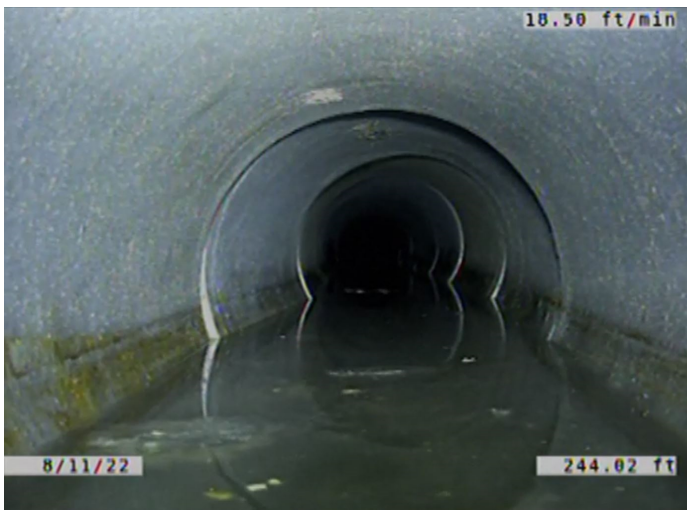
Code: **FL**
 Description: **Fracture Longitudinal**

Distance (ft): **244.0**
 Structural Grade: **3**
 O&M Grade: **0**
 Clock Start/From: **12**
 Clock To:
 1st Value:
 2nd Value:
 Value Percent:
 Continuous Index: **S12**
 Within 8" of Joint: **YES**
 Remarks:

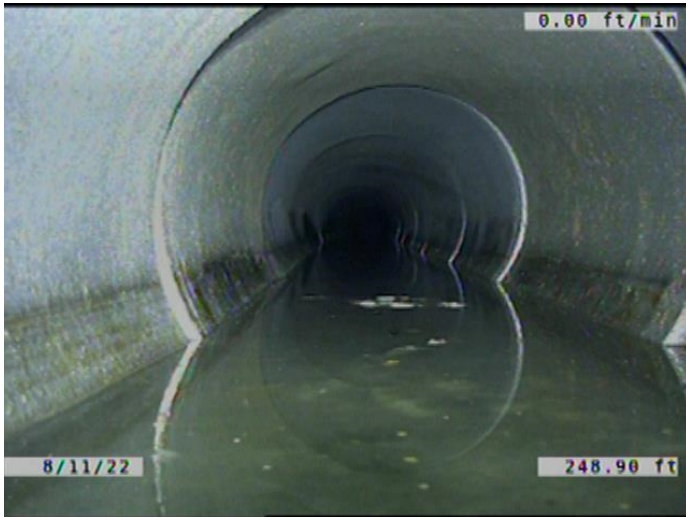
Code: **MWLS**
Description: **Miscellaneous Water Level Sag**

Distance (ft): **248.9**
Structural Grade: **2**
O&M Grade: **0**
Clock Start/From:
Clock To:
1st Value:
2nd Value:
Value Percent: **30.000**
Continuous Index:
Within 8" of Joint: **NO**
Remarks:

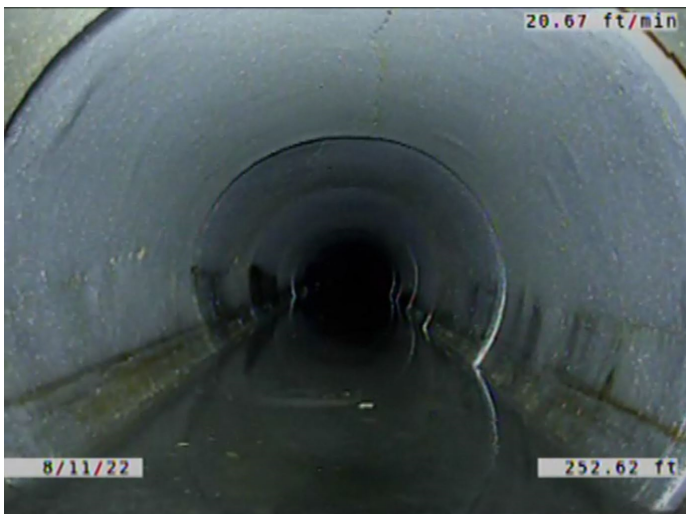
Code: **FL**
Description: **Fracture Longitudinal**

Distance (ft): **252.6**
Structural Grade: **3**
O&M Grade: **0**
Clock Start/From: **12**
Clock To:
1st Value:
2nd Value:
Value Percent:
Continuous Index: **F12**
Within 8" of Joint: **YES**
Remarks:

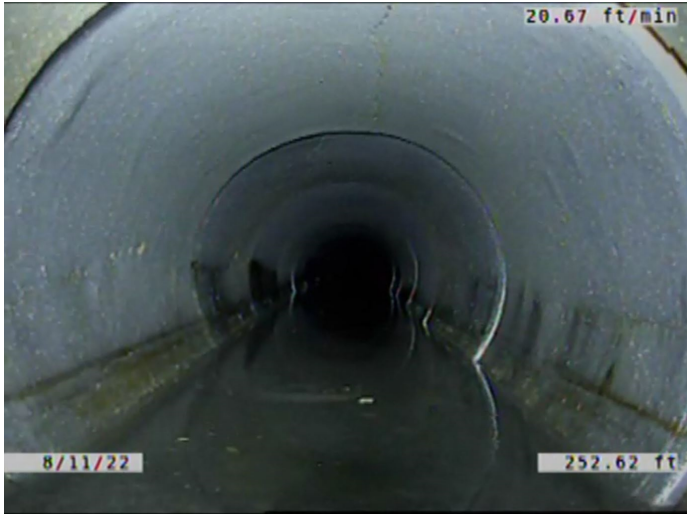
Code: **FH3**
Description: **Fracture Longitudinal Hinge, 3**

Distance (ft): **252.6**
Structural Grade: **4**
O&M Grade: **0**
Clock Start/From: **9**
Clock To: **3**
1st Value:
2nd Value:
Value Percent:
Continuous Index: **S13**
Within 8" of Joint: **YES**
Remarks:

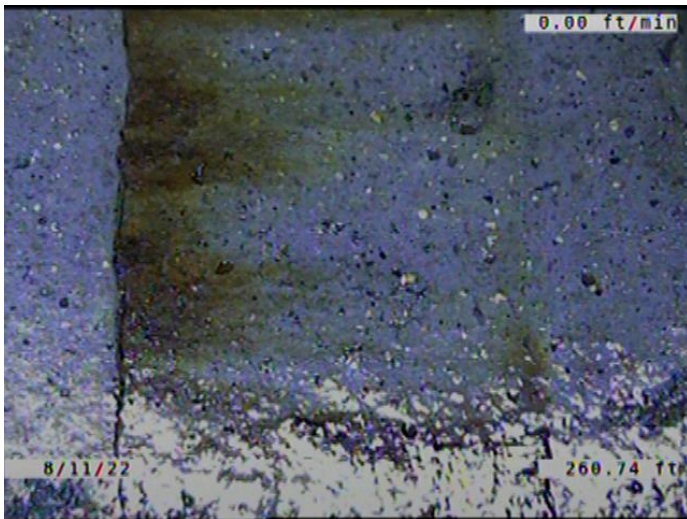
Code: **ISB**
Description: **Infiltration Stain Barrel**

Distance (ft): **260.7**
Structural Grade: **0**
O&M Grade: **1**
Clock Start/From: **8**
Clock To: **10**
1st Value:
2nd Value:
Value Percent:
Continuous Index: **S06**
Within 8" of Joint: **YES**
Remarks:

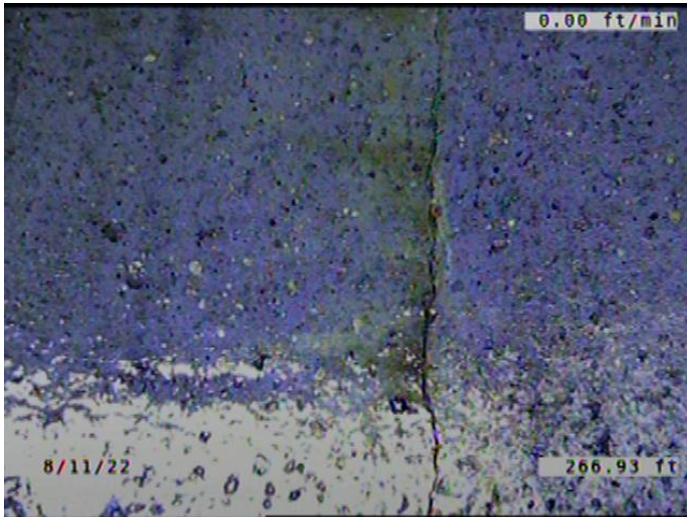
Code: **ISB**
Description: **Infiltration Stain Barrel**

Distance (ft): **266.9**
Structural Grade: **0**
O&M Grade: **1**
Clock Start/From: **2**
Clock To: **4**
1st Value:
2nd Value:
Value Percent:
Continuous Index: **S05**
Within 8" of Joint: **YES**
Remarks:

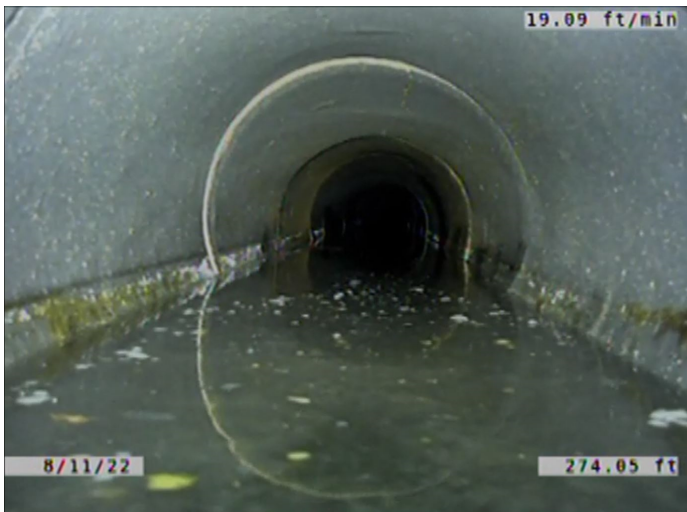
Code: **FH3**
Description: **Fracture Longitudinal Hinge, 3**

Distance (ft): **274.0**
Structural Grade: **4**
O&M Grade: **0**
Clock Start/From: **9**
Clock To: **3**
1st Value:
2nd Value:
Value Percent:
Continuous Index: **F13**
Within 8" of Joint: **YES**
Remarks:

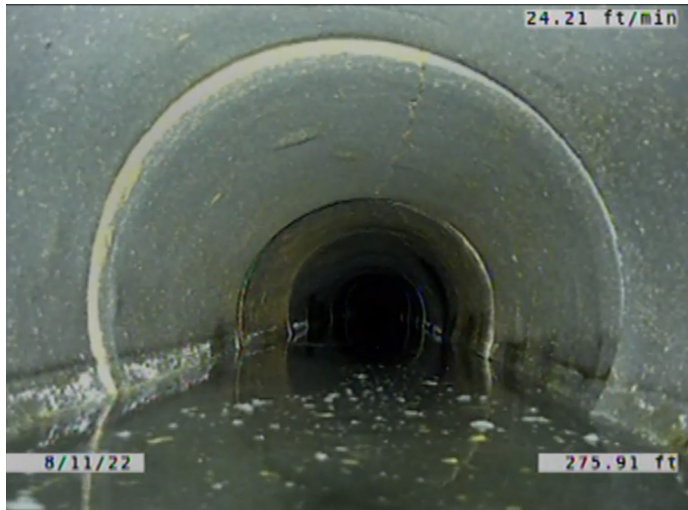
Code: **FM**
Description: **Fracture Multiple**

Distance (ft): **275.9**
Structural Grade: **4**
O&M Grade: **0**
Clock Start/From: **10**
Clock To: **4**
1st Value:
2nd Value:
Value Percent:
Continuous Index: **S14**
Within 8" of Joint: **YES**
Remarks:

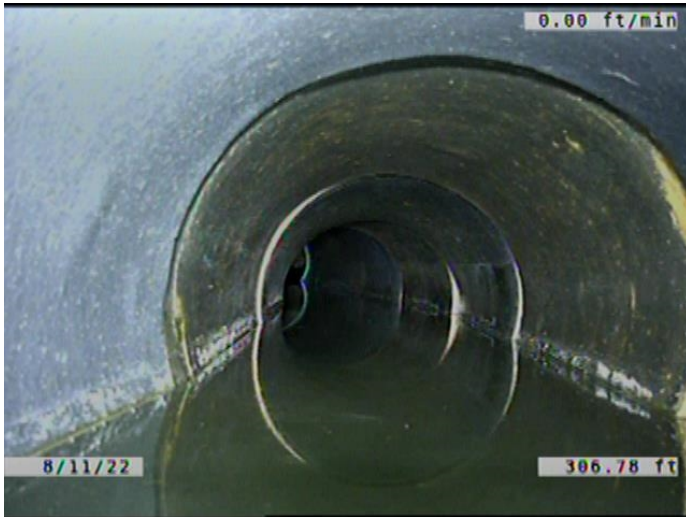
Code: **MWLS**
Description: **Miscellaneous Water Level Sag**

Distance (ft): **306.8**
Structural Grade: **3**
O&M Grade: **0**
Clock Start/From:
Clock To:
1st Value:
2nd Value:
Value Percent: **50.000**
Continuous Index: **S07**
Within 8" of Joint: **NO**
Remarks:

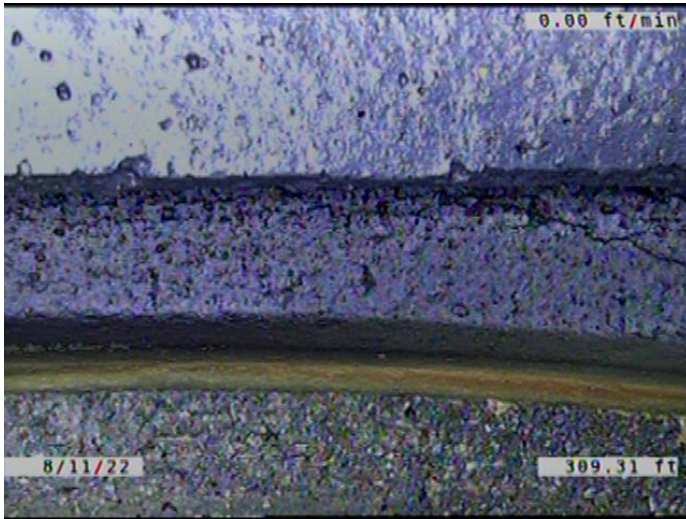
Code: **JAM**
Description: **Joint Angular Medium**

Distance (ft): **309.3**
Structural Grade: **3**
O&M Grade: **0**
Clock Start/From:
Clock To:
1st Value:
2nd Value:
Value Percent:
Continuous Index:
Within 8" of Joint: **NO**
Remarks:

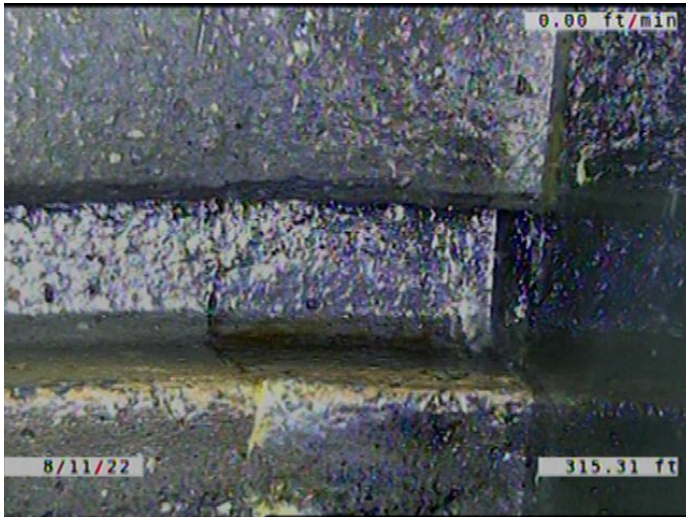
Code: **JAM**
 Description: **Joint Angular Medium**

Distance (ft): **315.3**
 Structural Grade: **3**
 O&M Grade: **0**
 Clock Start/From:
 Clock To:
 1st Value:
 2nd Value:
 Value Percent:
 Continuous Index:
 Within 8" of Joint: **NO**
 Remarks:

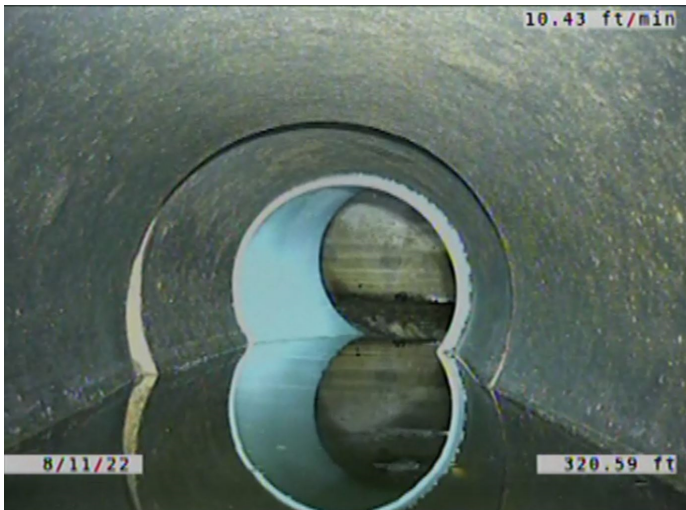
Code: **SZ**
 Description: **Surface Damage Other**

Distance (ft): **320.6**
 Structural Grade: **0**
 O&M Grade: **0**
 Clock Start/From: **9**
 Clock To: **3**
 1st Value:
 2nd Value:
 Value Percent:
 Continuous Index: **F10**
 Within 8" of Joint: **NO**
 Remarks: **Indentations, factory defect. Wandering.**
