Profile/Photo Observation Report

Date:	08/11/2022	Weather:		Coding:	PACP 7.0
Pipe Length (ft):	334.0	Owner:	City of Hobart	Pre Clean:	Heavy Cleaning
P.O.#:	YES502259	Surveyor:	S. Bucklin	PSR:	P-705-047-035
Customer:	City of Hobart	Clean Date:	08/03/2022	Shape:	C

Street:	2nd Street	Flow Control:	Not Controlled
City:	Hobart, IN	Year Renewed:	
Location:	Local rural streets with light traffic, t	Tape/Media #:	
Purpose:	Routine Assessment	Dia/Height:	18"
Use:	Sanitary Sewage Pipe	Material:	VCP
Drain Area:		Lining:	None
Category:	NA		
Comment:			
Location Details:		Direction of Survey:	Downstream
US MH:	M-705-035	DS MH:	M-705-047
		Total Length Surveyed (ft):	331.2

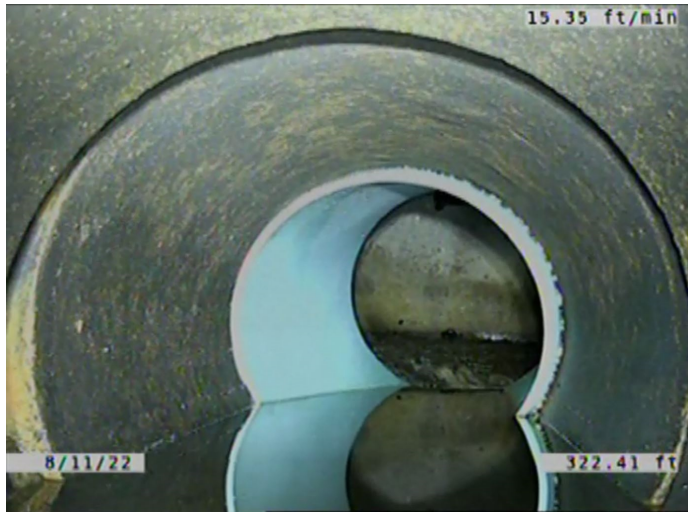
Code: **LR**
Description: **Line Right**

Distance (ft): **322.4**
Structural Grade: **0**
O&M Grade: **1**
Clock Start/From:
Clock To:
1st Value:
2nd Value:
Value Percent: **5.000**
Continuous Index:
Within 8" of Joint: **NO**
Remarks:

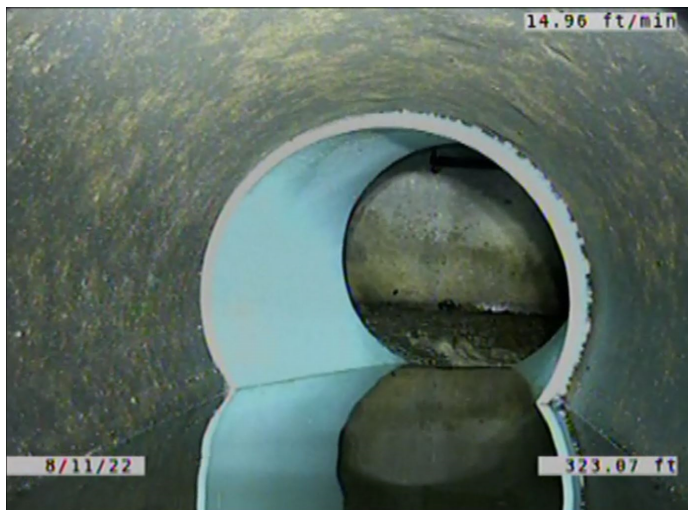
Code: **FM**
Description: **Fracture Multiple**

Distance (ft): **323.1**
Structural Grade: **4**
O&M Grade: **0**
Clock Start/From: **10**
Clock To: **4**
1st Value:
2nd Value:
Value Percent:
Continuous Index: **F14**
Within 8" of Joint: **YES**
Remarks: **Wandering 8 - 4**

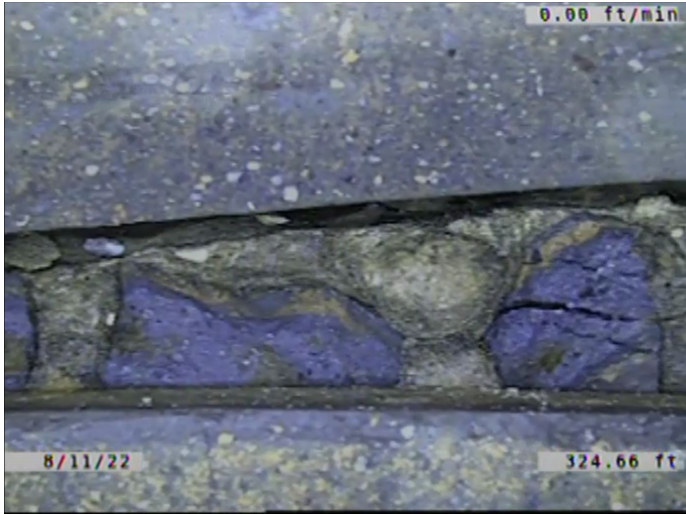
Code: **B**
Description: **Broken**

Distance (ft): **324.6**
Structural Grade: **4**
O&M Grade: **0**
Clock Start/From: **8**
Clock To: **2**
1st Value:
2nd Value:
Value Percent:
Continuous Index:
Within 8" of Joint: **YES**
Remarks:

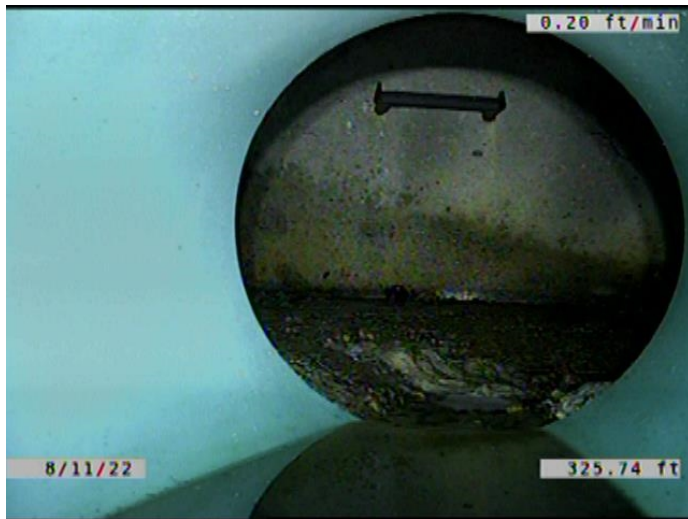
Code: **MWLS**
Description: **Miscellaneous Water Level Sag**

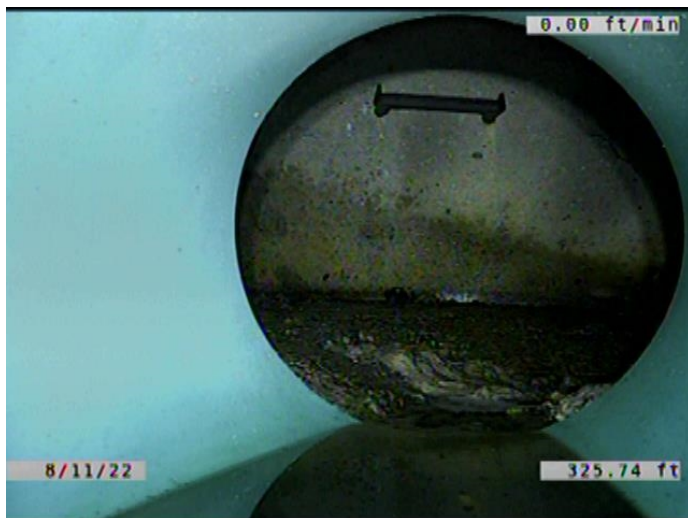
Code: **DSF**
Description: **Deposits Settled Fine**

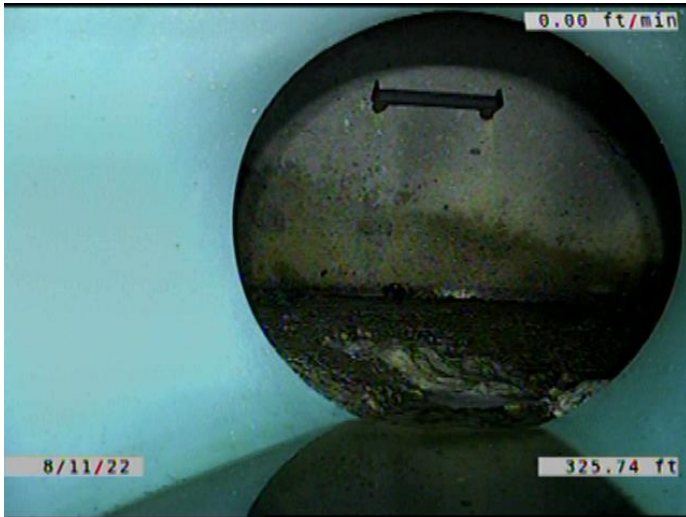
Code: **ISB**
Description: **Infiltration Stain Barrel**

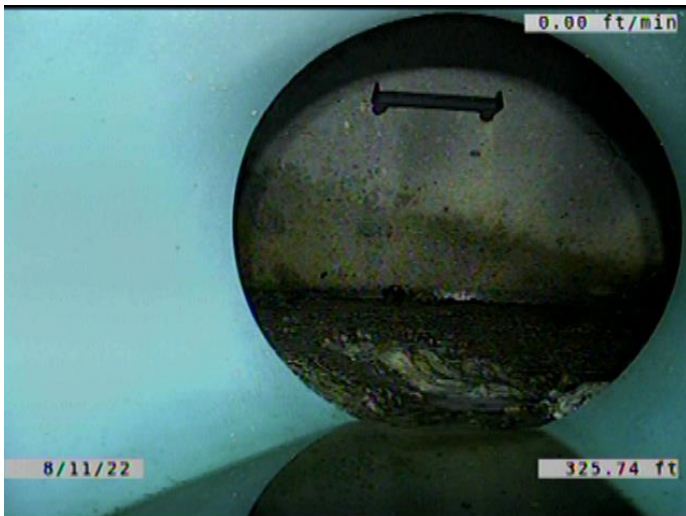
Code: **ISB**
Description: **Infiltration Stain Barrel**
