## Profile/Photo Observation Report

Date:	<b>05/02/2018</b>	Weather:		Coding:	<b>PACP 6.0</b>
Pipe Length (ft):		Owner:	<b>City of Hobart</b>	Pre Clean:	<b>No Pre-Cleaning</b>
P.O.#:	<b>164</b>	Surveyor:	<b>M. Pielacha</b>	PSR:	
Customer:	<b>City of Hobart</b>	Clean Date:		Shape:	<b>C</b>

Street:	<b>Center Street</b>	Flow Control:	<b>Not Controlled</b>
City:	<b>Hobart, IN</b>	Year Renewed:	
Location:	<b>Light Highway</b>	Tape/Media #:	<b>DEP 164</b>
Purpose:	<b>Routine Assessment</b>	Dia/Height:	<b>20"</b>
Use:	<b>Sanitary</b>	Material:	<b>PVC</b>
Drain Area:		Lining:	
Category:	<b>NA</b>		
Comment:	<b>5-21-2018</b>

Location Details:		Direction of Survey:	<b>Upstream</b>
US MH:	<b>M-705-035</b>	DS MH:	<b>M-705-035.1</b>
		Total Length Surveyed (ft):	<b>200.7</b>

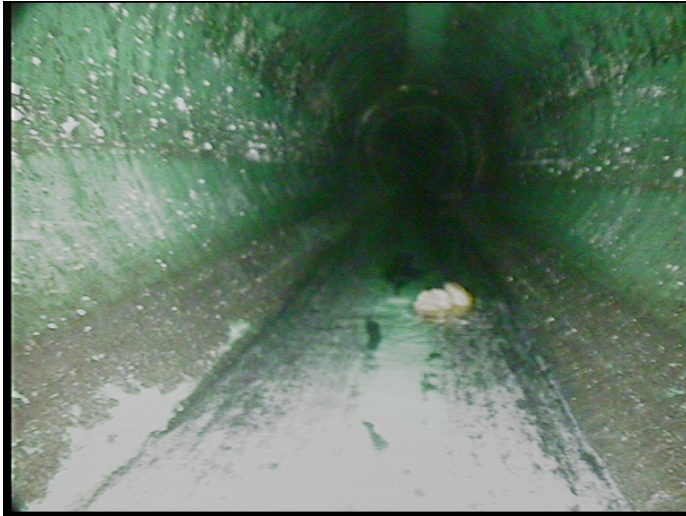
Code:	AMH
Description:	Manhole
Distance (ft):	.0
Structural Grade:	0
O&M Grade:	0
Clock Start/From:	
Clock To:	
1st Value:	
2nd Value:	
Value Percent:	
Continuous Index:	
Within 8" of Joint:	NO
Remarks:	M-705-035.1

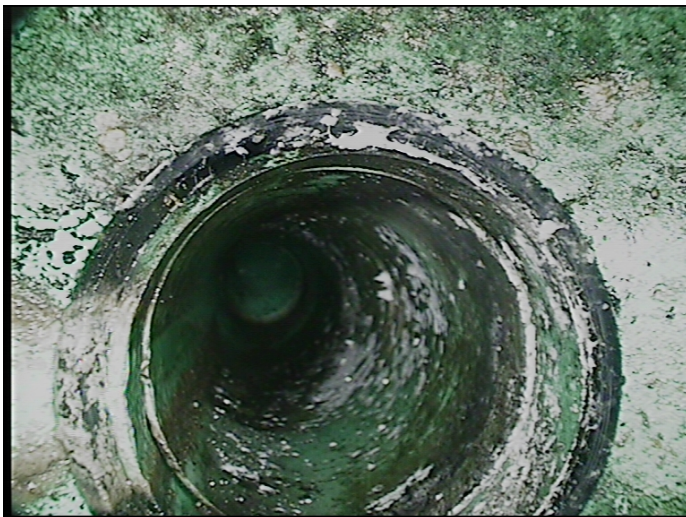
Code: **MWL**  
Description: **Water Level**

Distance (ft): **.0**  
Structural Grade: **0**  
O&M Grade: **0**  
Clock Start/From:  
Clock To:  
1st Value:  
2nd Value:  
Value Percent: **5.000**  
Continuous Index:  
Within 8" of Joint: **NO**  
Remarks:

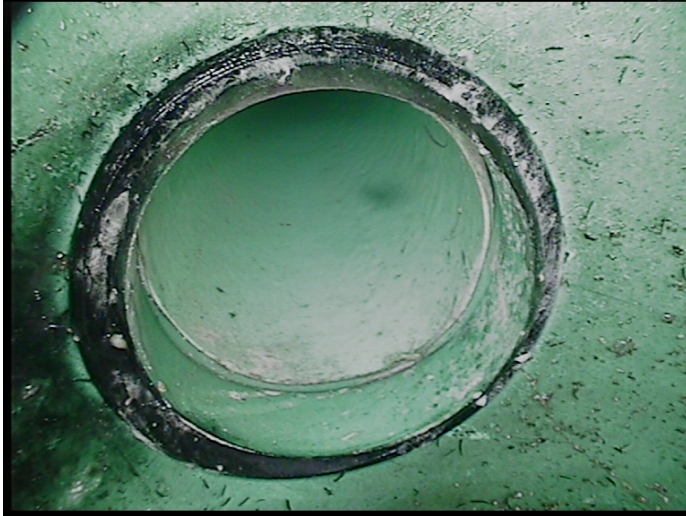
Code: **TBA**  
Description: **Tap Break-in Active**

Distance (ft): **10.7**  
Structural Grade: **0**  
O&M Grade: **0**  
Clock Start/From: **10**  
Clock To:  
1st Value: **4.000**  
2nd Value:  
Value Percent:  
Continuous Index:  
Within 8" of Joint: **NO**  
Remarks:

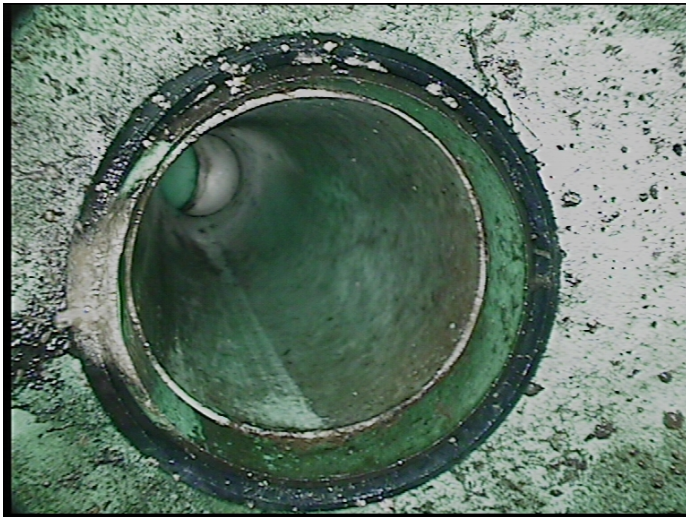
Code:	<b>TB</b>
Description:	<b>Tap Break-in</b>
Distance (ft):	<b>41.4</b>
Structural Grade:	<b>0</b>
O&M Grade:	<b>0</b>
Clock Start/From:	<b>10</b>
Clock To:	
1st Value:	<b>4.000</b>
2nd Value:	
Value Percent:	
Continuous Index:	
Within 8" of Joint:	<b>NO</b>
Remarks:

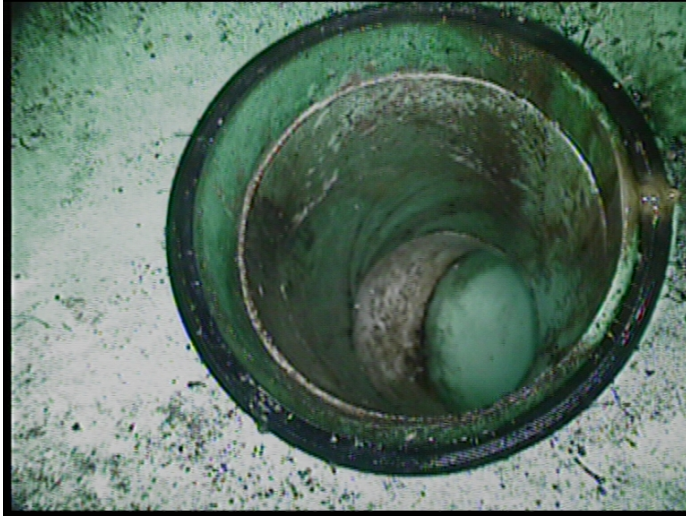
Code:	<b>TBA</b>
Description:	<b>Tap Break-in Active</b>
Distance (ft):	<b>162.3</b>
Structural Grade:	<b>0</b>
O&M Grade:	<b>0</b>
Clock Start/From:	<b>10</b>
Clock To:	
1st Value:	<b>4.000</b>
2nd Value:	
Value Percent:	
Continuous Index:	
Within 8" of Joint:	<b>NO</b>
Remarks:

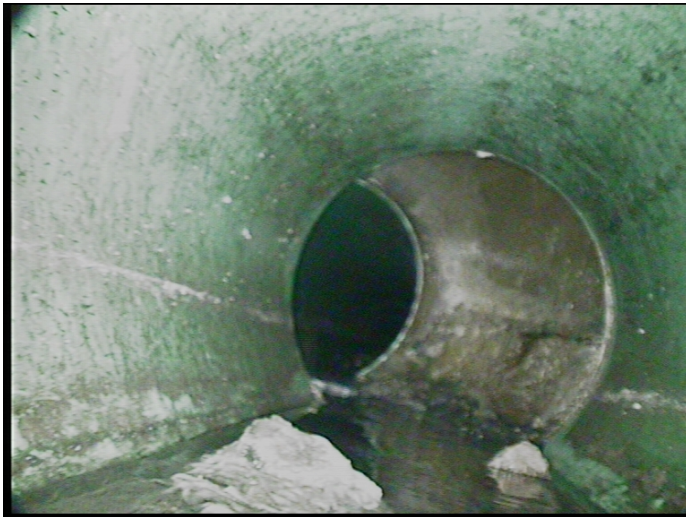
Code: **TBA**  
Description: **Tap Break-in Active**

Distance (ft): **179.5**  
Structural Grade: **0**  
O&M Grade: **0**  
Clock Start/From: **2**  
Clock To:  
1st Value: **4.000**  
2nd Value:  
Value Percent:  
Continuous Index:  
Within 8" of Joint: **NO**  
Remarks:
