## Profile/Photo Observation Report

Street:	<b>East 4th Street</b>	Flow Control:	
City:	<b>Hobart, IN</b>	Year Renewed:	
Location:	<b>Light Highway</b>	Tape/Media #:	<b>910</b>
Purpose:	<b>Routine Assessment</b>	Dia/Height:	<b>8"</b>
Use:	<b>Sanitary</b>	Material:	<b>VCP</b>
Drain Area:		Lining:	
Category:	<b>NA</b>		
Comment:

Location Details:		Direction of Survey:	<b>Upstream</b>
US MH:	<b>M-705-45</b>	DS MH:	<b>M-705-31</b>
		Total Length Surveyed (ft):	<b>15.5</b>

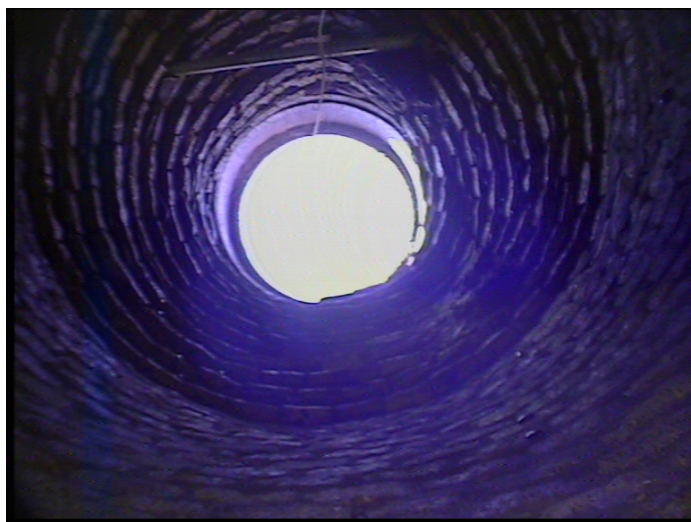
Code: **AMH**  
Description: **Manhole**

Distance (ft): **.0**  
Structural Grade: **0**  
O&M Grade: **0**  
Clock Start/From:  
Clock To:  
1st Value:  
2nd Value:  
Value Percent:  
Continuous Index:  
Within 8" of Joint: **NO**  
Remarks: **M-705-31**

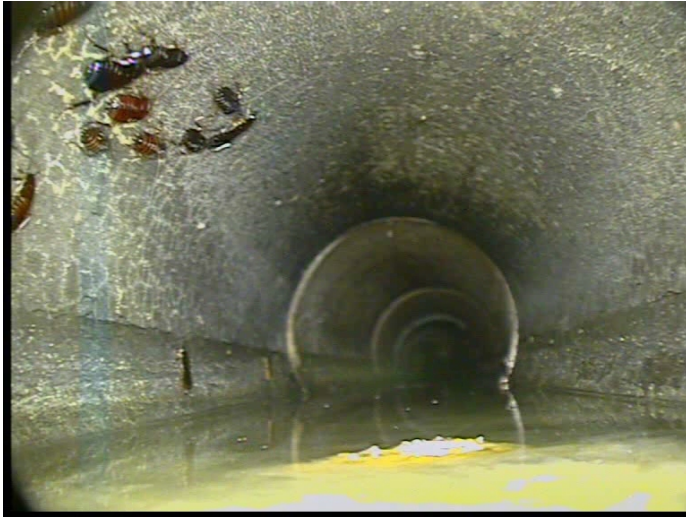
Code: **MWL**  
Description: **Water Level**

Distance (ft): **.0**  
Structural Grade: **0**  
O&M Grade: **0**  
Clock Start/From:  
Clock To:  
1st Value:  
2nd Value:  
Value Percent: **20.000**  
Continuous Index:  
Within 8" of Joint: **NO**  
Remarks:

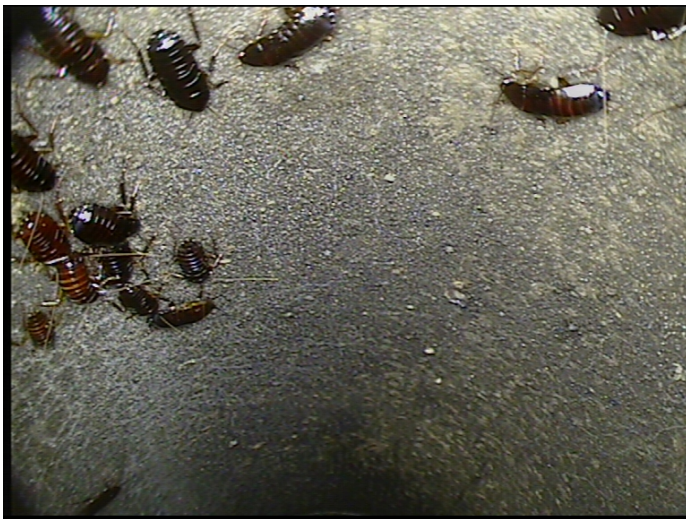
Code: **VC**  
Description: **Vermin Cockroach**

Distance (ft): **.0**  
Structural Grade: **0**  
O&M Grade: **1**  
Clock Start/From:  
Clock To:  
1st Value:  
2nd Value:  
Value Percent:  
Continuous Index:  
Within 8" of Joint: **NO**  
Remarks:

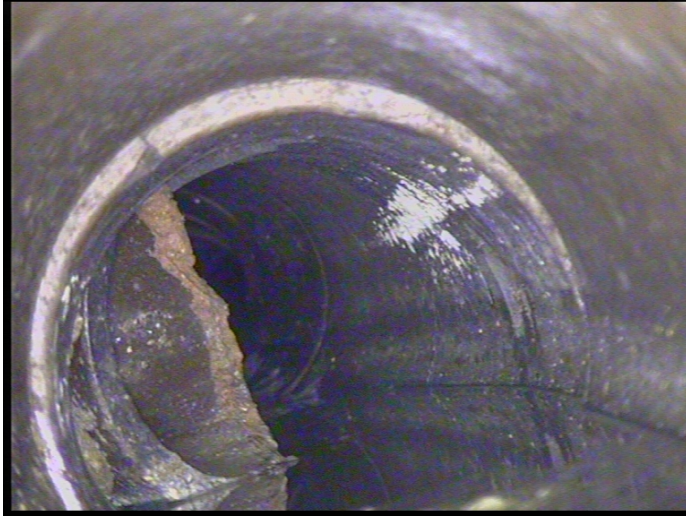
Code: **TBI**  
Description: **Tap Break-in Intruding**

Distance (ft): **15.5**  
Structural Grade: **0**  
O&M Grade: **2**  
Clock Start/From: **9**  
Clock To:  
1st Value: **4.000**  
2nd Value: **2.000**  
Value Percent:  
Continuous Index:  
Within 8" of Joint: **NO**  
Remarks:

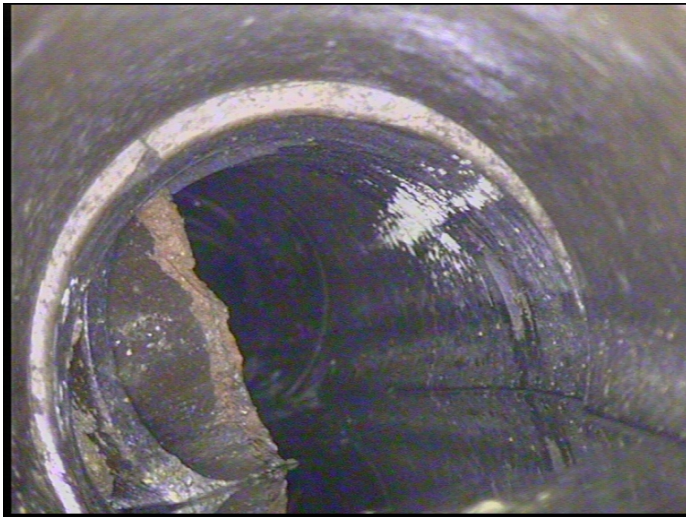
Code: **MSA**  
Description: **Abandoned Survey**

Distance (ft): **15.5**  
Structural Grade: **0**  
O&M Grade: **0**  
Clock Start/From:  
Clock To:  
1st Value:  
2nd Value:  
Value Percent:  
Continuous Index:  
Within 8" of Joint: **NO**  
Remarks: **Intruding tap**
