## Profile/Photo Observation Report

Date:	<b>09/17/2022</b>	Weather:		Coding:	<b>PACP 7.0</b>
Pipe Length (ft):	<b>194.0</b>	Owner:	<b>City of Hobart</b>	Pre Clean:	<b>No Pre-Cleaning</b>
P.O.#:	<b>YES502259</b>	Surveyor:	<b>S. Bucklin</b>	PSR:	<b>M-705-046-M-705-079</b>
Customer:	<b>City of Hobart</b>	Clean Date:		Shape:	<b>C</b>

Street:	<b>East Street</b>	Flow Control:	<b>Not Controlled</b>
City:	<b>Hobart, IN</b>	Year Renewed:	
Location:	<b>Local rural streets with light traffic, t</b>	Tape/Media #:	
Purpose:	<b>Routine Assessment</b>	Dia/Height:	<b>8"</b>
Use:	<b>Sanitary Sewage Pipe</b>	Material:	<b>VCP</b>
Drain Area:		Lining:	<b>None</b>
Category:	<b>NA</b>		
Comment:			
Location Details:		Direction of Survey:	<b>Downstream</b>
US MH:	<b>M-705-046</b>	DS MH:	<b>M-705-079</b>
		Total Length Surveyed (ft):	<b>24.4</b>

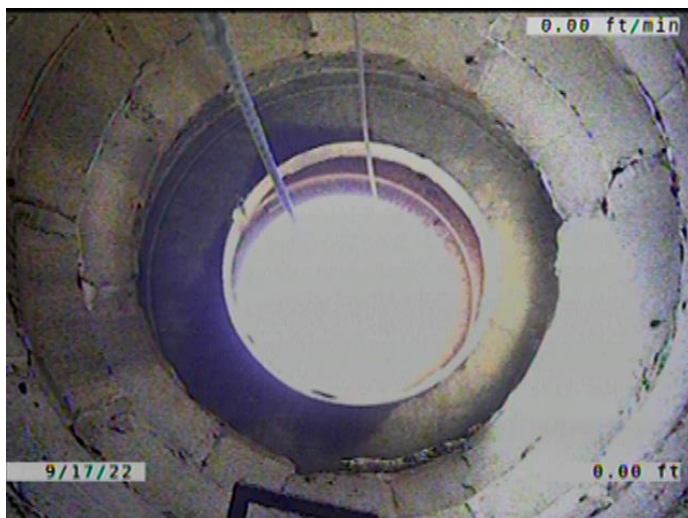
Code: **AMH**  
 Description: **Manhole**

Distance (ft): **.0**  
 Structural Grade: **0**  
 O&M Grade: **0**  
 Clock Start/From:  
 Clock To:  
 1st Value:  
 2nd Value:  
 Value Percent:  
 Continuous Index:  
 Within 8" of Joint: **NO**  
 Remarks: **M-705-046**

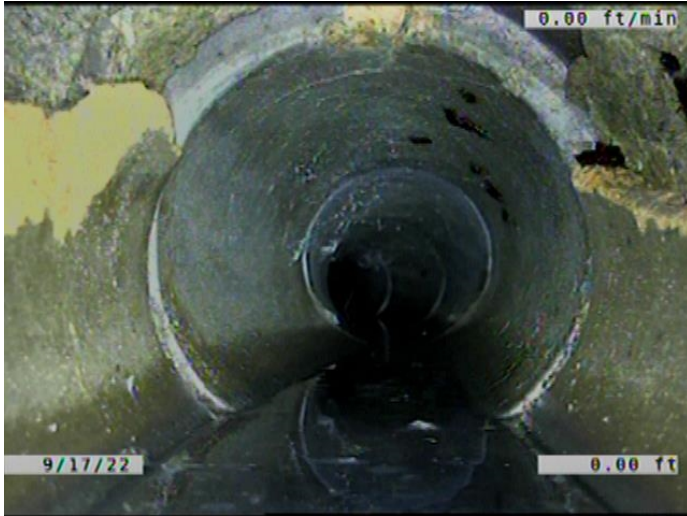
Code: **MWL**  
Description: **Miscellaneous Water Level**

Distance (ft): **.0**  
Structural Grade: **0**  
O&M Grade: **0**  
Clock Start/From:  
Clock To:  
1st Value:  
2nd Value:  
Value Percent: **5.000**  
Continuous Index:  
Within 8" of Joint: **NO**  
Remarks:

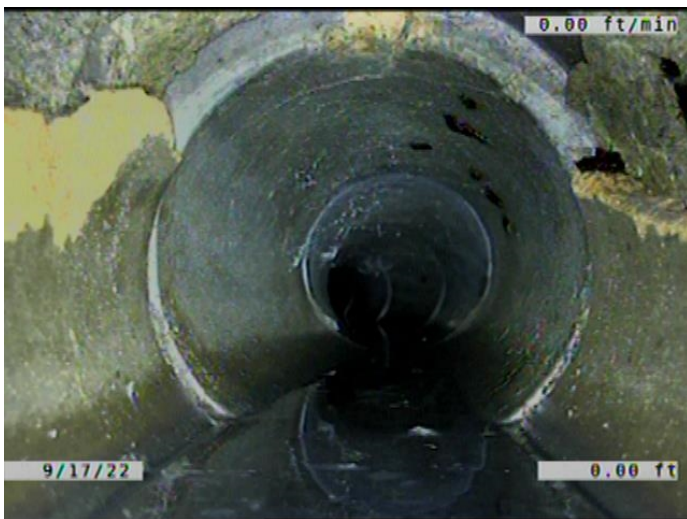
Code: **DSF**  
Description: **Deposits Settled Fine**

Distance (ft): **.0**  
Structural Grade: **0**  
O&M Grade: **2**  
Clock Start/From: **5**  
Clock To: **7**  
1st Value:  
2nd Value:  
Value Percent: **5.000**  
Continuous Index: **S01**  
Within 8" of Joint: **YES**  
Remarks:

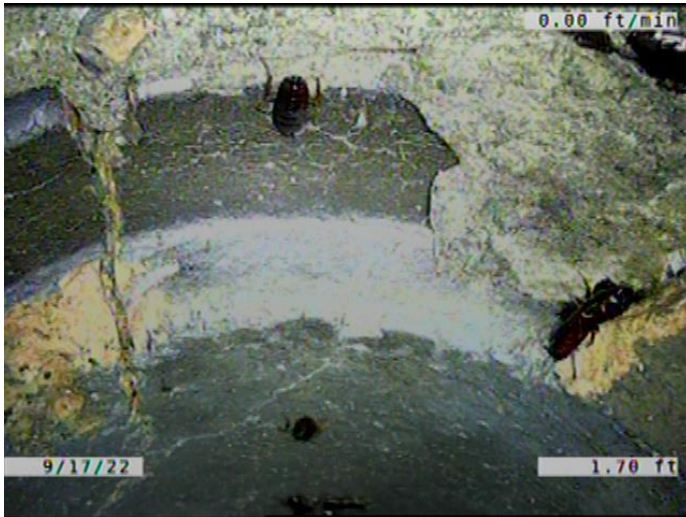
Code: **VC**  
 Description: **Vermin Cockroach**

Distance (ft): **1.7**  
 Structural Grade: **0**  
 O&M Grade: **1**  
 Clock Start/From:  
 Clock To:  
 1st Value:  
 2nd Value:  
 Value Percent:  
 Continuous Index:  
 Within 8" of Joint: **YES**  
 Remarks:

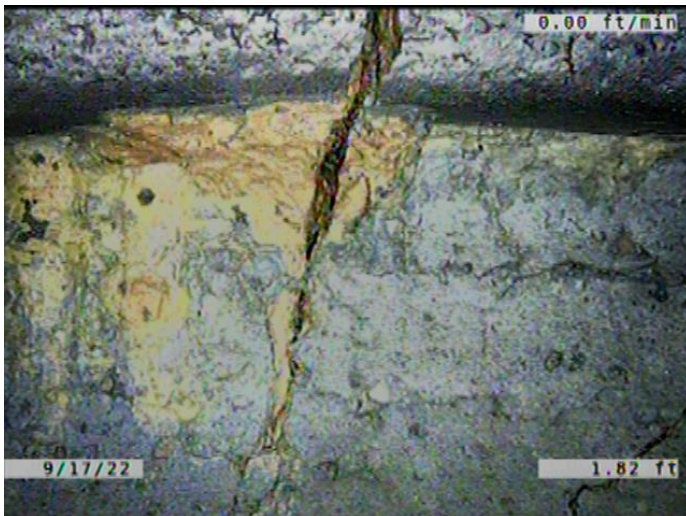
Code: **B**  
 Description: **Broken**

Distance (ft): **1.8**  
 Structural Grade: **4**  
 O&M Grade: **0**  
 Clock Start/From: **8**  
 Clock To: **4**  
 1st Value:  
 2nd Value:  
 Value Percent:  
 Continuous Index:  
 Within 8" of Joint: **YES**  
 Remarks:

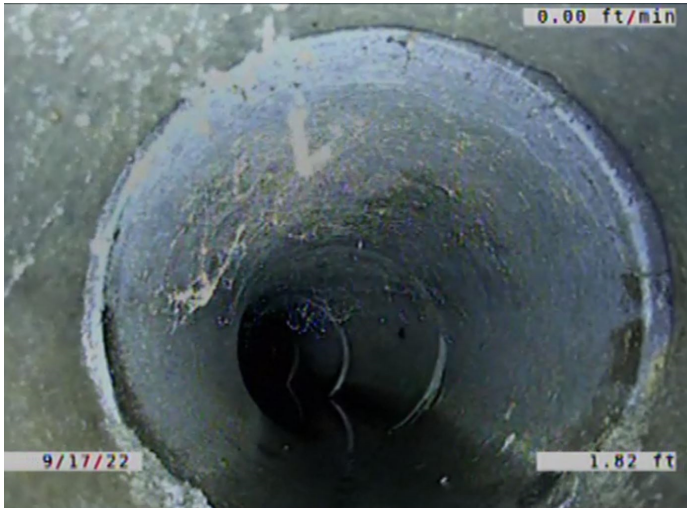
Code: **FM**  
Description: **Fracture Multiple**

Distance (ft): **1.8**  
Structural Grade: **4**  
O&M Grade: **0**  
Clock Start/From: **8**  
Clock To: **4**  
1st Value:  
2nd Value:  
Value Percent:  
Continuous Index: **S02**  
Within 8" of Joint: **YES**  
Remarks: **Wandering**

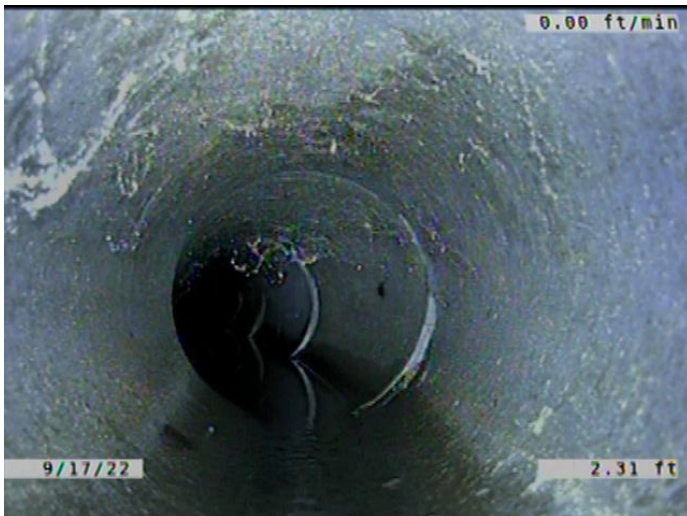
Code: **LL**  
Description: **Line Left**

Distance (ft): **2.3**  
Structural Grade: **0**  
O&M Grade: **2**  
Clock Start/From:  
Clock To:  
1st Value:  
2nd Value:  
Value Percent: **15.000**  
Continuous Index:  
Within 8" of Joint: **NO**  
Remarks:

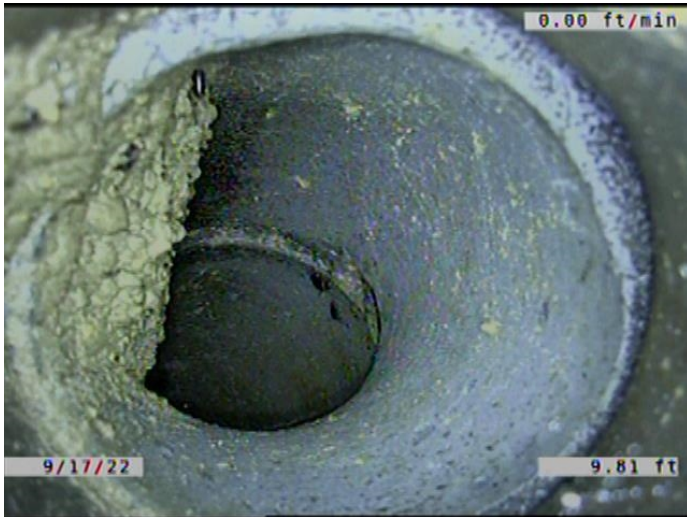
Code: **TF**  
 Description: **Tap Factory**

Distance (ft): **9.8**  
 Structural Grade: **0**  
 O&M Grade: **0**  
 Clock Start/From: **10**  
 Clock To:  
 1st Value: **6.000**

2nd Value:  
 Value Percent:  
 Continuous Index:  
 Within 8" of Joint: **YES**  
 Remarks: **SERVICE OFFSET. SOIL AND ROCKS VISIBLE IN THE SERVICE.**

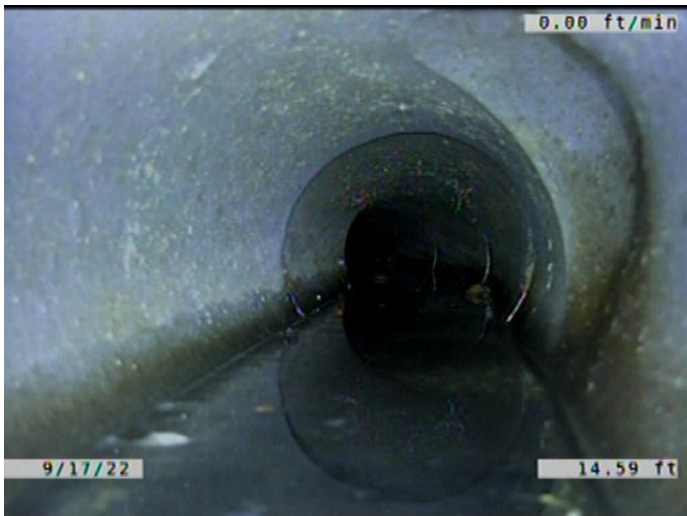
Code: **LR**  
 Description: **Line Right**

Distance (ft): **14.6**  
 Structural Grade: **0**  
 O&M Grade: **1**  
 Clock Start/From:  
 Clock To:  
 1st Value:  
 2nd Value:  
 Value Percent: **5.000**

Continuous Index:  
 Within 8" of Joint: **NO**  
 Remarks:

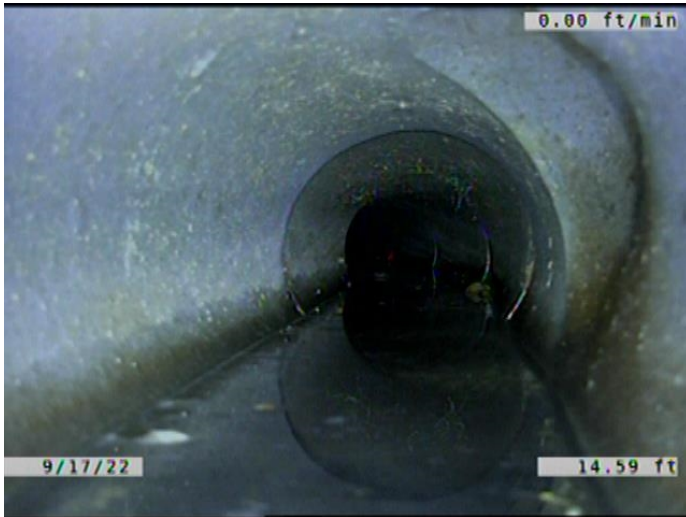
Code: **MWL**  
 Description: **Miscellaneous Water Level**

Distance (ft): **14.6**  
 Structural Grade: **0**  
 O&M Grade: **0**  
 Clock Start/From:  
 Clock To:  
 1st Value:  
 2nd Value:  
 Value Percent: **15.000**  
 Continuous Index:  
 Within 8" of Joint: **NO**  
 Remarks:

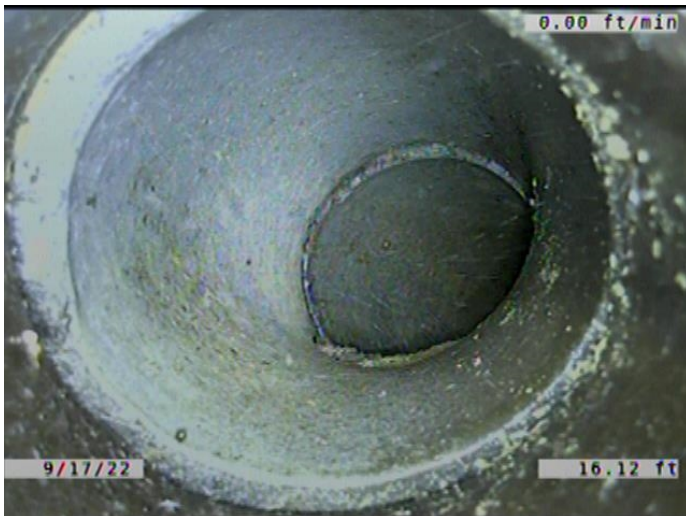
Code: **TF**  
 Description: **Tap Factory**

Distance (ft): **16.1**  
 Structural Grade: **0**  
 O&M Grade: **0**  
 Clock Start/From: **2**  
 Clock To:  
 1st Value: **6.000**  
 2nd Value:  
 Value Percent:  
 Continuous Index:  
 Within 8" of Joint: **YES**  
 Remarks: **SERVICE OFFSET. SOIL VISIBLE.**

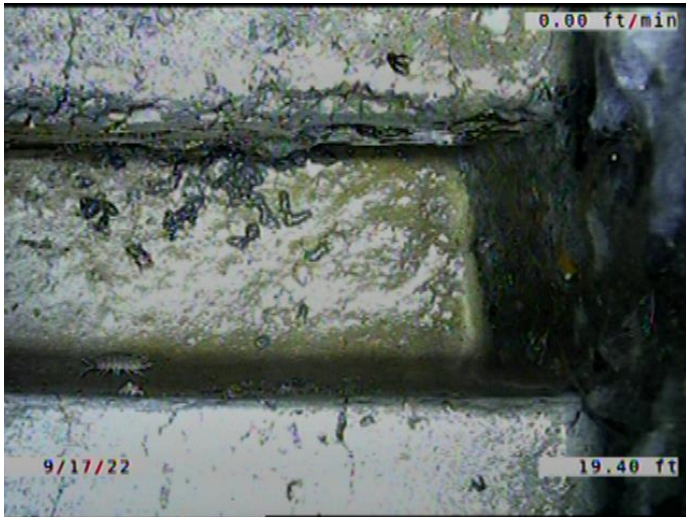
Code: **JAL**  
Description: **Joint Angular Large**

Distance (ft): **19.4**  
Structural Grade: **4**  
O&M Grade: **0**  
Clock Start/From:  
Clock To:  
1st Value:  
2nd Value:  
Value Percent:  
Continuous Index:  
Within 8" of Joint: **NO**  
Remarks:

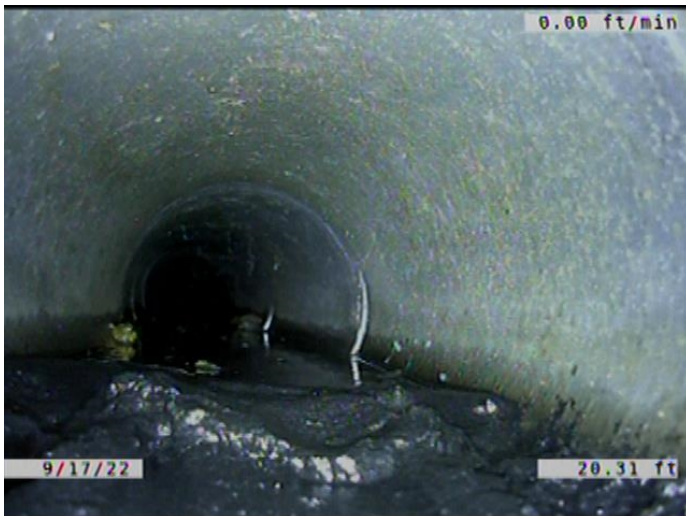
Code: **DSF**  
Description: **Deposits Settled Fine**

Distance (ft): **20.3**  
Structural Grade: **0**  
O&M Grade: **3**  
Clock Start/From: **4**  
Clock To: **8**  
1st Value:  
2nd Value:  
Value Percent: **15.000**  
Continuous Index: **S03**  
Within 8" of Joint: **YES**  
Remarks:

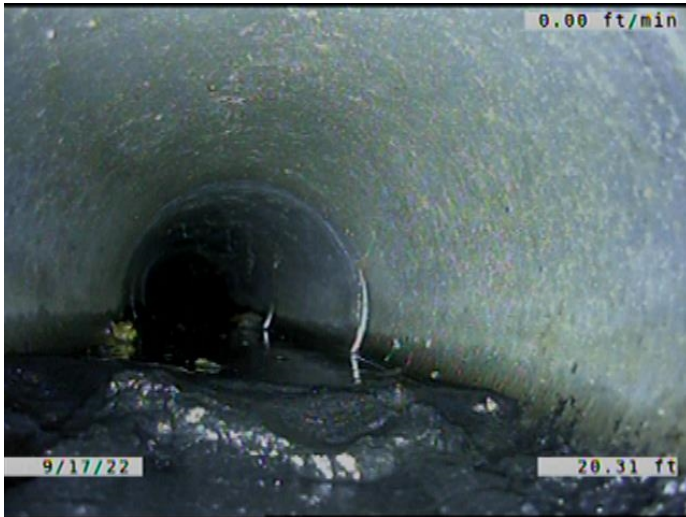
Code: **DSF**  
 Description: **Deposits Settled Fine**

Distance (ft): **20.3**  
 Structural Grade: **0**  
 O&M Grade: **2**  
 Clock Start/From: **5**  
 Clock To: **7**  
 1st Value:  
 2nd Value:  
 Value Percent: **5.000**  
 Continuous Index: **F01**  
 Within 8" of Joint: **YES**  
 Remarks:

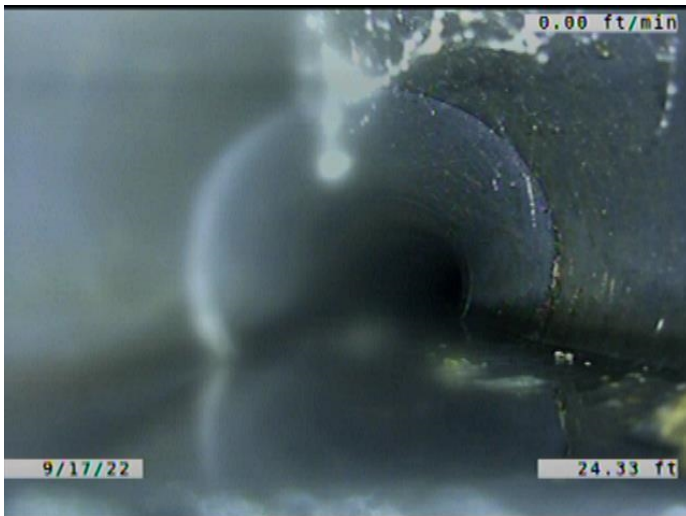
Code: **FM**  
 Description: **Fracture Multiple**

Distance (ft): **24.3**  
 Structural Grade: **4**  
 O&M Grade: **0**  
 Clock Start/From: **8**  
 Clock To: **4**  
 1st Value:  
 2nd Value:  
 Value Percent:  
 Continuous Index: **F02**  
 Within 8" of Joint: **YES**  
 Remarks: **Wandering**

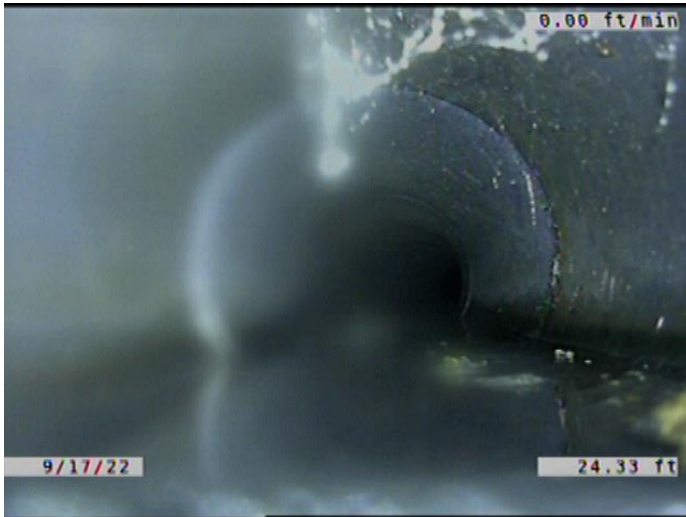
Code: **DSF**  
 Description: **Deposits Settled Fine**

Distance (ft): **24.3**  
 Structural Grade: **0**  
 O&M Grade: **3**  
 Clock Start/From: **4**  
 Clock To: **8**  
 1st Value:  
 2nd Value:  
 Value Percent: **15.000**  
 Continuous Index: **F03**  
 Within 8" of Joint: **YES**  
 Remarks:

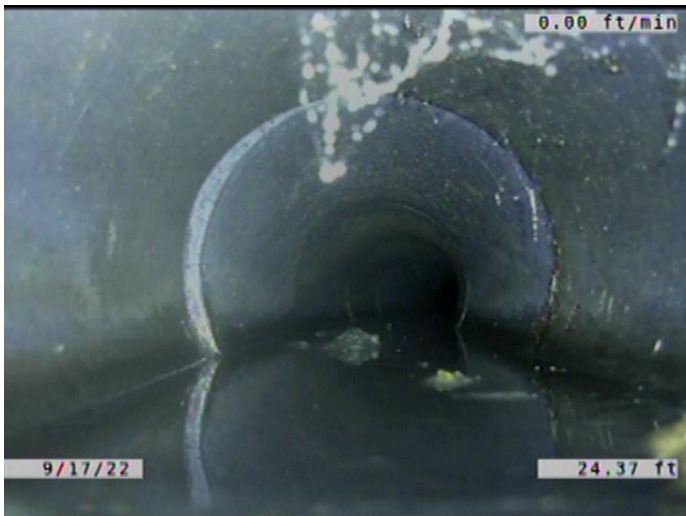
Code: **MSA**  
 Description: **Miscellaneous Survey Abandoned**

Distance (ft): **24.4**  
 Structural Grade: **0**  
 O&M Grade: **0**  
 Clock Start/From:  
 Clock To:  
 1st Value:  
 2nd Value:  
 Value Percent:  
 Continuous Index:  
 Within 8" of Joint: **NO**  
 Remarks: **CAMERA CANT MAKE IT PAST  
UNKNOWN OBJECT UNDER THE FINE**
