Profile/Photo Observation Report

Date:	10/20/2021	Weather:		Coding:	PACP 6.0
Pipe Length (ft):		Owner:	Hobart, IN	Pre Clean:	Not Known
P.O.#:	916_1	Surveyor:	M. Pielacha	PSR:	P-705-079-046
Customer:	Hobart, IN	Clean Date:		Shape:	C

Street:	East 3rd Street	Flow Control:	
City:	Hobart, IN	Year Renewed:	
Location:	Light Highway	Tape/Media #:	916
Purpose:	Routine Assessment	Dia/Height:	8"
Use:	Sanitary	Material:	PVC
Drain Area:		Lining:

US MH: **M-705-46** DS MH: **M-705-79** Total Length Surveyed (ft): **43.0**

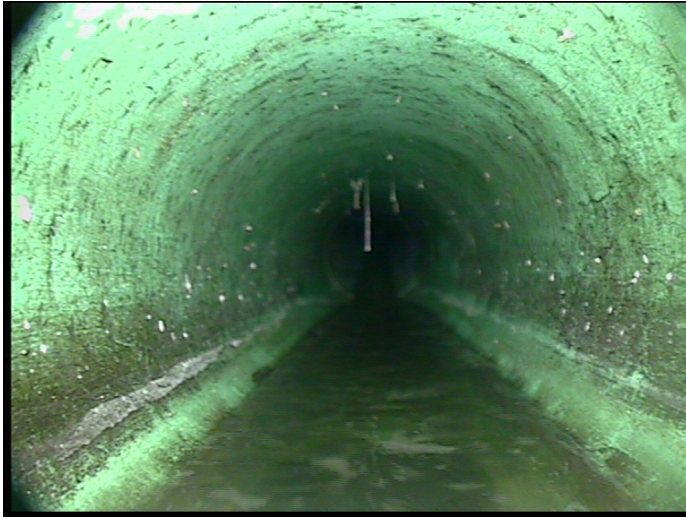
Code:	MWL
Description:	Water Level
Distance (ft):	.0
Structural Grade:	0
O&M Grade:	0
Clock Start/From:	
Clock To:	
1st Value:	
2nd Value:	
Value Percent:	5.000
Continuous Index:	
Within 8" of Joint:	NO
Remarks:

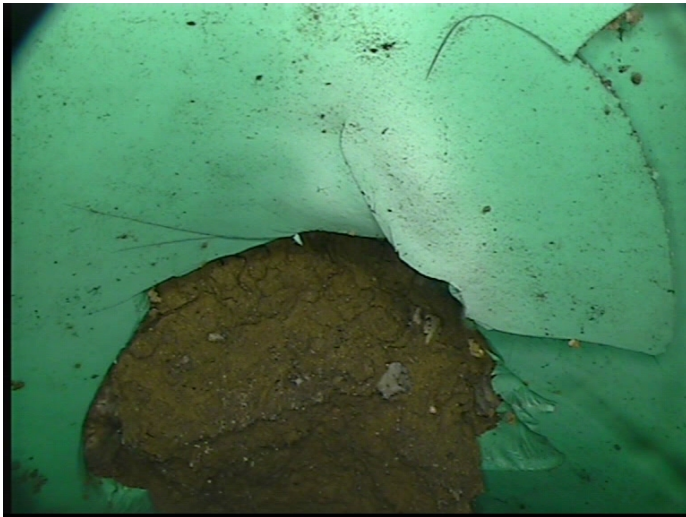
Code:	B
Description:	Broken
Distance (ft):	27.1
Structural Grade:	3
O&M Grade:	0
Clock Start/From:	1
Clock To:	
1st Value:	
2nd Value:	
Value Percent:	
Continuous Index:	
Within 8" of Joint:	NO
Remarks:

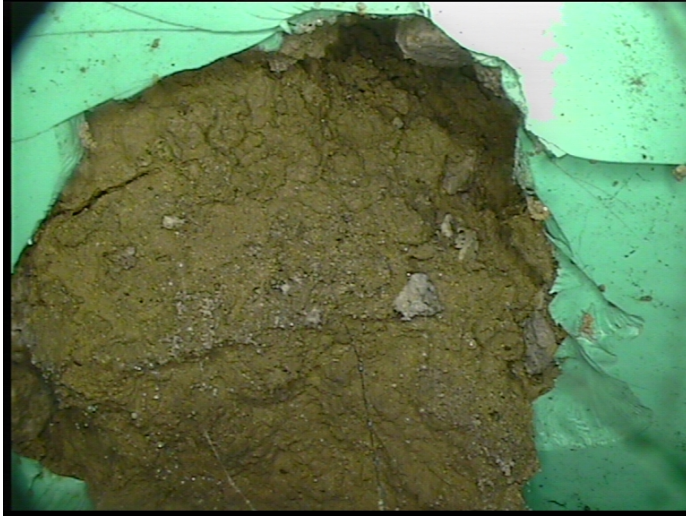
Code:	HSV
Description:	Hole Soil Visible
Distance (ft):	27.5
Structural Grade:	5
O&M Grade:	0
Clock Start/From:	12
Clock To:	
1st Value:	
2nd Value:	
Value Percent:	
Continuous Index:	
Within 8" of Joint:	NO
Remarks:

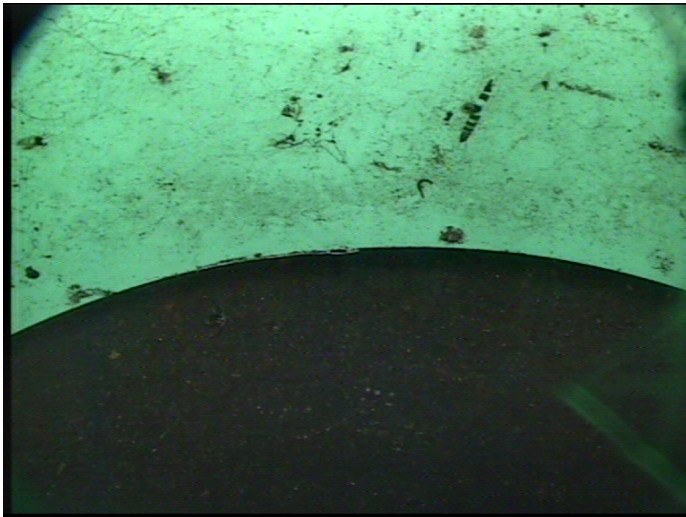
Code:	MMC
Description:	Material Change
Distance (ft):	39.6
Structural Grade:	0
O&M Grade:	0
Clock Start/From:	
Clock To:	
1st Value:	
2nd Value:	
Value Percent:	
Continuous Index:	
Within 8" of Joint:	NO
Remarks:	vcp

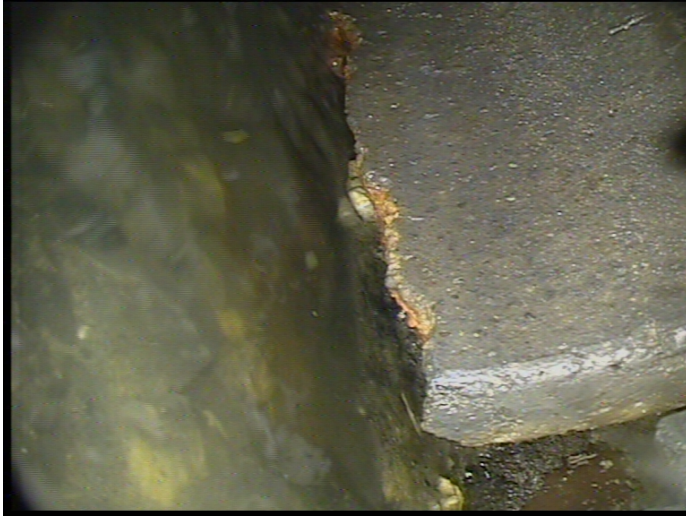
Code: **HVV**
Description: **Hole Void Visible**

Distance (ft): **43.0**
Structural Grade: **5**
O&M Grade: **0**
Clock Start/From: **5**
Clock To:
1st Value:
2nd Value:
Value Percent:
Continuous Index:
Within 8" of Joint: **YES**
Remarks:

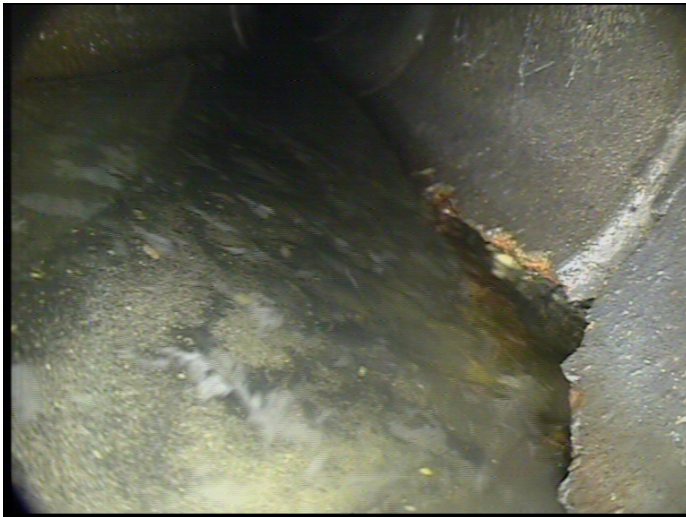
Code: **MSA**
Description: **Abandoned Survey**

Distance (ft): **43.0**
Structural Grade: **0**
O&M Grade: **0**
Clock Start/From:
Clock To:
1st Value:
2nd Value:
Value Percent:
Continuous Index:
Within 8" of Joint: **NO**
Remarks: **Hole on lower end of pipe. Will not pass.**
