## Profile/Photo Observation Report

Street:	<b>East Street</b>	Flow Control:	
City:	<b>Hobart, IN</b>	Year Renewed:	
Location:	<b>Light Highway</b>	Tape/Media #:	<b>917</b>
Purpose:	<b>Reversal</b>	Dia/Height:	<b>8"</b>
Use:	<b>Sanitary</b>	Material:	<b>VCP</b>
Drain Area:		Lining:	
Category:	<b>NA</b>		
Comment:

Location Details:		Direction of Survey:	<b>Downstream</b>
US MH:	<b>M-705-46</b>	DS MH:	<b>M-705-79</b>
		Total Length Surveyed (ft):	<b>26.2</b>

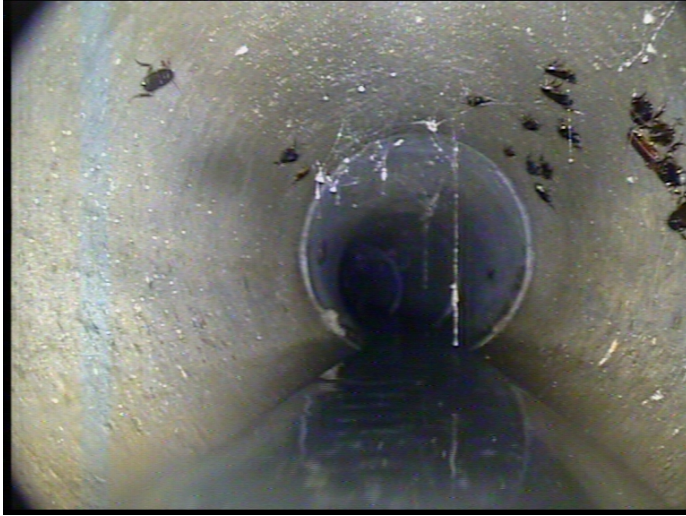
Code: **MWL**  
Description: **Water Level**

Distance (ft): **.0**  
Structural Grade: **0**  
O&M Grade: **0**  
Clock Start/From:  
Clock To:  
1st Value:  
2nd Value:  
Value Percent: **5.000**  
Continuous Index:  
Within 8" of Joint: **NO**  
Remarks:

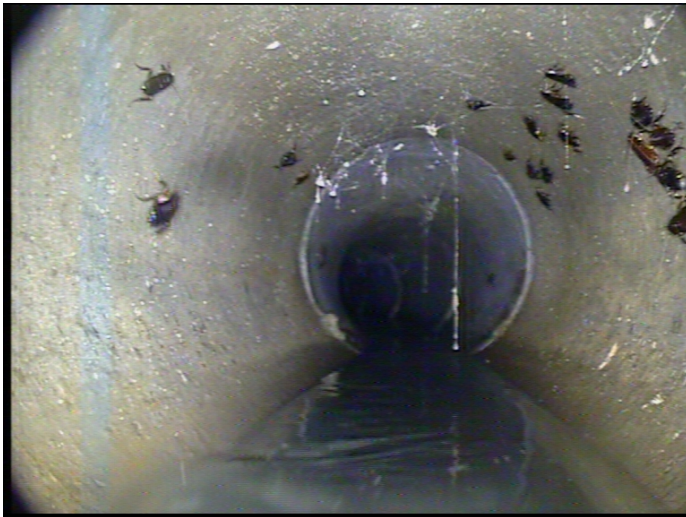
Code: **VC**  
Description: **Vermin Cockroach**

Distance (ft): **.0**  
Structural Grade: **0**  
O&M Grade: **1**  
Clock Start/From:  
Clock To:  
1st Value:  
2nd Value:  
Value Percent:  
Continuous Index:  
Within 8" of Joint: **NO**  
Remarks:

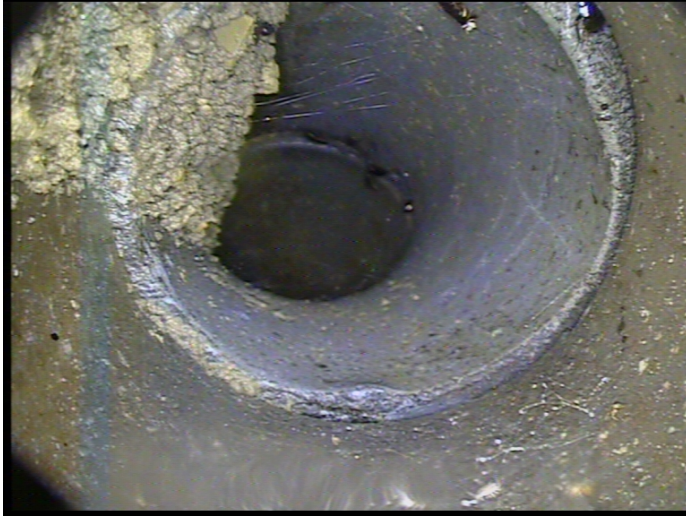
Code: **TF**  
Description: **Tap Factory**

Distance (ft): **10.0**  
Structural Grade: **0**  
O&M Grade: **0**  
Clock Start/From: **10**  
Clock To:  
1st Value: **4.000**  
2nd Value:  
Value Percent:  
Continuous Index:  
Within 8" of Joint: **NO**  
Remarks:

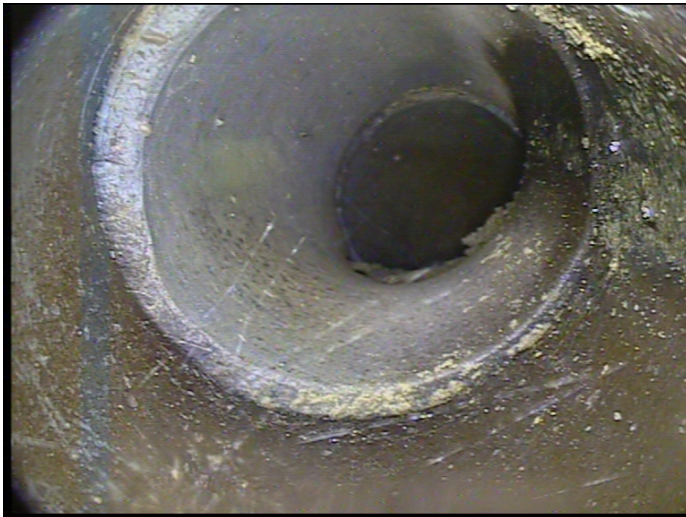
Code: **TF**  
Description: **Tap Factory**

Distance (ft): **17.1**  
Structural Grade: **0**  
O&M Grade: **0**  
Clock Start/From: **3**  
Clock To:  
1st Value: **4.000**  
2nd Value:  
Value Percent:  
Continuous Index:  
Within 8" of Joint: **NO**  
Remarks:

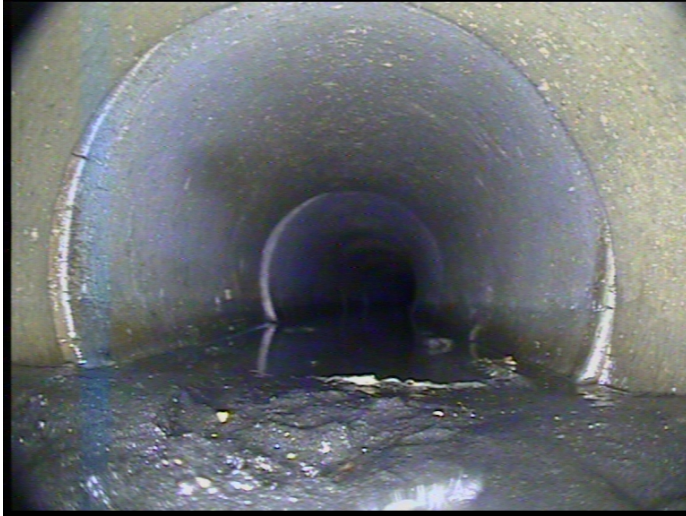
Code: **DSF**  
Description: **Deposits Settled Fine**

Distance (ft): **22.5**  
Structural Grade: **0**  
O&M Grade: **3**  
Clock Start/From: **4**  
Clock To: **8**  
1st Value:  
2nd Value:  
Value Percent: **15.000**  
Continuous Index:  
Within 8" of Joint: **NO**  
Remarks:

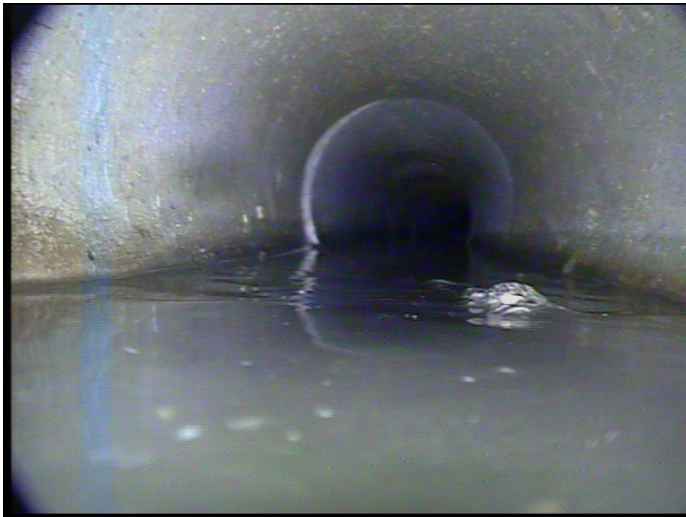
Code: **MSA**  
Description: **Abandoned Survey**

Distance (ft): **25.8**  
Structural Grade: **0**  
O&M Grade: **0**  
Clock Start/From:  
Clock To:  
1st Value:  
2nd Value:  
Value Percent:  
Continuous Index:  
Within 8" of Joint: **NO**  
Remarks: **deep sediment**
