## **Profile/Photo Observation Report**

| Date: | 04/30/2018 | Weather: | | Coding: | PACP 6.0 |
| Street: | East Street | | Flow Control: | Not Controlle | d |
| US MH: | M-705-047 | DS MH: | M-705-046 | Total Length Surveyed (f | t): <b>145.3</b> |

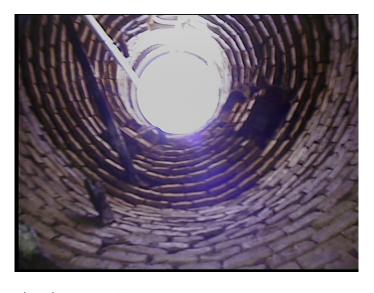
AMH

| Description: | Manhole | | | |
| Distance (ft): | .0 | | | |
| Remarks: | M-705-047 | | | |

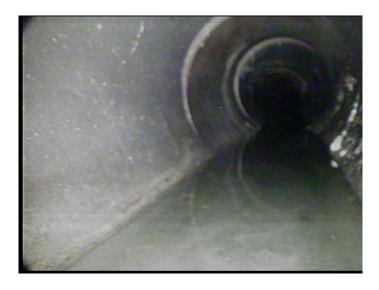
Code: MWL

Description: Water Level

Distance (ft): .0
Structural Grade: 0
O&M Grade: 0

Value Percent: 10.000

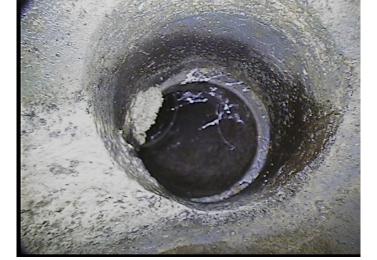
**TFA**

Description: Tap Factory Active

Distance (ft): 6.0
Structural Grade: 0
O&M Grade: 0
Clock Start/From: 11

1st Value: **4.000**

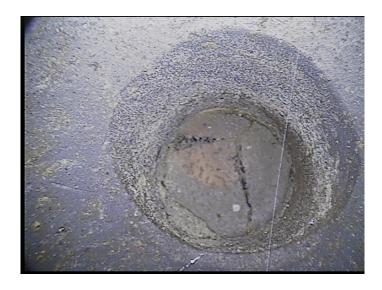
Code: **TF**

Description: Tap Factory

Distance (ft): 48.4
Structural Grade: 0

Clock Start/From: 10

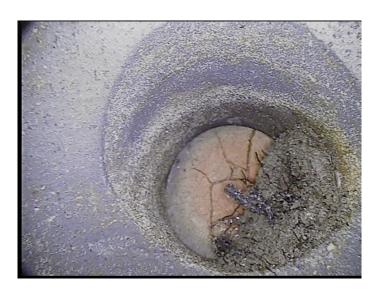
Code: **TFC**

Description: Tap Factory Capped

Distance (ft): 78.5
Structural Grade: 0
O&M Grade: 0
Clock Start/From: 2

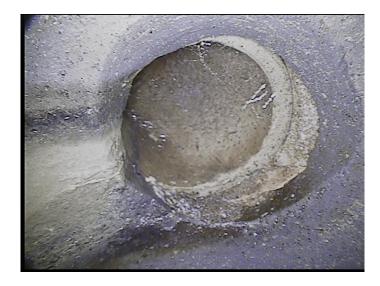
Code: **TF**

Description: Tap Factory

Distance (ft): 90.2
Structural Grade: 0

Clock Start/From: 10

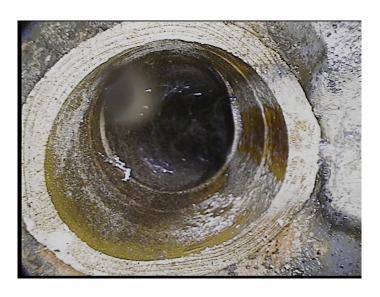
Code: TBA

Description: Tap Break-in Active

Distance (ft): 123.8
Structural Grade: 0
O&M Grade: 0
Clock Start/From: 2

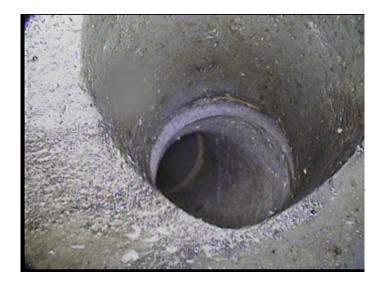
Code: **TF**

Description: Tap Factory

Distance (ft): 126.8
Structural Grade: 0
O&M Grade: 0
Clock Start/From: 10

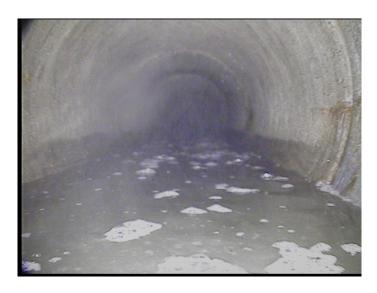
Code: MSA

Description: Abandoned Survey

Distance (ft): 140.9
Structural Grade: 0
O&M Grade: 0

Remarks: sediment/debris
