Profile/Photo Observation Report

Date:	04/30/2018	Weather:		Coding:	PACP 6.0
Pipe Length (ft):		Owner:	City of Hobart	Pre Clean:	No Pre-Cleaning
P.O.#:	147	Surveyor:	M. Pielacha	PSR:	P-705-046-047
Customer:	City of Hobart	Clean Date:		Shape:	C

Street:	3rd Street	Flow Control:	Not Controlled
City:	Hobart, IN	Year Renewed:	
Location:	Light Highway	Tape/Media #:	DEP 147
Purpose:	Routine Assessment	Dia/Height:	18"
Use:	Sanitary	Material:	VCP
Drain Area:		Lining:	
Category:	NA		
Comment:	5-21-2018		
Location Details:		Direction of Survey:	Downstream
US MH:	M-705-047	DS MH:	M-705-046
		Total Length Surveyed (ft):	94.1

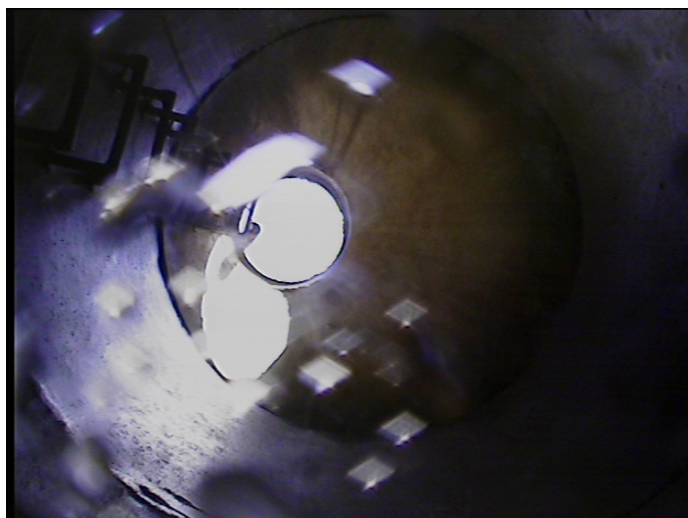
Code: **AMH**
Description: **Manhole**

Distance (ft): **.0**
Structural Grade: **0**
O&M Grade: **0**
Clock Start/From:
Clock To:
1st Value:
2nd Value:
Value Percent:
Continuous Index:
Within 8" of Joint: **NO**
Remarks: **M-705-046**

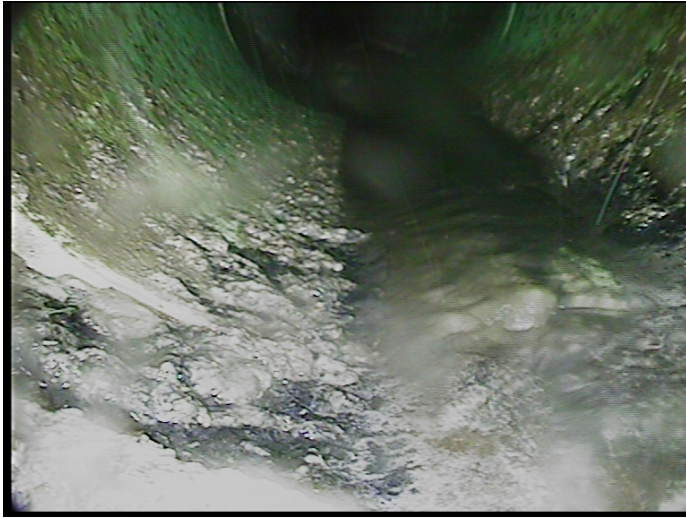
Code: **MWL**
Description: **Water Level**

Distance (ft): **.0**
Structural Grade: **0**
O&M Grade: **0**
Clock Start/From:
Clock To:
1st Value:
2nd Value:
Value Percent: **10.000**
Continuous Index:
Within 8" of Joint: **NO**
Remarks:

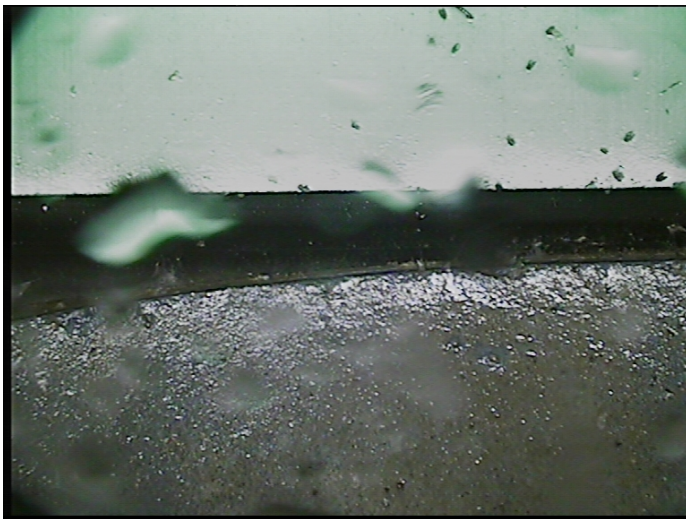
Code: **MMC**
Description: **Material Change**

Distance (ft): **15.5**
Structural Grade: **0**
O&M Grade: **0**
Clock Start/From:
Clock To:
1st Value:
2nd Value:
Value Percent:
Continuous Index:
Within 8" of Joint: **NO**
Remarks: **vcp**

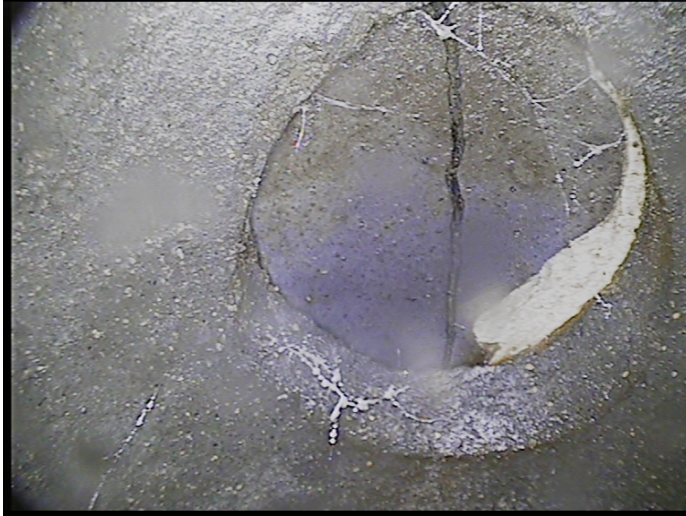
Code: **TFC**
Description: **Tap Factory Capped**

Distance (ft): **62.3**
Structural Grade: **0**
O&M Grade: **0**
Clock Start/From: **12**
Clock To:
1st Value: **4.000**
2nd Value:
Value Percent:
Continuous Index:
Within 8" of Joint: **NO**
Remarks:

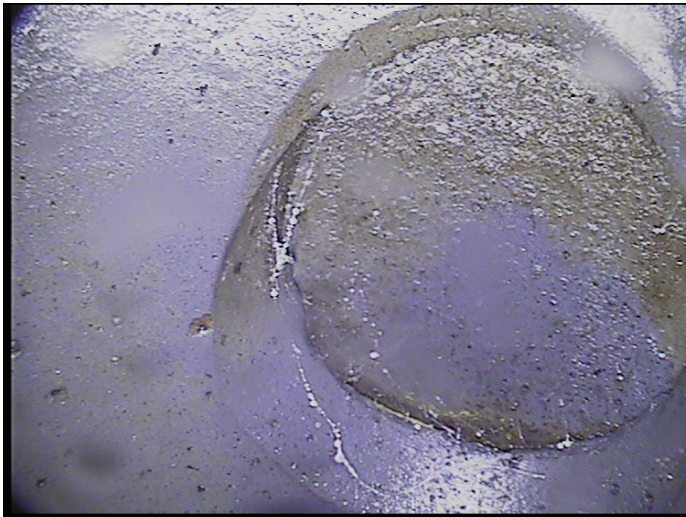
Code: **TFC**
Description: **Tap Factory Capped**

Distance (ft): **68.2**
Structural Grade: **0**
O&M Grade: **0**
Clock Start/From: **12**
Clock To:
1st Value: **4.000**
2nd Value:
Value Percent:
Continuous Index:
Within 8" of Joint: **NO**
Remarks:

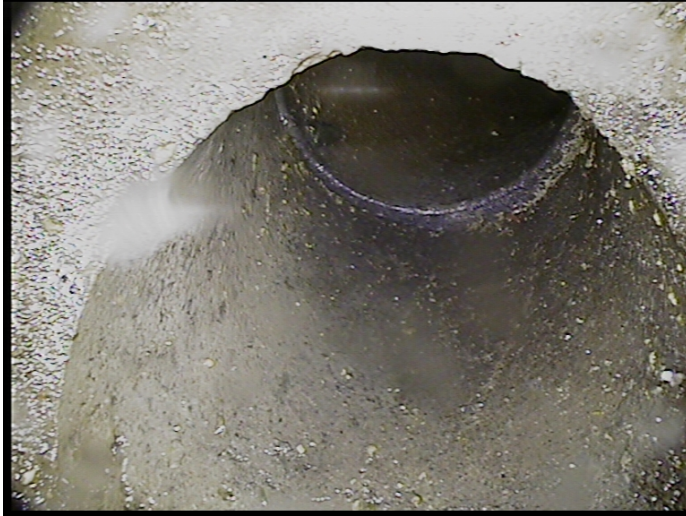
Code: **TF**
Description: **Tap Factory**

Distance (ft): **84.0**
Structural Grade: **0**
O&M Grade: **0**
Clock Start/From: **12**
Clock To:
1st Value: **4.000**
2nd Value:
Value Percent:
Continuous Index:
Within 8" of Joint: **NO**
Remarks:

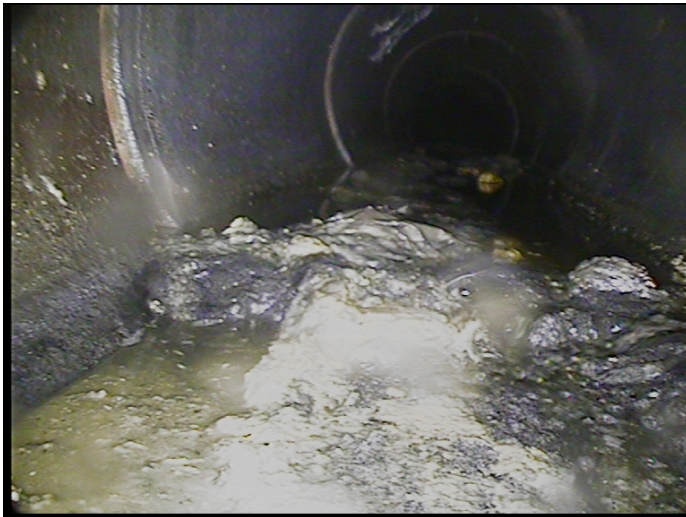
Code: **DSF**
Description: **Deposits Settled Fine**

Distance (ft): **84.3**
Structural Grade: **0**
O&M Grade: **3**
Clock Start/From: **5**
Clock To: **7**
1st Value:
2nd Value:
Value Percent: **15.000**
Continuous Index: **S01**
Within 8" of Joint: **YES**
Remarks:

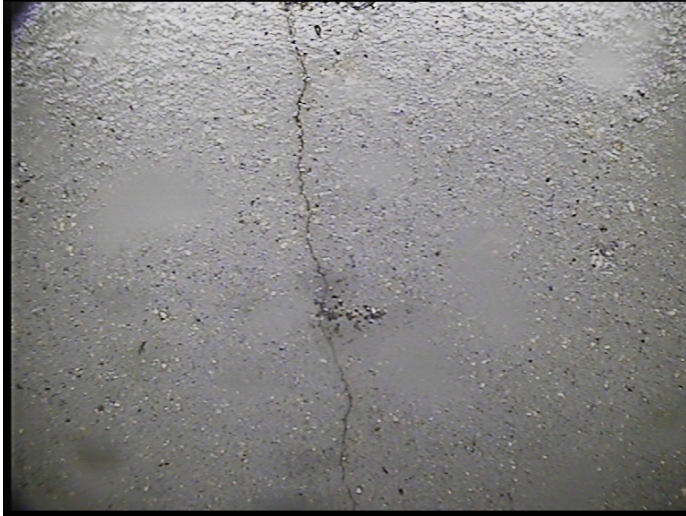
Code: **CL**
Description: **Crack Longitudinal**

Distance (ft): **84.8**
Structural Grade: **2**
O&M Grade: **0**
Clock Start/From: **12**
Clock To:
1st Value:
2nd Value:
Value Percent:
Continuous Index:
Within 8" of Joint: **YES**
Remarks:

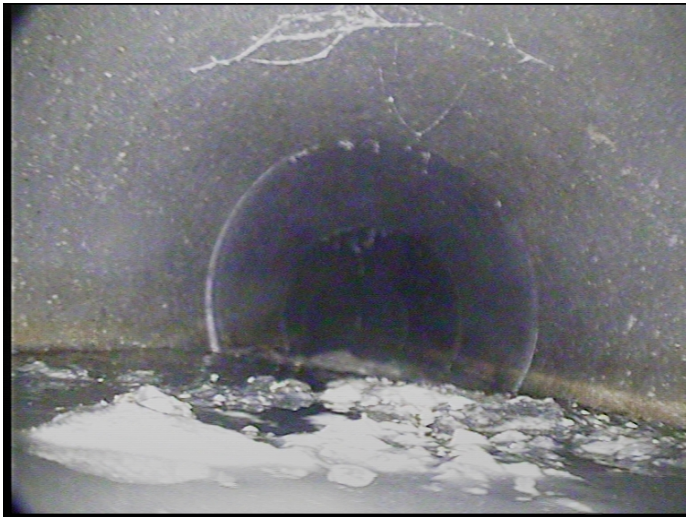
Code: **DSF**
Description: **Deposits Settled Fine**

Distance (ft): **94.1**
Structural Grade: **0**
O&M Grade: **3**
Clock Start/From: **5**
Clock To: **7**
1st Value:
2nd Value:
Value Percent: **20.000**
Continuous Index: **F01**
Within 8" of Joint: **NO**
Remarks:

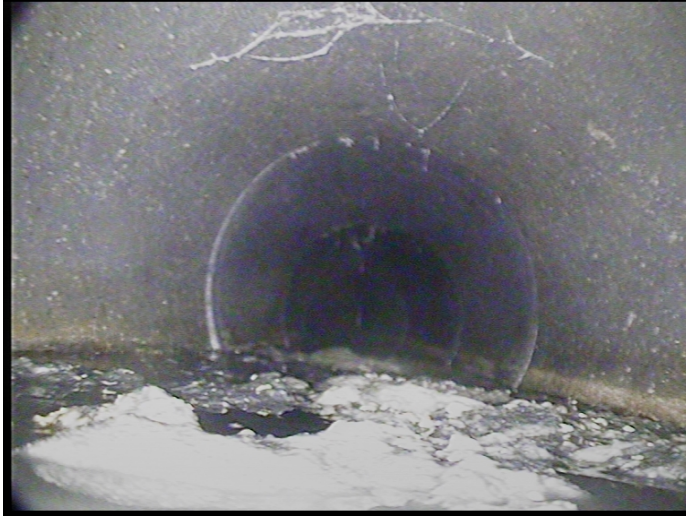
Code:	MSA
Description:	Abandoned Survey
Distance (ft):	94.1
Structural Grade:	0
O&M Grade:	0
Clock Start/From:	
Clock To:	
1st Value:	
2nd Value:	
Value Percent:	
Continuous Index:	
Within 8" of Joint:	NO
Remarks:	sediment
