Profile/Photo Observation Report

Date: 08/11/2022 Weather: **PACP 7.0** Coding: Pipe Length (ft): 390.0 Owner: **City of Hobart** Pre Clean: **Heavy Cleaning** P.O.#: S. Bucklin PSR: P-705-046-047 YES502259 Surveyor:

Street: East Street Flow Control: Not Controlled

US MH: M-705-047 DS MH: M-705-046 Total Length Surveyed (ft): 388.1

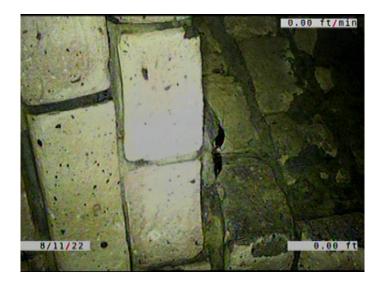
Description: Vermin Cockroach

Distance (ft): .0
Structural Grade: 0
O&M Grade: 1

Remarks: IN THE MANHOLE.

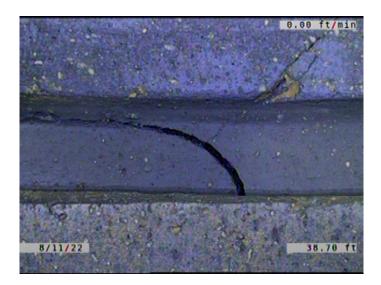
Code: B
Description: Broken

Distance (ft): 38.7
Structural Grade: 4

Clock Start/From: 12

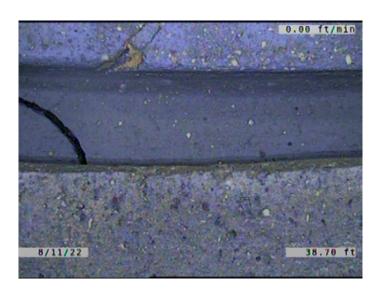
Description: Joint Angular Medium

Distance (ft): 38.7
Structural Grade: 3
O&M Grade: 0

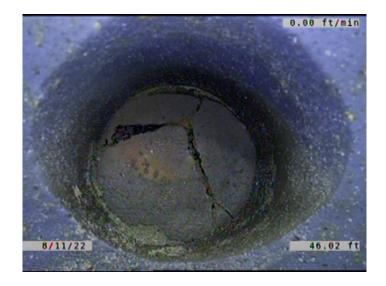
Description: Tap Factory Defective

Distance (ft): 46.0
Structural Grade: 0
O&M Grade: 3
Clock Start/From: 11

Remarks: CAPPED. CAP BROKEN.

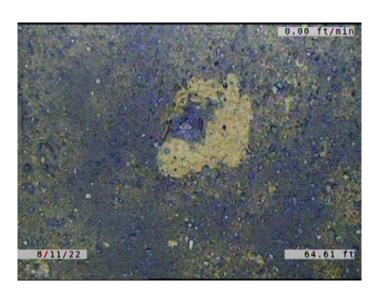
Description: Surface Damage Surface Spalling

Distance (ft): 64.6
Structural Grade: 2
O&M Grade: 0
Clock Start/From: 1

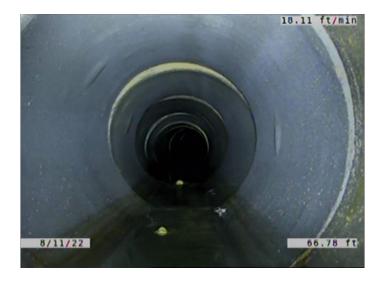
Description: Surface Damage Other

Remarks: Indentations factory defect.

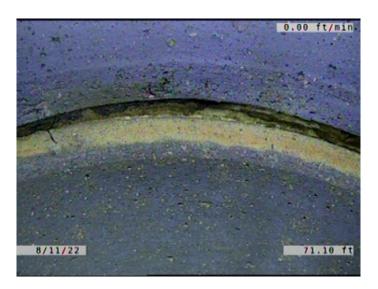
Description: Joint Offset Medium Defective

Distance (ft): 71.1
Structural Grade: 3
O&M Grade: 0

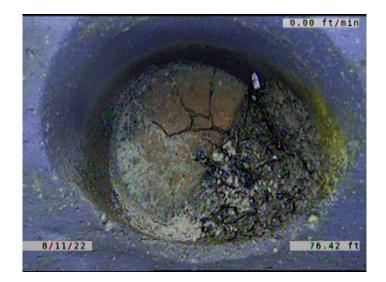
Description: Tap Factory Defective

Distance (ft): 76.4
Structural Grade: 0

O&M Grade: 3

Remarks: CAPPED. CAP BROKEN. ROOTS
GROWING THROUGH THE CAP.

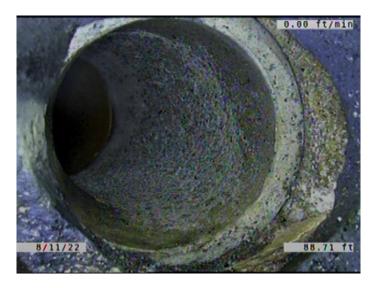
Description: Tap Factory

Remarks: SERVICE ANGLED.

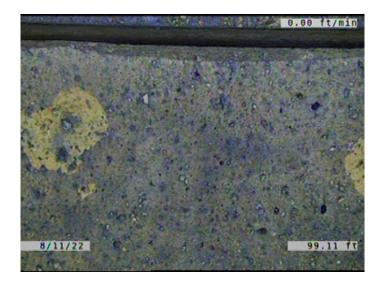
Description: Surface Damage Surface Spalling

Distance (ft): 99.1
Structural Grade: 2
O&M Grade: 0
Clock Start/From: 1
Clock To: 2

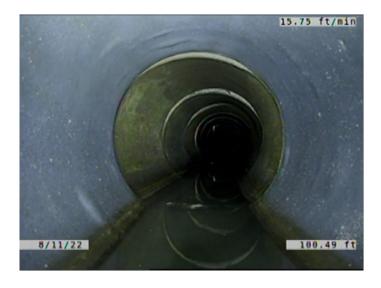
Description: Surface Damage Other

Remarks: Indentations factory defect.

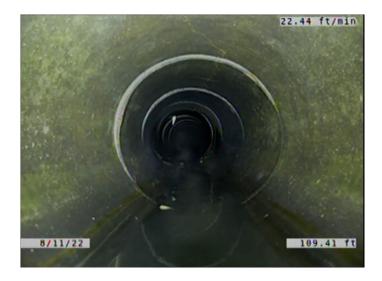
Description: Fracture Multiple

Distance (ft): 109.4
Structural Grade: 4

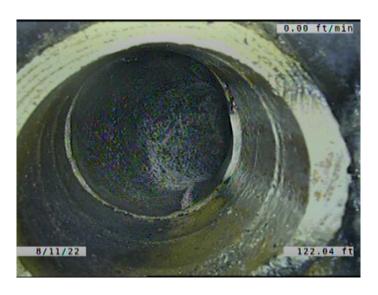
Description: Tap Factory Intruding

Distance (ft): 122.0
Structural Grade: 0
O&M Grade: 2
Clock Start/From: 1

Remarks: TAP BROKEN. CONSTANTLY

RUNNING WATER.

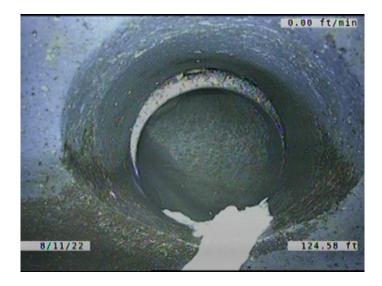
Description: Tap Factory

Remarks: SERVICE OFFSET.

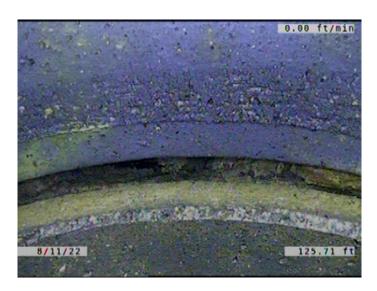
Description: Joint Offset Medium Defective

Distance (ft): 125.7
Structural Grade: 3
O&M Grade: 0

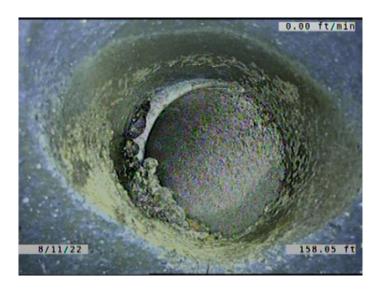
Description: Tap Factory Defective

Distance (ft): 158.0
Structural Grade: 0
O&M Grade: 3
Clock Start/From: 11

Remarks: TAP BROKEN. SERVICE OFFSET AND

ANGLED.

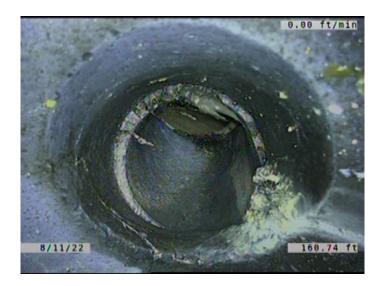
Description: Tap Factory Defective

Distance (ft): 160.7
Structural Grade: 0
O&M Grade: 3
Clock Start/From: 1

Remarks: TAP BROKEN. ROOTS GROWING IN

THE JOINTS.

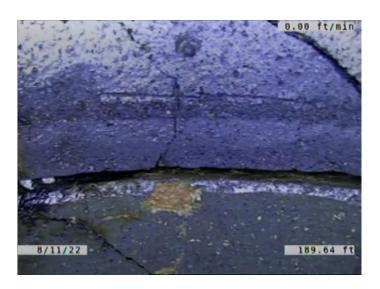
Description: Broken

Distance (ft): 189.6
Structural Grade: 4
O&M Grade: 0
Clock Start/From: 8
Clock To: 4
1st Value:
2nd Value:
Value Percent:

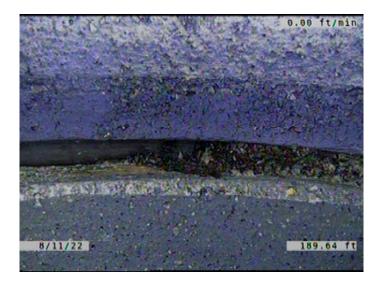
Description: Roots Fine Joint

Distance (ft): 189.6
Structural Grade: 0
O&M Grade: 1
Clock Start/From: 1

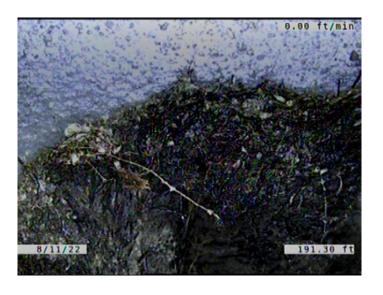
Description: Roots Medium Lateral

Distance (ft): 191.3
Structural Grade: 0
O&M Grade: 3
Clock Start/From: 1
Clock To: 2
1st Value:

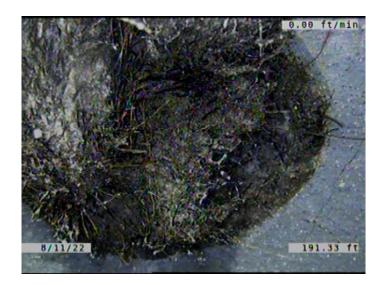
Description: Tap Factory Defective

Distance (ft): 191.3
Structural Grade: 0
O&M Grade: 3
Clock Start/From: 1

Remarks: LOOKS TO BE 100% PLUGGED WITH

ROOTS.

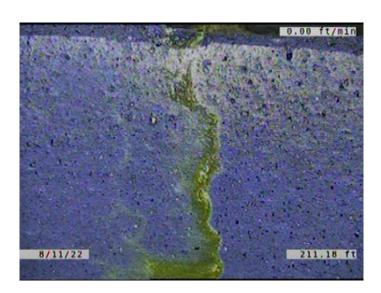
Description: Infiltration Stain Barrel

Distance (ft): 211.2
Structural Grade: 0
O&M Grade: 1
Clock Start/From: 11

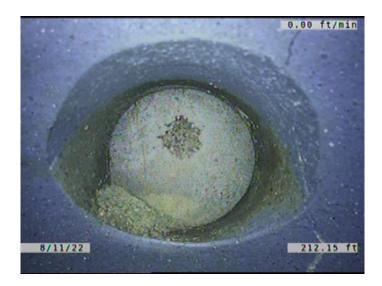
Description: Tap Factory Defective

Distance (ft): 212.2
Structural Grade: 0
O&M Grade: 3
Clock Start/From: 11

Remarks: TAP BROKEN. CAPPED.

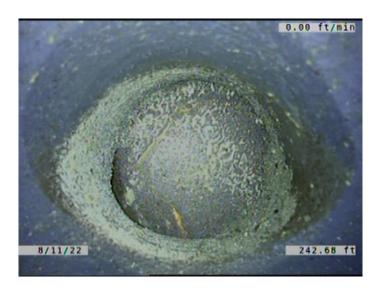
Description: Tap Factory Defective

Distance (ft): 242.7
Structural Grade: 0
O&M Grade: 3
Clock Start/From: 2

Remarks: CAPPED. CAP BROKEN.

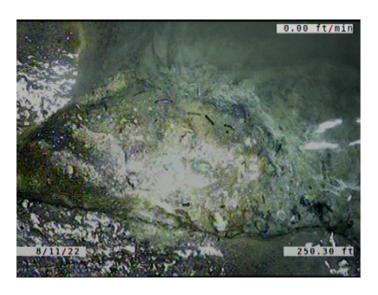
Description: **Deposits Attached Encrustation**

Distance (ft): 250.3 Structural Grade: 0 O&M Grade: 2 Clock Start/From: 4 Clock To: 8 1st Value:

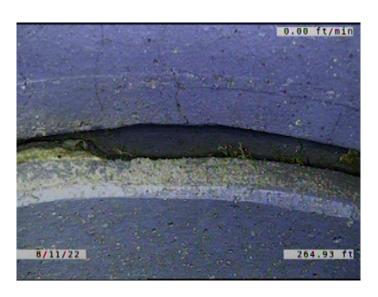
Description: Joint Offset Medium Defective

Distance (ft): 264.9
Structural Grade: 3
O&M Grade: 0

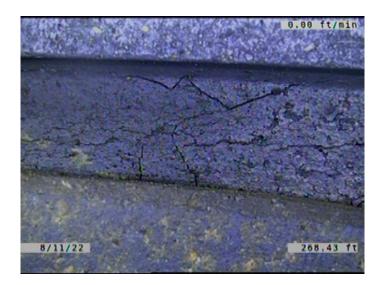
Description: **Joint Angular Large**

Distance (ft): 268.4 Structural Grade: 0 O&M Grade:

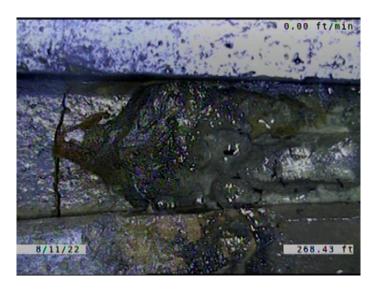
Description: **Infiltration Runner Joint**

Distance (ft): 268.4 Structural Grade: 0 O&M Grade: Clock Start/From: Clock To: 1st Value:

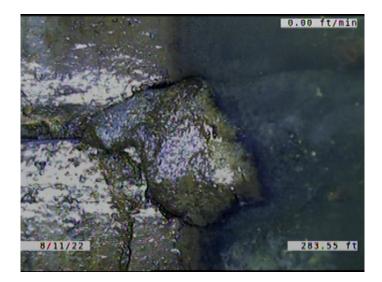
Description: Deposits Attached Encrustation

Distance (ft): 283.5
Structural Grade: 0
O&M Grade: 2
Clock Start/From: 7
Clock To: 8

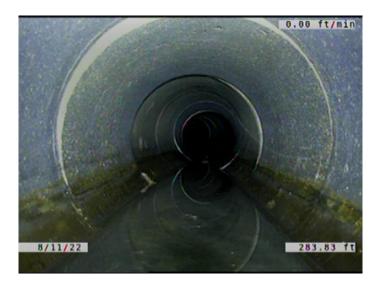
Description: Miscellaneous Water Level Sag

Distance (ft): 283.8
Structural Grade: 2
O&M Grade: 0

Value Percent: 10.000

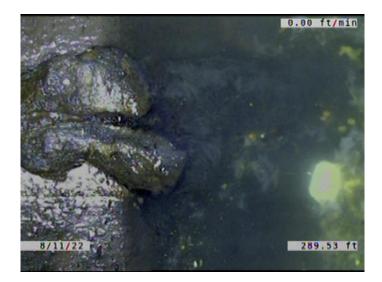
Description: Deposits Attached Encrustation

Distance (ft): 289.5
Structural Grade: 0
O&M Grade: 2
Clock Start/From: 7
Clock To: 8

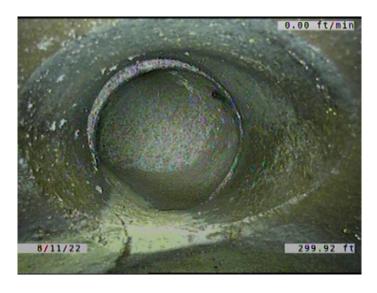
Description: Tap Factory Defective

Distance (ft): 299.9
Structural Grade: 0
O&M Grade: 3
Clock Start/From: 11

Remarks: TAP BROKEN.

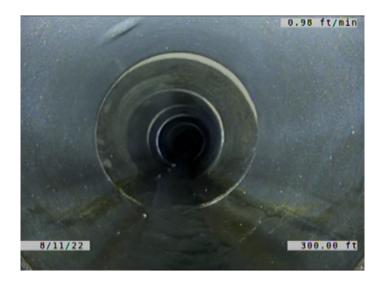
Description: Surface Damage Other

Remarks: Indentation, factory defect.

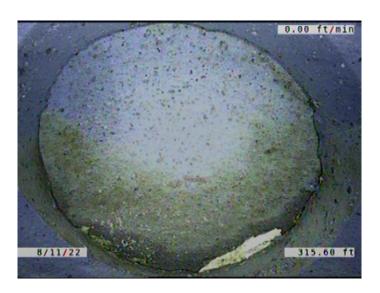
Description: Tap Factory Defective

Distance (ft): 315.6
Structural Grade: 0
O&M Grade: 3
Clock Start/From: 12

Remarks: TAP CRACKED, CAPPED.

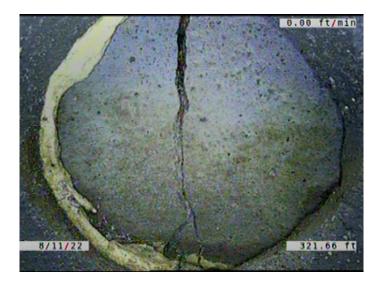
Description: **Tap Factory Defective**

Distance (ft): 321.7 Structural Grade: 0 3 O&M Grade: Clock Start/From: 12

Remarks: TAP CRACKED. CAPPED. CAP

BROKEN.

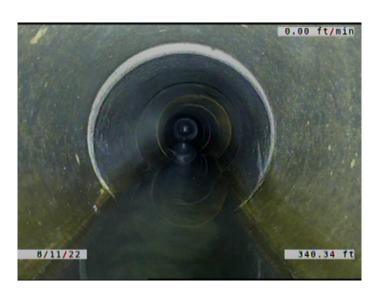
Description: **Miscellaneous Water Level Sag**

Distance (ft): 340.3 Structural Grade: 2 O&M Grade: 0

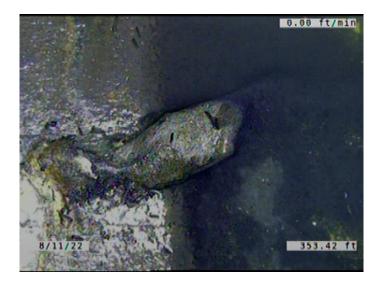
Description: **Deposits Attached Encrustation**

Distance (ft): 353.4 Structural Grade: 0 2 O&M Grade: Clock Start/From: 4 Clock To: 8

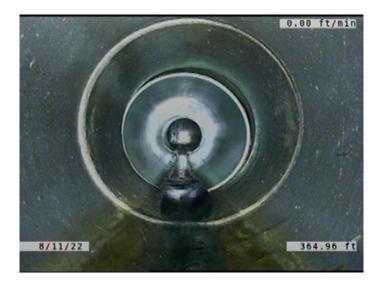
Description: **Miscellaneous Water Level Sag**

Distance (ft): 365.0 Structural Grade: 2 O&M Grade: 0

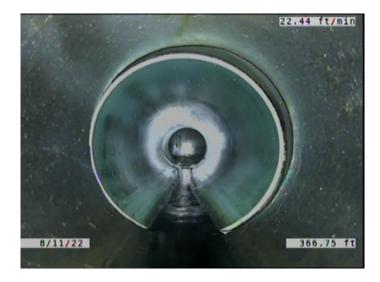
Description: Fracture Multiple

Distance (ft): 366.8
Structural Grade: 4

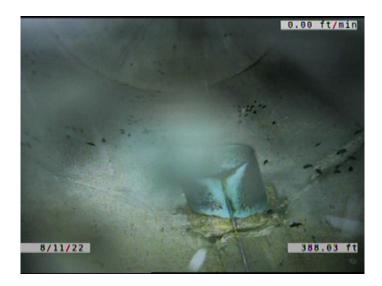
Description: Vermin Cockroach

Remarks: IN THE MANHOLE.
