## Profile/Photo Observation Report

Date:	<b>09/17/2022</b>	Weather:		Coding:	<b>PACP 7.0</b>
Pipe Length (ft):	<b>214.4</b>	Owner:	<b>City of Hobart</b>	Pre Clean:	<b>No Pre-Cleaning</b>
P.O.#:	<b>YES502259</b>	Surveyor:	<b>S. Bucklin</b>	PSR:	<b>M-705-050-M-705-085</b>
Customer:	<b>City of Hobart</b>	Clean Date:		Shape:	<b>C</b>

US MH: **M-705-050**

DS MH: **M-705-085**

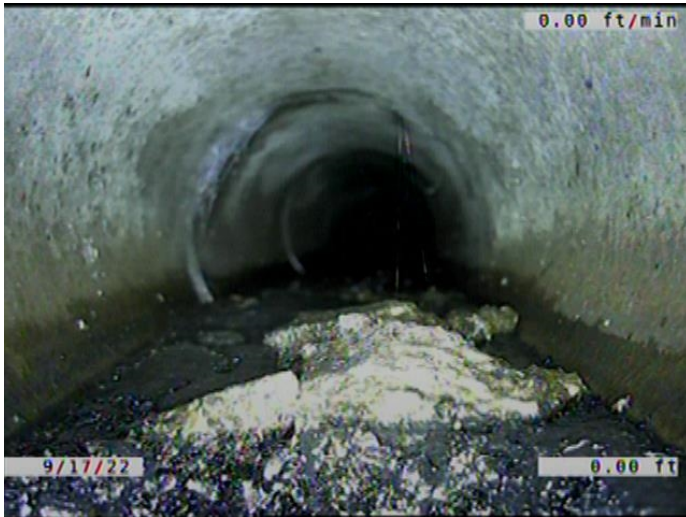
Code: **DSF**  
 Description: **Deposits Settled Fine**

Distance (ft): **.0**  
 Structural Grade: **0**  
 O&M Grade: **3**  
 Clock Start/From: **4**  
 Clock To: **8**  
 1st Value:  
 2nd Value:  
 Value Percent: **15.000**  
 Continuous Index: **S01**  
 Within 8" of Joint: **YES**  
 Remarks:

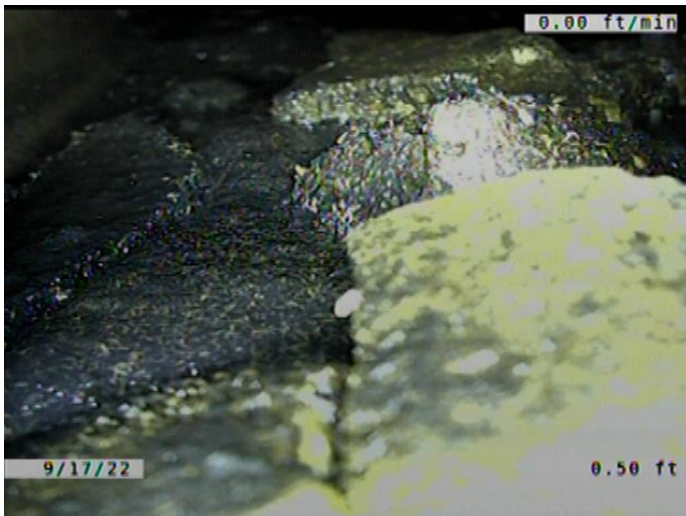
Code: **OBN**  
 Description: **Obstruction Construction Debris**

Distance (ft): **.5**  
 Structural Grade: **0**  
 O&M Grade: **2**  
 Clock Start/From: **5**  
 Clock To: **7**  
 1st Value:  
 2nd Value:  
 Value Percent: **10.000**  
 Continuous Index:  
 Within 8" of Joint: **YES**  
 Remarks:

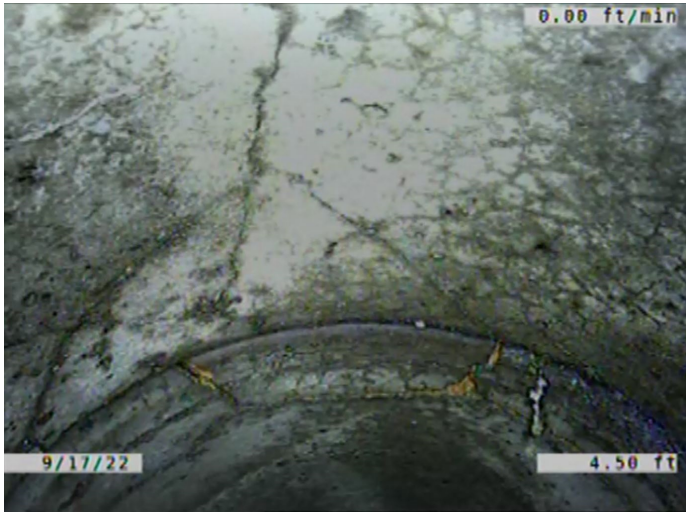
Code: **B**  
Description: **Broken**

Distance (ft): **4.5**  
Structural Grade: **4**  
O&M Grade: **0**  
Clock Start/From: **11**  
Clock To: **1**  
1st Value:  
2nd Value:  
Value Percent:  
Continuous Index:  
Within 8" of Joint: **YES**  
Remarks:

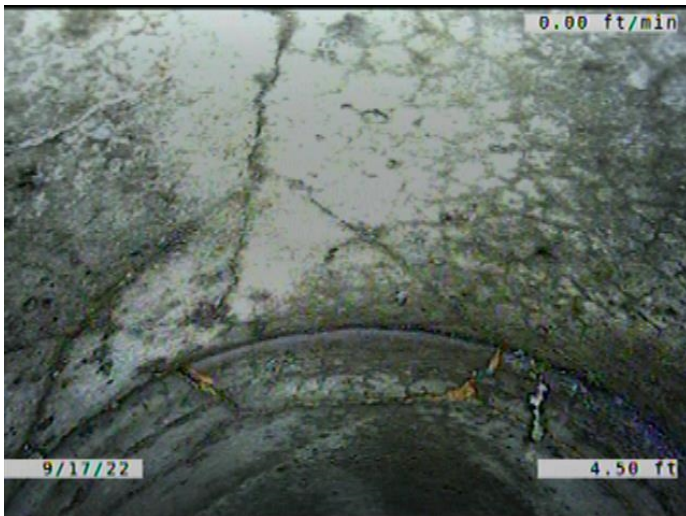
Code: **FM**  
Description: **Fracture Multiple**

Distance (ft): **4.5**  
Structural Grade: **4**  
O&M Grade: **0**  
Clock Start/From: **12**  
Clock To: **12**  
1st Value:  
2nd Value:  
Value Percent:  
Continuous Index: **S02**  
Within 8" of Joint: **YES**  
Remarks:

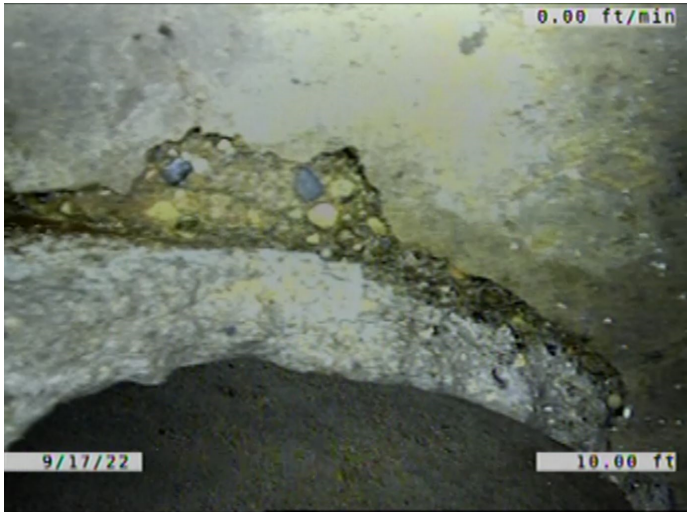
Code: **SMW**  
Description: **Surface Damage Missing Wall**

Distance (ft): **10.0**  
Structural Grade: **5**  
O&M Grade: **0**  
Clock Start/From: **12**  
Clock To:  
1st Value:  
2nd Value:  
Value Percent:  
Continuous Index:  
Within 8" of Joint: **NO**  
Remarks:

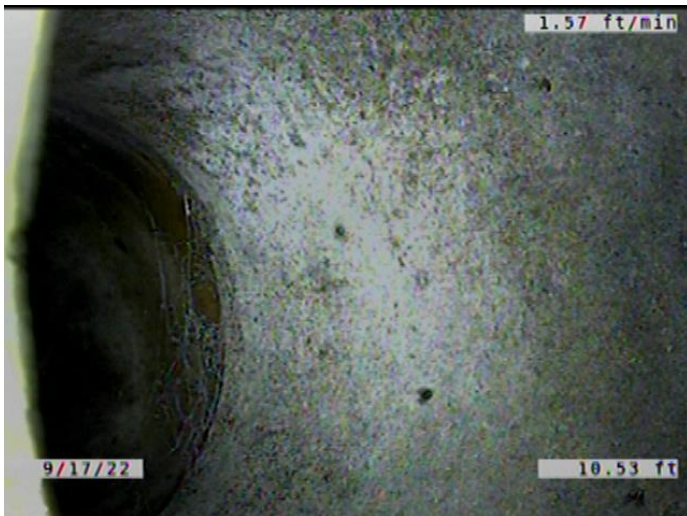
Code: **TBI**  
Description: **Tap Break-in Intruding**

Distance (ft): **10.5**  
Structural Grade: **0**  
O&M Grade: **2**  
Clock Start/From: **11**  
Clock To:  
1st Value: **6.000**  
2nd Value: **2.000**  
Value Percent:  
Continuous Index:  
Within 8" of Joint: **YES**  
Remarks:

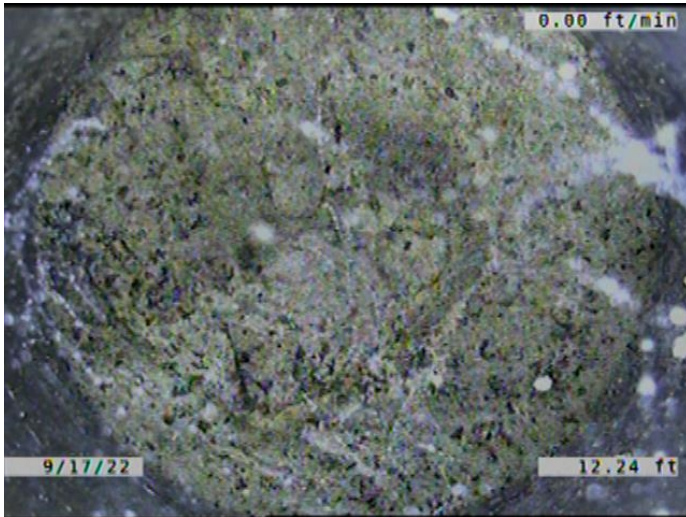
Code: **TFD**  
Description: **Tap Factory Defective**

Distance (ft): **12.2**  
Structural Grade: **0**  
O&M Grade: **3**  
Clock Start/From: **11**  
Clock To:  
1st Value: **6.000**  
2nd Value:  
Value Percent:  
Continuous Index:  
Within 8" of Joint: **YES**  
Remarks: **CAP MISSING. SOIL VISIBLE.**

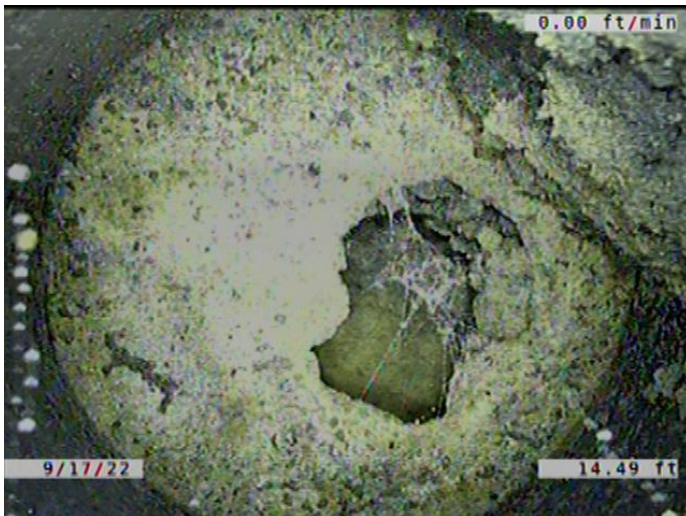
Code: **TFD**  
Description: **Tap Factory Defective**

Distance (ft): **14.5**  
Structural Grade: **0**  
O&M Grade: **3**  
Clock Start/From: **1**  
Clock To:  
1st Value: **6.000**  
2nd Value:  
Value Percent:  
Continuous Index:  
Within 8" of Joint: **YES**  
Remarks: **CAP MISSING. SOIL AND VOID VISIBLE.**

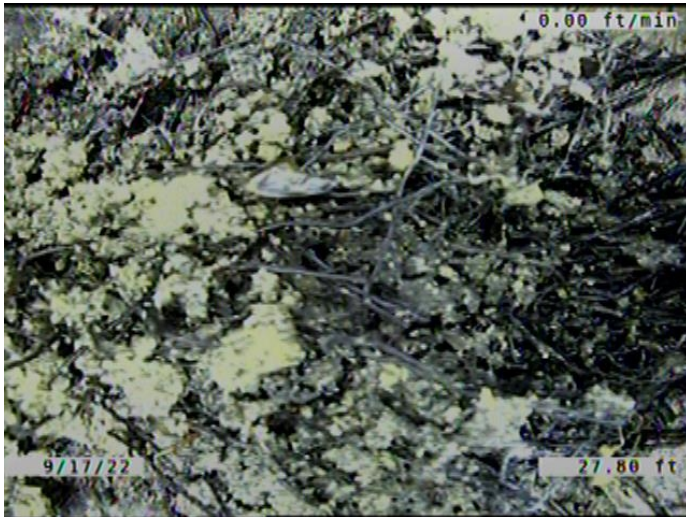
Code: **RFJ**  
 Description: **Roots Fine Joint**

Distance (ft): **27.8**  
 Structural Grade: **0**  
 O&M Grade: **1**  
 Clock Start/From: **7**  
 Clock To: **5**  
 1st Value:  
 2nd Value:  
 Value Percent:  
 Continuous Index: **S03**  
 Within 8" of Joint: **YES**  
 Remarks:

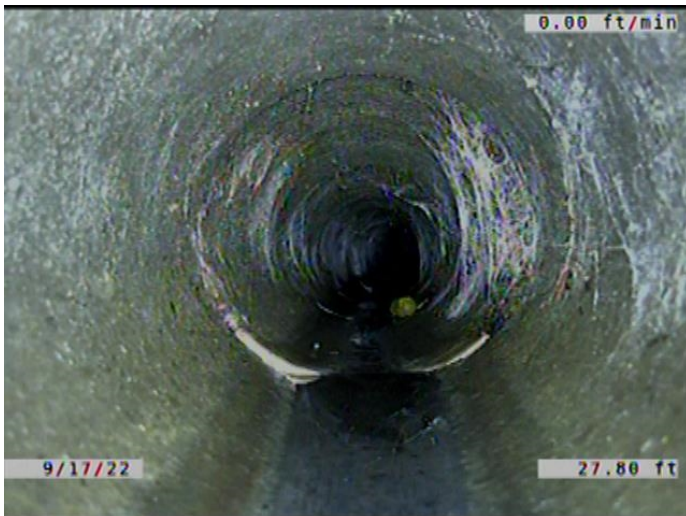
Code: **DSF**  
 Description: **Deposits Settled Fine**

Distance (ft): **27.8**  
 Structural Grade: **0**  
 O&M Grade: **3**  
 Clock Start/From: **4**  
 Clock To: **8**  
 1st Value:  
 2nd Value:  
 Value Percent: **15.000**  
 Continuous Index: **F01**  
 Within 8" of Joint: **YES**  
 Remarks:

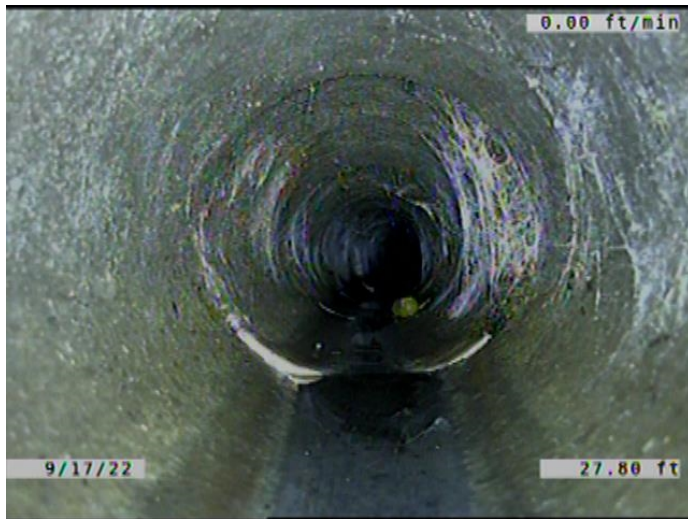
Code: **DSF**  
 Description: **Deposits Settled Fine**

Distance (ft): **27.8**  
 Structural Grade: **0**  
 O&M Grade: **2**  
 Clock Start/From: **5**  
 Clock To: **7**  
 1st Value:  
 2nd Value:  
 Value Percent: **5.000**  
 Continuous Index: **S04**  
 Within 8" of Joint: **YES**  
 Remarks:

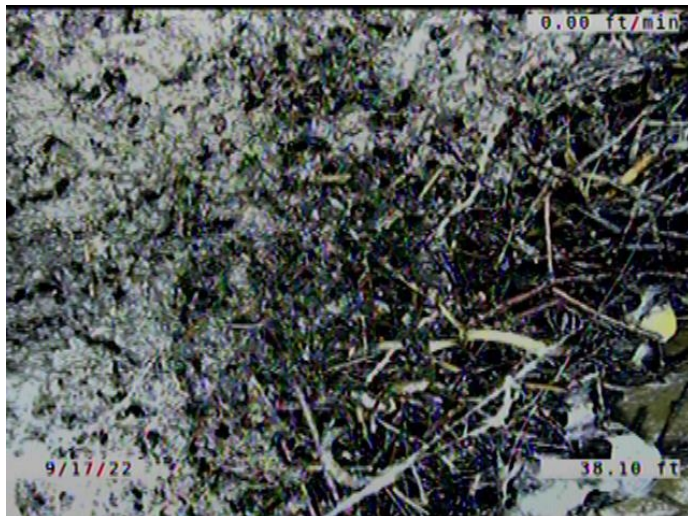
Code: **RMJ**  
 Description: **Roots Medium Joint**

Distance (ft): **38.1**  
 Structural Grade: **0**  
 O&M Grade: **3**  
 Clock Start/From: **7**  
 Clock To: **5**  
 1st Value:  
 2nd Value:  
 Value Percent: **10.000**  
 Continuous Index:  
 Within 8" of Joint: **YES**  
 Remarks:

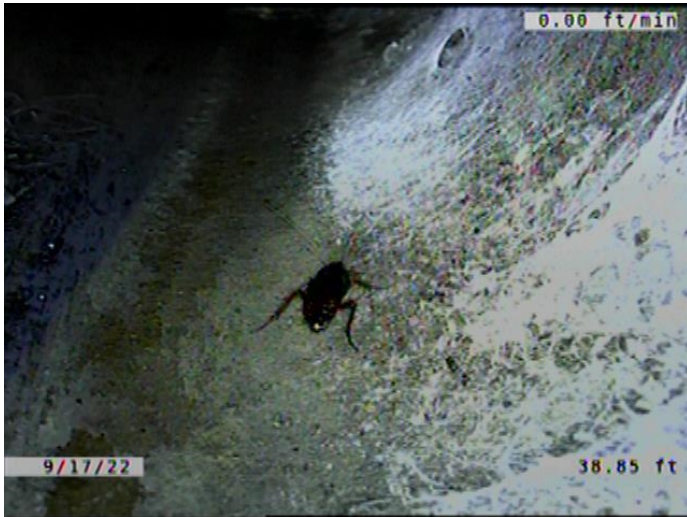
Code: **VC**  
Description: **Vermin Cockroach**

Distance (ft): **38.8**  
Structural Grade: **0**  
O&M Grade: **1**  
Clock Start/From:  
Clock To:  
1st Value:  
2nd Value:  
Value Percent:  
Continuous Index:  
Within 8" of Joint: **YES**  
Remarks:

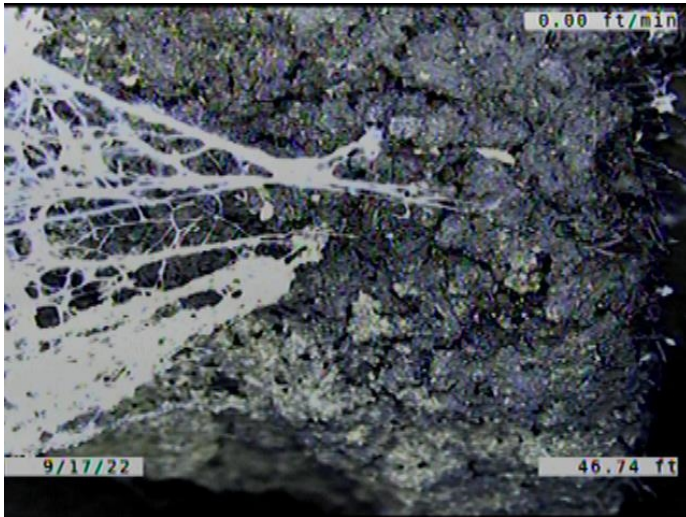
Code: **RMJ**  
 Description: **Roots Medium Joint**

Distance (ft): **46.7**  
 Structural Grade: **0**  
 O&M Grade: **3**  
 Clock Start/From: **10**  
 Clock To: **5**  
 1st Value:  
 2nd Value:  
 Value Percent: **10.000**  
 Continuous Index:  
 Within 8" of Joint: **YES**  
 Remarks:

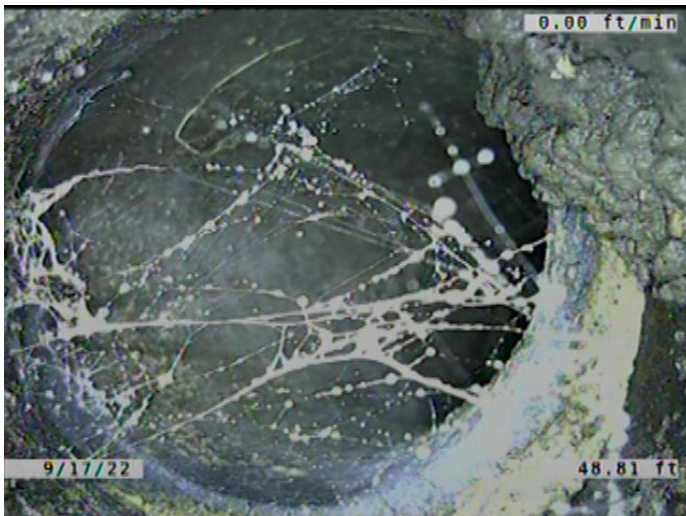
Code: **TFD**  
 Description: **Tap Factory Defective**

Distance (ft): **48.8**  
 Structural Grade: **0**  
 O&M Grade: **3**  
 Clock Start/From: **2**  
 Clock To:  
 1st Value: **6.000**  
 2nd Value:  
 Value Percent:  
 Continuous Index:  
 Within 8" of Joint: **YES**  
 Remarks: **TAP CRACKED. SERVICE OFFSET. SOIL VISIBLE.**

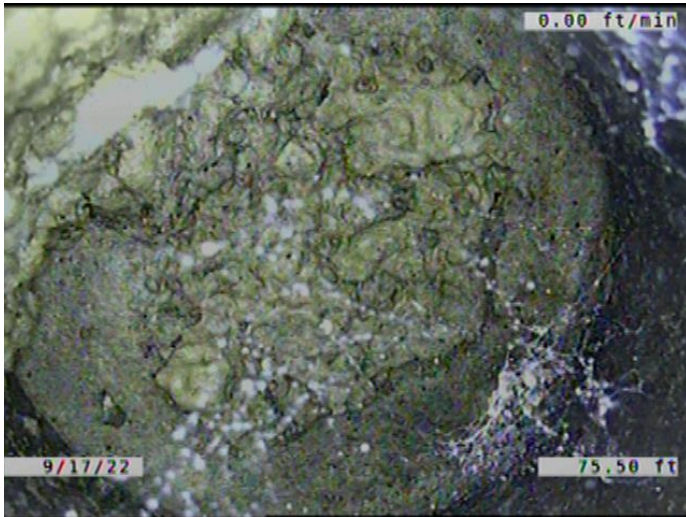
Code: **TFD**  
Description: **Tap Factory Defective**

Distance (ft): **75.5**  
Structural Grade: **0**  
O&M Grade: **3**  
Clock Start/From: **11**  
Clock To:  
1st Value: **6.000**  
2nd Value:  
Value Percent:  
Continuous Index:  
Within 8" of Joint: **YES**  
Remarks: **CAP MISSING. SOIL VISIBLE.**

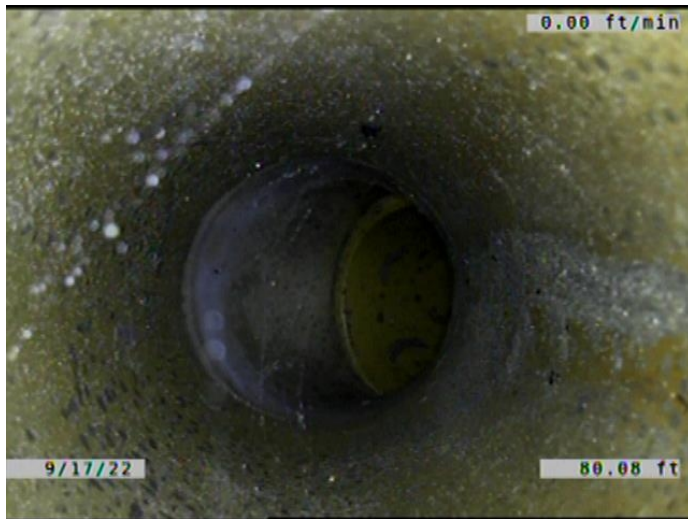
Code: **TBI**  
 Description: **Tap Break-in Intruding**

Distance (ft): **80.1**  
 Structural Grade: **0**  
 O&M Grade: **2**  
 Clock Start/From: **2**  
 Clock To:  
 1st Value: **6.000**  
 2nd Value: **1.000**  
 Value Percent:  
 Continuous Index:  
 Within 8" of Joint: **YES**  
 Remarks:

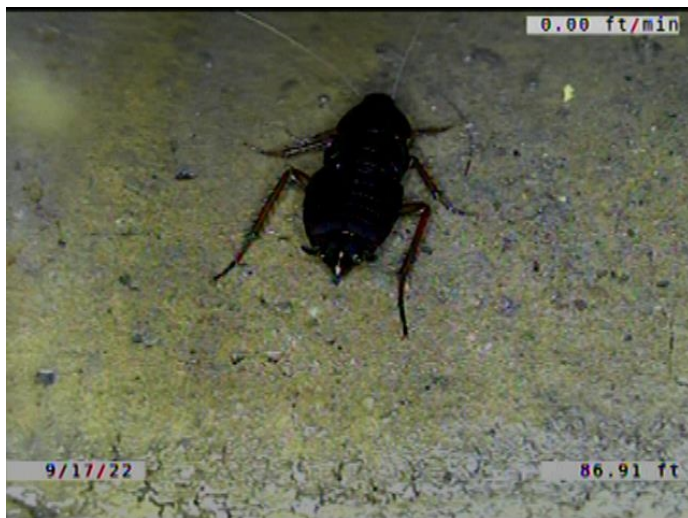
Code: **VC**  
 Description: **Vermin Cockroach**

Distance (ft): **86.9**  
 Structural Grade: **0**  
 O&M Grade: **1**  
 Clock Start/From:  
 Clock To:  
 1st Value:  
 2nd Value:  
 Value Percent:  
 Continuous Index:  
 Within 8" of Joint: **YES**  
 Remarks:

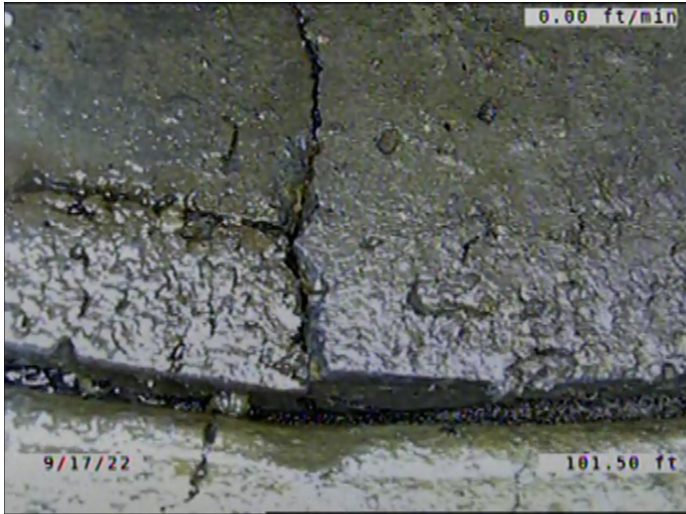
Code: **B**  
Description: **Broken**

Distance (ft): **101.5**  
Structural Grade: **4**  
O&M Grade: **0**  
Clock Start/From: **4**  
Clock To: **8**  
1st Value:  
2nd Value:  
Value Percent:  
Continuous Index:  
Within 8" of Joint: **YES**  
Remarks:

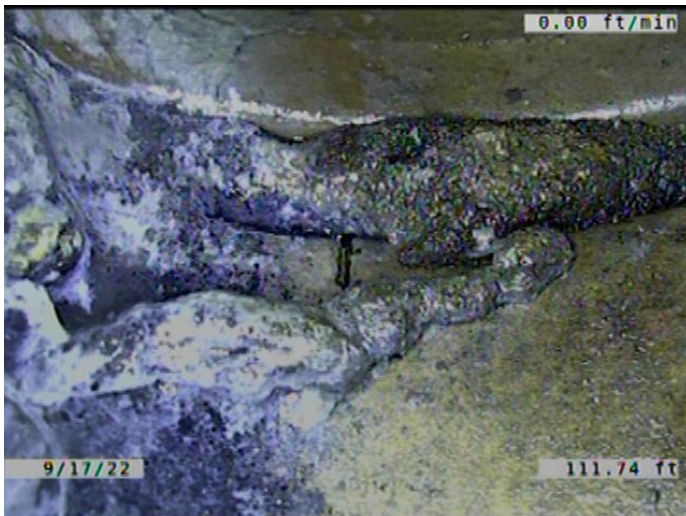
Code: **DAE**  
Description: **Deposits Attached Encrustation**

Distance (ft): **111.7**  
Structural Grade: **0**  
O&M Grade: **2**  
Clock Start/From: **4**  
Clock To: **8**  
1st Value:  
2nd Value:  
Value Percent: **5.000**  
Continuous Index:  
Within 8" of Joint: **YES**  
Remarks:

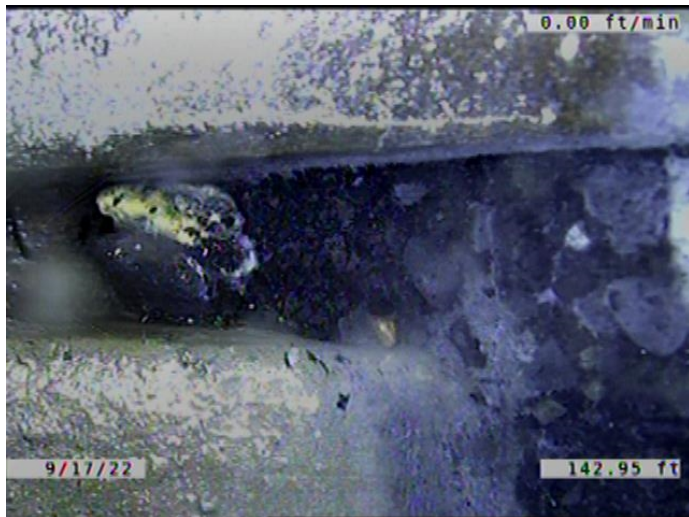
Code: **JAM**  
Description: **Joint Angular Medium**

Distance (ft): **142.9**  
Structural Grade: **3**  
O&M Grade: **0**  
Clock Start/From:  
Clock To:  
1st Value:  
2nd Value:  
Value Percent:  
Continuous Index:  
Within 8" of Joint: **NO**  
Remarks:

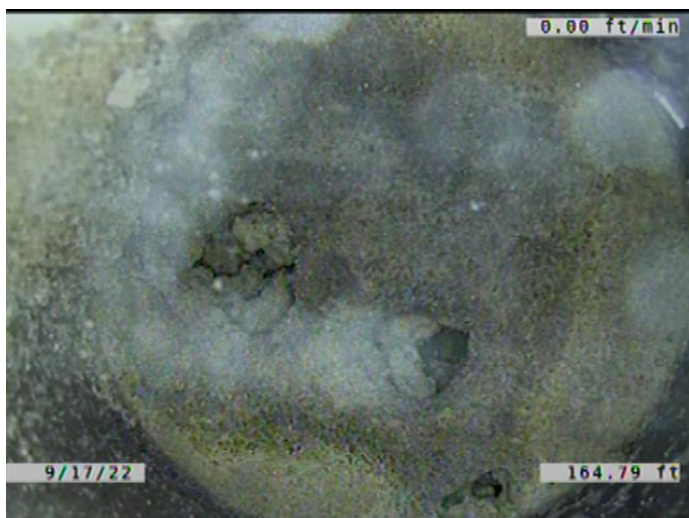
Code: **TFD**  
Description: **Tap Factory Defective**

Distance (ft): **164.8**  
Structural Grade: **0**  
O&M Grade: **3**  
Clock Start/From: **11**  
Clock To:  
1st Value: **6.000**  
2nd Value:  
Value Percent:  
Continuous Index:  
Within 8" of Joint: **YES**  
Remarks: **CAP MISSING. SOIL VISIBLE.**

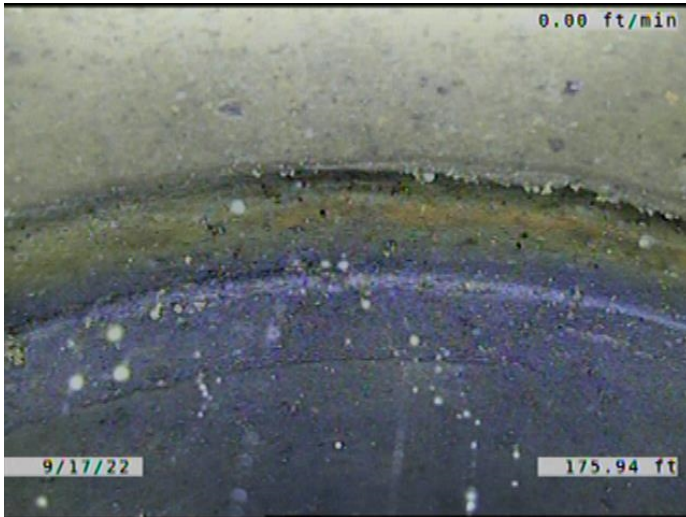
Code: **JOM**  
 Description: **Joint Offset Medium**

Distance (ft): **175.9**  
 Structural Grade: **3**  
 O&M Grade: **0**  
 Clock Start/From:  
 Clock To:  
 1st Value:  
 2nd Value:  
 Value Percent:  
 Continuous Index:  
 Within 8" of Joint: **NO**  
 Remarks:

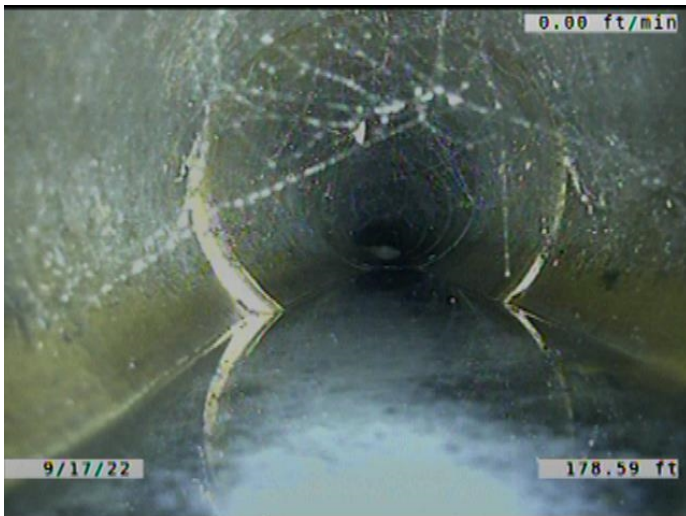
Code: **MWLS**  
 Description: **Miscellaneous Water Level Sag**

Distance (ft): **178.6**  
 Structural Grade: **2**  
 O&M Grade: **0**  
 Clock Start/From:  
 Clock To:  
 1st Value:  
 2nd Value:  
 Value Percent: **10.000**  
 Continuous Index:  
 Within 8" of Joint: **NO**  
 Remarks:

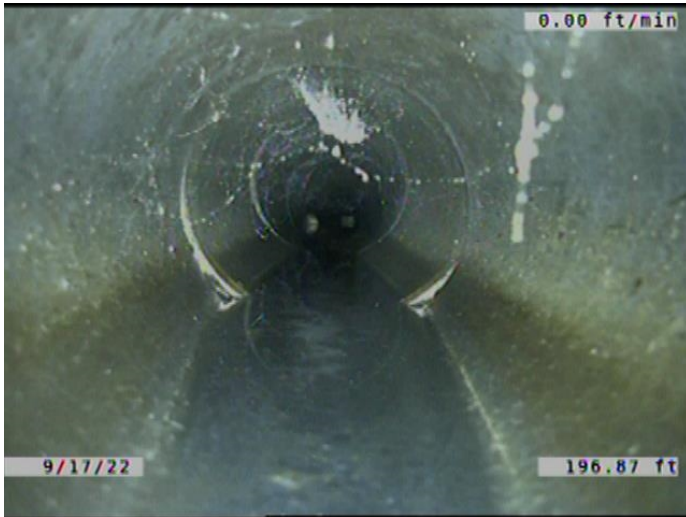
Code: **MWLS**  
Description: **Miscellaneous Water Level Sag**

Distance (ft): **196.9**  
Structural Grade: **2**  
O&M Grade: **0**  
Clock Start/From:  
Clock To:  
1st Value:  
2nd Value:  
Value Percent: **15.000**  
Continuous Index: **S05**  
Within 8" of Joint: **NO**  
Remarks:

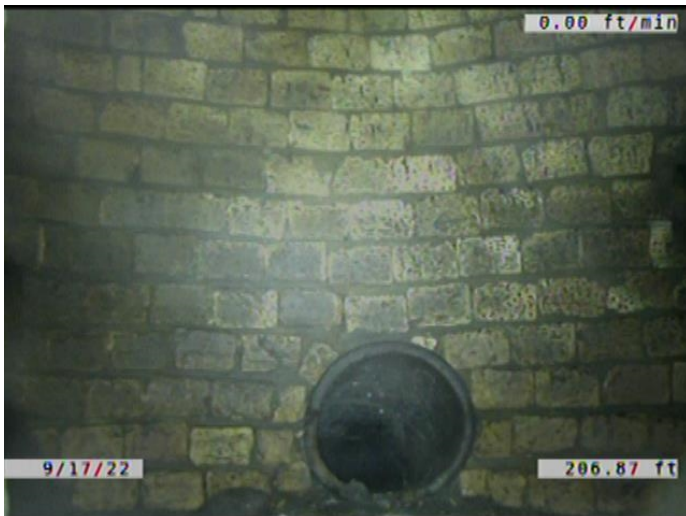
Code: **FM**  
Description: **Fracture Multiple**

Distance (ft): **206.9**  
Structural Grade: **4**  
O&M Grade: **0**  
Clock Start/From: **12**  
Clock To: **12**  
1st Value:  
2nd Value:  
Value Percent:  
Continuous Index: **F02**  
Within 8" of Joint: **YES**  
Remarks:

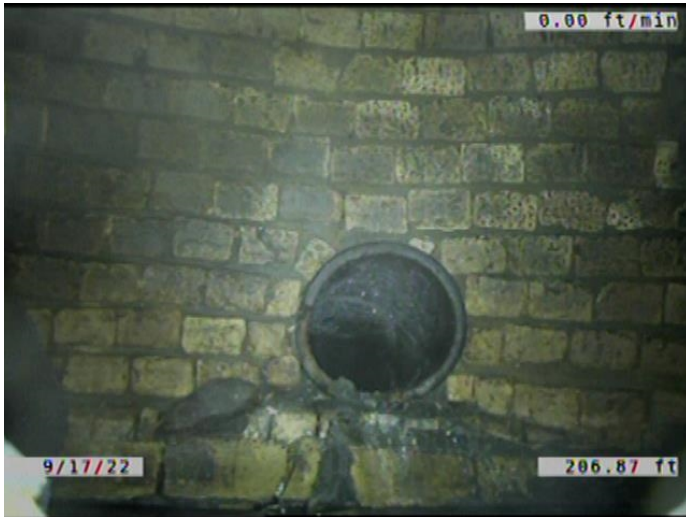
Code: **DSF**  
Description: **Deposits Settled Fine**

Distance (ft): **206.9**  
Structural Grade: **0**  
O&M Grade: **2**  
Clock Start/From: **5**  
Clock To: **7**  
1st Value:  
2nd Value:  
Value Percent: **5.000**  
Continuous Index: **F04**  
Within 8" of Joint: **YES**  
Remarks:

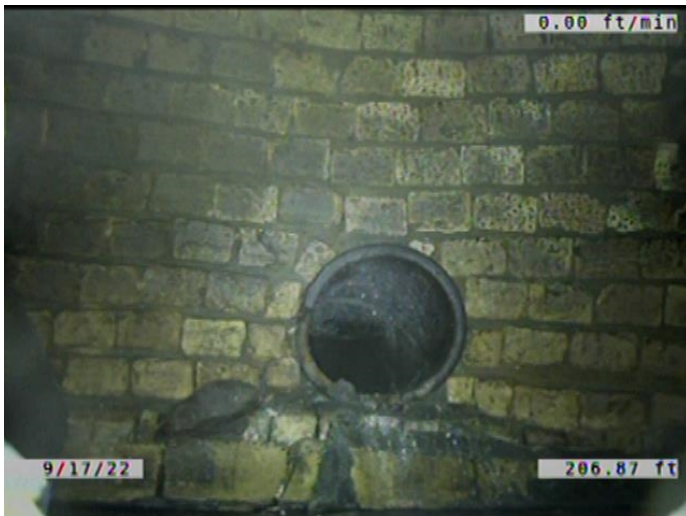
Code: **RFJ**  
Description: **Roots Fine Joint**

Distance (ft): **206.9**  
Structural Grade: **0**  
O&M Grade: **1**  
Clock Start/From: **7**  
Clock To: **5**  
1st Value:  
2nd Value:  
Value Percent:  
Continuous Index: **F03**  
Within 8" of Joint: **YES**  
Remarks:

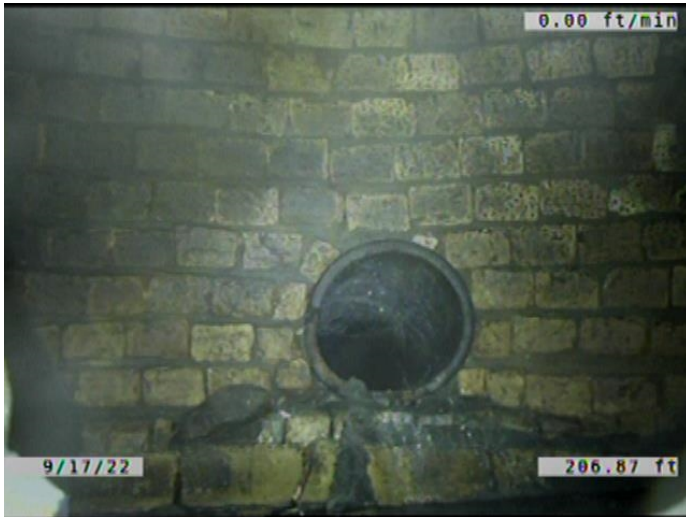
Code: **MWLS**  
 Description: **Miscellaneous Water Level Sag**

Distance (ft): **206.9**  
 Structural Grade: **2**  
 O&M Grade: **0**  
 Clock Start/From:  
 Clock To:  
 1st Value:  
 2nd Value:  
 Value Percent: **15.000**  
 Continuous Index: **F05**  
 Within 8" of Joint: **NO**  
 Remarks:
