## Profile/Photo Observation Report

Date:	<b>10/20/2021</b>	Weather:		Coding:	<b>PACP 6.0</b>
Pipe Length (ft):		Owner:	<b>Hobart, IN</b>	Pre Clean:	<b>Not Known</b>
P.O.#:	<b>918_1</b>	Surveyor:	<b>M. Pielacha</b>	PSR:	<b>P-705-085-050</b>
Customer:	<b>Hobart, IN</b>	Clean Date:		Shape:	<b>C</b>

Street:	<b>New Street</b>	Flow Control:	
City:	<b>Hobart, IN</b>	Year Renewed:	
Location:	<b>Light Highway</b>	Tape/Media #:	<b>918</b>
Purpose:	<b>Routine Assessment</b>	Dia/Height:	<b>8"</b>
Use:	<b>Sanitary</b>	Material:	<b>VCP</b>
Drain Area:		Lining:

US MH: **M-705-50** DS MH: **M-705-85** Total Length Surveyed (ft): **210.7**

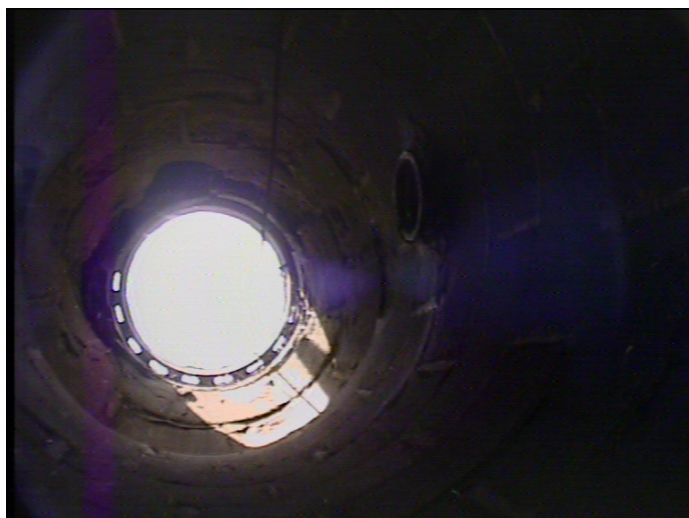
Code: **AMH**  
 Description: **Manhole**

Distance (ft): **.0**  
 Structural Grade: **0**  
 O&M Grade: **0**  
 Clock Start/From:  
 Clock To:  
 1st Value:  
 2nd Value:  
 Value Percent:  
 Continuous Index:  
 Within 8" of Joint: **NO**  
 Remarks: **M-705-50**

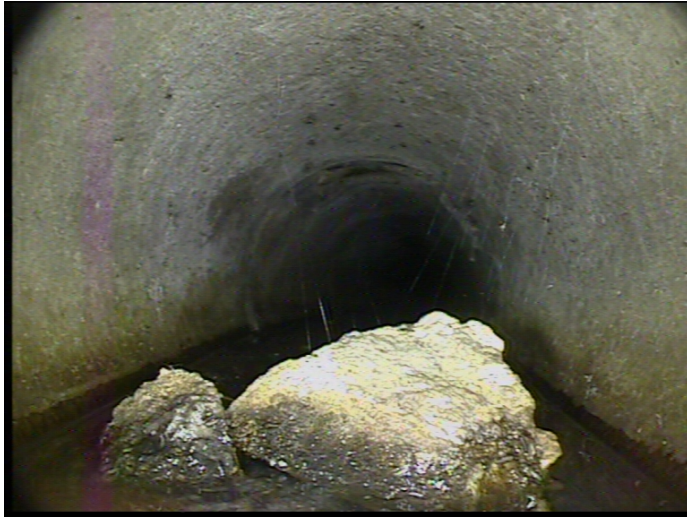
Code: **MWL**  
Description: **Water Level**

Distance (ft): **.0**  
Structural Grade: **0**  
O&M Grade: **0**  
Clock Start/From:  
Clock To:  
1st Value:  
2nd Value:  
Value Percent: **5.000**  
Continuous Index:  
Within 8" of Joint: **NO**  
Remarks:

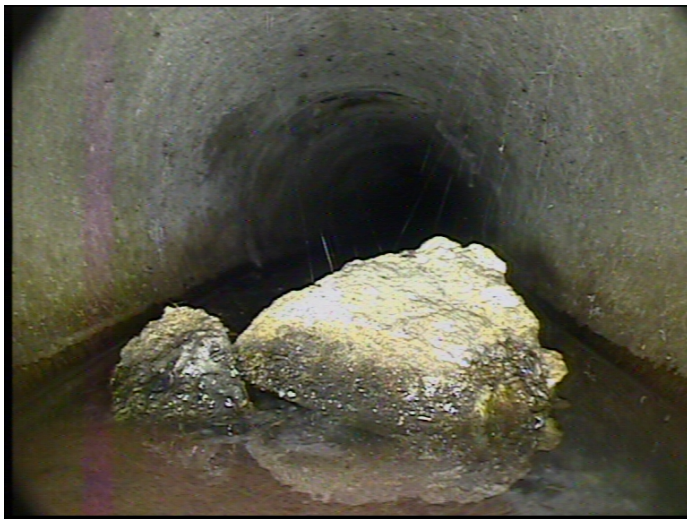
Code: **OBR**  
Description: **Obstacle Rocks**

Distance (ft): **1.0**  
Structural Grade: **0**  
O&M Grade: **3**  
Clock Start/From: **4**  
Clock To: **8**  
1st Value:  
2nd Value:  
Value Percent: **15.000**  
Continuous Index:  
Within 8" of Joint: **NO**  
Remarks:

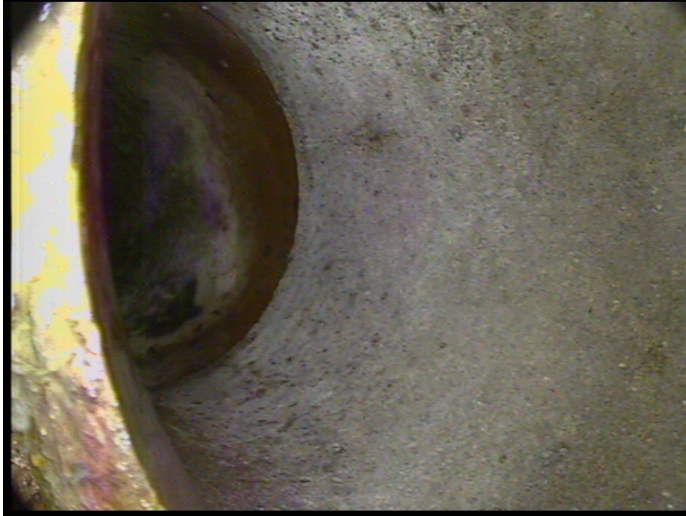
Code:	<b>TBI</b>
Description:	<b>Tap Break-in Intruding</b>
Distance (ft):	<b>13.4</b>
Structural Grade:	<b>0</b>
O&M Grade:	<b>2</b>
Clock Start/From:	<b>10</b>
Clock To:	
1st Value:	<b>4.000</b>
2nd Value:	<b>1.000</b>
Value Percent:	
Continuous Index:	
Within 8" of Joint:	<b>NO</b>
Remarks:

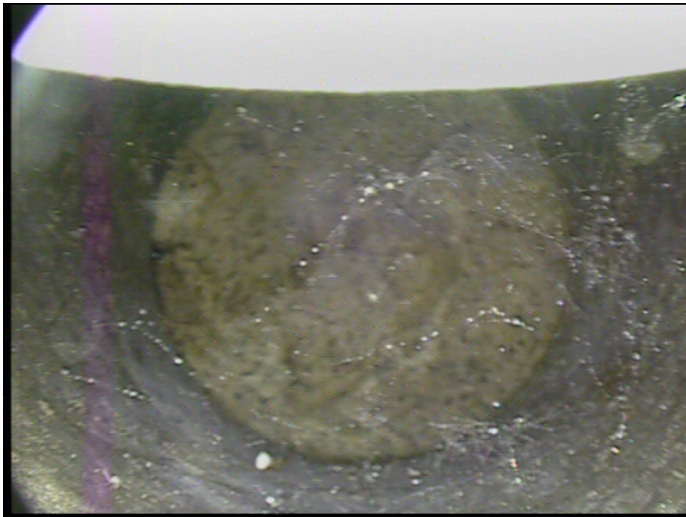
Code:	<b>TFC</b>
Description:	<b>Tap Factory Capped</b>
Distance (ft):	<b>15.5</b>
Structural Grade:	<b>0</b>
O&M Grade:	<b>0</b>
Clock Start/From:	<b>10</b>
Clock To:	
1st Value:	<b>4.000</b>
2nd Value:	
Value Percent:	
Continuous Index:	
Within 8" of Joint:	<b>NO</b>
Remarks:

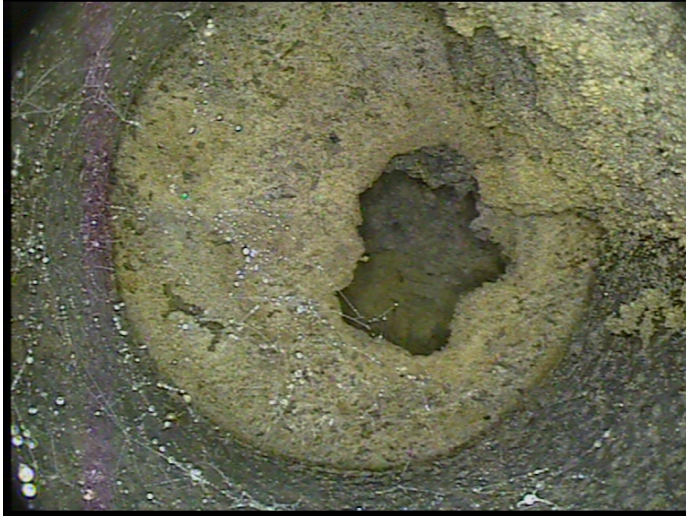
Code:	<b>TFC</b>
Description:	<b>Tap Factory Capped</b>
Distance (ft):	<b>17.1</b>
Structural Grade:	<b>0</b>
O&M Grade:	<b>0</b>
Clock Start/From:	<b>2</b>
Clock To:	
1st Value:	<b>4.000</b>
2nd Value:	
Value Percent:	
Continuous Index:	
Within 8" of Joint:	<b>NO</b>
Remarks:

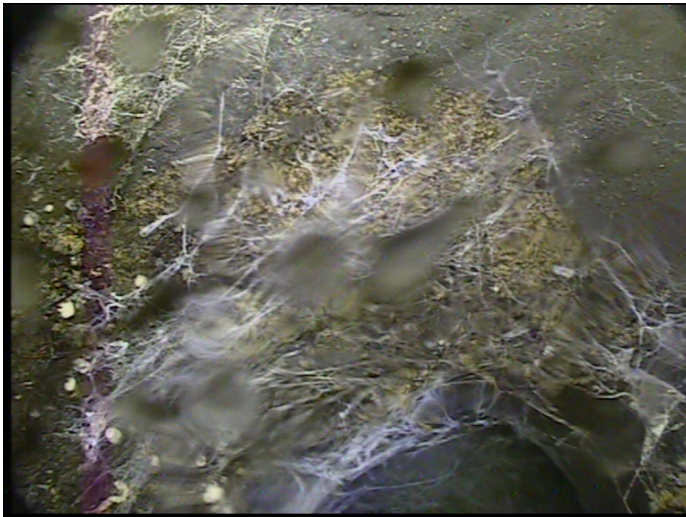
Code:	<b>RMJ</b>
Description:	<b>Roots Medium Joint</b>
Distance (ft):	<b>39.7</b>
Structural Grade:	<b>0</b>
O&M Grade:	<b>3</b>
Clock Start/From:	<b>7</b>
Clock To:	<b>10</b>
1st Value:	
2nd Value:	
Value Percent:	<b>10.000</b>
Continuous Index:	<b>S01</b>
Within 8" of Joint:	<b>YES</b>
Remarks:

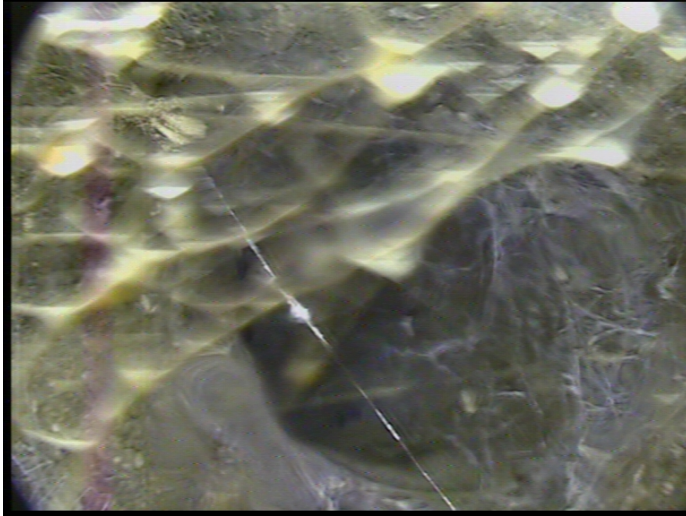
Code:	<b>TF</b>
Description:	<b>Tap Factory</b>
Distance (ft):	<b>41.1</b>
Structural Grade:	<b>0</b>
O&M Grade:	<b>0</b>
Clock Start/From:	<b>10</b>
Clock To:	
1st Value:	<b>4.000</b>
2nd Value:	
Value Percent:	
Continuous Index:	
Within 8" of Joint:	<b>NO</b>
Remarks:

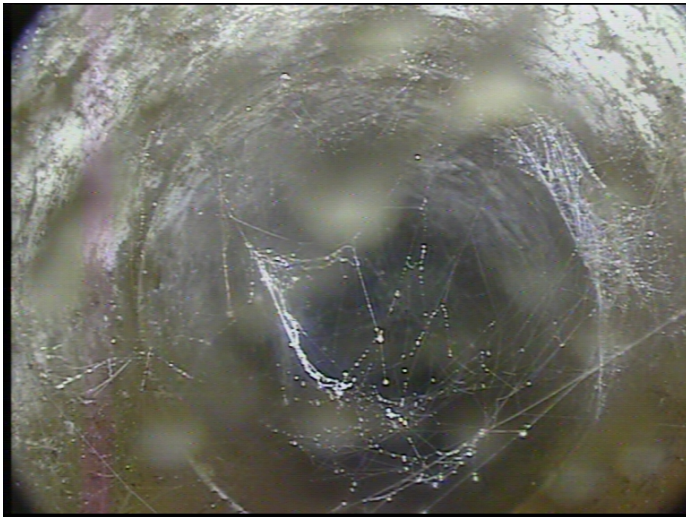
Code:	<b>RMJ</b>
Description:	<b>Roots Medium Joint</b>
Distance (ft):	<b>73.6</b>
Structural Grade:	<b>0</b>
O&M Grade:	<b>3</b>
Clock Start/From:	<b>7</b>
Clock To:	<b>10</b>
1st Value:	
2nd Value:	
Value Percent:	<b>10.000</b>
Continuous Index:	<b>F01</b>
Within 8" of Joint:	<b>YES</b>
Remarks:

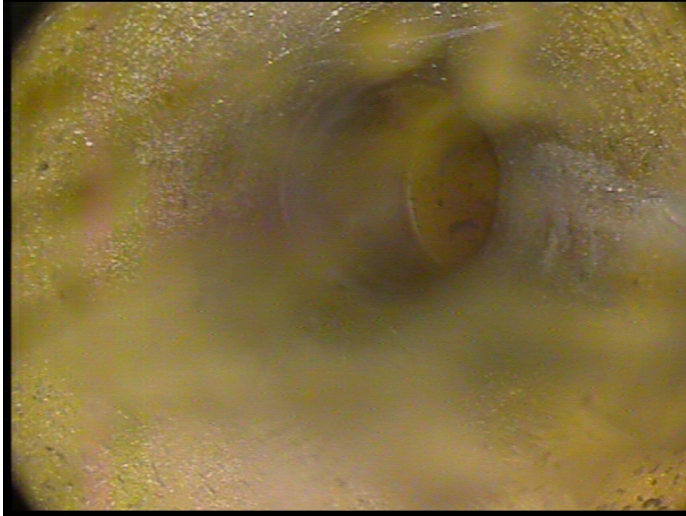
Code: **TB**  
Description: **Tap Break-in**

Distance (ft): **82.1**  
Structural Grade: **0**  
O&M Grade: **0**  
Clock Start/From: **3**  
Clock To:  
1st Value: **4.000**  
2nd Value:  
Value Percent:  
Continuous Index:  
Within 8" of Joint: **NO**  
Remarks:

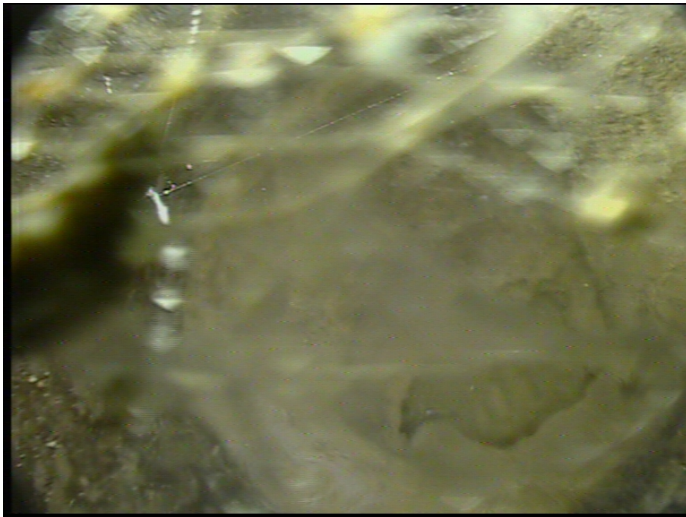
Code: **TFC**  
Description: **Tap Factory Capped**

Distance (ft): **145.5**  
Structural Grade: **0**  
O&M Grade: **0**  
Clock Start/From: **2**  
Clock To:  
1st Value: **4.000**  
2nd Value:  
Value Percent:  
Continuous Index:  
Within 8" of Joint: **NO**  
Remarks:

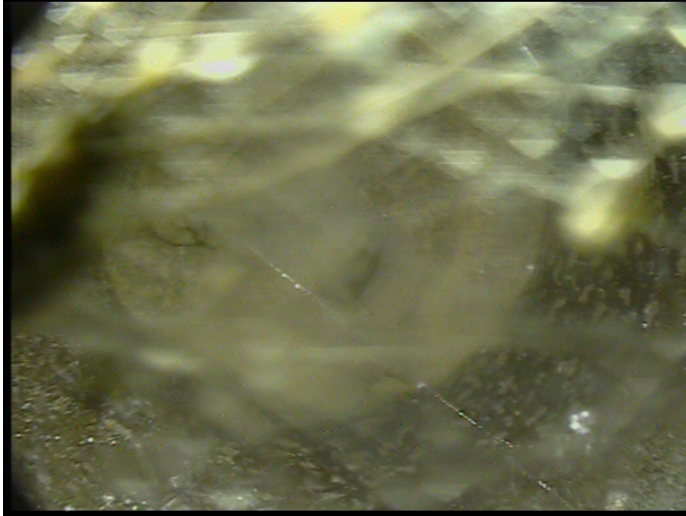
Code: **TFC**  
Description: **Tap Factory Capped**

Distance (ft): **166.3**  
Structural Grade: **0**  
O&M Grade: **0**  
Clock Start/From: **9**  
Clock To:  
1st Value: **4.000**  
2nd Value:  
Value Percent:  
Continuous Index:  
Within 8" of Joint: **NO**  
Remarks:

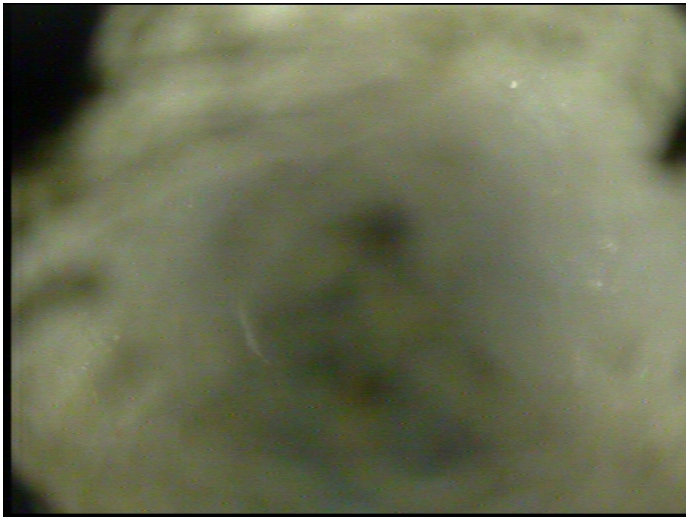
Code: **MGO**  
Description: **General Observation**

Distance (ft): **197.7**  
Structural Grade: **0**  
O&M Grade: **0**  
Clock Start/From:  
Clock To:  
1st Value:  
2nd Value:  
Value Percent:  
Continuous Index:  
Within 8" of Joint: **NO**  
Remarks: **Pulling back, cleaning lens, and continuing.**

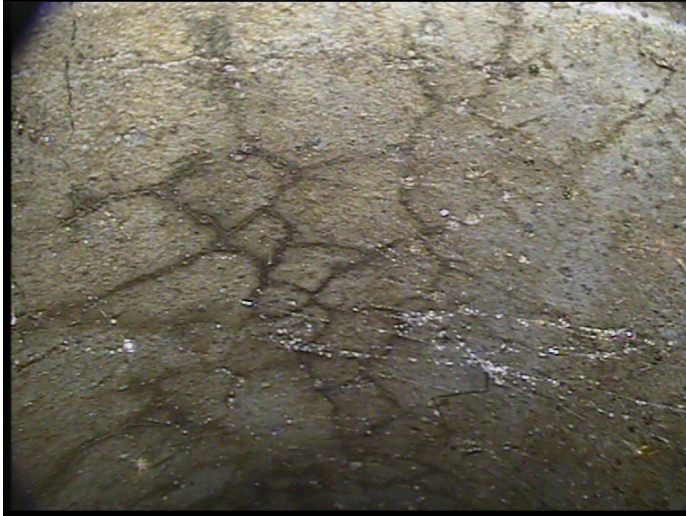
Code: **CM**  
Description: **Crack Multiple**

Distance (ft): **205.0**  
Structural Grade: **3**  
O&M Grade: **0**  
Clock Start/From: **12**  
Clock To: **5**  
1st Value:  
2nd Value:  
Value Percent:  
Continuous Index:  
Within 8" of Joint: **YES**  
Remarks:

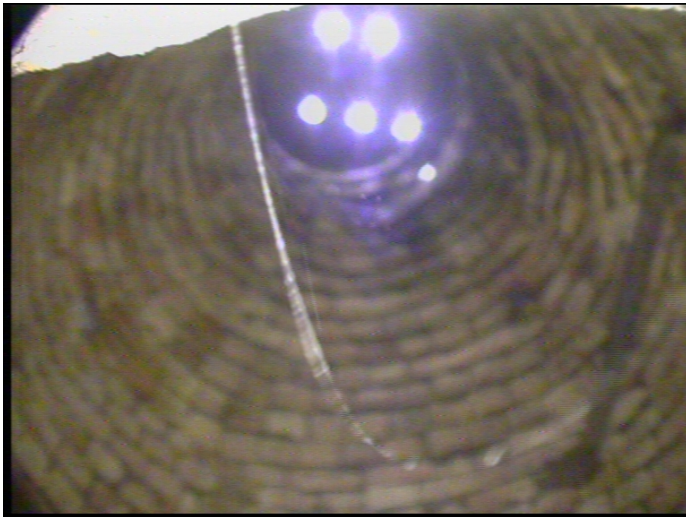
Code: **AMH**  
Description: **Manhole**

Distance (ft): **210.7**  
Structural Grade: **0**  
O&M Grade: **0**  
Clock Start/From:  
Clock To:  
1st Value:  
2nd Value:  
Value Percent:  
Continuous Index:  
Within 8" of Joint: **NO**  
Remarks: **M-705-85**
