Profile/Photo Observation Report

Profile/Photo Observation Report								
Date:	05/02/2018	Weather:			Coding:	PACP 6.0		
Pipe Length (ft	t):	Owner:	City of Ho	bart	Pre Clean:	No Pre-Cleaning		
P.O.#:	166	Surveyor:	M. Pielach	na	PSR:	P-805-053-052.1		
Customer:	City of Hobart	Clean Date:			Shape:	С		
Street:	3rd Street		Flow Contro	ol:	Not Controlled			
City:	Hobart, IN		Year Renew	ed:				
Location:	Light Highway		Tape/Media	a #:	DEP 166			
Purpose:	Routine Assessment		Dia/Height:		18"			
Use:	Sanitary		Material:		VCP			
Drain Area:			Lining:					
Category:	NA							
Comment:	5-21-2018							
Location Details:			Direction of	Survey:	Upstream			
US MH:	M-705-052.1	DS MH:	M-805-053	To	otal Length Surveyed (ft)	.1		
O&M Index:	0.00	O&M Quick:		0000	O&M Rating:	0.00		
Structural Index	0.00	Structural Q		0000	Structural Rating:	0.00		
Overall Index:	0.00	Overall Quic		0000	Overall Rating:	0.00

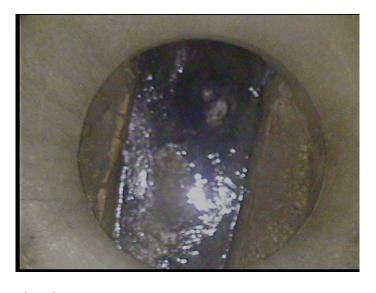
Code: Description:	AMH Manhole
Distance (ft):	.0
Structural Grade:	0
O&M Grade:	0
Clock Start/From:	
Clock To:	
1st Value:	
2nd Value:	
Value Percent:	
Continuous Index:	
Within 8" of Joint:	NO
Remarks:	M-705-52.1

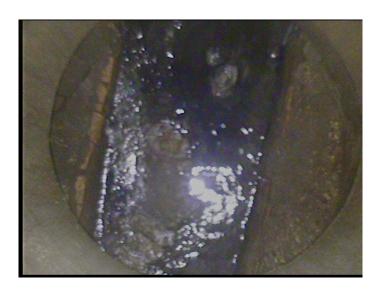
Code: MWL

Description: **Water Level**

Distance (ft): .0 Structural Grade: 0 O&M Grade: 0

15.000

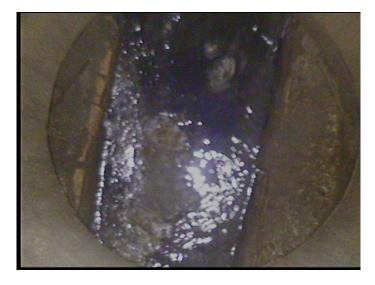
Code: MSA

Description: **Abandoned Survey**

Remarks: Very heavy debris in MH. Needs

cleaned
