Profile/Photo Observation Report

Date:	09/16/2022	Weather:		Coding:	PACP 7.0
Pipe Length (ft):	234.8	Owner:	City of Hobart	Pre Clean:	No Pre-Cleaning
P.O.#:	YES502259	Surveyor:	S. Bucklin	PSR:	M-705-055-M-705-054
Customer:	City of Hobart	Clean Date:		Shape:	C

Street:	East 3rd Street	Flow Control:	Not Controlled
City:	Hobart, IN	Year Renewed:	
Location:	Local rural streets with light traffic, t	Tape/Media #:	
Purpose:	Routine Assessment	Dia/Height:	10"
Use:	Sanitary Sewage Pipe	Material:	VCP
Drain Area:		Lining:	None
Category:	NA

Location Details:		Direction of Survey:	Downstream
US MH:	M-705-055	DS MH:	M-705-054
		Total Length Surveyed (ft):	123.3

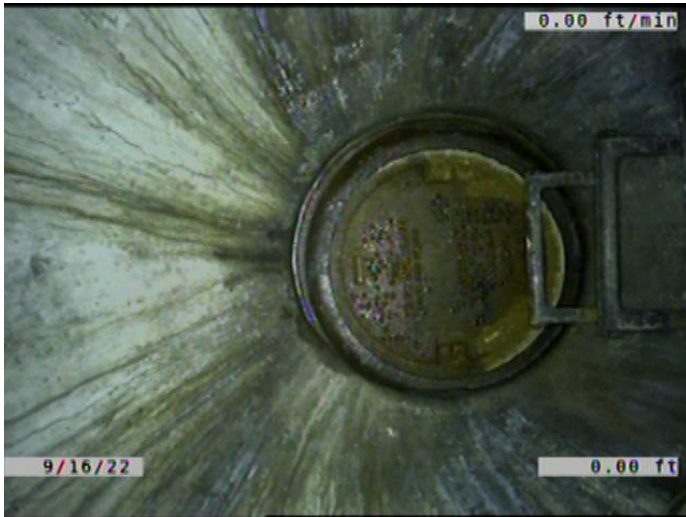
Code: **AMH**
 Description: **Manhole**

Distance (ft): **.0**
 Structural Grade: **0**
 O&M Grade: **0**
 Clock Start/From:
 Clock To:
 1st Value:
 2nd Value:
 Value Percent:
 Continuous Index:
 Within 8" of Joint: **NO**
 Remarks: **M-705-055**

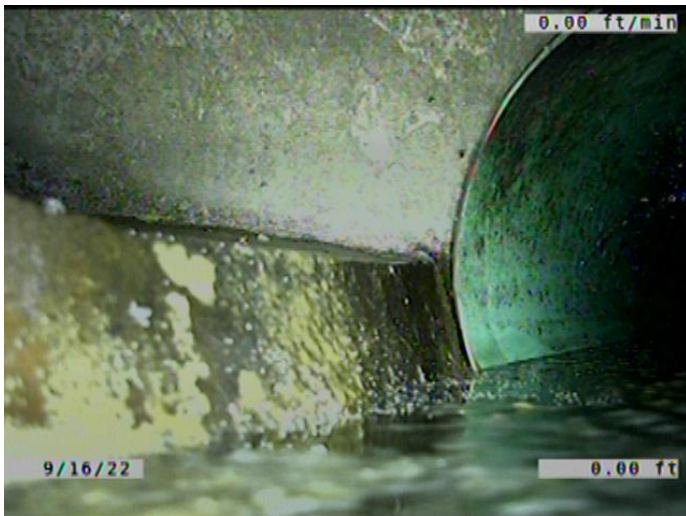
Code: **MWL**
 Description: **Miscellaneous Water Level**

Distance (ft): **.0**
 Structural Grade: **0**
 O&M Grade: **0**
 Clock Start/From:
 Clock To:
 1st Value:
 2nd Value:
 Value Percent: **20.000**
 Continuous Index:
 Within 8" of Joint: **NO**
 Remarks:

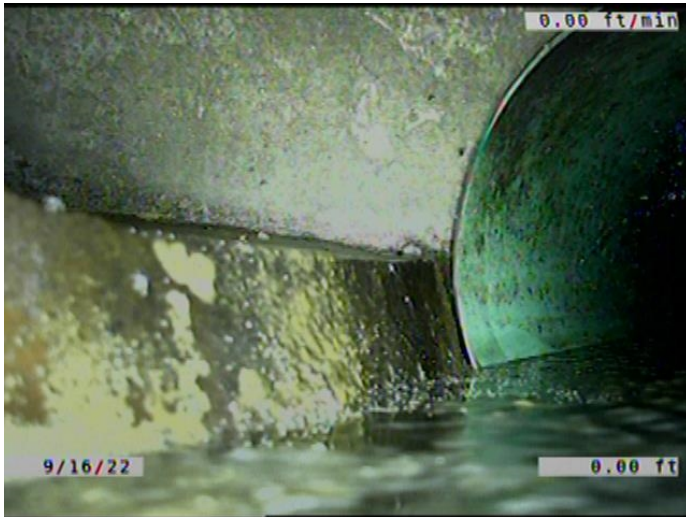
Code: **DSF**
 Description: **Deposits Settled Fine**

Distance (ft): **.0**
 Structural Grade: **0**
 O&M Grade: **3**
 Clock Start/From: **4**
 Clock To: **8**
 1st Value:
 2nd Value:
 Value Percent: **20.000**
 Continuous Index: **S01**
 Within 8" of Joint: **YES**
 Remarks:

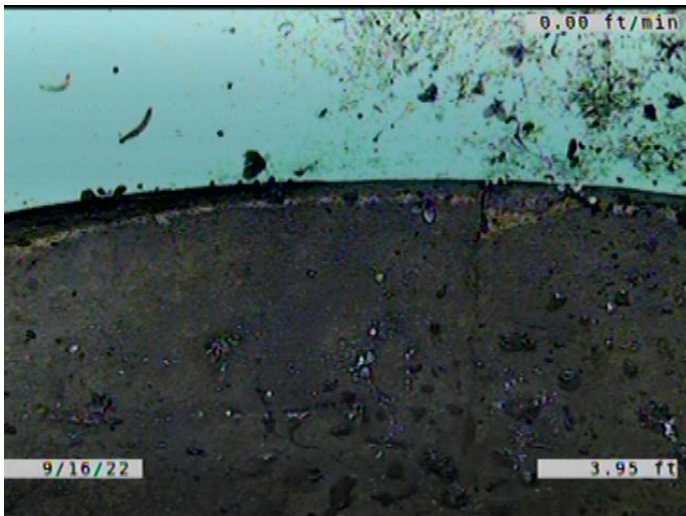
Code: **MMC**
 Description: **Miscellaneous Material Change**

Distance (ft): **3.9**
 Structural Grade: **0**
 O&M Grade: **0**
 Clock Start/From:
 Clock To:
 1st Value:
 2nd Value:
 Value Percent:
 Continuous Index:
 Within 8" of Joint: **NO**
 Remarks: **PVC TO VCP**

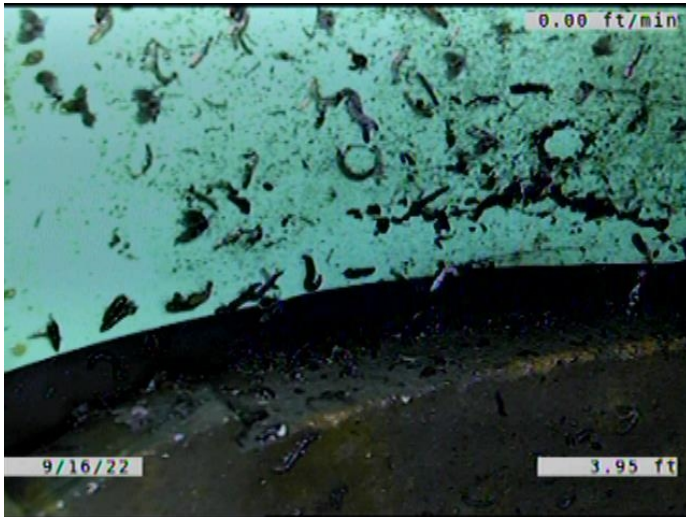
Code: **MSC**
Description: **Miscellaneous Shape/Size Change**

Distance (ft): **3.9**
Structural Grade: **0**
O&M Grade: **0**
Clock Start/From:
Clock To:
1st Value: **10.000**
2nd Value:
Value Percent:
Continuous Index:
Within 8" of Joint: **NO**
Remarks:

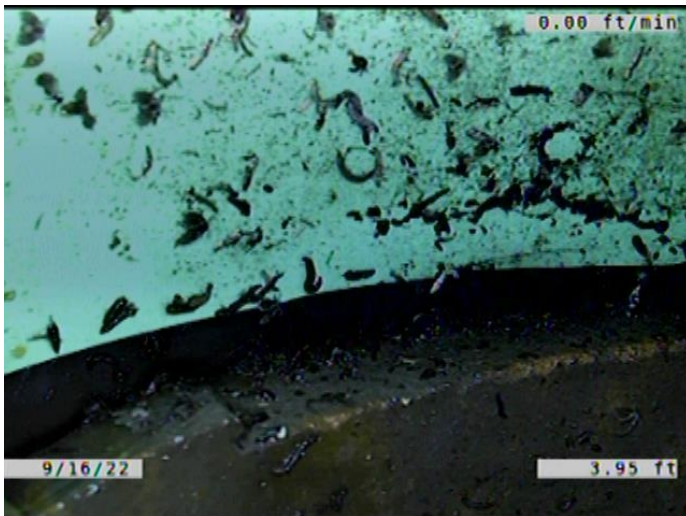
Code: **MGO**
Description: **Miscellaneous General Observation**

Distance (ft): **3.9**
Structural Grade: **0**
O&M Grade: **0**
Clock Start/From:
Clock To:
1st Value:
2nd Value:
Value Percent:
Continuous Index:
Within 8" of Joint: **NO**
Remarks: **12" PVC TO 10" VCP.**

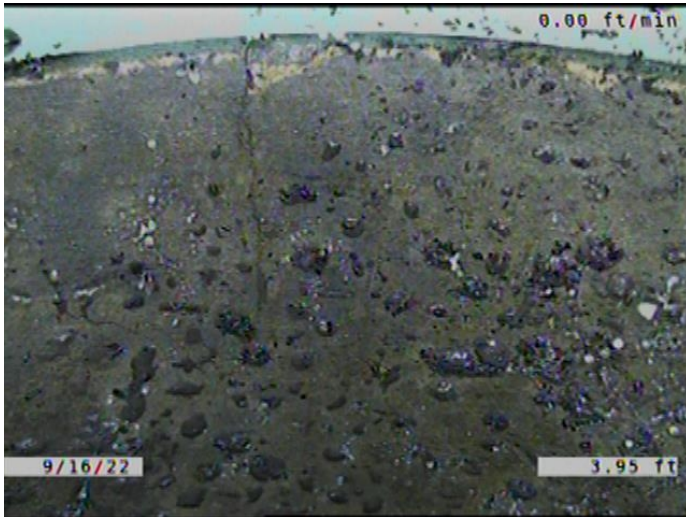
Code: **CM**
 Description: **Crack Multiple**

Distance (ft): **3.9**
 Structural Grade: **3**
 O&M Grade: **0**
 Clock Start/From: **11**
 Clock To: **1**
 1st Value:
 2nd Value:
 Value Percent:
 Continuous Index:
 Within 8" of Joint: **YES**
 Remarks:

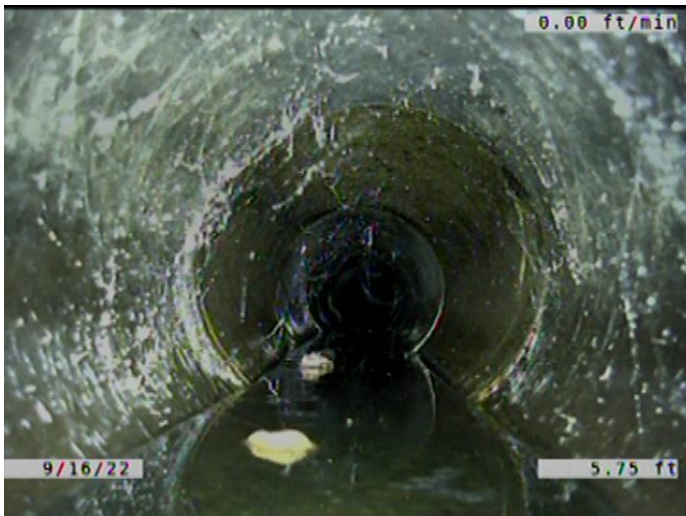
Code: **DSF**
 Description: **Deposits Settled Fine**

Distance (ft): **5.7**
 Structural Grade: **0**
 O&M Grade: **3**
 Clock Start/From: **4**
 Clock To: **8**
 1st Value:
 2nd Value:
 Value Percent: **20.000**
 Continuous Index: **F01**
 Within 8" of Joint: **YES**
 Remarks:

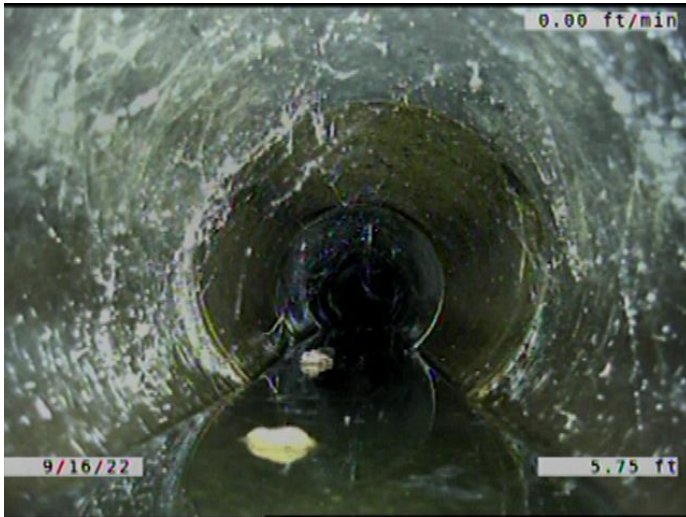
Code: **DSF**
Description: **Deposits Settled Fine**

Distance (ft): **5.7**
Structural Grade: **0**
O&M Grade: **2**
Clock Start/From: **5**
Clock To: **7**
1st Value:
2nd Value:
Value Percent: **10.000**
Continuous Index: **S02**
Within 8" of Joint: **YES**
Remarks:

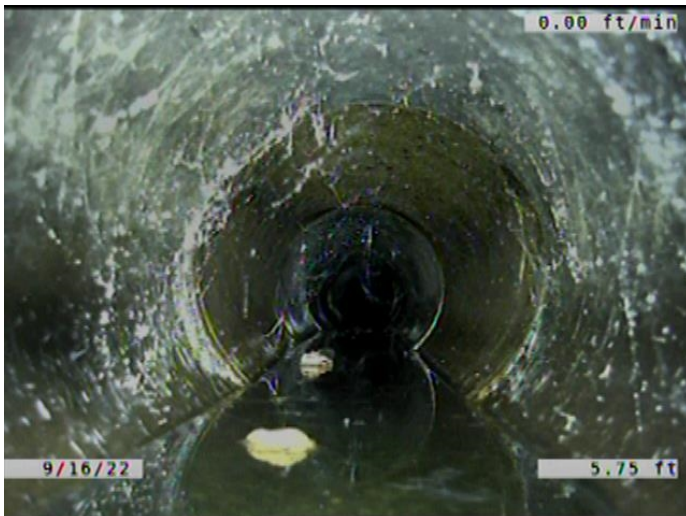
Code: **MWL**
Description: **Miscellaneous Water Level**

Distance (ft): **5.7**
Structural Grade: **0**
O&M Grade: **0**
Clock Start/From:
Clock To:
1st Value:
2nd Value:
Value Percent: **10.000**
Continuous Index:
Within 8" of Joint: **NO**
Remarks:

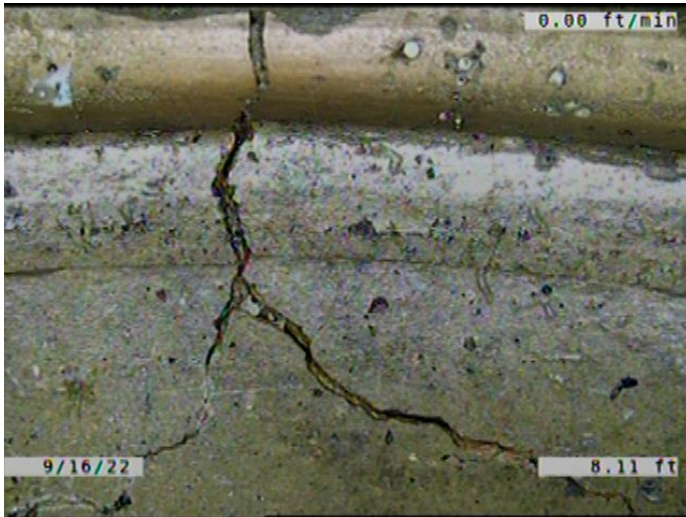
Code: **B**
 Description: **Broken**

Distance (ft): **8.1**
 Structural Grade: **4**
 O&M Grade: **0**
 Clock Start/From: **8**
 Clock To: **4**
 1st Value:
 2nd Value:
 Value Percent:
 Continuous Index:
 Within 8" of Joint: **YES**
 Remarks:

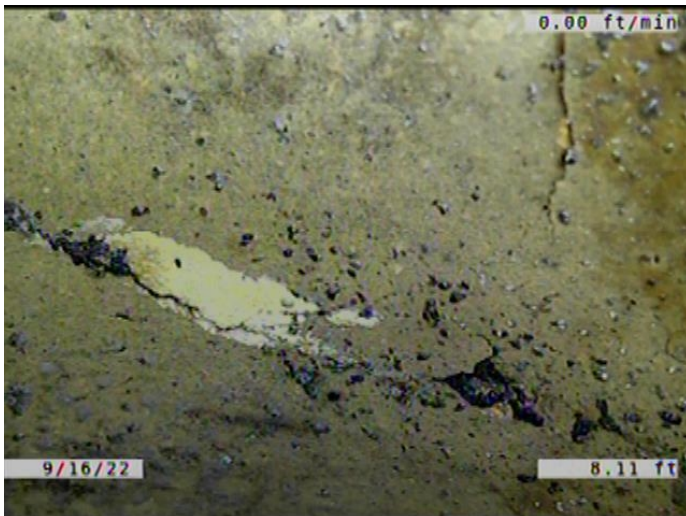
Code: **DAE**
 Description: **Deposits Attached Encrustation**

Distance (ft): **8.1**
 Structural Grade: **0**
 O&M Grade: **2**
 Clock Start/From: **8**
 Clock To: **4**
 1st Value:
 2nd Value:
 Value Percent: **5.000**
 Continuous Index: **S04**
 Within 8" of Joint: **YES**
 Remarks:

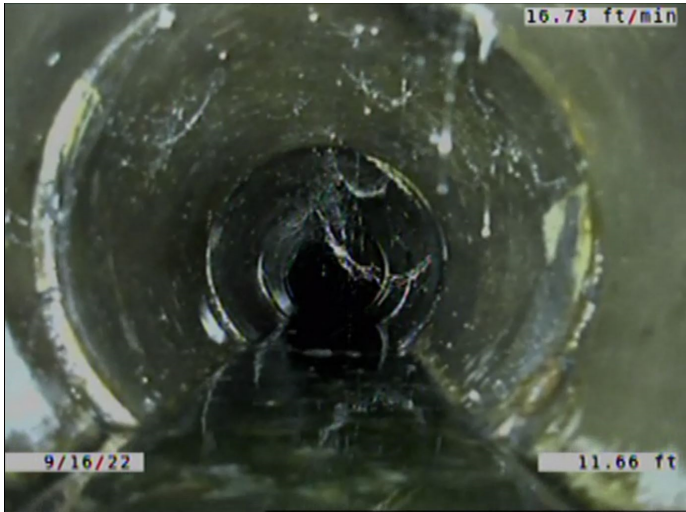
Code: **CM**
Description: **Crack Multiple**

Distance (ft): **11.8**
Structural Grade: **3**
O&M Grade: **0**
Clock Start/From: **10**
Clock To: **3**
1st Value:
2nd Value:
Value Percent:
Continuous Index:
Within 8" of Joint: **YES**
Remarks:

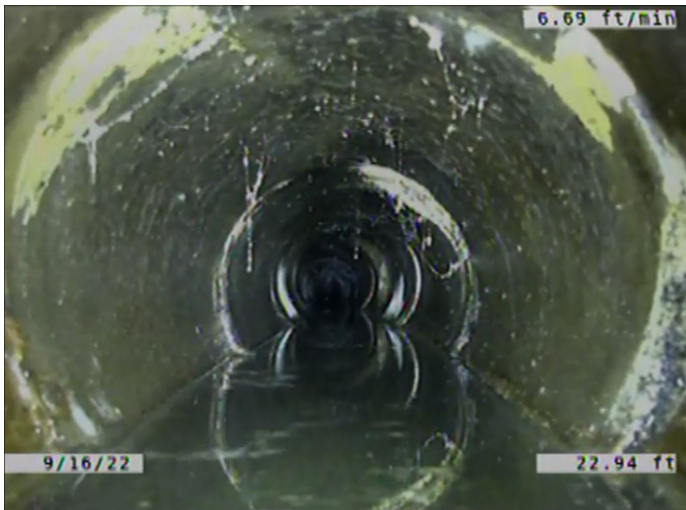
Code: **B**
Description: **Broken**

Distance (ft): **22.9**
Structural Grade: **4**
O&M Grade: **0**
Clock Start/From: **10**
Clock To: **2**
1st Value:
2nd Value:
Value Percent:
Continuous Index:
Within 8" of Joint: **YES**
Remarks:

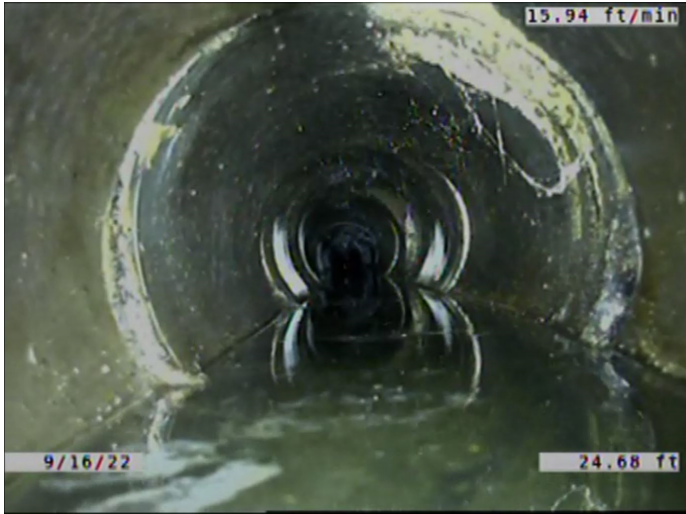
Code: **CM**
Description: **Crack Multiple**

Distance (ft): **24.7**
Structural Grade: **3**
O&M Grade: **0**
Clock Start/From: **10**
Clock To: **2**
1st Value:
2nd Value:
Value Percent:
Continuous Index:
Within 8" of Joint: **YES**
Remarks:

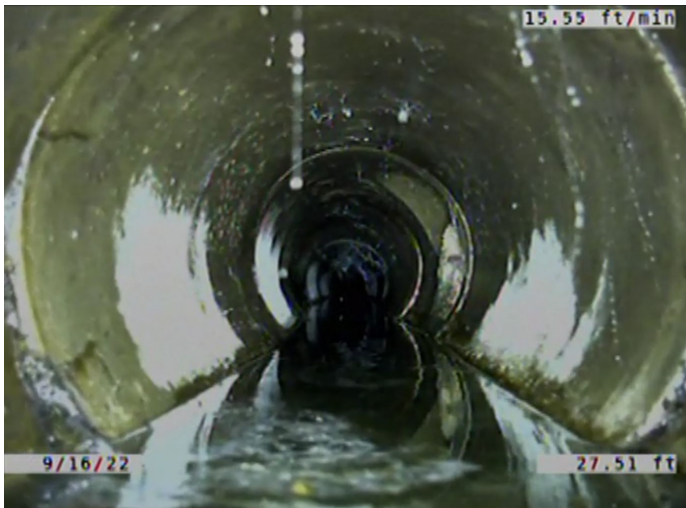
Code: **CM**
Description: **Crack Multiple**

Distance (ft): **27.5**
Structural Grade: **3**
O&M Grade: **0**
Clock Start/From: **8**
Clock To: **4**
1st Value:
2nd Value:
Value Percent:
Continuous Index:
Within 8" of Joint: **YES**
Remarks: **Wandering**

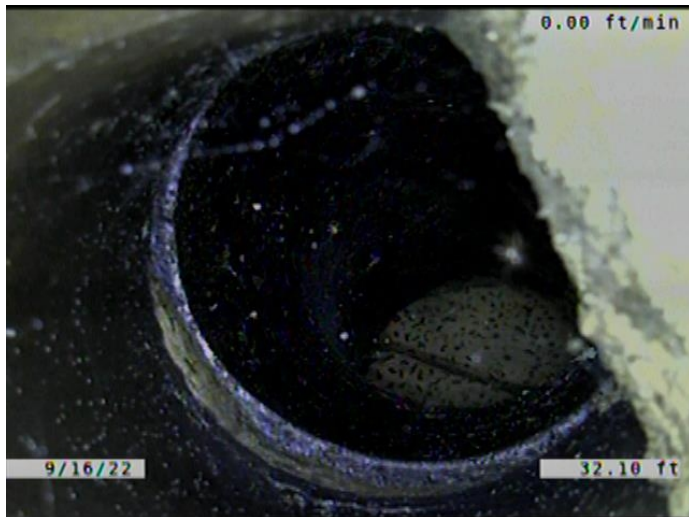
Code:	TFD
Description:	Tap Factory Defective
Distance (ft):	32.1
Structural Grade:	0
O&M Grade:	3
Clock Start/From:	1
Clock To:	
1st Value:	6.000
2nd Value:	
Value Percent:	
Continuous Index:	
Within 8" of Joint:	YES
Remarks:	CAPPED. CAP BROKEN. SERVICE OFFSET. ENCRUSTATION COMING FR

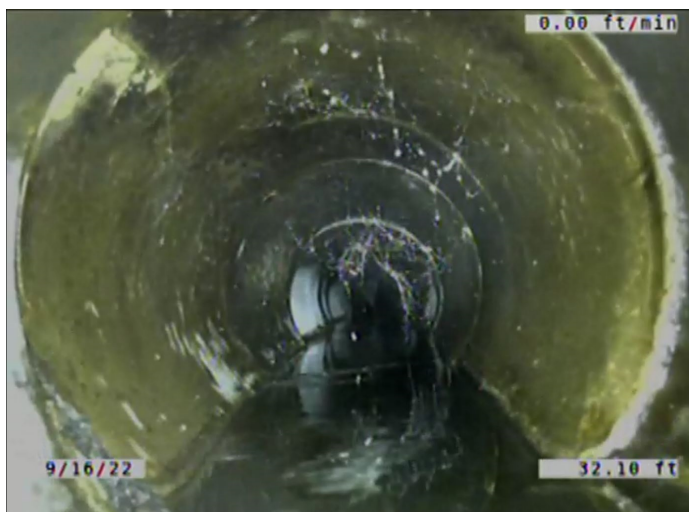
Code:	CM
Description:	Crack Multiple
Distance (ft):	32.1
Structural Grade:	3
O&M Grade:	0
Clock Start/From:	8
Clock To:	4
1st Value:	
2nd Value:	
Value Percent:	
Continuous Index:	S06
Within 8" of Joint:	YES
Remarks:	Wandering

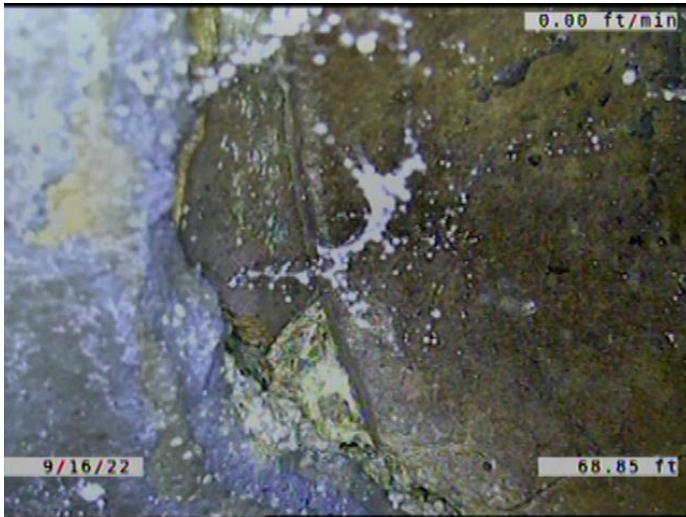
Code: **BSV**
Description: **Broken Soil Visible**

Distance (ft): **68.9**
Structural Grade: **5**
O&M Grade: **0**
Clock Start/From: **12**
Clock To: **3**
1st Value:
2nd Value:
Value Percent:
Continuous Index:
Within 8" of Joint: **YES**
Remarks:

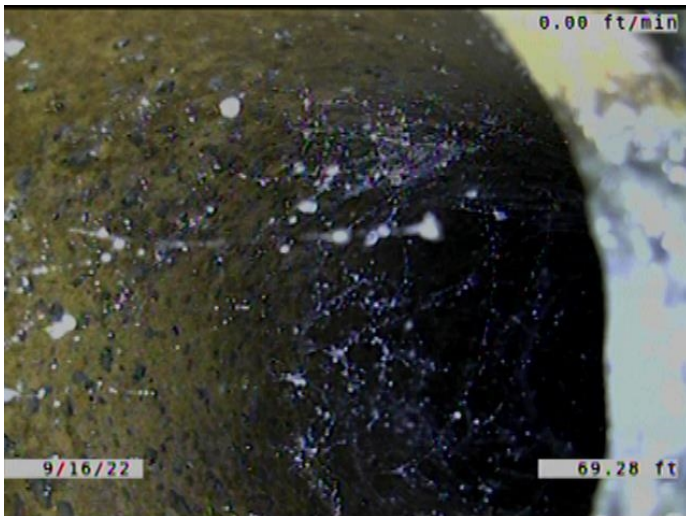
Code: **TBI**
Description: **Tap Break-in Intruding**

Distance (ft): **69.3**
Structural Grade: **0**
O&M Grade: **2**
Clock Start/From: **2**
Clock To:
1st Value: **6.000**
2nd Value: **1.000**
Value Percent:
Continuous Index:
Within 8" of Joint: **YES**
Remarks:

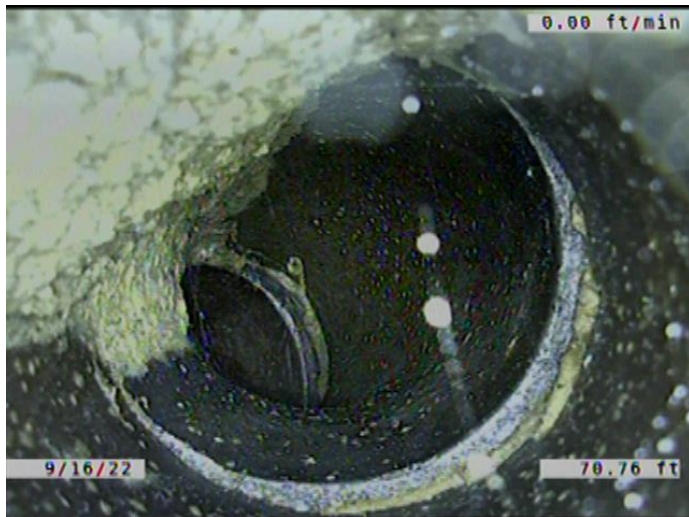
Code: **TFD**
 Description: **Tap Factory Defective**

Distance (ft): **70.8**
 Structural Grade: **0**
 O&M Grade: **3**
 Clock Start/From: **11**
 Clock To:
 1st Value: **6.000**
 2nd Value:
 Value Percent:
 Continuous Index:
 Within 8" of Joint: **YES**
 Remarks: **TAP CRACKED. ENCRUSTATION COMING FROM THE JOINTS AND DO**

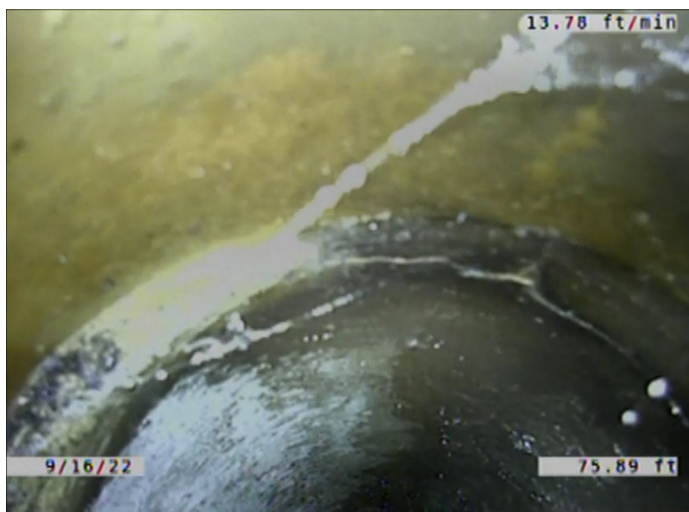
Code: **CM**
 Description: **Crack Multiple**

Distance (ft): **75.9**
 Structural Grade: **3**
 O&M Grade: **0**
 Clock Start/From: **8**
 Clock To: **4**
 1st Value:
 2nd Value:
 Value Percent:
 Continuous Index: **F06**
 Within 8" of Joint: **YES**
 Remarks: **Wandering**

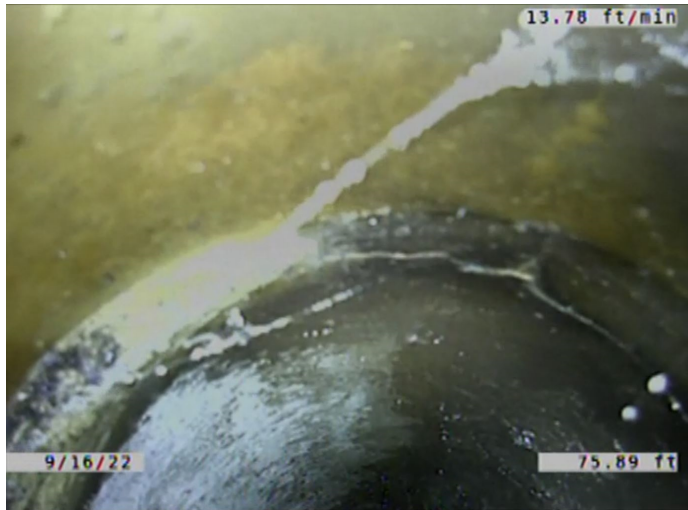
Code: **FM**
 Description: **Fracture Multiple**

Distance (ft): **75.9**
 Structural Grade: **4**
 O&M Grade: **0**
 Clock Start/From: **8**
 Clock To: **4**
 1st Value:
 2nd Value:
 Value Percent:
 Continuous Index: **S07**
 Within 8" of Joint: **YES**
 Remarks: **Wandering**

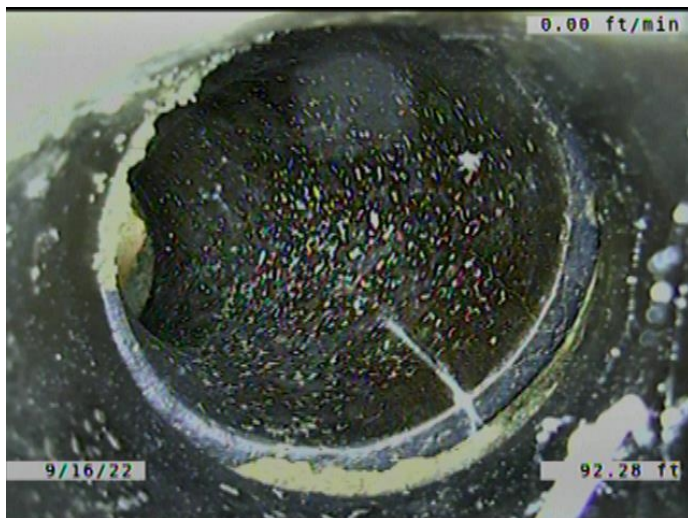
Code: **TF**
 Description: **Tap Factory**

Distance (ft): **92.3**
 Structural Grade: **0**
 O&M Grade: **0**
 Clock Start/From: **11**
 Clock To:
 1st Value: **6.000**
 2nd Value:
 Value Percent:
 Continuous Index:
 Within 8" of Joint: **YES**
 Remarks: **SERVICE OFFSET. LOOKS LIKE IT COULD BE BRICKED OFF.**

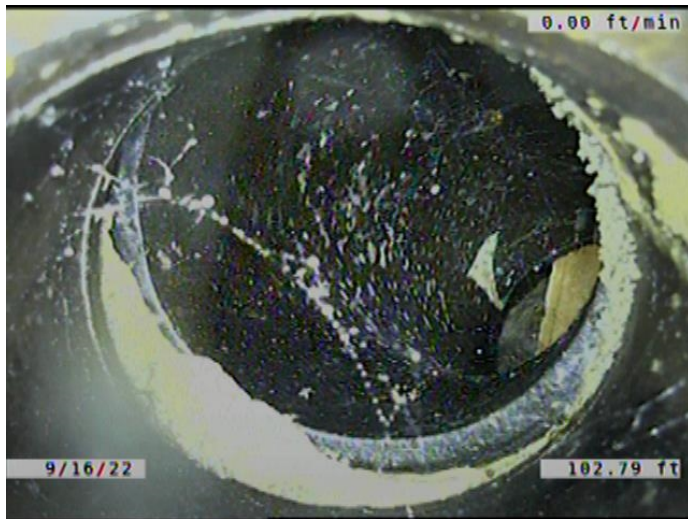
Code: **TFD**
 Description: **Tap Factory Defective**

Distance (ft): **102.8**
 Structural Grade: **0**
 O&M Grade: **3**
 Clock Start/From: **1**
 Clock To:
 1st Value: **6.000**
 2nd Value:
 Value Percent:
 Continuous Index:
 Within 8" of Joint: **YES**
 Remarks: **TAP BROKEN. LOOKS TO BE CAPPED. PART OF THE CAP MISSING. SOIL VIS**

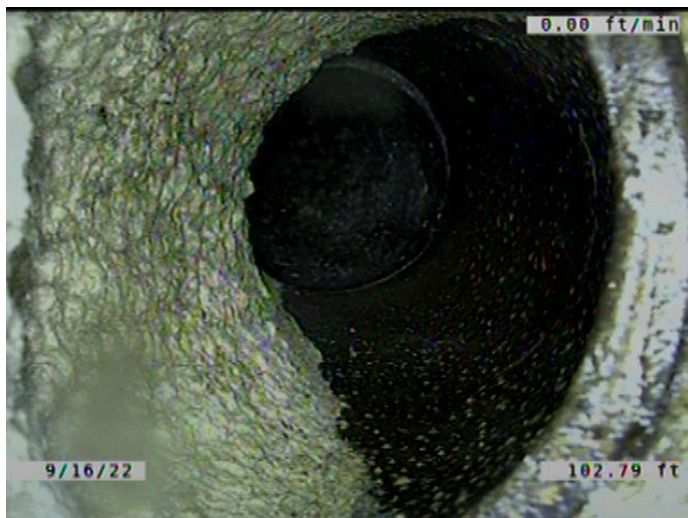
Code: **TBD**
 Description: **Tap Break-in/Hammer Defective**

Distance (ft): **102.8**
 Structural Grade: **0**
 O&M Grade: **3**
 Clock Start/From: **11**
 Clock To:
 1st Value: **6.000**
 2nd Value:
 Value Percent:
 Continuous Index:
 Within 8" of Joint: **YES**
 Remarks: **ENCRUSTATION COMING DOWN THE SERVICE INTO THE MIAN.**

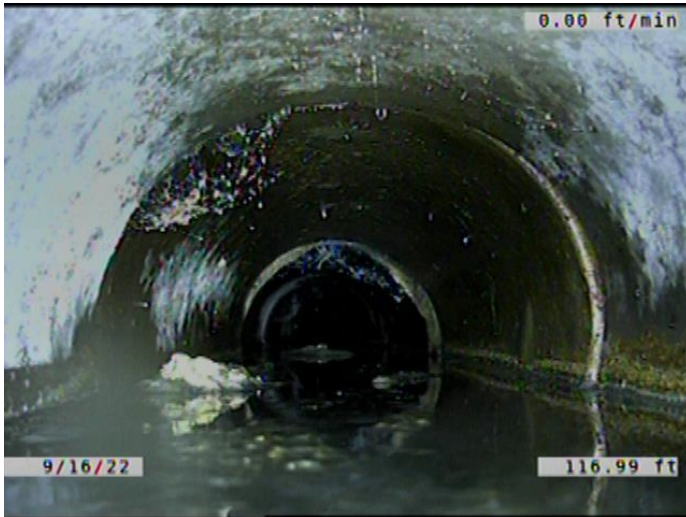
Code: **DSF**
Description: **Deposits Settled Fine**

Distance (ft): **117.0**
Structural Grade: **0**
O&M Grade: **4**
Clock Start/From: **4**
Clock To: **8**
1st Value:
2nd Value:
Value Percent: **25.000**
Continuous Index: **S05**
Within 8" of Joint: **YES**
Remarks:

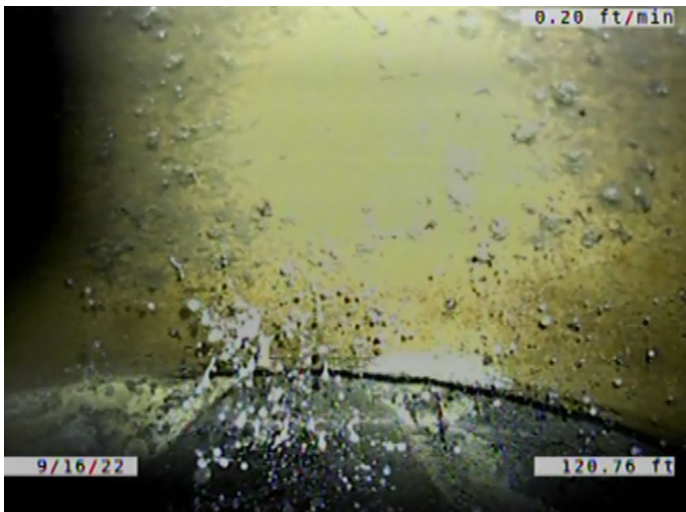
Code: **FM**
Description: **Fracture Multiple**

Distance (ft): **120.8**
Structural Grade: **4**
O&M Grade: **0**
Clock Start/From: **8**
Clock To: **4**
1st Value:
2nd Value:
Value Percent:
Continuous Index: **F07**
Within 8" of Joint: **YES**
Remarks: **Wandering**

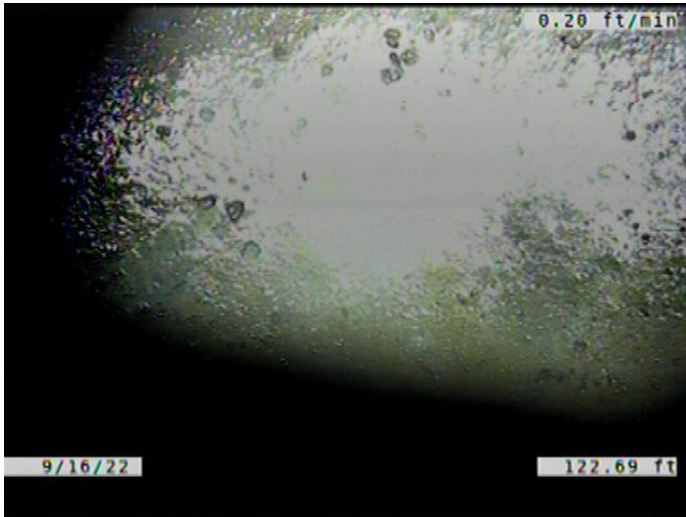
Code: **DSF**
Description: **Deposits Settled Fine**

Distance (ft): **122.7**
Structural Grade: **0**
O&M Grade: **2**
Clock Start/From: **5**
Clock To: **7**
1st Value:
2nd Value:
Value Percent: **10.000**
Continuous Index: **F02**
Within 8" of Joint: **YES**
Remarks:

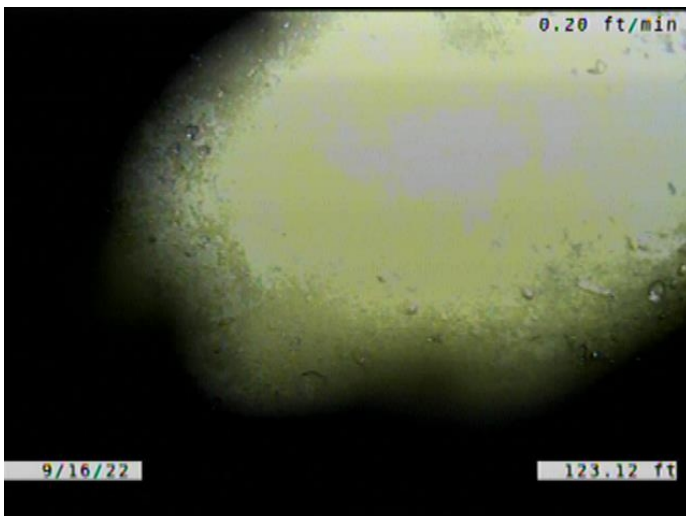
Code: **DAE**
Description: **Deposits Attached Encrustation**

Distance (ft): **123.1**
Structural Grade: **0**
O&M Grade: **2**
Clock Start/From: **8**
Clock To: **4**
1st Value:
2nd Value:
Value Percent: **5.000**
Continuous Index: **F04**
Within 8" of Joint: **YES**
Remarks:

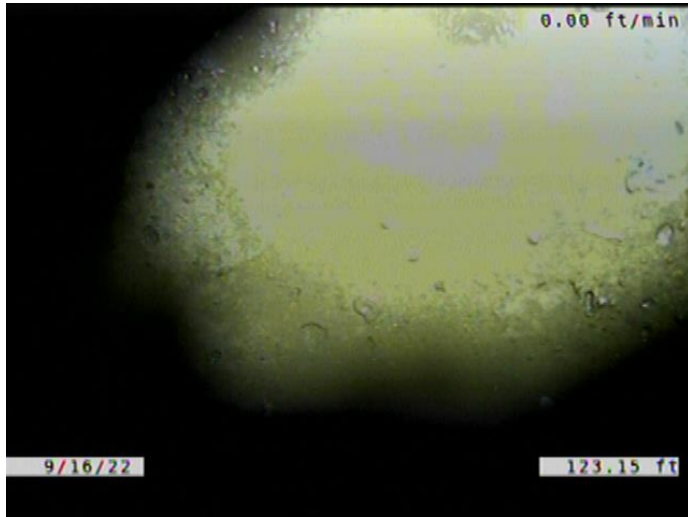
Code: **DSF**
 Description: **Deposits Settled Fine**

Distance (ft): **123.1**
 Structural Grade: **0**
 O&M Grade: **4**
 Clock Start/From: **4**
 Clock To: **8**
 1st Value:
 2nd Value:
 Value Percent: **25.000**
 Continuous Index: **F05**
 Within 8" of Joint: **YES**
 Remarks:

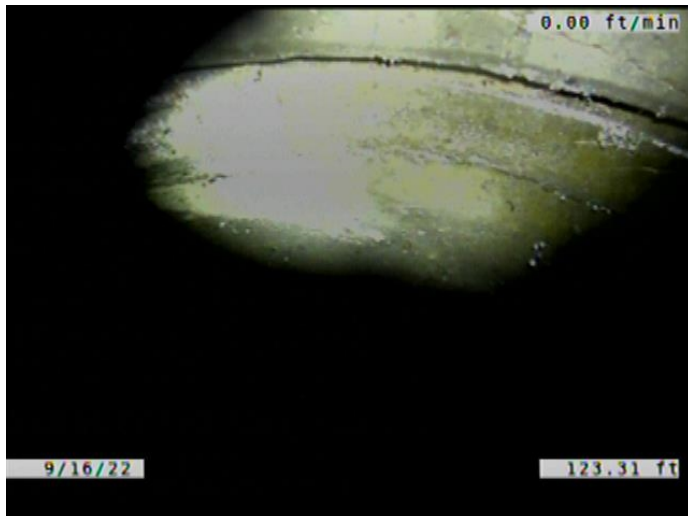
Code: **MSA**
 Description: **Miscellaneous Survey Abandoned**

Distance (ft): **123.3**
 Structural Grade: **0**
 O&M Grade: **0**
 Clock Start/From:
 Clock To:
 1st Value:
 2nd Value:
 Value Percent:
 Continuous Index:
 Within 8" of Joint: **NO**
 Remarks: **CAMERA CANT MAKE IT PAST DEBRIS.**
