Profile/Photo Observation Report

Date:	09/16/2022	Weather:		Coding:	PACP 7.0
Pipe Length (ft):	234.8	Owner:	City of Hobart	Pre Clean:	No Pre-Cleaning
P.O.#:	YES502259	Surveyor:	S. Bucklin	PSR:	M-705-055-M-705-054
Customer:	City of Hobart	Clean Date:		Shape:	C

Street:	East 3rd Street	Flow Control:	Not Controlled
City:	Hobart, IN	Year Renewed:	
Location:	Local rural streets with light traffic, t	Tape/Media #:	
Purpose:	Routine Assessment	Dia/Height:	10"
Use:	Sanitary Sewage Pipe	Material:	VCP
Drain Area:		Lining:	None
Category:	NA		
Comment:			
Location Details:		Direction of Survey:	Upstream
US MH:	M-705-055	DS MH:	M-705-054
		Total Length Surveyed (ft):	52.8

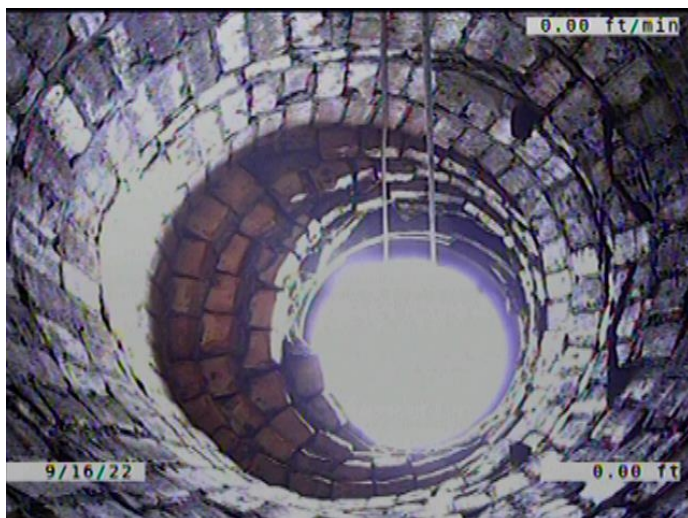
Code: **AMH**
 Description: **Manhole**

Distance (ft): **.0**
 Structural Grade: **0**
 O&M Grade: **0**
 Clock Start/From:
 Clock To:
 1st Value:
 2nd Value:
 Value Percent:
 Continuous Index:
 Within 8" of Joint: **NO**
 Remarks: **M-705-054**

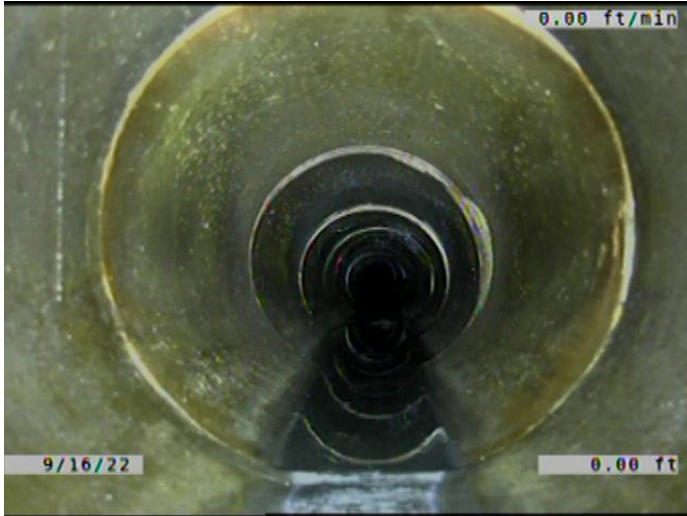
Code: **MWL**
Description: **Miscellaneous Water Level**

Distance (ft): **.0**
Structural Grade: **0**
O&M Grade: **0**
Clock Start/From:
Clock To:
1st Value:
2nd Value:
Value Percent: **5.000**
Continuous Index:
Within 8" of Joint: **NO**
Remarks:

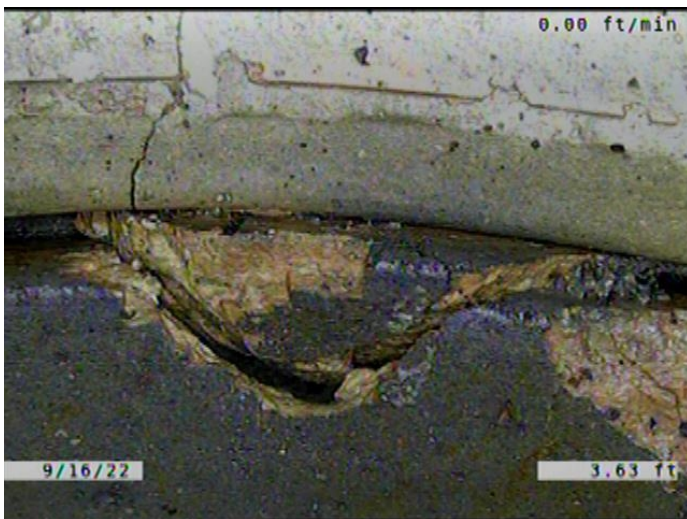
Code: **B**
Description: **Broken**

Distance (ft): **3.6**
Structural Grade: **4**
O&M Grade: **0**
Clock Start/From: **7**
Clock To: **5**
1st Value:
2nd Value:
Value Percent:
Continuous Index: **S01**
Within 8" of Joint: **YES**
Remarks:

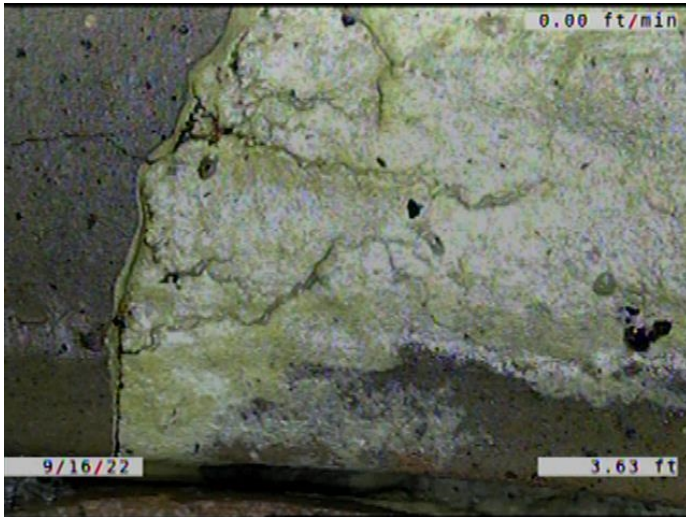
Code: **DAE**
 Description: **Deposits Attached Encrustation**

Distance (ft): **3.6**
 Structural Grade: **0**
 O&M Grade: **2**
 Clock Start/From: **8**
 Clock To: **4**
 1st Value:
 2nd Value:
 Value Percent: **5.000**
 Continuous Index: **S02**
 Within 8" of Joint: **NO**
 Remarks:

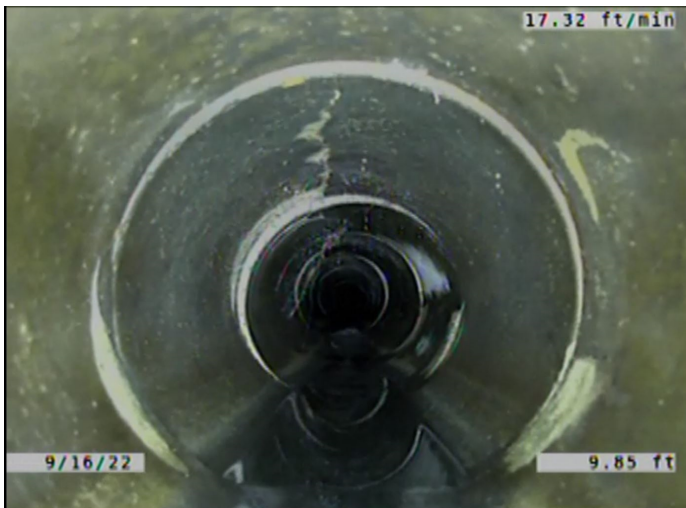
Code: **B**
 Description: **Broken**

Distance (ft): **9.9**
 Structural Grade: **4**
 O&M Grade: **0**
 Clock Start/From: **7**
 Clock To: **5**
 1st Value:
 2nd Value:
 Value Percent:
 Continuous Index: **F01**
 Within 8" of Joint: **YES**
 Remarks:

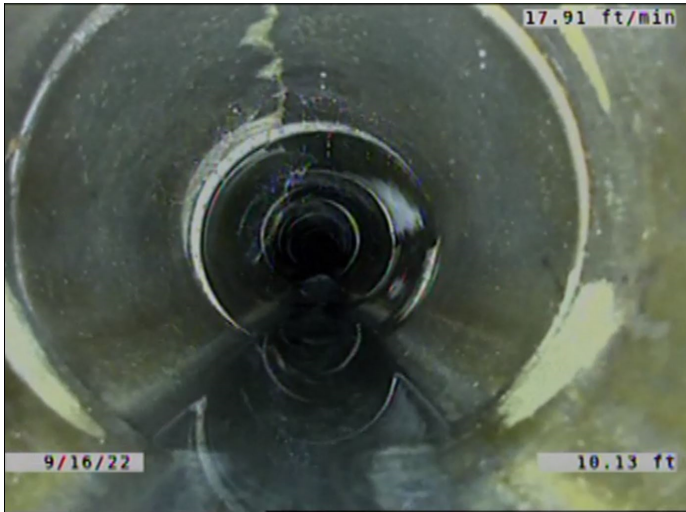
Code: **FM**
Description: **Fracture Multiple**

Distance (ft): **10.1**
Structural Grade: **4**
O&M Grade: **0**
Clock Start/From: **8**
Clock To: **4**
1st Value:
2nd Value:
Value Percent:
Continuous Index: **S03**
Within 8" of Joint: **YES**
Remarks: **Wandering**

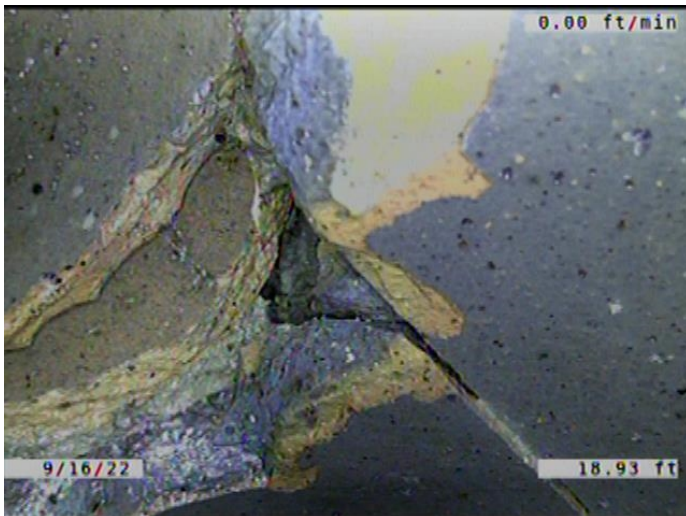
Code: **BSV**
Description: **Broken Soil Visible**

Distance (ft): **18.9**
Structural Grade: **5**
O&M Grade: **0**
Clock Start/From: **8**
Clock To: **4**
1st Value:
2nd Value:
Value Percent:
Continuous Index:
Within 8" of Joint: **YES**
Remarks:

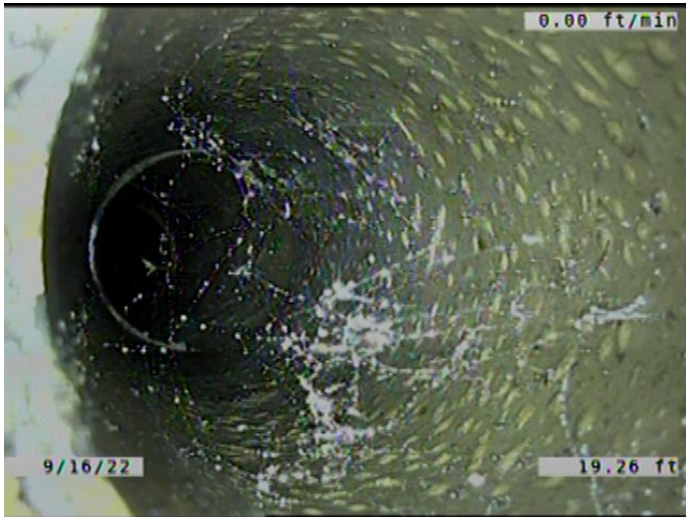
Code: **TBI**
 Description: **Tap Break-in Intruding**

Distance (ft): **19.3**
 Structural Grade: **0**
 O&M Grade: **2**
 Clock Start/From: **10**
 Clock To:
 1st Value: **6.000**
 2nd Value: **1.000**
 Value Percent:
 Continuous Index:
 Within 8" of Joint: **YES**
 Remarks:

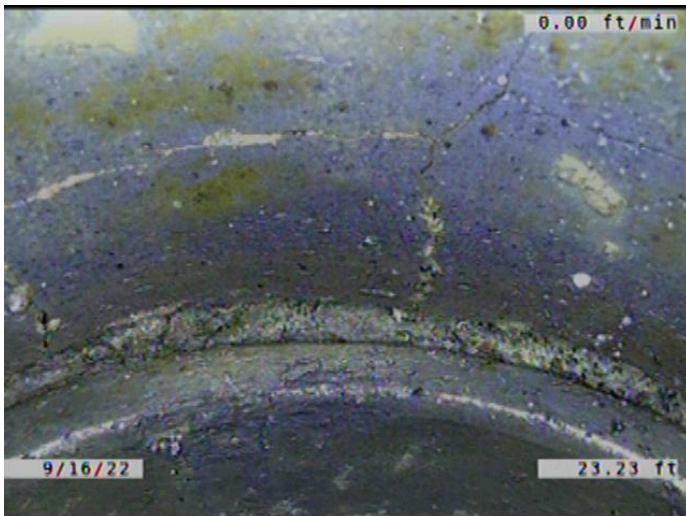
Code: **JOMD**
 Description: **Joint Offset Medium Defective**

Distance (ft): **23.2**
 Structural Grade: **3**
 O&M Grade: **0**
 Clock Start/From:
 Clock To:
 1st Value:
 2nd Value:
 Value Percent:
 Continuous Index:
 Within 8" of Joint: **NO**
 Remarks:

Code: **B**
Description: **Broken**

Distance (ft): **23.2**
Structural Grade: **4**
O&M Grade: **0**
Clock Start/From: **10**
Clock To: **2**
1st Value:
2nd Value:
Value Percent:
Continuous Index:
Within 8" of Joint: **YES**
Remarks:

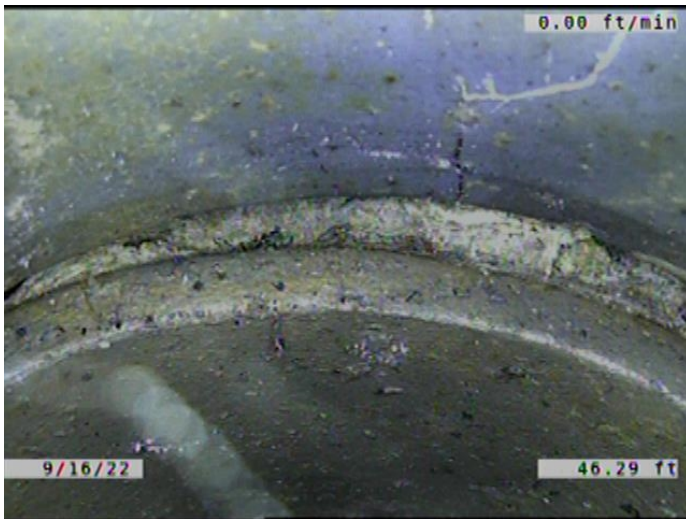
Code: **JOMD**
Description: **Joint Offset Medium Defective**

Distance (ft): **46.3**
Structural Grade: **3**
O&M Grade: **0**
Clock Start/From:
Clock To:
1st Value:
2nd Value:
Value Percent:
Continuous Index:
Within 8" of Joint: **NO**
Remarks:

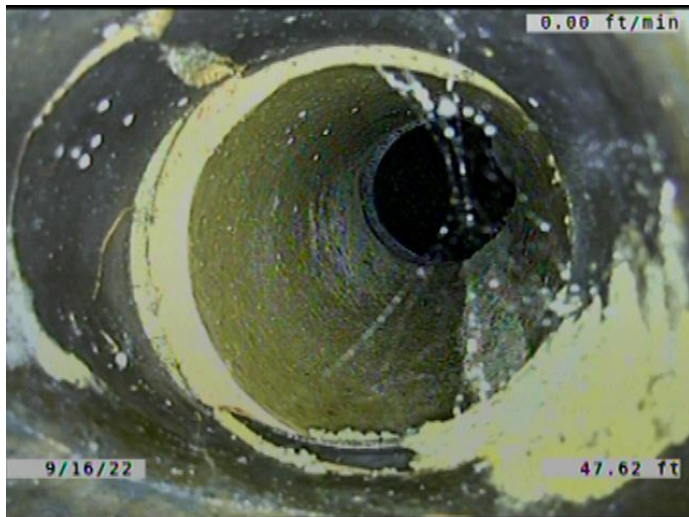
Code: **TFD**
Description: **Tap Factory Defective**

Distance (ft): **47.6**
Structural Grade: **0**
O&M Grade: **3**
Clock Start/From: **1**
Clock To:
1st Value: **6.000**
2nd Value:
Value Percent:
Continuous Index:
Within 8" of Joint: **YES**
Remarks: **TAP BROKEN. SERVICE OFFSET. SOIL VISIBLE.**

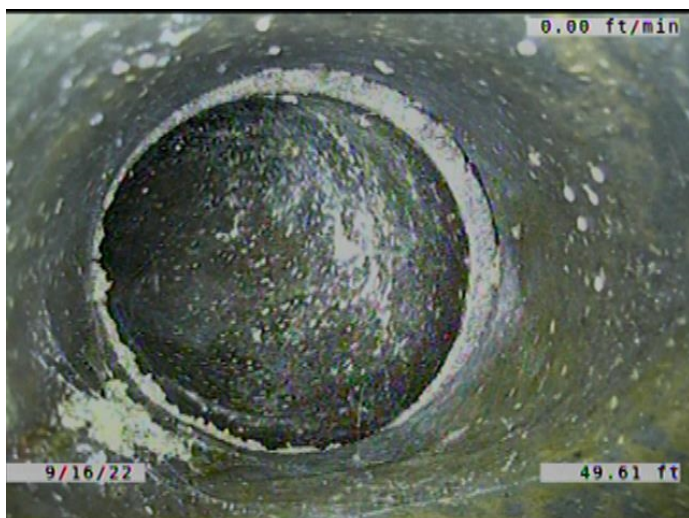
Code: **TFD**
Description: **Tap Factory Defective**

Distance (ft): **49.6**
Structural Grade: **0**
O&M Grade: **3**
Clock Start/From: **11**
Clock To:
1st Value: **6.000**
2nd Value:
Value Percent:
Continuous Index:
Within 8" of Joint: **YES**
Remarks: **TAP BROKEN.**

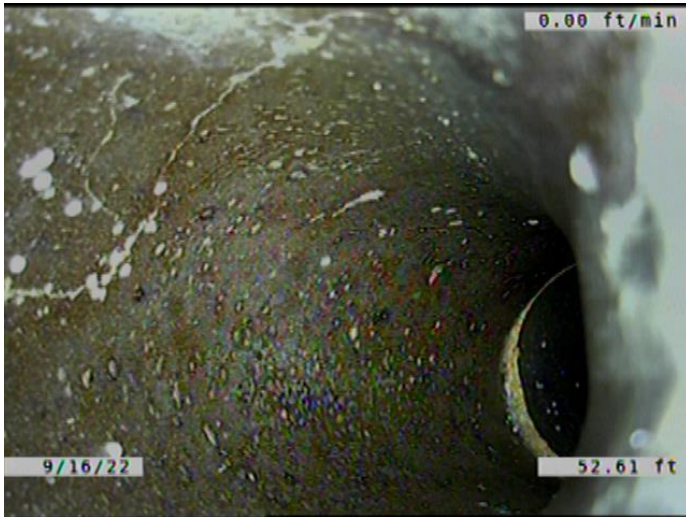
Code: **TBI**
Description: **Tap Break-in Intruding**

Distance (ft): **52.6**
Structural Grade: **0**
O&M Grade: **2**
Clock Start/From: **1**
Clock To:
1st Value: **6.000**
2nd Value: **5.000**
Value Percent:
Continuous Index:
Within 8" of Joint: **YES**
Remarks: **CONSTANLTY RUNNING WATER.**

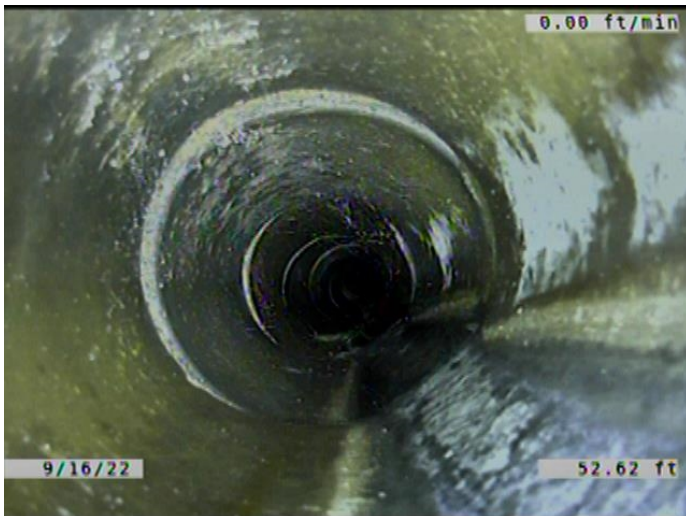
Code: **FM**
Description: **Fracture Multiple**

Distance (ft): **52.6**
Structural Grade: **4**
O&M Grade: **0**
Clock Start/From: **8**
Clock To: **4**
1st Value:
2nd Value:
Value Percent:
Continuous Index: **F03**
Within 8" of Joint: **YES**
Remarks: **Wandering**

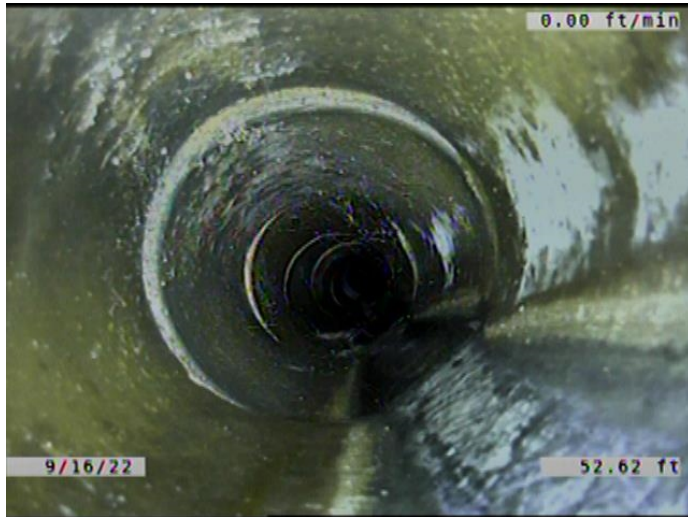
Code: **DAE**
 Description: **Deposits Attached Encrustation**

Distance (ft): **52.6**
 Structural Grade: **0**
 O&M Grade: **2**
 Clock Start/From: **8**
 Clock To: **4**
 1st Value:
 2nd Value:
 Value Percent: **5.000**
 Continuous Index: **F02**
 Within 8" of Joint: **NO**
 Remarks:

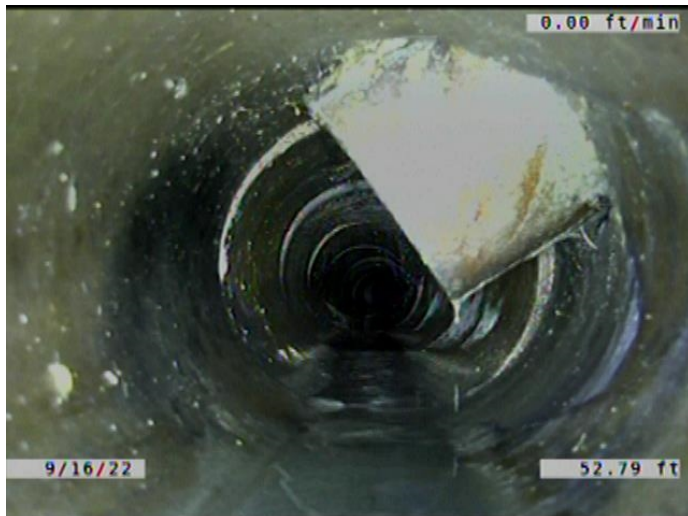
Code: **MSA**
 Description: **Miscellaneous Survey Abandoned**

Distance (ft): **52.8**
 Structural Grade: **0**
 O&M Grade: **0**
 Clock Start/From:
 Clock To:
 1st Value:
 2nd Value:
 Value Percent:
 Continuous Index:
 Within 8" of Joint: **NO**
 Remarks: **CAMERA CANT MAKE IT PAST PROTRUDING TAP.**
