Profile/Photo Observation Report

Street:	E 3RD ST & E PARK AVE	Flow Control:	Not Controlled
City:	Hobart, IN	Year Renewed:	
Location:	Light Highway	Tape/Media #:	
Purpose:	Maintenance Related	Dia/Height:	10"
Use:	Sanitary	Material:	VCP
Drain Area:	NA	Lining:	Cured in Place
Category:	NA		
Comment:	tap at 51'.

Location Details:		Direction of Survey:	Downstream
US MH:	M-705-055	DS MH:	M-705-054
		Total Length Surveyed (ft):	52.7

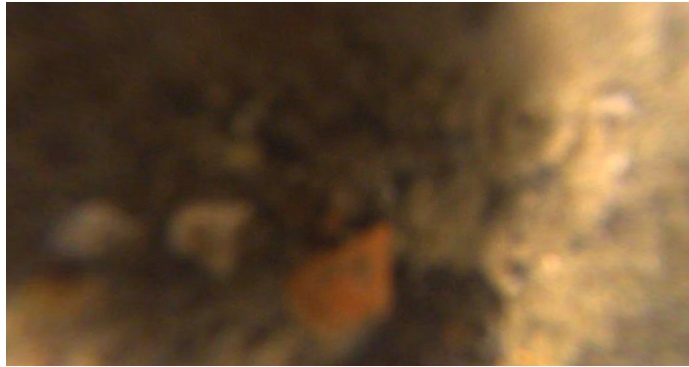
Code: **MWL**
Description: **Water Level**

Distance (ft): **.0**
Structural Grade: **0**
O&M Grade: **0**
Clock Start/From:
Clock To:
1st Value:
2nd Value:
Value Percent: **10.000**
Continuous Index:
Within 8" of Joint: **NO**
Remarks:

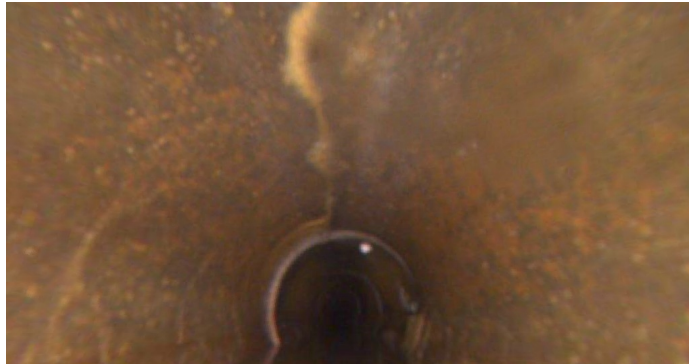
Code: **CL**
Description: **Crack Longitudinal**

Distance (ft): **12.1**
Structural Grade: **2**
O&M Grade: **0**
Clock Start/From: **12**
Clock To:
1st Value:
2nd Value:
Value Percent:
Continuous Index:
Within 8" of Joint:
Remarks:

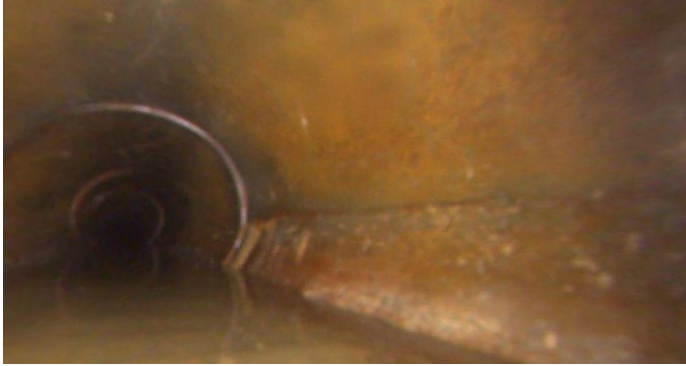
Code: **CL**
Description: **Crack Longitudinal**

Distance (ft): **14.6**
Structural Grade: **2**
O&M Grade: **0**
Clock Start/From: **4**
Clock To:
1st Value:
2nd Value:
Value Percent:
Continuous Index:
Within 8" of Joint: **YES**
Remarks:

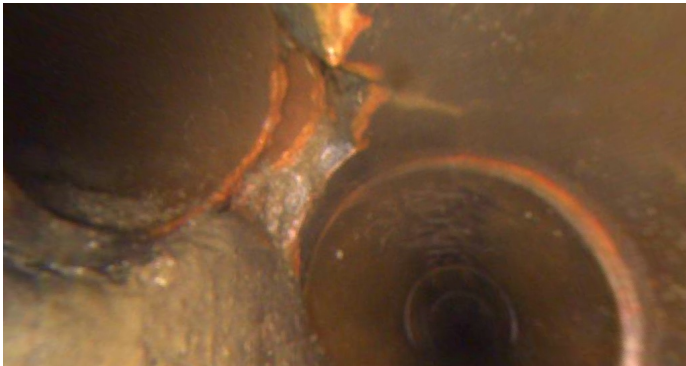
Code: **TB**
Description: **Tap Break-in**

Distance (ft): **19.2**
Structural Grade: **0**
O&M Grade: **0**
Clock Start/From: **10**
Clock To:
1st Value: **4.000**
2nd Value:
Value Percent:
Continuous Index:
Within 8" of Joint:
Remarks:

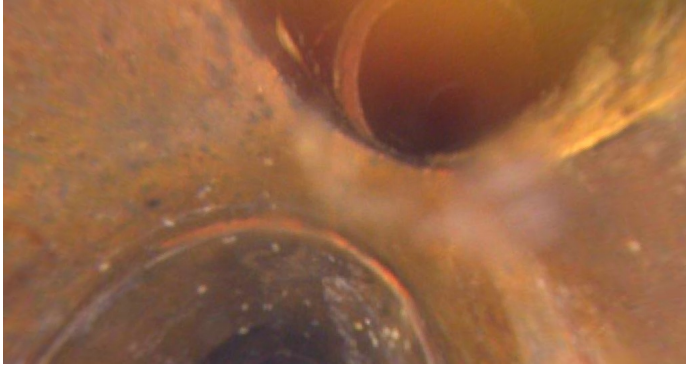
Code: **TF**
Description: **Tap Factory**

Distance (ft): **48.4**
Structural Grade: **0**
O&M Grade: **0**
Clock Start/From: **2**
Clock To:
1st Value: **4.000**
2nd Value:
Value Percent:
Continuous Index:
Within 8" of Joint:
Remarks:

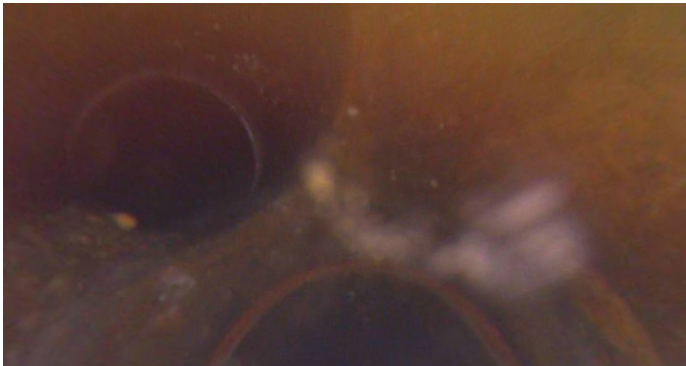
Code: **TF**
Description: **Tap Factory**

Distance (ft): **50.2**
Structural Grade: **0**
O&M Grade: **0**
Clock Start/From: **10**
Clock To:
1st Value: **4.000**
2nd Value:
Value Percent:
Continuous Index:
Within 8" of Joint:
Remarks:

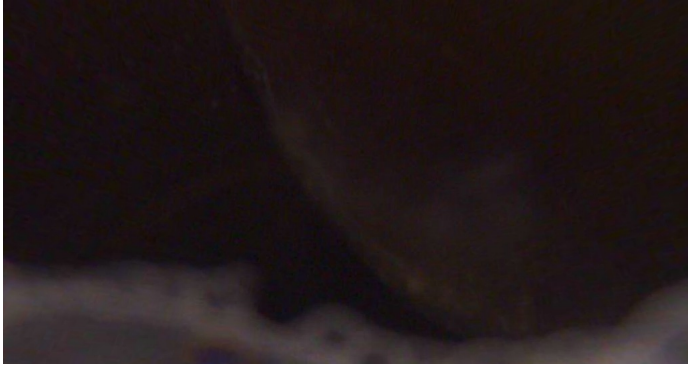
Code:	TBI
Description:	Tap Break-in Intruding
Distance (ft):	52.6
Structural Grade:	0
O&M Grade:	2
Clock Start/From:	3
Clock To:	
1st Value:	4.000
2nd Value:	4.000
Value Percent:	
Continuous Index:	
Within 8" of Joint:	
Remarks:

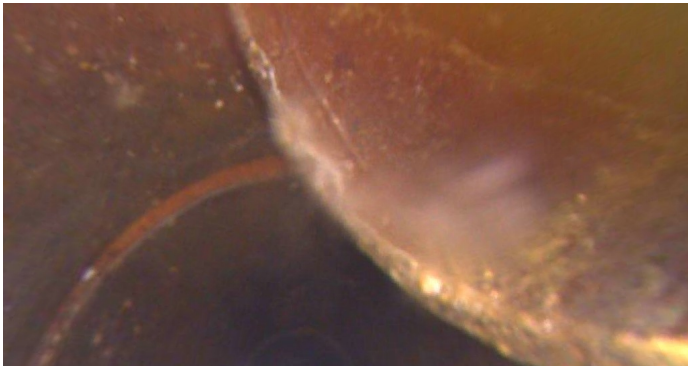
Code:	MSA
Description:	Abandoned Survey
Distance (ft):	52.7
Structural Grade:	0
O&M Grade:	0
Clock Start/From:	
Clock To:	
1st Value:	
2nd Value:	
Value Percent:	
Continuous Index:	
Within 8" of Joint:	NO
Remarks:	TBI
