## Profile/Photo Observation Report

Street:	<b>Capitol</b>	Flow Control:	<b>Not Controlled</b>
City:	<b>Hobart, IN</b>	Year Renewed:	
Location:	<b>Light Highway</b>	Tape/Media #:	
Purpose:	<b>Maintenance Related</b>	Dia/Height:	<b>10"</b>
Use:	<b>Sanitary</b>	Material:	<b>VCP</b>
Drain Area:	<b>NA</b>	Lining:	<b>Cured in Place</b>
Category:	<b>NA</b>		
Comment:	<b>tap at 51'.</b>

Location Details:		Direction of Survey:	<b>Downstream</b>
US MH:	<b>M-705-055</b>	DS MH:	<b>M-705-054</b>
		Total Length Surveyed (ft):	<b>52.7</b>

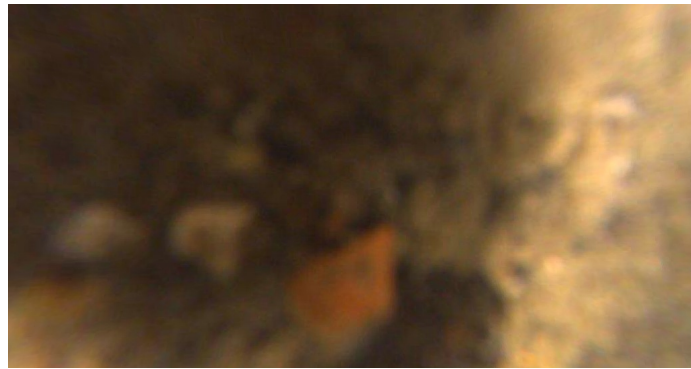
Code: **MWL**  
Description: **Water Level**

Distance (ft): **.0**  
Structural Grade: **0**  
O&M Grade: **0**  
Clock Start/From:  
Clock To:  
1st Value:  
2nd Value:  
Value Percent: **10.000**  
Continuous Index:  
Within 8" of Joint: **NO**  
Remarks:

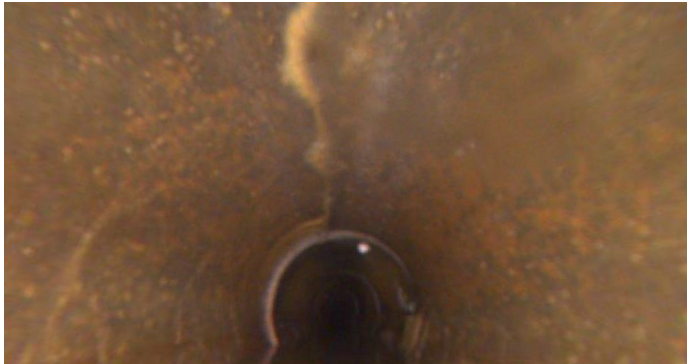
Code: **CL**  
Description: **Crack Longitudinal**

Distance (ft): **12.1**  
Structural Grade: **2**  
O&M Grade: **0**  
Clock Start/From: **12**  
Clock To:  
1st Value:  
2nd Value:  
Value Percent:  
Continuous Index:  
Within 8" of Joint:  
Remarks:

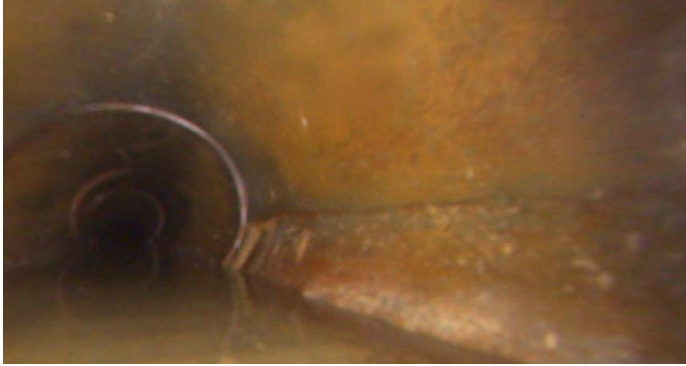
Code: **CL**  
Description: **Crack Longitudinal**

Distance (ft): **14.6**  
Structural Grade: **2**  
O&M Grade: **0**  
Clock Start/From: **4**  
Clock To:  
1st Value:  
2nd Value:  
Value Percent:  
Continuous Index:  
Within 8" of Joint: **YES**  
Remarks:

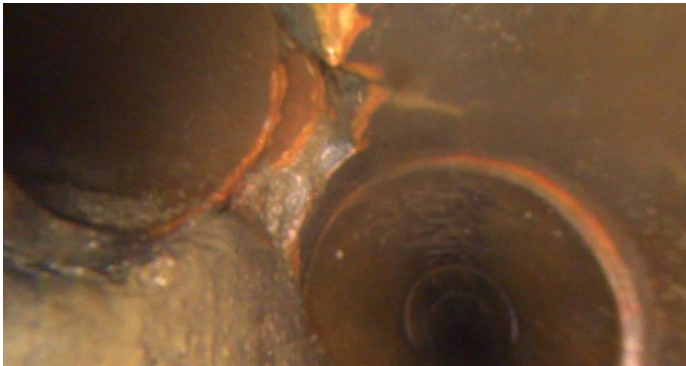
Code: **TB**  
Description: **Tap Break-in**

Distance (ft): **19.2**  
Structural Grade: **0**  
O&M Grade: **0**  
Clock Start/From: **10**  
Clock To:  
1st Value: **4.000**  
2nd Value:  
Value Percent:  
Continuous Index:  
Within 8" of Joint:  
Remarks:

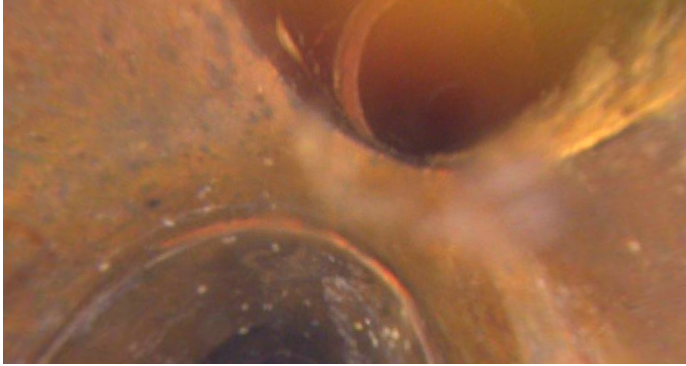
Code: **TF**  
Description: **Tap Factory**

Distance (ft): **48.4**  
Structural Grade: **0**  
O&M Grade: **0**  
Clock Start/From: **2**  
Clock To:  
1st Value: **4.000**  
2nd Value:  
Value Percent:  
Continuous Index:  
Within 8" of Joint:  
Remarks:

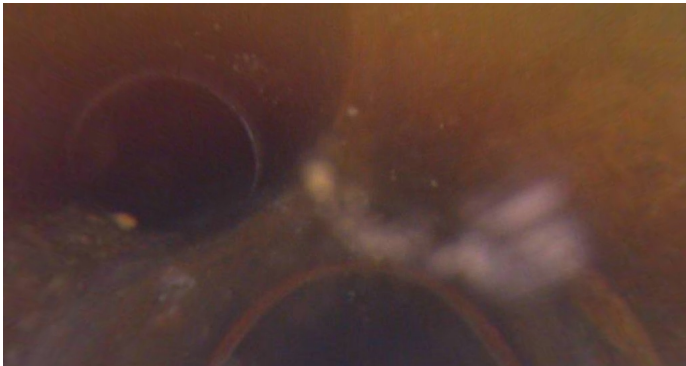
Code: **TF**  
Description: **Tap Factory**

Distance (ft): **50.2**  
Structural Grade: **0**  
O&M Grade: **0**  
Clock Start/From: **10**  
Clock To:  
1st Value: **4.000**  
2nd Value:  
Value Percent:  
Continuous Index:  
Within 8" of Joint:  
Remarks:

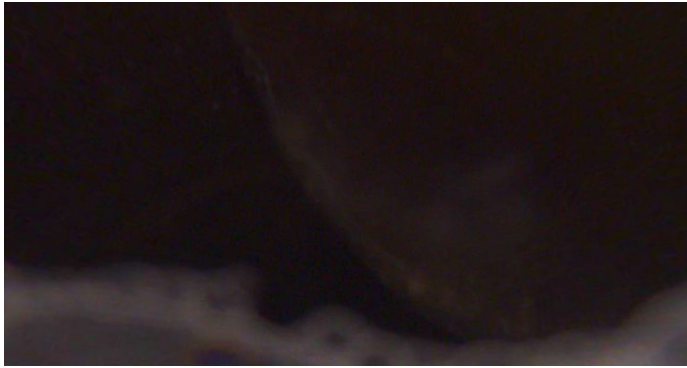
Code:	<b>TBI</b>
Description:	<b>Tap Break-in Intruding</b>
Distance (ft):	<b>52.6</b>
Structural Grade:	<b>0</b>
O&M Grade:	<b>2</b>
Clock Start/From:	<b>3</b>
Clock To:	
1st Value:	<b>4.000</b>
2nd Value:	<b>4.000</b>
Value Percent:	
Continuous Index:	
Within 8" of Joint:	
Remarks:

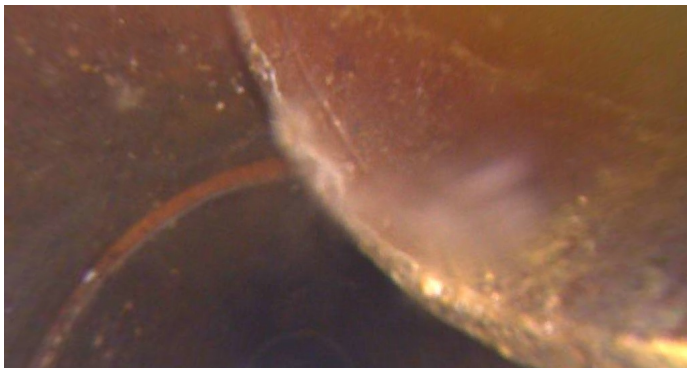
Code:	<b>MSA</b>
Description:	<b>Abandoned Survey</b>
Distance (ft):	<b>52.7</b>
Structural Grade:	<b>0</b>
O&M Grade:	<b>0</b>
Clock Start/From:	
Clock To:	
1st Value:	
2nd Value:	
Value Percent:	
Continuous Index:	
Within 8" of Joint:	<b>NO</b>
Remarks:	<b>TBI</b>
