Profile/Photo Observation Report

Date:	05/01/2018	Weather:		Coding:	PACP 6.0
Pipe Length (ft):		Owner:	City of Hobart	Pre Clean:	No Pre-Cleaning
P.O.#:	151	Surveyor:	M. Pielacha	PSR:	P-705-070-060
Customer:	City of Hobart	Clean Date:		Shape:	C

Street:	Off Center Street	Flow Control:	Not Controlled
City:	Hobart, IN	Year Renewed:	
Location:	Light Highway	Tape/Media #:	DEP 151
Purpose:	Routine Assessment	Dia/Height:	15"
Use:	Sanitary	Material:	RCP
Drain Area:		Lining:	
Category:	NA		
Comment:	5-21-2018		
Location Details:		Direction of Survey:	Downstream
US MH:	M-705-060	DS MH:	M-705-070
		Total Length Surveyed (ft):	8.2

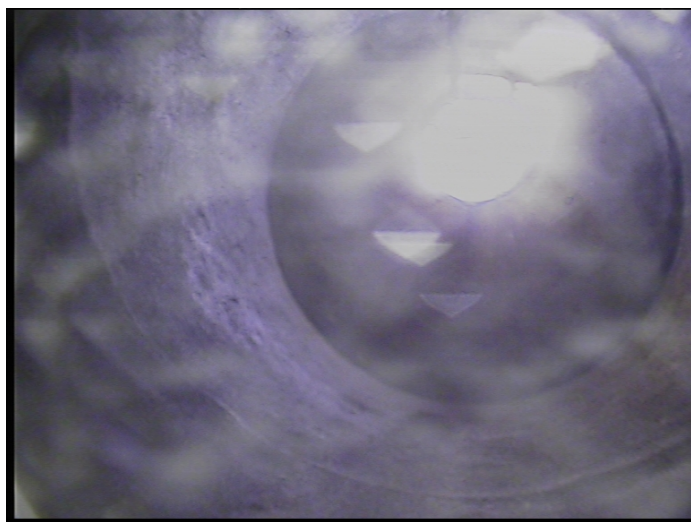
Code: **AMH**
Description: **Manhole**

Distance (ft): **.0**
Structural Grade: **0**
O&M Grade: **0**
Clock Start/From:
Clock To:
1st Value:
2nd Value:
Value Percent:
Continuous Index:
Within 8" of Joint: **NO**
Remarks: **M-705-070**

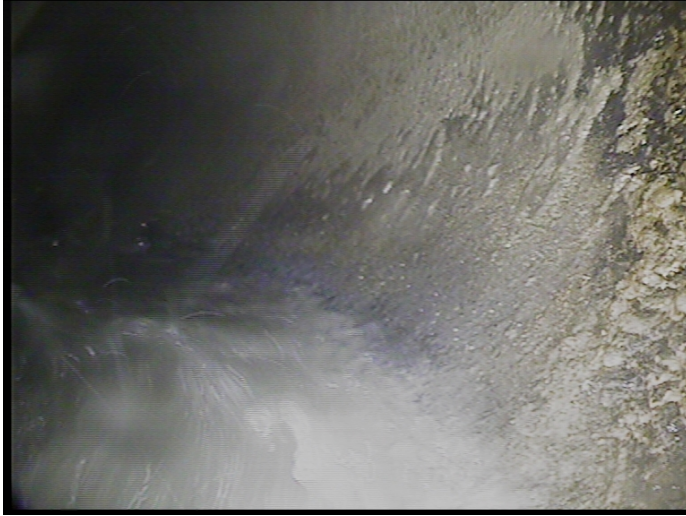
Code: **MWL**
Description: **Water Level**

Distance (ft): **.0**
Structural Grade: **0**
O&M Grade: **0**
Clock Start/From:
Clock To:
1st Value:
2nd Value:
Value Percent: **10.000**
Continuous Index:
Within 8" of Joint: **NO**
Remarks:

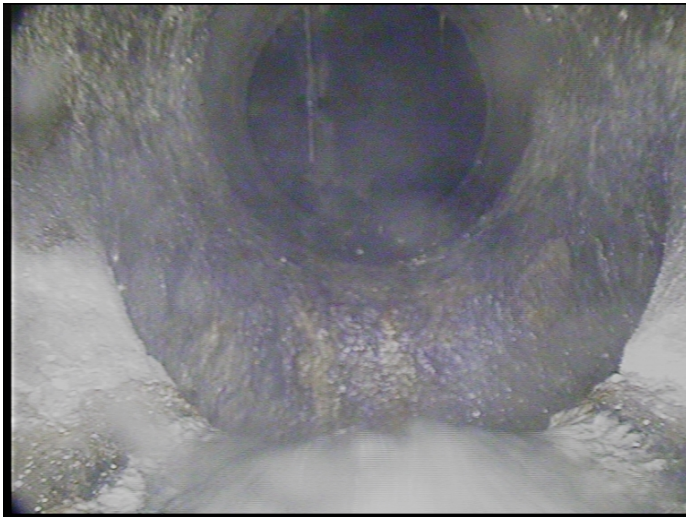
Code: **TFA**
Description: **Tap Factory Active**

Distance (ft): **7.2**
Structural Grade: **0**
O&M Grade: **0**
Clock Start/From: **6**
Clock To:
1st Value: **12.000**
2nd Value:
Value Percent:
Continuous Index:
Within 8" of Joint: **NO**
Remarks:

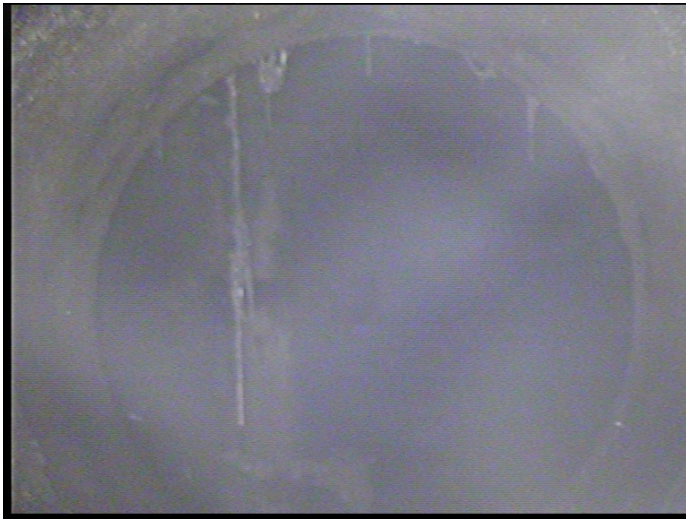
Code:	AMH
Description:	Manhole
Distance (ft):	8.2
Structural Grade:	0
O&M Grade:	0
Clock Start/From:	
Clock To:	
1st Value:	
2nd Value:	
Value Percent:	
Continuous Index:	
Within 8" of Joint:	NO
Remarks:	M-705-060
