Profile/Photo Observation Report

Date:	04/21/2018	Weather:		Coding:	PACP 6.0
Pipe Length (ft):	182.4	Owner:	NA	Pre Clean:	Not Known
P.O.#:		Surveyor:	Jen Costello	PSR:	P-705-045-079
Customer:		Clean Date:	01/01/1900	Shape:	C

Street:	E 4TH ST & EAST ST	Flow Control:	Not Controlled
City:	Hobart, IN	Year Renewed:	
Location:	Light Highway	Tape/Media #:	
Purpose:	Maintenance Related	Dia/Height:	8"
Use:	Sanitary	Material:	VCP
Drain Area:	NA	Lining:	Cured in Place
Category:	NA		
Comment:	gravel at 23'.

Location Details:		Direction of Survey:	Upstream
US MH:	M-705-079	DS MH:	M-705-045
		Total Length Surveyed (ft):	25.0

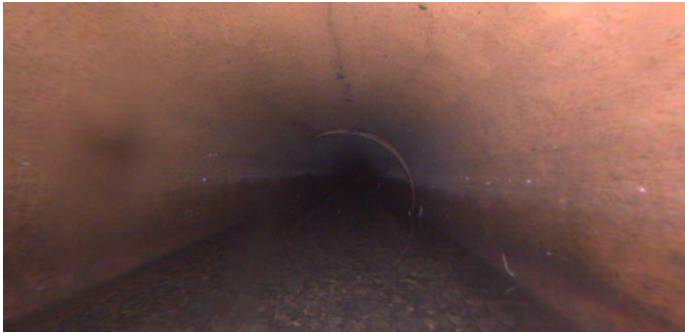
Code:	MWL
Description:	Water Level

Distance (ft):	.0
Structural Grade:	0
O&M Grade:	0
Clock Start/From:	
Clock To:	
1st Value:	
2nd Value:	
Value Percent:	30.000
Continuous Index:	
Within 8" of Joint:	NO
Remarks:

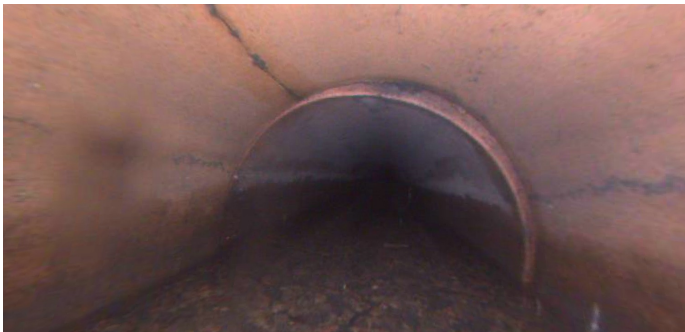
Code:	FL
Description:	Fracture Longitudinal

Distance (ft):	2.2
Structural Grade:	3
O&M Grade:	0
Clock Start/From:	11
Clock To:	
1st Value:	
2nd Value:	
Value Percent:	
Continuous Index:	
Within 8" of Joint:	YES
Remarks:

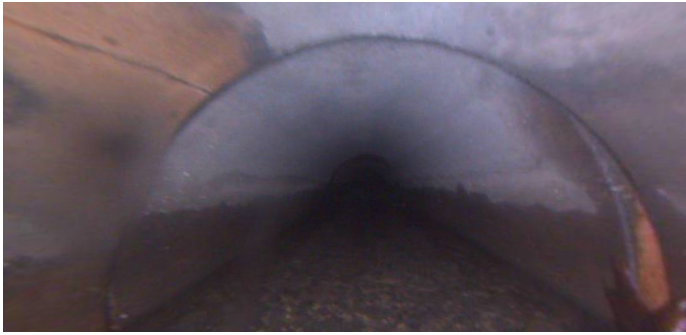
Code: **FL**
Description: **Fracture Longitudinal**

Distance (ft): **6.5**
Structural Grade: **3**
O&M Grade: **0**
Clock Start/From: **11**
Clock To:
1st Value:
2nd Value:
Value Percent:
Continuous Index:
Within 8" of Joint: **YES**
Remarks:

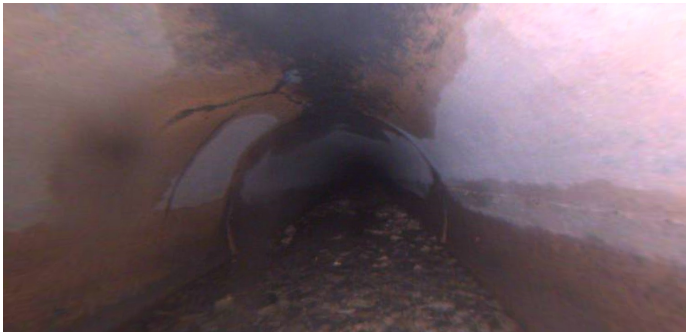
Code: **FM**
Description: **Fracture Multiple**

Distance (ft): **9.7**
Structural Grade: **4**
O&M Grade: **0**
Clock Start/From: **8**
Clock To: **12**
1st Value:
2nd Value:
Value Percent:
Continuous Index:
Within 8" of Joint: **YES**
Remarks:

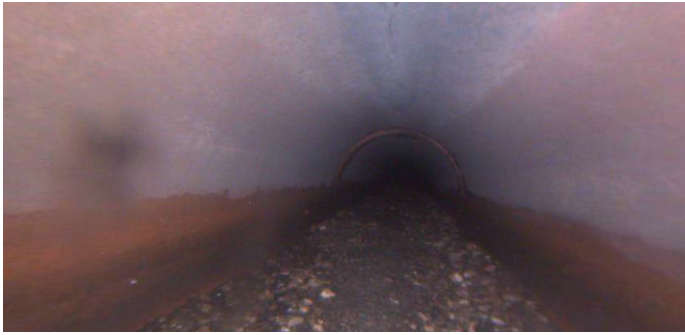
Code: **DSGV**
Description: **Deposits Settled Gravel**

Distance (ft): **12.8**
Structural Grade: **0**
O&M Grade: **5**
Clock Start/From: **3**
Clock To: **9**
1st Value:
2nd Value:
Value Percent: **40.000**
Continuous Index: **S01**
Within 8" of Joint: **NO**
Remarks:

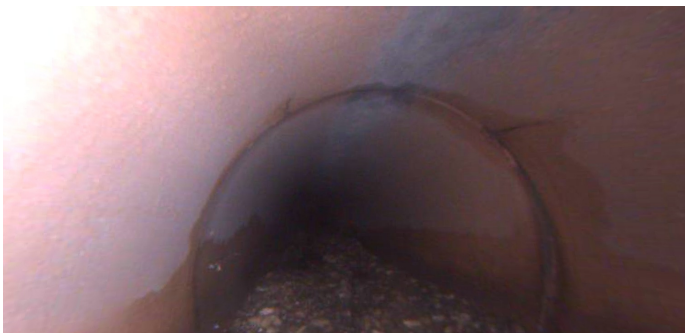
Code: **FM**
Description: **Fracture Multiple**

Distance (ft): **18.3**
Structural Grade: **4**
O&M Grade: **0**
Clock Start/From: **10**
Clock To: **2**
1st Value:
2nd Value:
Value Percent:
Continuous Index:
Within 8" of Joint: **YES**
Remarks:

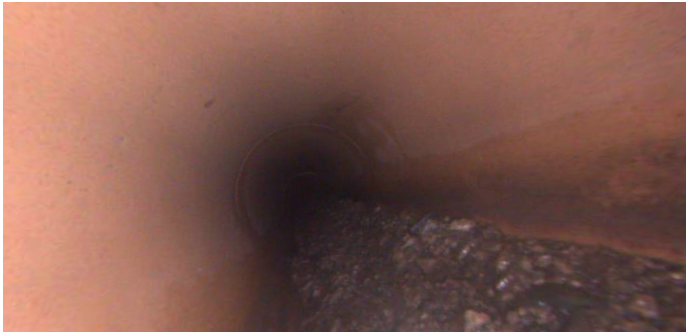
Code: **DSGV**
Description: **Deposits Settled Gravel**

Distance (ft): **25.0**
Structural Grade: **0**
O&M Grade: **5**
Clock Start/From: **3**
Clock To: **9**
1st Value:
2nd Value:
Value Percent: **40.000**
Continuous Index: **F01**
Within 8" of Joint: **NO**
Remarks:

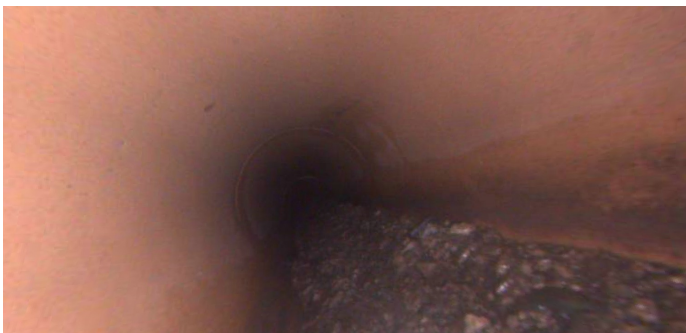
Code: **MSA**
Description: **Abandoned Survey**

Distance (ft): **25.0**
Structural Grade: **0**
O&M Grade: **0**
Clock Start/From:
Clock To:
1st Value:
2nd Value:
Value Percent:
Continuous Index:
Within 8" of Joint: **NO**
Remarks: **overturned**
