## **Profile/Photo Observation Report**

Date: 04/26/2018 Weather: **PACP 6.0** Coding: Pipe Length (ft): Owner: **City of Hobart** Pre Clean: No Pre-Cleaning P.O.#: M. Pielacha PSR: P-705-081-080 107 Surveyor: Customer: **City of Hobart** Clean Date: Shape: **West 3rd Street** Flow Control: **Not Controlled** Street: City: Hobart, IN Year Renewed: Tape/Media #: **DEP 107** Location: **Light Highway** Purpose: **Routine Assessment** Dia/Height: 6" Use: Sanitary Material: **PVC** Drain Area: Lining: Category: NA YES501824 Submital 2 Comment: **Location Details:** Direction of Survey: **Downstream** US MH: M-705-080 DS MH: M-705-081 Total Length Surveyed (ft): 47.1 0.00 0000 0.00 O&M Index: O&M Quick: O&M Rating: 0.00 0000 0.00 Structural Quick: Structural Rating: Structural Index:

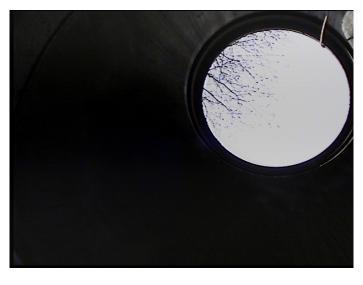
Cod	de:	AMH
Des	scription:	Manhole
Dis	tance (ft):	.0
Str	uctural Grade:	0
0&	M Grade:	0
Clo	ck Start/From:	
Clo	ck To:	
1st	Value:	
2nd	d Value:	
Val	ue Percent:	
Cor	ntinuous Index:	
Wit	thin 8" of Joint:	NO
Rer	marks:	M-705-080

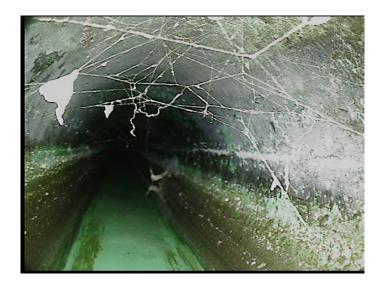
Code: MWL

Description: **Water Level**

Distance (ft): .0 Structural Grade: 0 O&M Grade: 0

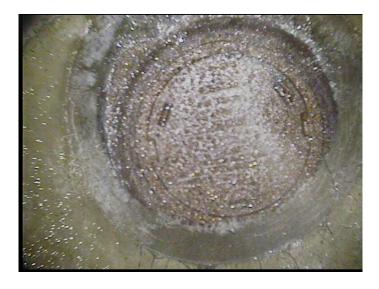
Code: AMH Description: Manhole

Distance (ft): 47.1 Structural Grade: 0 O&M Grade: 0 Clock Start/From:

Remarks: M-705-081
