Profile/Photo Observation Report

Street:	NEW ST & E 4TH ST	Flow Control:	Not Controlled
City:	Hobart, IN	Year Renewed:	
Location:	Light Highway	Tape/Media #:	
Purpose:	Maintenance Related	Dia/Height:	8"
Use:	Sanitary	Material:	VCP
Drain Area:	NA	Lining:	Cured in Place
Category:	NA		
Comment:	mh

Location Details:		Direction of Survey:	Downstream
US MH:	M-705-085	DS MH:	M-705-049
		Total Length Surveyed (ft):	162.7

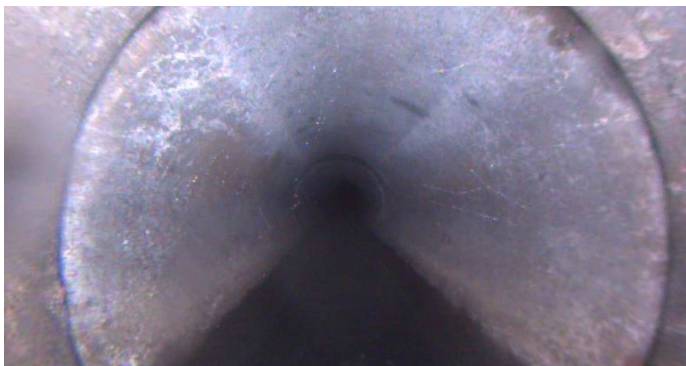
Code: **AMH**
Description: **Manhole**

Distance (ft): **.0**
Structural Grade: **0**
O&M Grade: **0**
Clock Start/From:
Clock To:
1st Value:
2nd Value:
Value Percent:
Continuous Index:
Within 8" of Joint: **NO**
Remarks: **M-705-085**

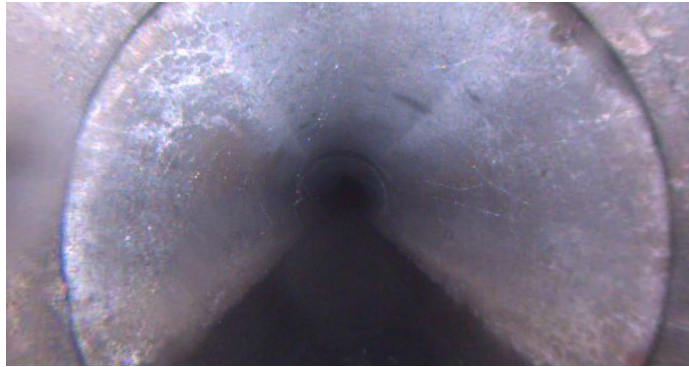
Code: **MWL**
Description: **Water Level**

Distance (ft): **.0**
Structural Grade: **0**
O&M Grade: **0**
Clock Start/From:
Clock To:
1st Value:
2nd Value:
Value Percent: **10.000**
Continuous Index:
Within 8" of Joint: **NO**
Remarks:

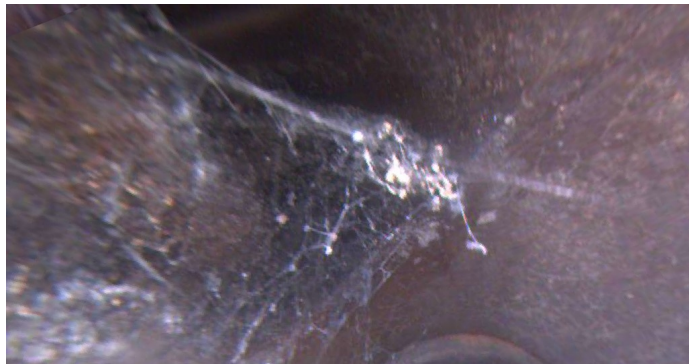
Code: **TFD**
Description: **Tap Factory Defective**

Distance (ft): **18.8**
Structural Grade: **0**
O&M Grade: **2**
Clock Start/From: **10**
Clock To:
1st Value: **4.000**
2nd Value:
Value Percent:
Continuous Index:
Within 8" of Joint:
Remarks: **Debris**

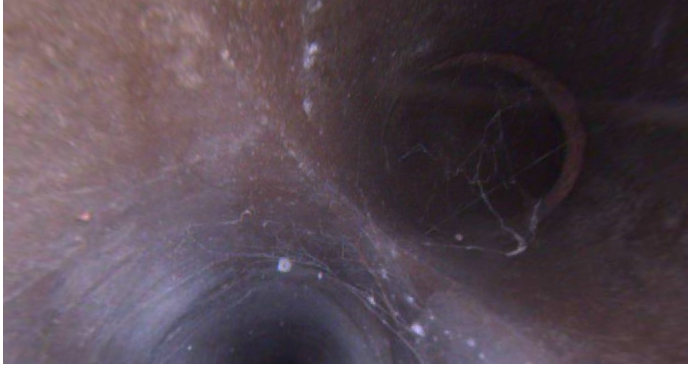
Code: **TF**
Description: **Tap Factory**

Distance (ft): **20.8**
Structural Grade: **0**
O&M Grade: **0**
Clock Start/From: **2**
Clock To:
1st Value: **4.000**
2nd Value:
Value Percent:
Continuous Index:
Within 8" of Joint:
Remarks:

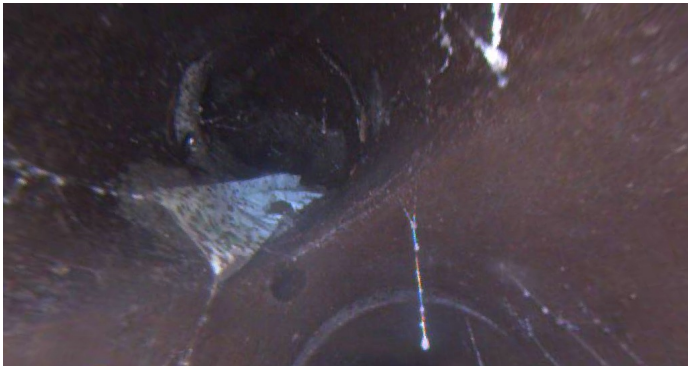
Code: **TF**
Description: **Tap Factory**

Distance (ft): **47.7**
Structural Grade: **0**
O&M Grade: **0**
Clock Start/From: **10**
Clock To:
1st Value: **4.000**
2nd Value:
Value Percent:
Continuous Index:
Within 8" of Joint:
Remarks:

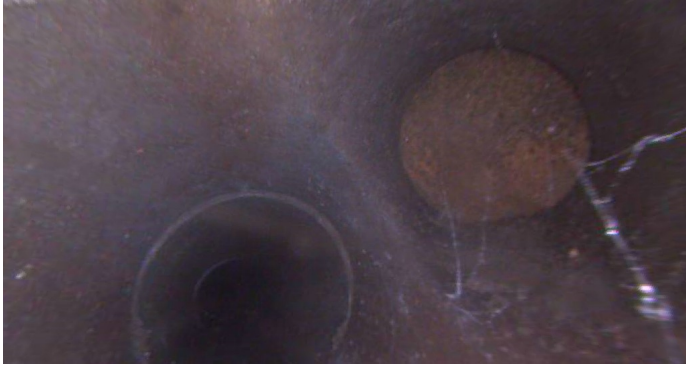
Code: **TFC**
Description: **Tap Factory Capped**

Distance (ft): **49.6**
Structural Grade: **0**
O&M Grade: **0**
Clock Start/From: **2**
Clock To:
1st Value: **4.000**
2nd Value:
Value Percent:
Continuous Index:
Within 8" of Joint:
Remarks:

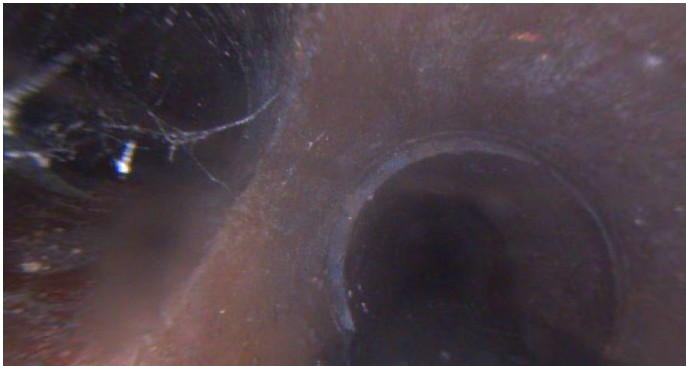
Code: **TF**
Description: **Tap Factory**

Distance (ft): **83.0**
Structural Grade: **0**
O&M Grade: **0**
Clock Start/From: **10**
Clock To:
1st Value: **4.000**
2nd Value:
Value Percent:
Continuous Index:
Within 8" of Joint:
Remarks:

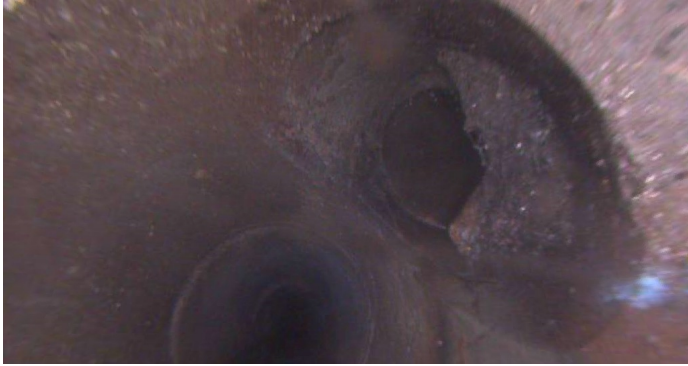
Code: **TF**
Description: **Tap Factory**

Distance (ft): **84.7**
Structural Grade: **0**
O&M Grade: **0**
Clock Start/From: **2**
Clock To:
1st Value: **4.000**
2nd Value:
Value Percent:
Continuous Index:
Within 8" of Joint:
Remarks:

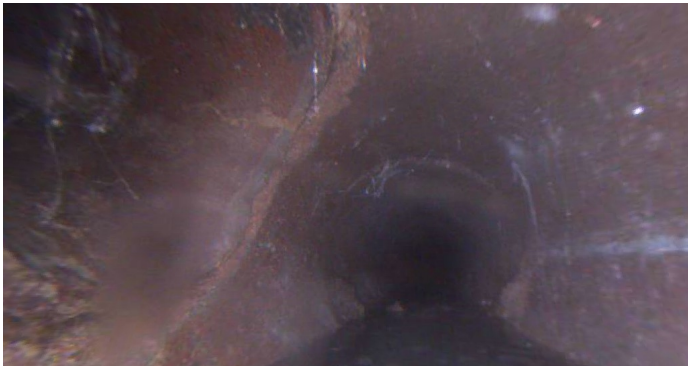
Code: **TF**
Description: **Tap Factory**

Distance (ft): **88.9**
Structural Grade: **0**
O&M Grade: **0**
Clock Start/From: **10**
Clock To:
1st Value: **4.000**
2nd Value:
Value Percent:
Continuous Index:
Within 8" of Joint:
Remarks:

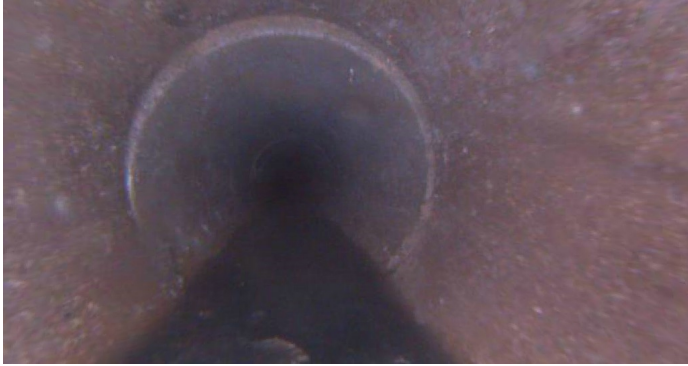
Code:	DAE
Description:	Deposits Attached Encrustation
Distance (ft):	93.5
Structural Grade:	0
O&M Grade:	2
Clock Start/From:	7
Clock To:	5
1st Value:	
2nd Value:	
Value Percent:	5.000
Continuous Index:	S01
Within 8" of Joint:	YES
Remarks:

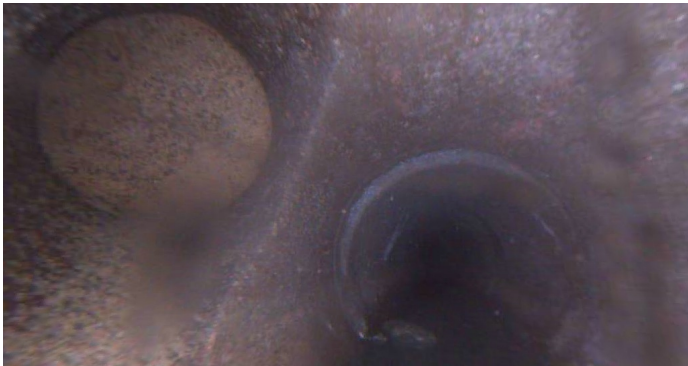
Code:	TFC
Description:	Tap Factory Capped
Distance (ft):	109.6
Structural Grade:	0
O&M Grade:	0
Clock Start/From:	10
Clock To:	
1st Value:	4.000
2nd Value:	
Value Percent:	
Continuous Index:	
Within 8" of Joint:	
Remarks:

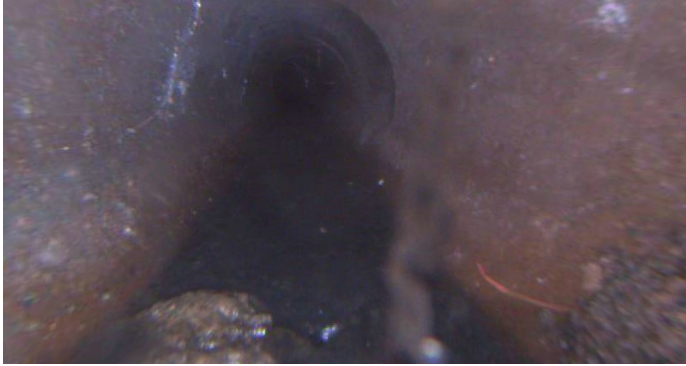
Code: **DAE**
Description: **Deposits Attached Encrustation**

Distance (ft): **110.4**
Structural Grade: **0**
O&M Grade: **2**
Clock Start/From: **7**
Clock To: **5**
1st Value:
2nd Value:
Value Percent: **5.000**
Continuous Index: **F01**
Within 8" of Joint: **YES**
Remarks:

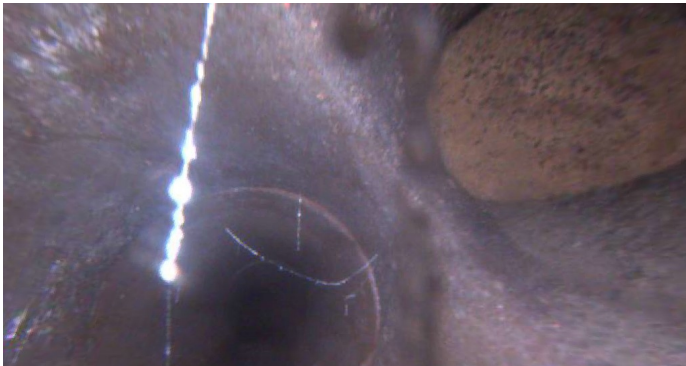
Code: **TFC**
Description: **Tap Factory Capped**

Distance (ft): **111.7**
Structural Grade: **0**
O&M Grade: **0**
Clock Start/From: **2**
Clock To:
1st Value: **4.000**
2nd Value:
Value Percent:
Continuous Index:
Within 8" of Joint:
Remarks:

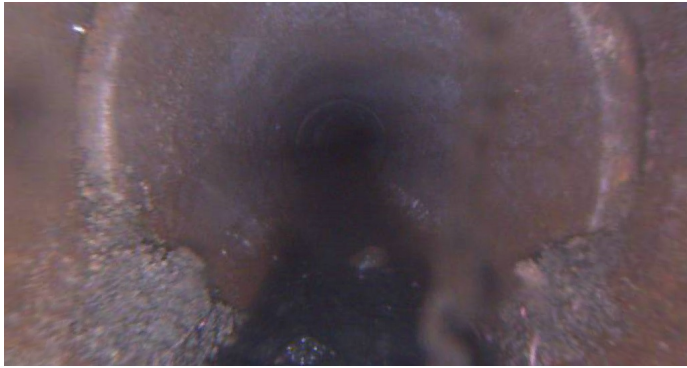
Code:	DAZ
Description:	Deposits Attached Other
Distance (ft):	118.6
Structural Grade:	0
O&M Grade:	2
Clock Start/From:	7
Clock To:	5
1st Value:	
2nd Value:	
Value Percent:	5.000
Continuous Index:	S02
Within 8" of Joint:	YES
Remarks:

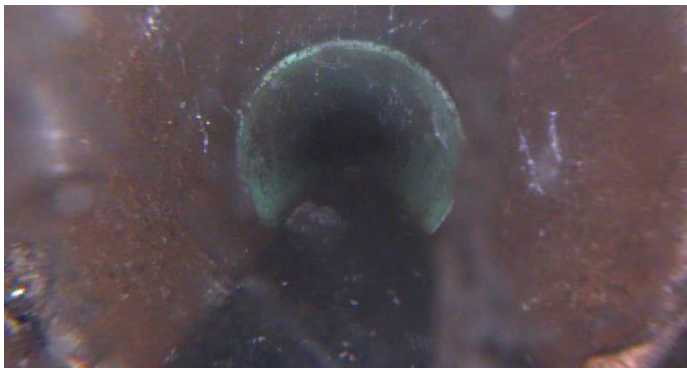
Code:	DAZ
Description:	Deposits Attached Other
Distance (ft):	158.7
Structural Grade:	0
O&M Grade:	2
Clock Start/From:	7
Clock To:	5
1st Value:	
2nd Value:	
Value Percent:	5.000
Continuous Index:	F02
Within 8" of Joint:	YES
Remarks:

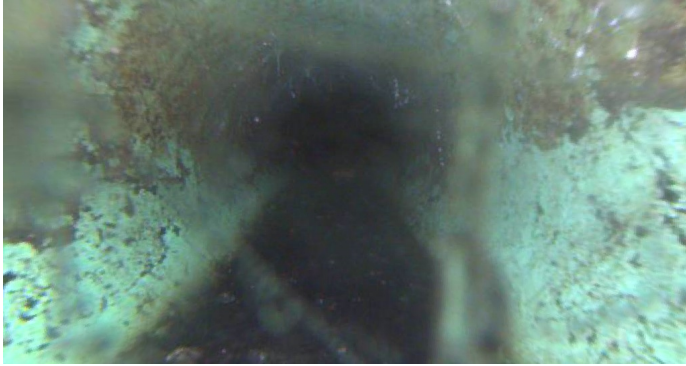
Code: **MMC**
Description: **Material Change**

Distance (ft): **159.8**
Structural Grade: **0**
O&M Grade: **0**
Clock Start/From:
Clock To:
1st Value:
2nd Value:
Value Percent:
Continuous Index:
Within 8" of Joint: **NO**
Remarks: **PVC**

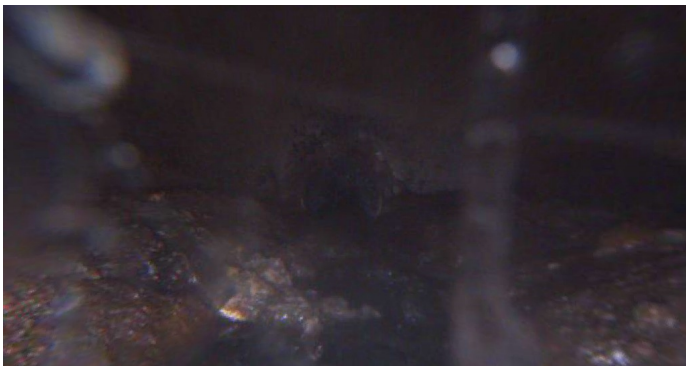
Code: **AMH**
Description: **Manhole**

Distance (ft): **162.7**
Structural Grade: **0**
O&M Grade: **0**
Clock Start/From:
Clock To:
1st Value:
2nd Value:
Value Percent:
Continuous Index:
Within 8" of Joint: **NO**
Remarks: **M-705-049**
