## Profile/Photo Observation Report

Date:	<b>05/03/2018</b>	Weather:		Coding:	<b>PACP 6.0</b>
Pipe Length (ft):		Owner:	<b>City of Hobart</b>	Pre Clean:	<b>No Pre-Cleaning</b>
P.O.#:	<b>174</b>	Surveyor:	<b>M. Pielacha</b>	PSR:	<b>P-705-086-087</b>
Customer:	<b>City of Hobart</b>	Clean Date:		Shape:	<b>C</b>

Street:	<b>E. #rd Street</b>	Flow Control:	<b>Not Controlled</b>
City:	<b>Hobart, IN</b>	Year Renewed:	
Location:	<b>Light Highway</b>	Tape/Media #:	<b>DEP 174</b>
Purpose:	<b>Routine Assessment</b>	Dia/Height:	<b>6"</b>
Use:	<b>Sanitary</b>	Material:	<b>VCP</b>
Drain Area:		Lining:	
Category:	<b>NA</b>		
Comment:	<b>5-21-2018</b>		
Location Details:		Direction of Survey:	<b>Downstream</b>
US MH:	<b>M-705-087</b>	DS MH:	<b>M-705-086</b>
		Total Length Surveyed (ft):	<b>.1</b>

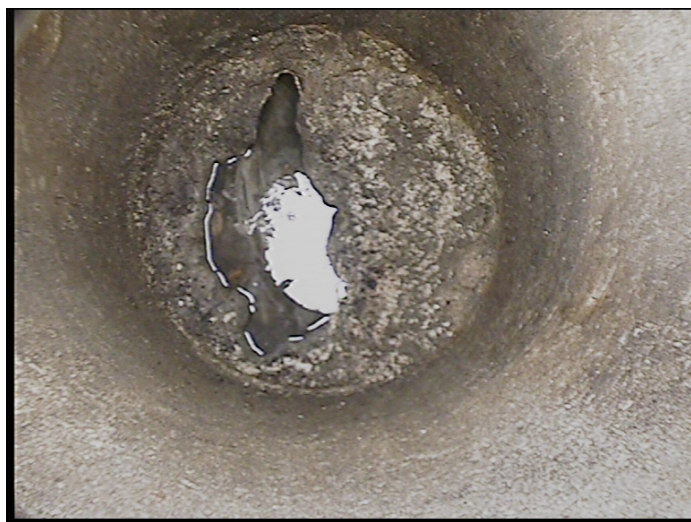
Code: **AMH**  
Description: **Manhole**

Distance (ft): **.0**  
Structural Grade: **0**  
O&M Grade: **0**  
Clock Start/From:  
Clock To:  
1st Value:  
2nd Value:  
Value Percent:  
Continuous Index:  
Within 8" of Joint: **NO**  
Remarks: **M-705-086**

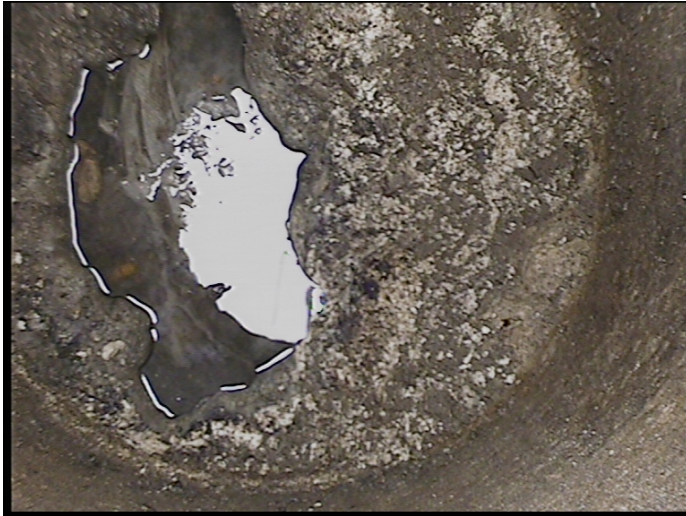
Code: **MWL**  
Description: **Water Level**

Distance (ft): **.0**  
Structural Grade: **0**  
O&M Grade: **0**  
Clock Start/From:  
Clock To:  
1st Value:  
2nd Value:  
Value Percent: **20.000**  
Continuous Index:  
Within 8" of Joint: **NO**  
Remarks:

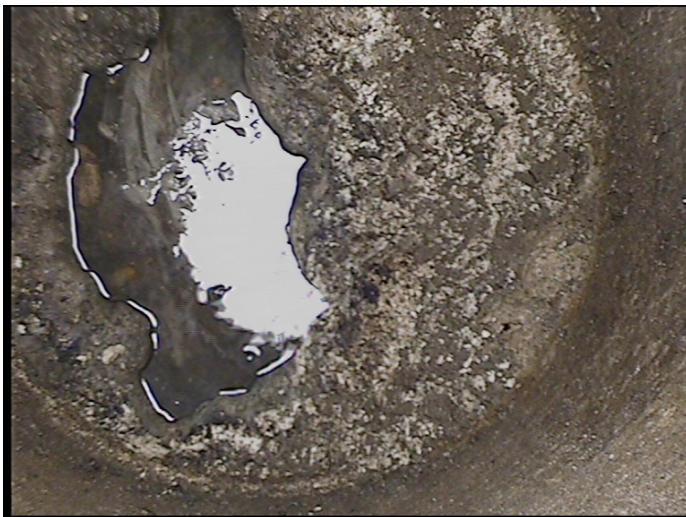
Code: **MSA**  
Description: **Abandoned Survey**

Distance (ft): **.0**  
Structural Grade: **0**  
O&M Grade: **0**  
Clock Start/From:  
Clock To:  
1st Value:  
2nd Value:  
Value Percent:  
Continuous Index:  
Within 8" of Joint: **NO**  
Remarks: **pipe is blocked**
