Profile/Photo Observation Report

Date:	05/03/2018	Weather:		Coding:	PACP 6.0
Pipe Length (ft):		Owner:	City of Hobart	Pre Clean:	No Pre-Cleaning
P.O.#:	175	Surveyor:	M. Pielacha	PSR:	P-705-086-087
Customer:	City of Hobart	Clean Date:		Shape:	C

Street:	3rd Street	Flow Control:	Not Controlled
City:	Hobart, IN	Year Renewed:	
Location:	Light Highway	Tape/Media #:	DEP 175
Purpose:	Routine Assessment	Dia/Height:	6"
Use:	Sanitary	Material:	VCP
Drain Area:		Lining:	
Category:	NA		
Comment:	5-21-2018		
Location Details:		Direction of Survey:	Upstream
US MH:	M-705-086	DS MH:	M-705-087
		Total Length Surveyed (ft):	14.2

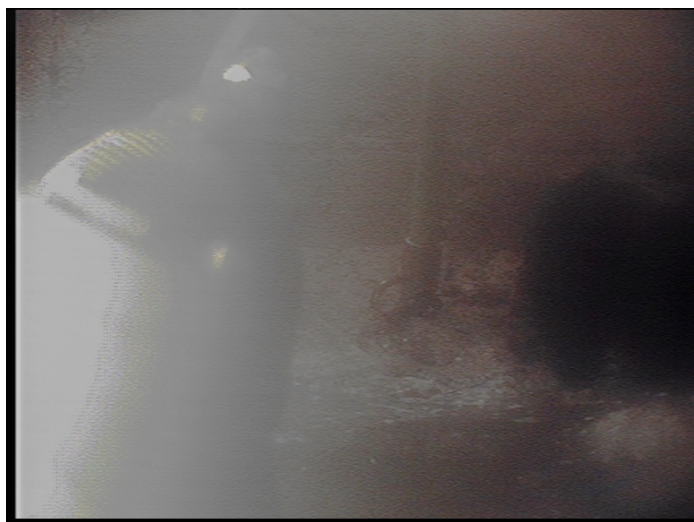
Code: **AMH**
 Description: **Manhole**

Distance (ft): **.0**
 Structural Grade: **0**
 O&M Grade: **0**
 Clock Start/From:
 Clock To:
 1st Value:
 2nd Value:
 Value Percent:
 Continuous Index:
 Within 8" of Joint: **NO**
 Remarks: **M-705-087**

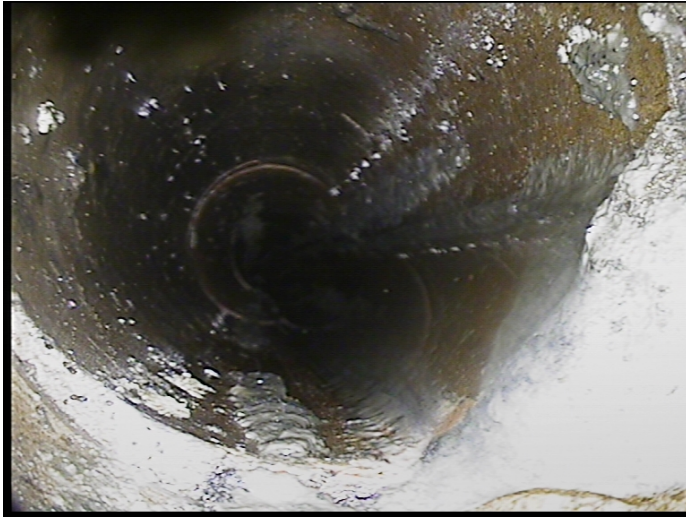
Code: **MWL**
Description: **Water Level**

Distance (ft): **.0**
Structural Grade: **0**
O&M Grade: **0**
Clock Start/From:
Clock To:
1st Value:
2nd Value:
Value Percent: **10.000**
Continuous Index:
Within 8" of Joint: **NO**
Remarks:

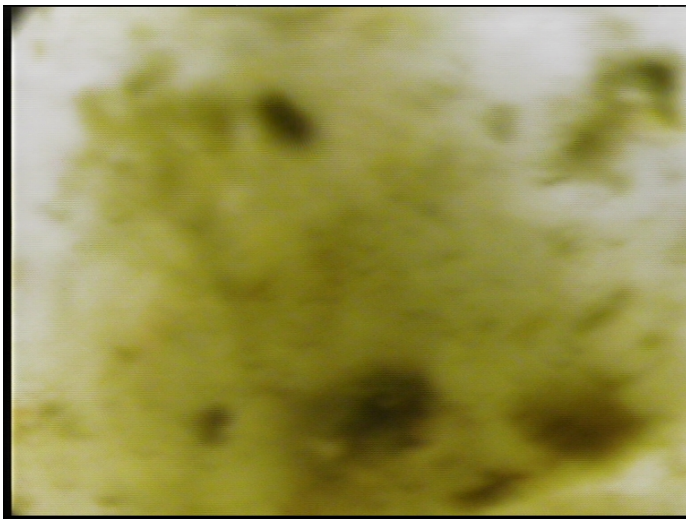
Code: **MCU**
Description: **Camera Underwater**

Distance (ft): **11.7**
Structural Grade: **0**
O&M Grade: **4**
Clock Start/From:
Clock To:
1st Value:
2nd Value:
Value Percent:
Continuous Index:
Within 8" of Joint: **NO**
Remarks:
