Profile/Photo Observation Report

Date:	02/26/2022	Weather:		Coding:	PACP 7.0
Pipe Length (ft):	304.3	Owner:	City of Hobart	Pre Clean:	Heavy Cleaning
P.O.#:	YES502259	Surveyor:	S. Bucklin	PSR:	P-706-007.1-007
Customer:	City of Hobart, IN (Red	Clean Date:	02/22/2022	Shape:	C

Street:	South Linda Street	Flow Control:	Not Controlled
City:	Hobart, IN	Year Renewed:	
Location:	Local rural streets with light traffic, t	Tape/Media #:	
Purpose:	Routine Assessment	Dia/Height:	12"
Use:	Sanitary Sewage Pipe	Material:	VCP
Drain Area:		Lining:	None
Category:	NA		
Comment:			
Location Details:		Direction of Survey:	Downstream
US MH:	M-706-007	DS MH:	M-706-007.1
		Total Length Surveyed (ft):	299.8

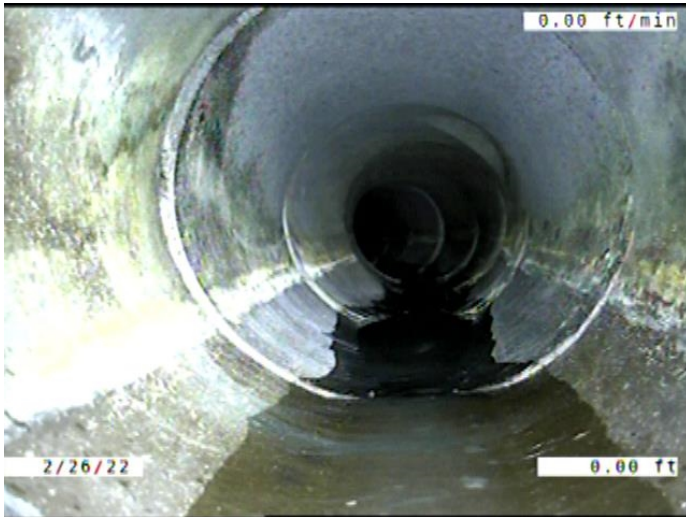
Code: **MWL**
 Description: **Miscellaneous Water Level**

Distance (ft): **.0**
 Structural Grade: **0**
 O&M Grade: **0**
 Clock Start/From:
 Clock To:
 1st Value:
 2nd Value:
 Value Percent: **5.000**
 Continuous Index:
 Within 8" of Joint: **NO**
 Remarks:

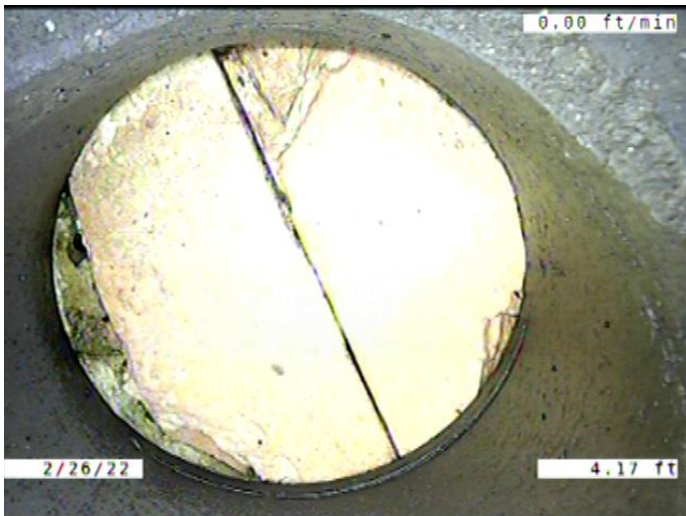
Code: **TFD**
 Description: **Tap Factory Defective**

Distance (ft): **4.2**
 Structural Grade: **0**
 O&M Grade: **3**
 Clock Start/From: **1**
 Clock To:
 1st Value: **6.000**
 2nd Value:
 Value Percent:
 Continuous Index:
 Within 8" of Joint: **YES**
 Remarks: **CAP BROKEN. SOIL VISIBLE**

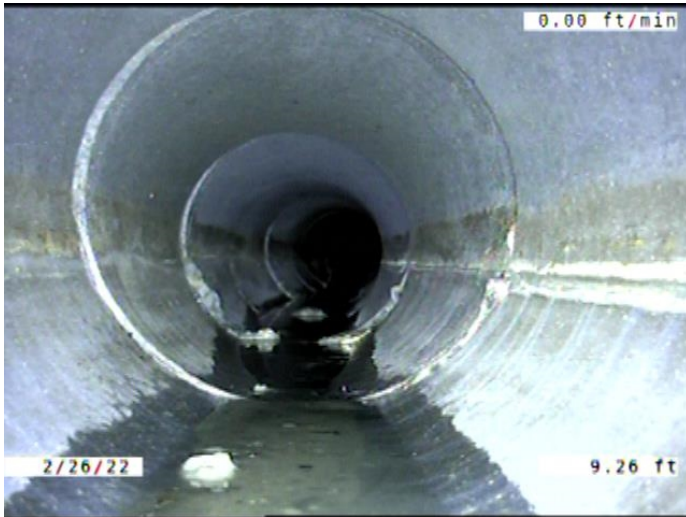
Code: **DSF**
 Description: **Deposits Settled Fine**

Distance (ft): **9.3**
 Structural Grade: **0**
 O&M Grade: **2**
 Clock Start/From: **5**
 Clock To: **7**
 1st Value:
 2nd Value:
 Value Percent: **5.000**
 Continuous Index: **S01**
 Within 8" of Joint: **YES**
 Remarks:

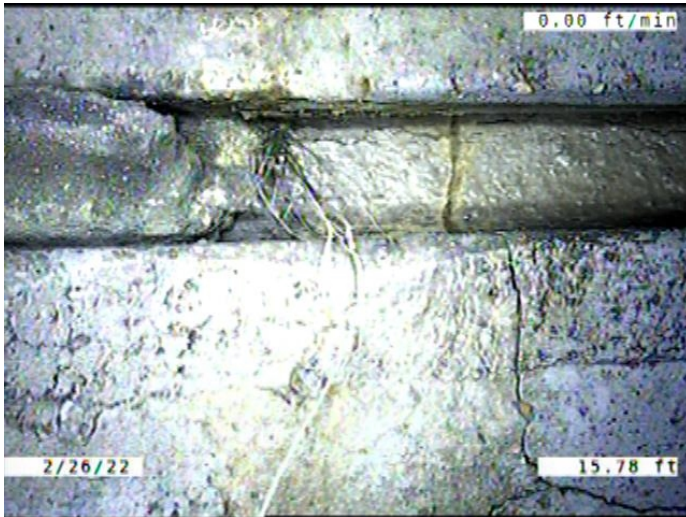
Code: **RFJ**
 Description: **Roots Fine Joint**

Distance (ft): **15.8**
 Structural Grade: **0**
 O&M Grade: **1**
 Clock Start/From: **9**
 Clock To: **3**
 1st Value:
 2nd Value:
 Value Percent:
 Continuous Index: **S02**
 Within 8" of Joint: **YES**
 Remarks:

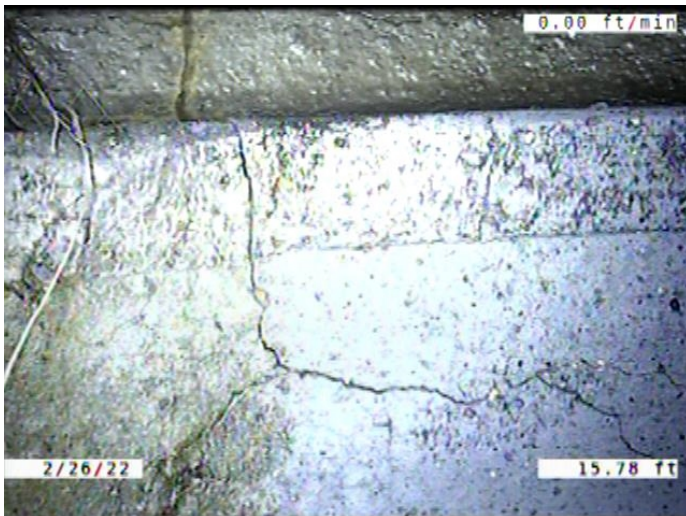
Code: **CM**
 Description: **Crack Multiple**

Distance (ft): **15.8**
 Structural Grade: **3**
 O&M Grade: **0**
 Clock Start/From: **12**
 Clock To: **12**
 1st Value:
 2nd Value:
 Value Percent:
 Continuous Index: **S03**
 Within 8" of Joint: **YES**
 Remarks:

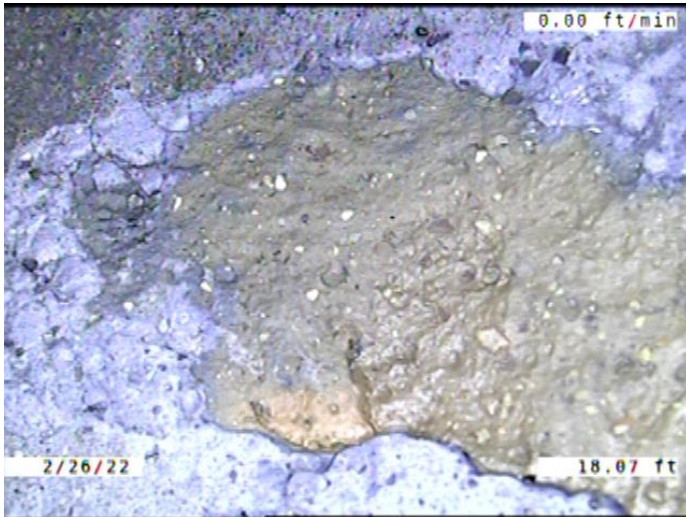
Code: **SSS**
Description: **Surface Damage Surface Spalling**

Distance (ft): **18.1**
Structural Grade: **2**
O&M Grade: **0**
Clock Start/From: **4**
Clock To: **8**
1st Value:
2nd Value:
Value Percent:
Continuous Index:
Within 8" of Joint: **NO**
Remarks:

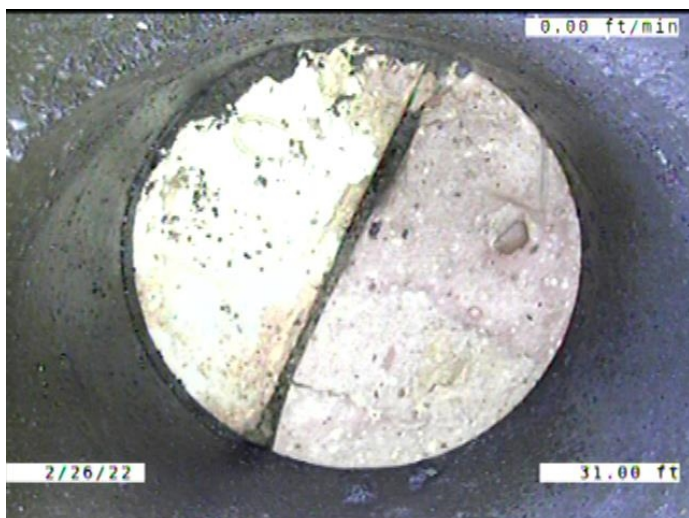
Code: **TFD**
 Description: **Tap Factory Defective**

Distance (ft): **31.0**
 Structural Grade: **0**
 O&M Grade: **3**
 Clock Start/From: **11**
 Clock To:
 1st Value: **6.000**
 2nd Value:
 Value Percent:
 Continuous Index:
 Within 8" of Joint: **YES**
 Remarks: **CAP BROKEN, SOIL VISIBLE**

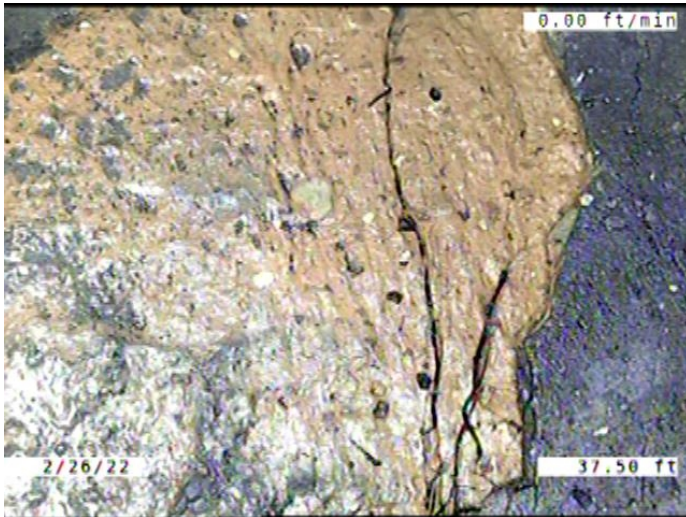
Code: **SSS**
 Description: **Surface Damage Surface Spalling**

Distance (ft): **37.5**
 Structural Grade: **2**
 O&M Grade: **0**
 Clock Start/From: **4**
 Clock To: **8**
 1st Value:
 2nd Value:
 Value Percent:
 Continuous Index:
 Within 8" of Joint: **YES**
 Remarks:

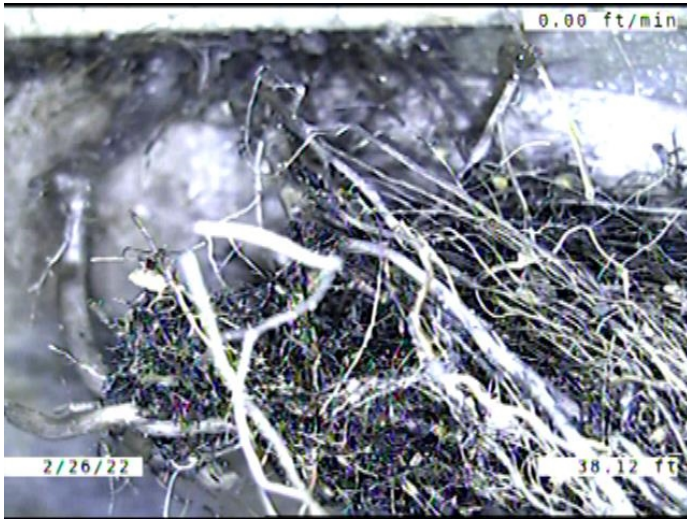
Code: **RMJ**
Description: **Roots Medium Joint**

Distance (ft): **38.1**
Structural Grade: **0**
O&M Grade: **3**
Clock Start/From: **3**
Clock To: **4**
1st Value:
2nd Value:
Value Percent: **5.000**
Continuous Index:
Within 8" of Joint: **YES**
Remarks:

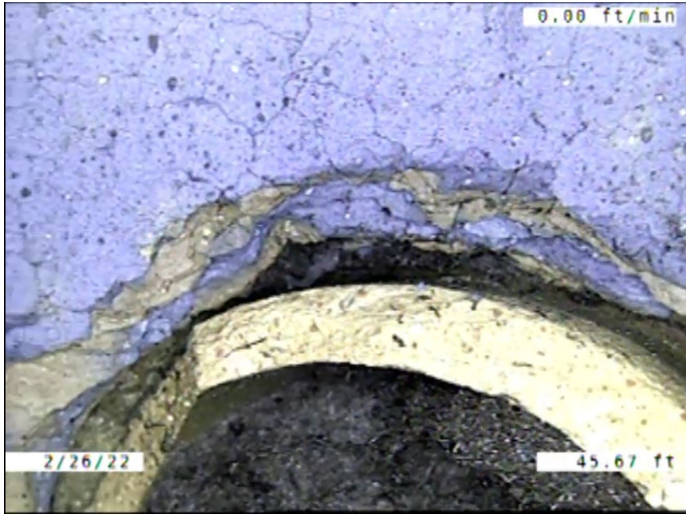
Code: **CM**
Description: **Crack Multiple**

Distance (ft): **45.7**
Structural Grade: **3**
O&M Grade: **0**
Clock Start/From: **12**
Clock To: **1**
1st Value:
2nd Value:
Value Percent:
Continuous Index:
Within 8" of Joint: **NO**
Remarks:

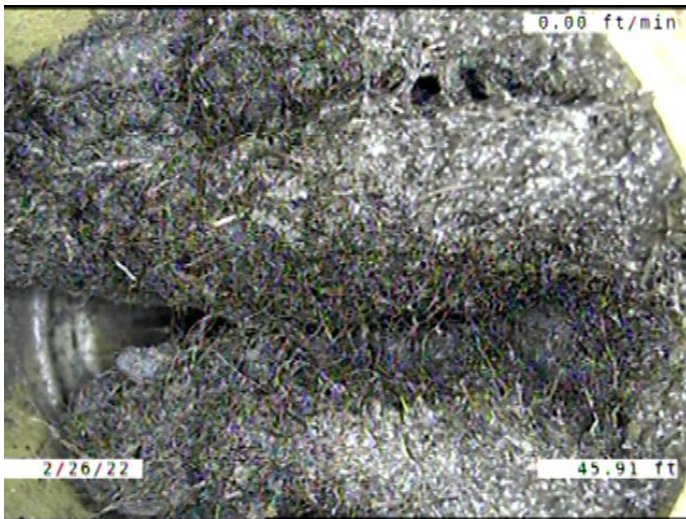
Code: **TBI**
Description: **Tap Break-in Intruding**

Distance (ft): **45.9**
Structural Grade: **0**
O&M Grade: **2**
Clock Start/From: **1**
Clock To:
1st Value: **6.000**
2nd Value: **1.000**
Value Percent:
Continuous Index:
Within 8" of Joint: **YES**
Remarks: **LOOKS TO BE 95% PLUGGED WITH ROOTS**

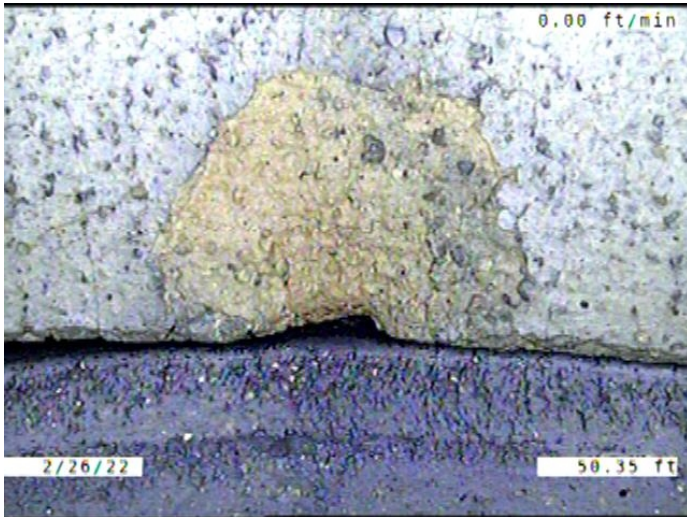
Code: **SZ**
 Description: **Surface Damage Other**

Distance (ft): **50.4**
 Structural Grade: **0**
 O&M Grade: **0**
 Clock Start/From: **1**
 Clock To:
 1st Value:
 2nd Value:
 Value Percent:
 Continuous Index:
 Within 8" of Joint: **YES**
 Remarks: **A PIECE CHIPPED AWAY FROM THE JOINT**

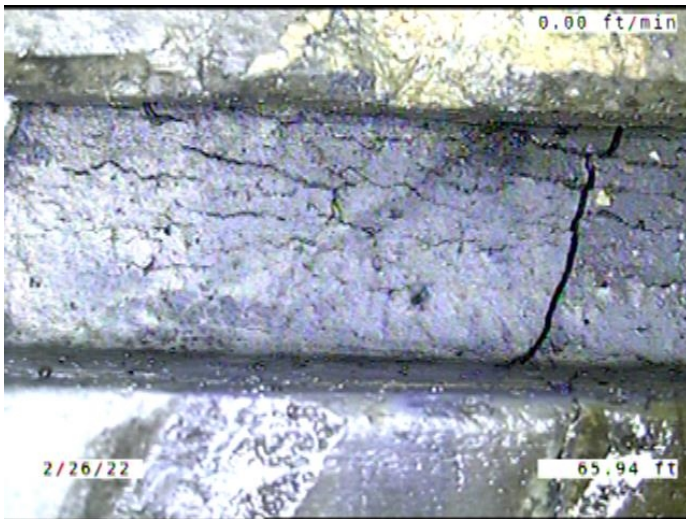
Code: **JAL**
Description: **Joint Angular Large**

Distance (ft): **65.9**
Structural Grade: **4**
O&M Grade: **0**
Clock Start/From:
Clock To:
1st Value:
2nd Value:
Value Percent:
Continuous Index:
Within 8" of Joint: **NO**
Remarks:

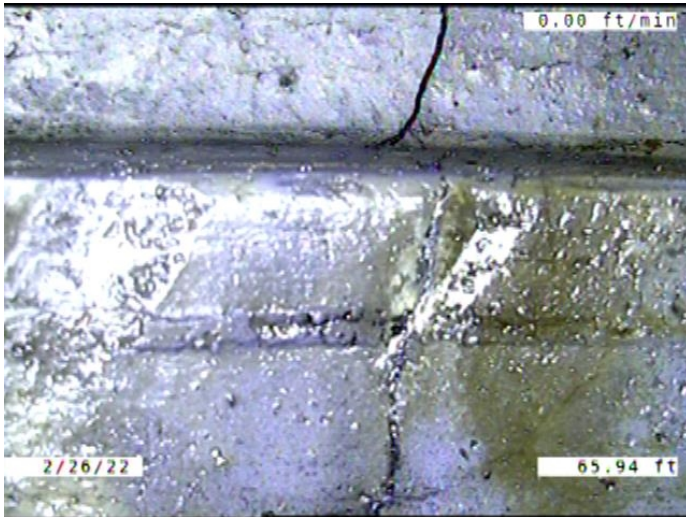
Code: **FM**
Description: **Fracture Multiple**

Distance (ft): **65.9**
Structural Grade: **4**
O&M Grade: **0**
Clock Start/From: **8**
Clock To: **11**
1st Value:
2nd Value:
Value Percent:
Continuous Index:
Within 8" of Joint: **YES**
Remarks:

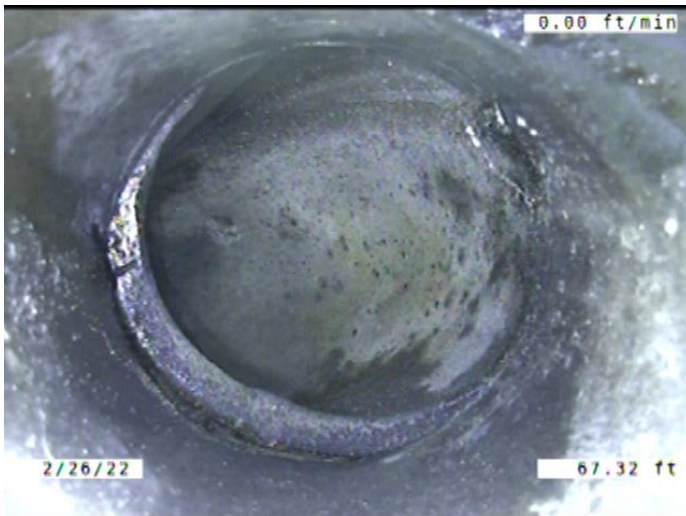
Code: **TF**
Description: **Tap Factory**

Distance (ft): **67.3**
Structural Grade: **0**
O&M Grade: **0**
Clock Start/From: **11**
Clock To:
1st Value: **6.000**
2nd Value:
Value Percent:
Continuous Index:
Within 8" of Joint: **YES**
Remarks: **SERVICE TO MAIN CONNECTION
OFFSET**

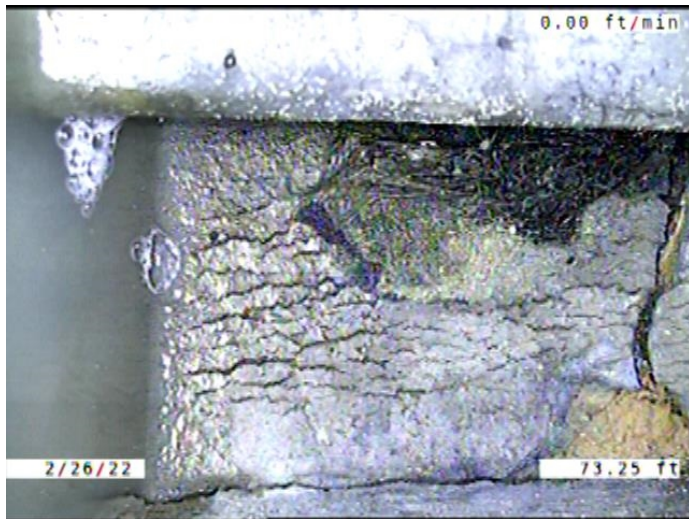
Code: **JAL**
 Description: **Joint Angular Large**

Distance (ft): **73.3**
 Structural Grade: **4**
 O&M Grade: **0**
 Clock Start/From:
 Clock To:
 1st Value:
 2nd Value:
 Value Percent:
 Continuous Index:
 Within 8" of Joint: **NO**
 Remarks:

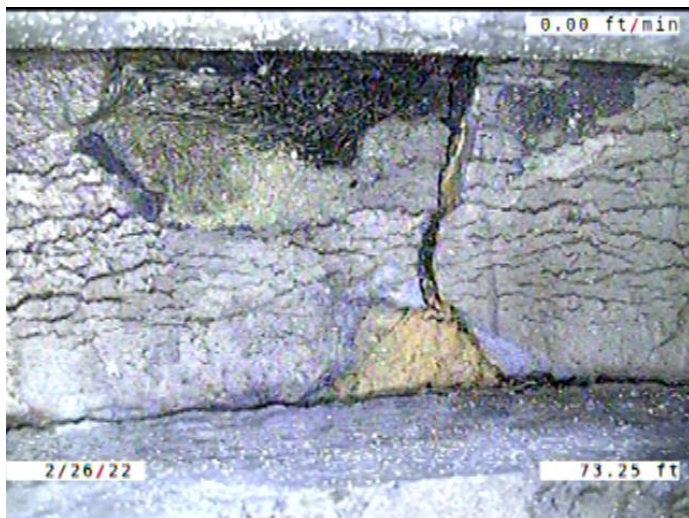
Code: **FM**
 Description: **Fracture Multiple**

Distance (ft): **73.3**
 Structural Grade: **4**
 O&M Grade: **0**
 Clock Start/From: **9**
 Clock To: **3**
 1st Value:
 2nd Value:
 Value Percent:
 Continuous Index:
 Within 8" of Joint: **YES**
 Remarks:

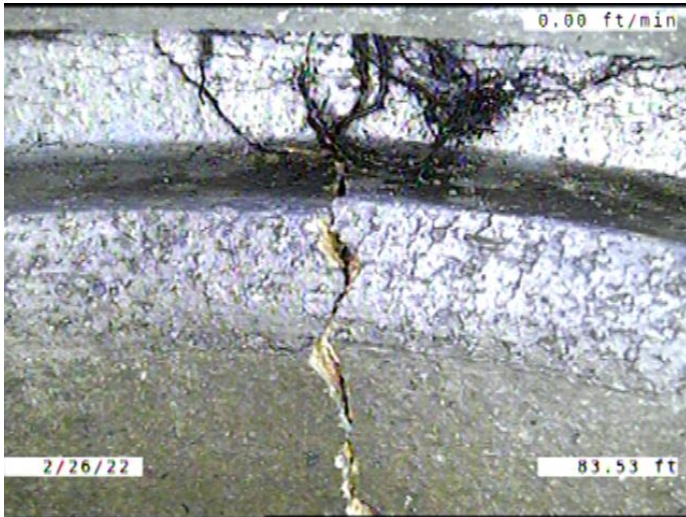
Code: **B**
Description: **Broken**

Distance (ft): **83.5**
Structural Grade: **4**
O&M Grade: **0**
Clock Start/From: **2**
Clock To: **5**
1st Value:
2nd Value:
Value Percent:
Continuous Index:
Within 8" of Joint: **YES**
Remarks:

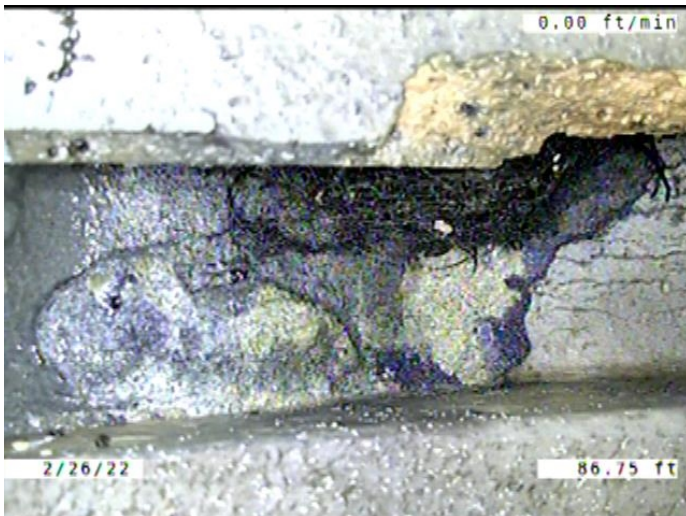
Code: **JAL**
Description: **Joint Angular Large**

Distance (ft): **86.8**
Structural Grade: **4**
O&M Grade: **0**
Clock Start/From:
Clock To:
1st Value:
2nd Value:
Value Percent:
Continuous Index:
Within 8" of Joint: **NO**
Remarks:

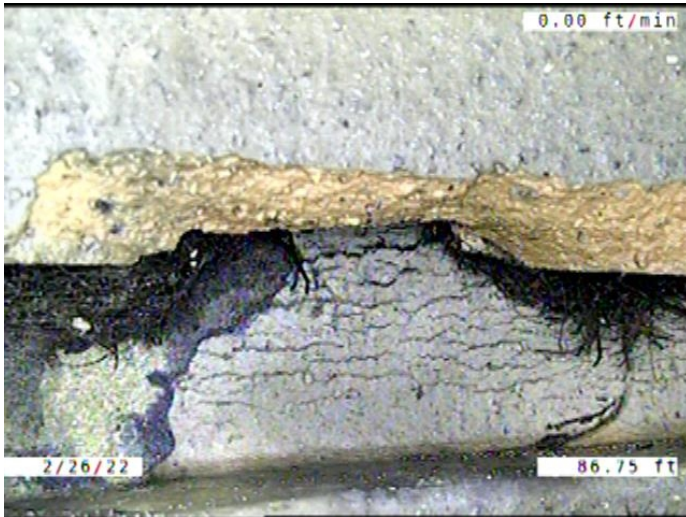
Code: **SZ**
Description: **Surface Damage Other**

Distance (ft): **86.8**
Structural Grade: **0**
O&M Grade: **0**
Clock Start/From: **10**
Clock To:
1st Value:
2nd Value:
Value Percent:
Continuous Index:
Within 8" of Joint: **YES**
Remarks: **A PIECE CHIPPED AWAY FROM THE JOINT**

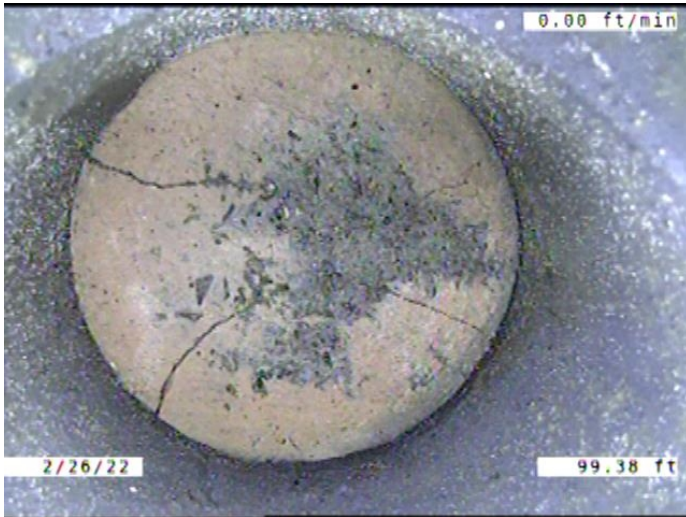
Code: **TFD**
 Description: **Tap Factory Defective**

Distance (ft): **99.4**
 Structural Grade: **0**
 O&M Grade: **3**
 Clock Start/From: **10**
 Clock To:
 1st Value: **6.000**
 2nd Value:
 Value Percent:
 Continuous Index:
 Within 8" of Joint: **YES**
 Remarks: **CAPPED, CAP CRACKED**

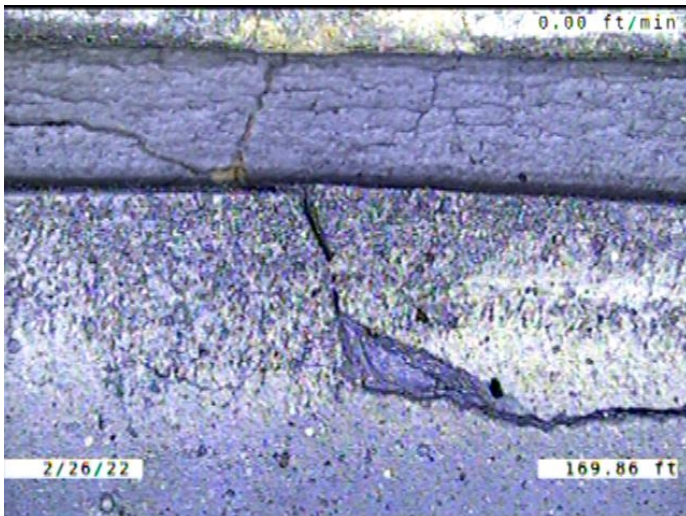
Code: **B**
 Description: **Broken**

Distance (ft): **169.9**
 Structural Grade: **4**
 O&M Grade: **0**
 Clock Start/From: **9**
 Clock To: **4**
 1st Value:
 2nd Value:
 Value Percent:
 Continuous Index:
 Within 8" of Joint: **YES**
 Remarks:

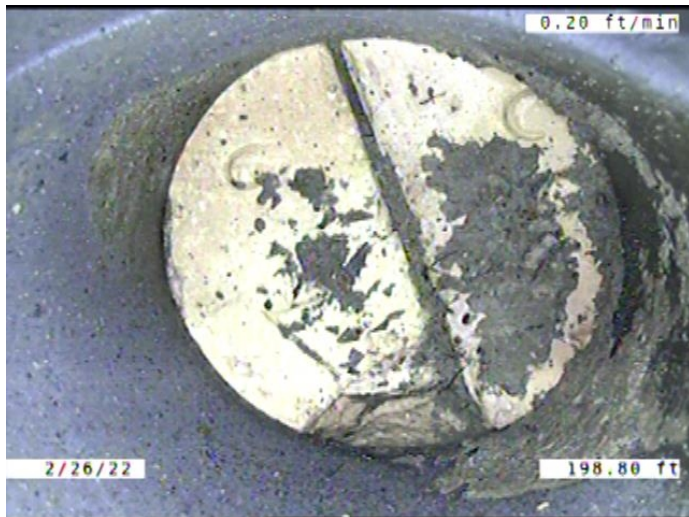
Code: **TFD**
 Description: **Tap Factory Defective**

Distance (ft): **198.8**
 Structural Grade: **0**
 O&M Grade: **3**
 Clock Start/From: **2**
 Clock To:
 1st Value: **6.000**
 2nd Value:
 Value Percent:
 Continuous Index:
 Within 8" of Joint: **YES**
 Remarks: **CAP BROKEN, SOIL VISIBLE**

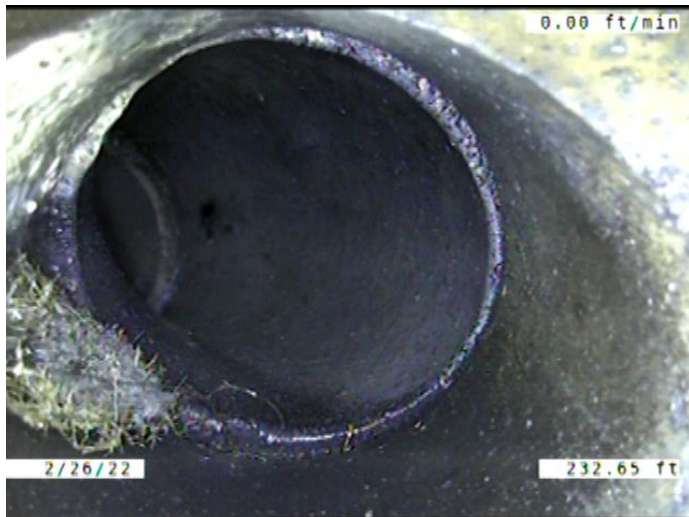
Code: **TFA**
 Description: **Tap Factory Activity**

Distance (ft): **232.7**
 Structural Grade: **0**
 O&M Grade: **0**
 Clock Start/From: **11**
 Clock To:
 1st Value: **6.000**
 2nd Value:
 Value Percent:
 Continuous Index:
 Within 8" of Joint: **YES**
 Remarks: **ROOTS GROWING FROM THE SERVICE TO MAIN CONNECTION .**

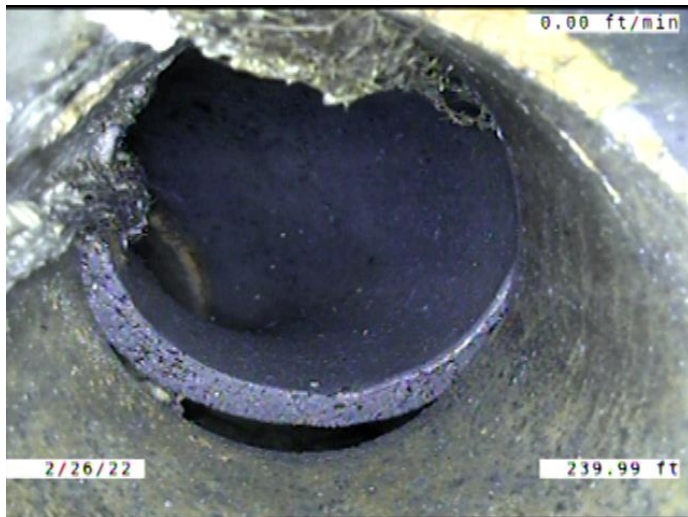
Code:	TF
Description:	Tap Factory
Distance (ft):	240.0
Structural Grade:	0
O&M Grade:	0
Clock Start/From:	11
Clock To:	
1st Value:	6.000
2nd Value:	
Value Percent:	
Continuous Index:	
Within 8" of Joint:	YES
Remarks:	ROOTS GROWING FROM THE SERVICE TO MAIN CONNECTION .SE

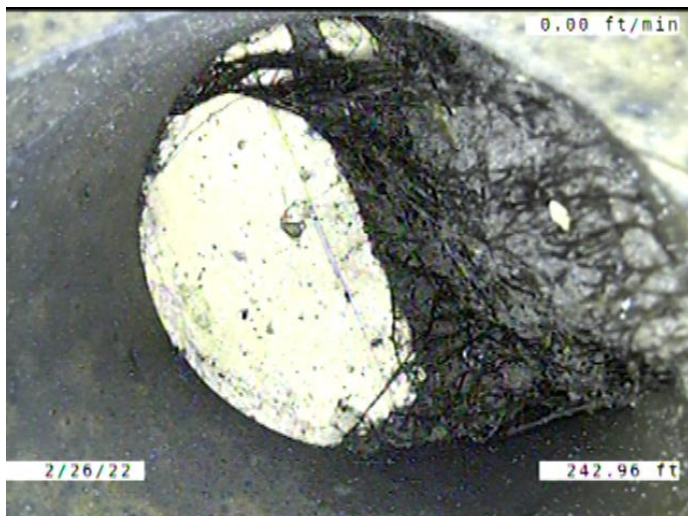
Code:	TFD
Description:	Tap Factory Defective
Distance (ft):	243.0
Structural Grade:	0
O&M Grade:	3
Clock Start/From:	2
Clock To:	
1st Value:	6.000
2nd Value:	
Value Percent:	
Continuous Index:	
Within 8" of Joint:	YES
Remarks:	CAP BROKEN. ROOTS GROWING THROUGH AND AROUND THE CAP

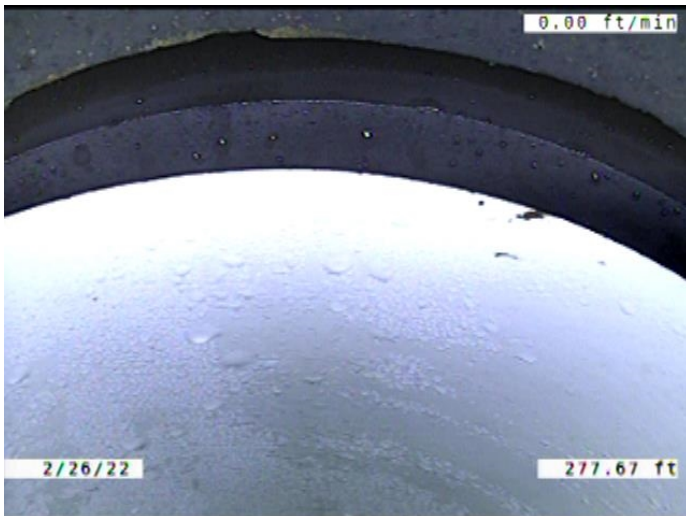
Code: **JOL**
 Description: **Joint Offset Large**

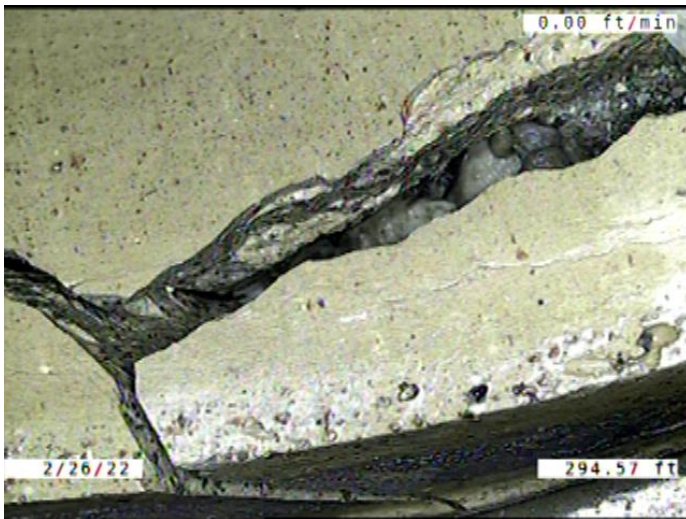
Code: **BSV**
 Description: **Broken Soil Visible**
