Profile/Photo Observation Report

Date:	02/26/2022	Weather:		Coding:	PACP 7.0
Pipe Length (ft):	336.0	Owner:	City of Hobart	Pre Clean:	Heavy Cleaning
P.O.#:	YES502259	Surveyor:	S. Bucklin	PSR:	P-706-007.2-007.1
Customer:	City of Hobart, IN (Red	Clean Date:	02/21/2022	Shape:	C

Street:	South Linda Street	Flow Control:	Not Controlled
City:	Hobart, IN	Year Renewed:	
Location:	Local rural streets with light traffic, t	Tape/Media #:	
Purpose:	Routine Assessment	Dia/Height:	10"
Use:	Sanitary Sewage Pipe	Material:	VCP
Drain Area:		Lining:	None
Category:	NA		
Comment:			
Location Details:		Direction of Survey:	Downstream
US MH:	M-706-007.1	DS MH:	M-706-007.2
		Total Length Surveyed (ft):	335.5

O&M Index:	1.59	O&M Quick:	2M11	O&M Rating:	200.00
Structural Index:	2.41	Structural Quick:	443B	Structural Rating:	152.00
Overall Index:	1.86	Overall Quick:	443B	Overall Rating:	352.00

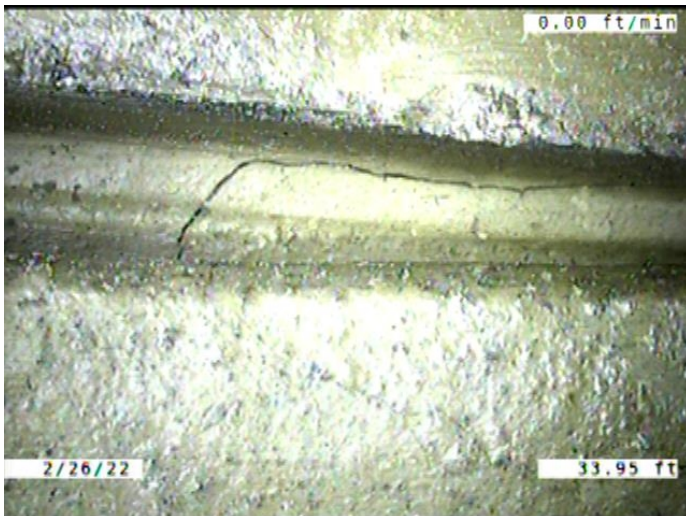
Code: **JAM**
 Description: **Joint Angular Medium**

Distance (ft): **33.9**
 Structural Grade: **3**
 O&M Grade: **0**
 Clock Start/From:
 Clock To:
 1st Value:
 2nd Value:
 Value Percent:
 Continuous Index:
 Within 8" of Joint: **NO**
 Remarks:

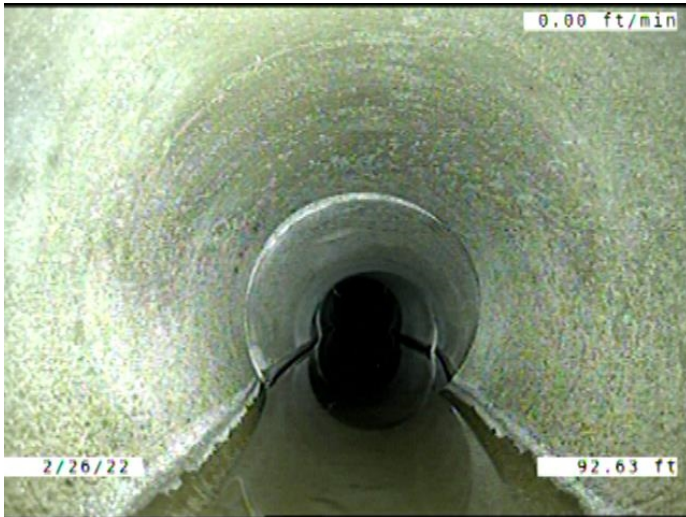
Code: **TFC**
 Description: **Tap Factory Capped**

Distance (ft): **88.0**
 Structural Grade: **0**
 O&M Grade: **0**
 Clock Start/From: **10**
 Clock To:
 1st Value: **6.000**
 2nd Value:
 Value Percent:
 Continuous Index:
 Within 8" of Joint: **YES**
 Remarks: **CAP LOOKS CRACKED**

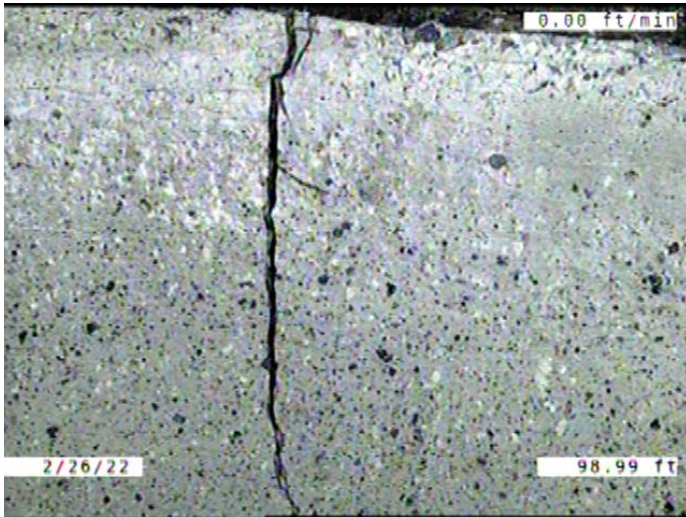
Code: **CL**
 Description: **Crack Longitudinal**

Distance (ft): **99.0**
 Structural Grade: **2**
 O&M Grade: **0**
 Clock Start/From: **9**
 Clock To:
 1st Value:
 2nd Value:
 Value Percent:
 Continuous Index:
 Within 8" of Joint: **YES**
 Remarks:

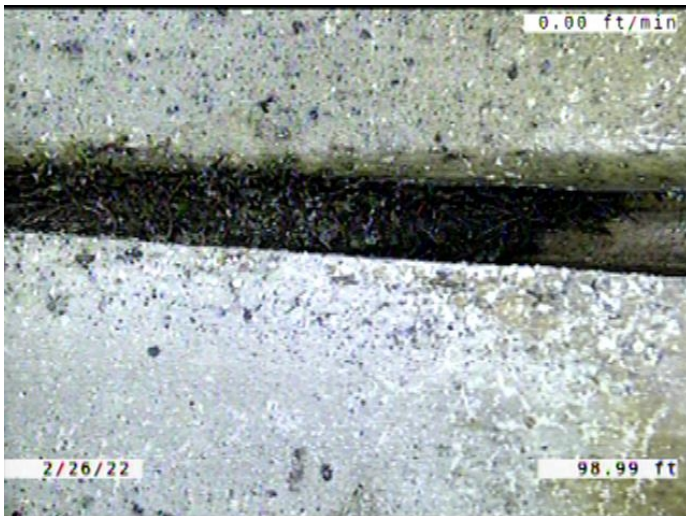
Code: **FS**
 Description: **Fracture Spiral**

Distance (ft): **99.0**
 Structural Grade: **3**
 O&M Grade: **0**
 Clock Start/From: **12**
 Clock To: **1**
 1st Value:
 2nd Value:
 Value Percent:
 Continuous Index:
 Within 8" of Joint: **YES**
 Remarks:

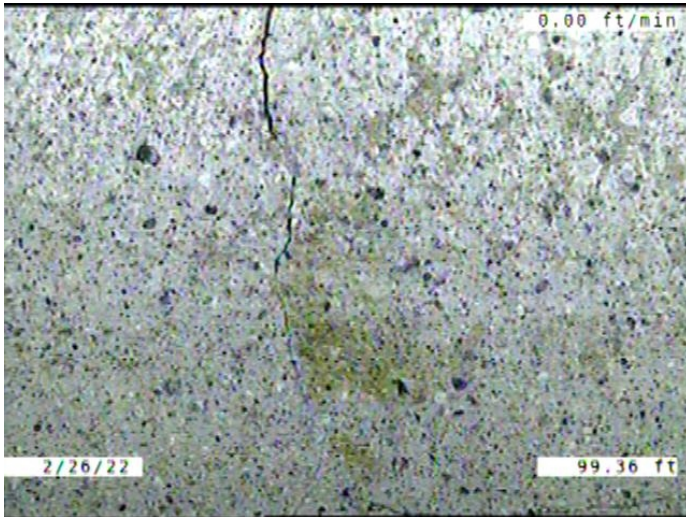
Code: **RFJ**
 Description: **Roots Fine Joint**

Distance (ft): **99.0**
 Structural Grade: **0**
 O&M Grade: **1**
 Clock Start/From: **9**
 Clock To: **3**
 1st Value:
 2nd Value:
 Value Percent:
 Continuous Index:
 Within 8" of Joint: **YES**
 Remarks:

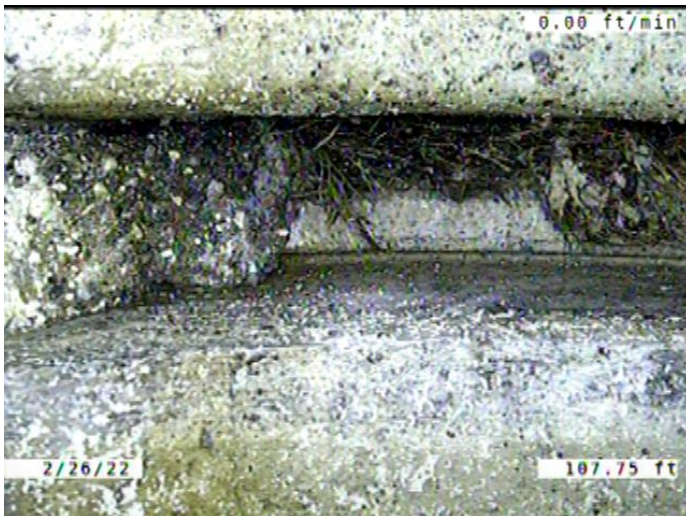
Code: **CL**
Description: **Crack Longitudinal**

Distance (ft): **101.9**
Structural Grade: **2**
O&M Grade: **0**
Clock Start/From: **10**
Clock To:
1st Value:
2nd Value:
Value Percent:
Continuous Index:
Within 8" of Joint: **YES**
Remarks:

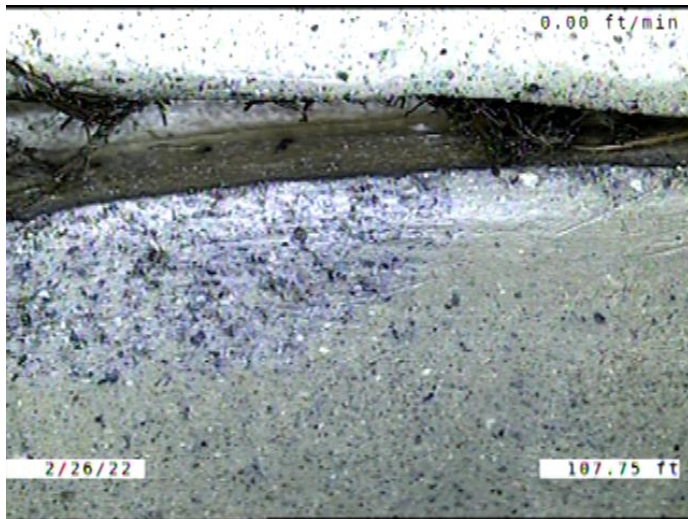
Code: **JAM**
Description: **Joint Angular Medium**

Distance (ft): **107.7**
Structural Grade: **3**
O&M Grade: **0**
Clock Start/From:
Clock To:
1st Value:
2nd Value:
Value Percent:
Continuous Index:
Within 8" of Joint: **NO**
Remarks:

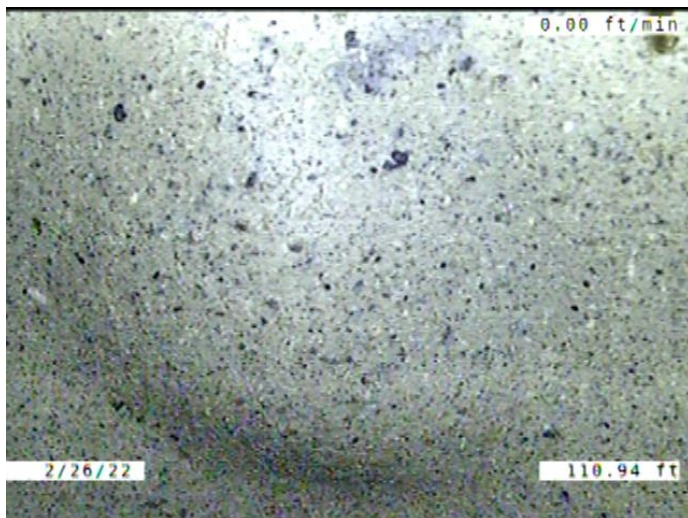
Code: **CM**
Description: **Crack Multiple**

Distance (ft): **110.9**
Structural Grade: **3**
O&M Grade: **0**
Clock Start/From: **10**
Clock To: **12**
1st Value:
2nd Value:
Value Percent:
Continuous Index:
Within 8" of Joint: **YES**
Remarks:

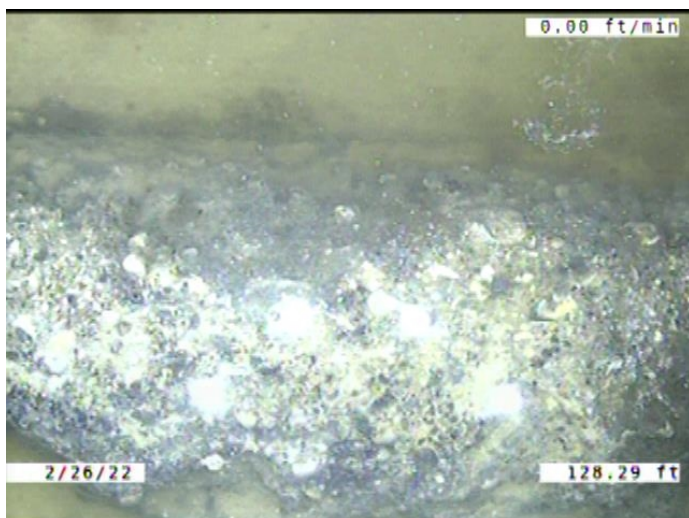
Code: **SSS**
 Description: **Surface Damage Surface Spalling**

Distance (ft): **127.2**
 Structural Grade: **2**
 O&M Grade: **0**
 Clock Start/From: **10**
 Clock To:
 1st Value:
 2nd Value:
 Value Percent:
 Continuous Index:
 Within 8" of Joint: **NO**
 Remarks:

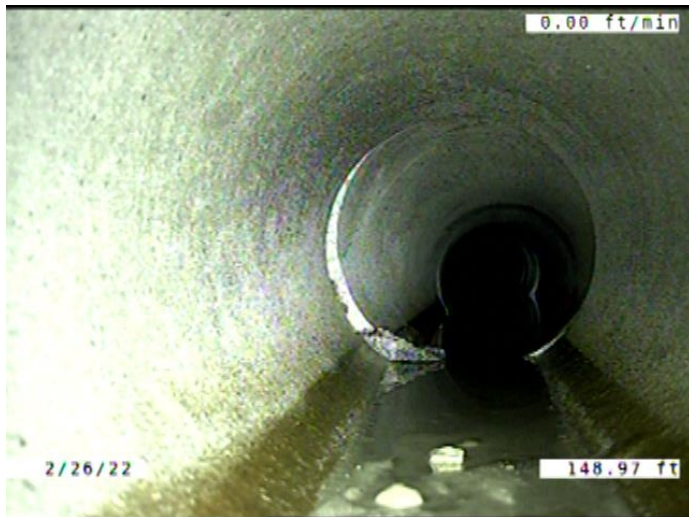
Code: **JAM**
Description: **Joint Angular Medium**

Distance (ft): **148.9**
Structural Grade: **3**
O&M Grade: **0**
Clock Start/From:
Clock To:
1st Value:
2nd Value:
Value Percent:
Continuous Index:
Within 8" of Joint: **NO**
Remarks:

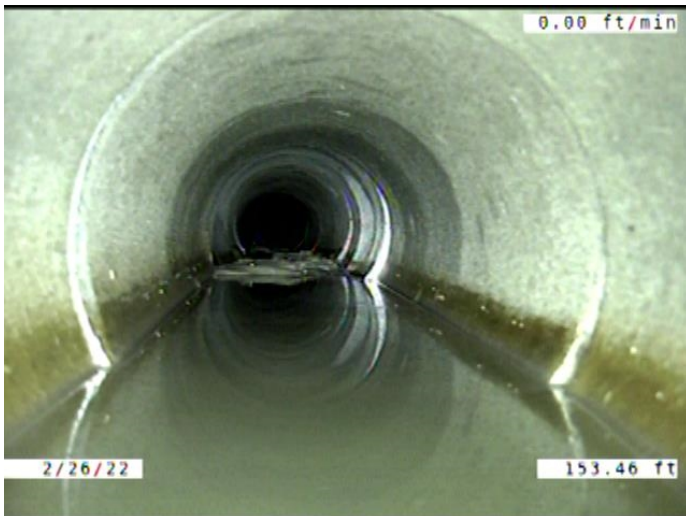
Code: **FS**
Description: **Fracture Spiral**

Distance (ft): **152.0**
Structural Grade: **3**
O&M Grade: **0**
Clock Start/From: **9**
Clock To: **12**
1st Value:
2nd Value:
Value Percent:
Continuous Index:
Within 8" of Joint: **YES**
Remarks:

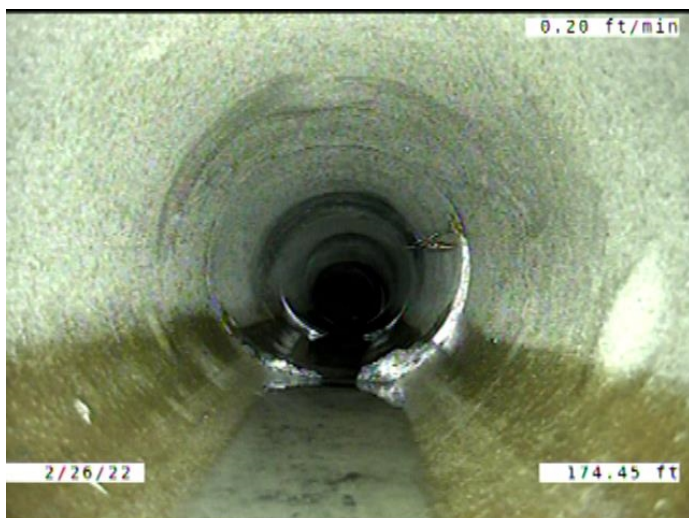
Code: **TF**
Description: **Tap Factory**

Distance (ft): **169.5**
Structural Grade: **0**
O&M Grade: **0**
Clock Start/From: **10**
Clock To:
1st Value: **6.000**

2nd Value:
Value Percent:
Continuous Index:
Within 8" of Joint: **YES**
Remarks: **ROOTS GROWING FROM THE TAP TO MAIN CONNECTION INTO THE MAIN**

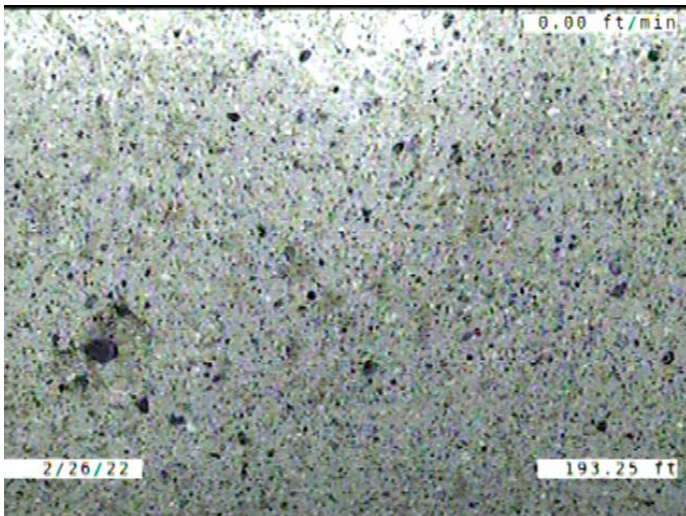
Code: **FS**
Description: **Fracture Spiral**

Distance (ft): **189.4**
Structural Grade: **3**
O&M Grade: **0**
Clock Start/From: **10**
Clock To: **11**
1st Value:
2nd Value:
Value Percent:
Continuous Index:
Within 8" of Joint: **YES**
Remarks:

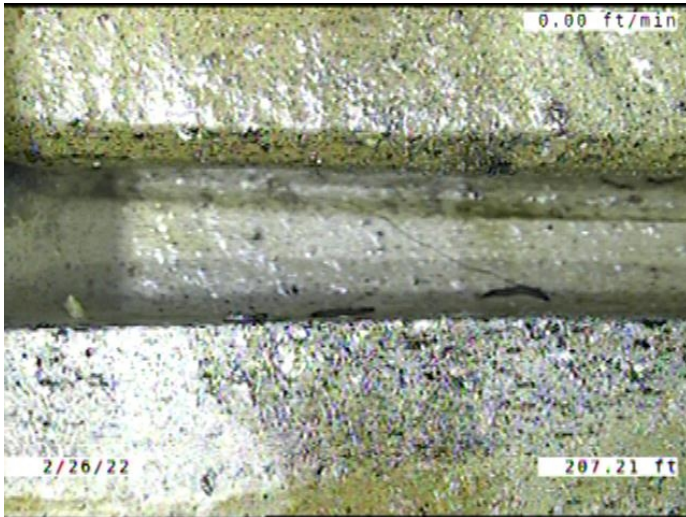
Code: **FM**
 Description: **Fracture Multiple**

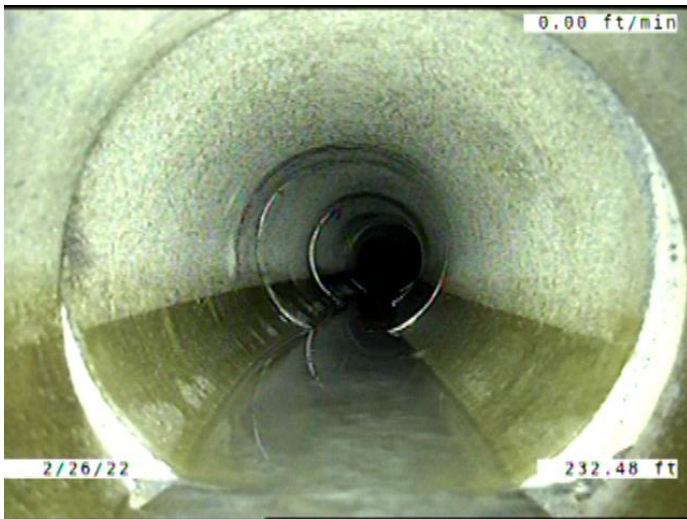
Code: **B**
 Description: **Broken**

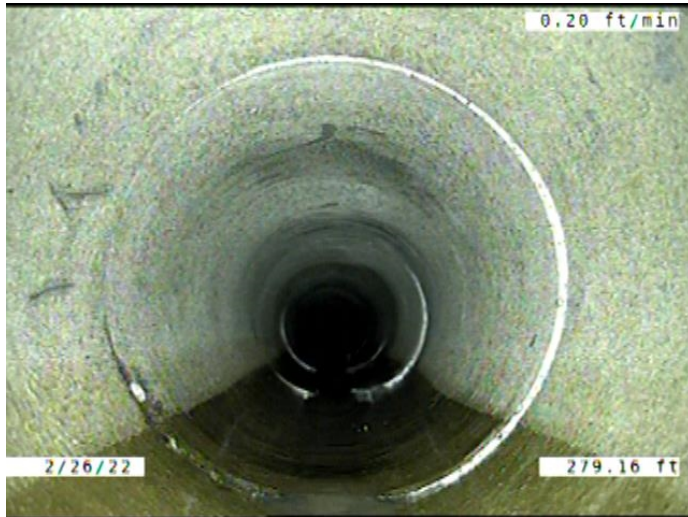
Code: **JAL**
 Description: **Joint Angular Large**
