## Profile/Photo Observation Report

Street:	<b>GARFIELD ST &amp; E 8TH ST</b>	Flow Control:	<b>Not Controlled</b>
City:	<b>Hobart, IN</b>	Year Renewed:	
Location:	<b>Light Highway</b>	Tape/Media #:	
Purpose:	<b>Maintenance Related</b>	Dia/Height:	<b>8"</b>
Use:	<b>Sanitary</b>	Material:	<b>VCP</b>
Drain Area:	<b>NA</b>	Lining:	<b>Cured in Place</b>
Category:	<b>NA</b>		
Comment:	<b>debris at 107'.</b>

Location Details:		Direction of Survey:	<b>Upstream</b>
US MH:	<b>M-706-008</b>	DS MH:	<b>M-706-049</b>
		Total Length Surveyed (ft):	<b>108.4</b>

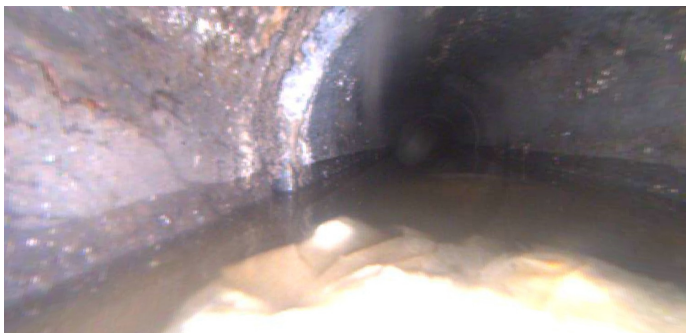
Code: **AMH**  
Description: **Manhole**

Distance (ft): **.0**  
Structural Grade: **0**  
O&M Grade: **0**  
Clock Start/From:  
Clock To:  
1st Value:  
2nd Value:  
Value Percent:  
Continuous Index:  
Within 8" of Joint: **NO**  
Remarks: **M-706-049**

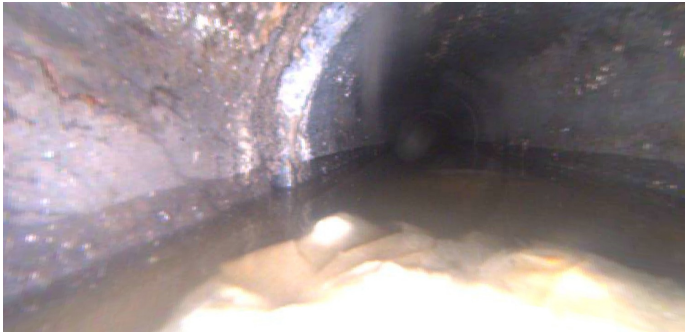
Code:	<b>MWL</b>
Description:	<b>Water Level</b>

Distance (ft):	<b>.0</b>
Structural Grade:	<b>0</b>
O&M Grade:	<b>0</b>
Clock Start/From:	
Clock To:	
1st Value:	
2nd Value:	
Value Percent:	<b>10.000</b>
Continuous Index:	
Within 8" of Joint:	<b>NO</b>
Remarks:

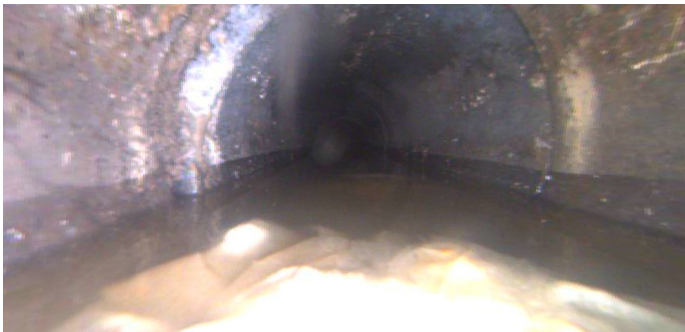
Code:	<b>DSZ</b>
Description:	<b>Deposits Settled Other</b>

Distance (ft):	<b>.0</b>
Structural Grade:	<b>0</b>
O&M Grade:	<b>2</b>
Clock Start/From:	<b>6</b>
Clock To:	
1st Value:	
2nd Value:	
Value Percent:	<b>5.000</b>
Continuous Index:	<b>S01</b>
Within 8" of Joint:	<b>NO</b>
Remarks:	<b>tissue</b>

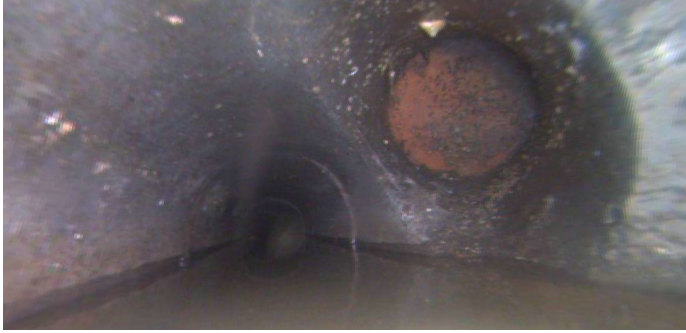
Code: **TFC**  
Description: **Tap Factory Capped**

Distance (ft): **2.2**  
Structural Grade: **0**  
O&M Grade: **0**  
Clock Start/From: **2**  
Clock To:  
1st Value: **4.000**  
2nd Value:  
Value Percent:  
Continuous Index:  
Within 8" of Joint:  
Remarks:

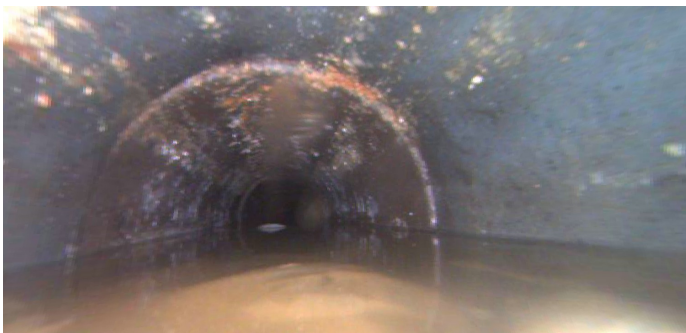
Code: **MWL**  
Description: **Water Level**

Distance (ft): **8.7**  
Structural Grade: **0**  
O&M Grade: **0**  
Clock Start/From:  
Clock To:  
1st Value:  
2nd Value:  
Value Percent: **25.000**  
Continuous Index:  
Within 8" of Joint: **NO**  
Remarks:

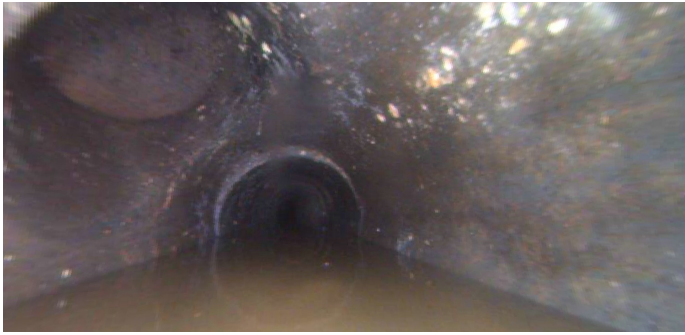
Code: **TFC**  
Description: **Tap Factory Capped**

Distance (ft): **26.2**  
Structural Grade: **0**  
O&M Grade: **0**  
Clock Start/From: **11**  
Clock To:  
1st Value: **4.000**  
2nd Value:  
Value Percent:  
Continuous Index:  
Within 8" of Joint: **YES**  
Remarks:

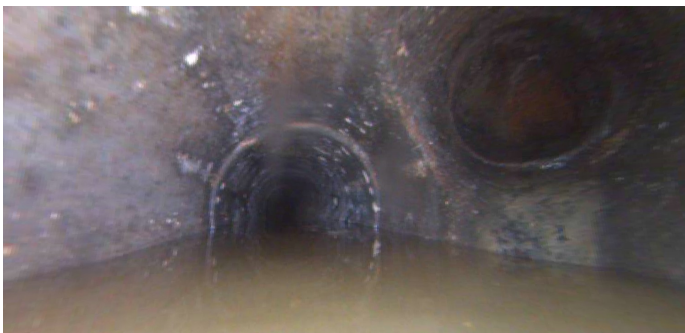
Code: **TF**  
Description: **Tap Factory**

Distance (ft): **28.4**  
Structural Grade: **0**  
O&M Grade: **0**  
Clock Start/From: **2**  
Clock To:  
1st Value: **4.000**  
2nd Value:  
Value Percent:  
Continuous Index:  
Within 8" of Joint: **YES**  
Remarks:

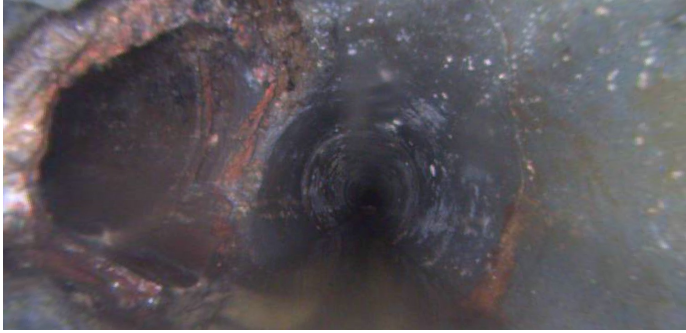
Code: **FC**  
Description: **Fracture Circumferential**

Distance (ft): **38.1**  
Structural Grade: **2**  
O&M Grade: **0**  
Clock Start/From: **12**  
Clock To: **4**  
1st Value:  
2nd Value:  
Value Percent:  
Continuous Index:  
Within 8" of Joint:  
Remarks:

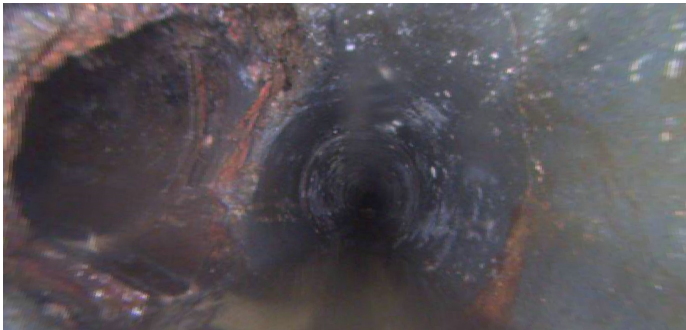
Code: **TB**  
Description: **Tap Break-in**

Distance (ft): **38.1**  
Structural Grade: **0**  
O&M Grade: **0**  
Clock Start/From: **9**  
Clock To:  
1st Value: **6.000**  
2nd Value:  
Value Percent:  
Continuous Index:  
Within 8" of Joint:  
Remarks:

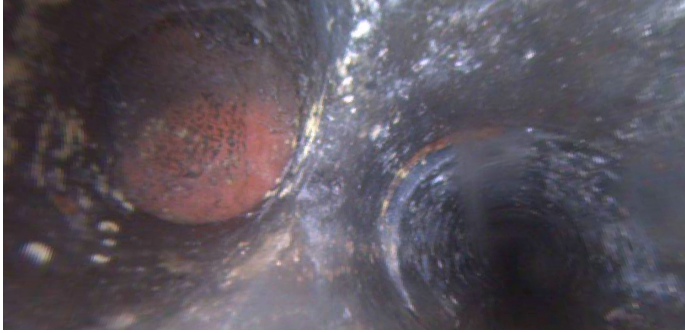
Code: **TFC**  
Description: **Tap Factory Capped**

Distance (ft): **49.0**  
Structural Grade: **0**  
O&M Grade: **0**  
Clock Start/From: **10**  
Clock To:  
1st Value: **4.000**  
2nd Value:  
Value Percent:  
Continuous Index:  
Within 8" of Joint: **YES**  
Remarks:

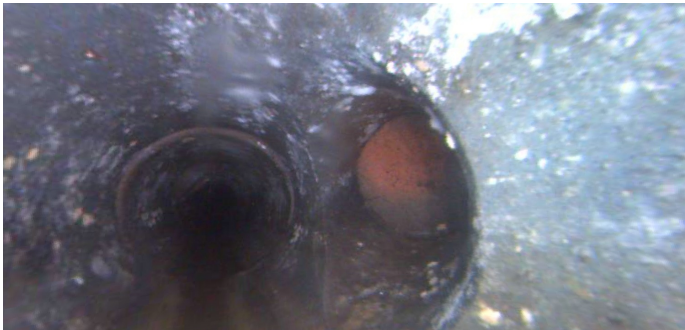
Code: **TFC**  
Description: **Tap Factory Capped**

Distance (ft): **50.6**  
Structural Grade: **0**  
O&M Grade: **0**  
Clock Start/From: **3**  
Clock To:  
1st Value: **4.000**  
2nd Value:  
Value Percent:  
Continuous Index:  
Within 8" of Joint:  
Remarks:

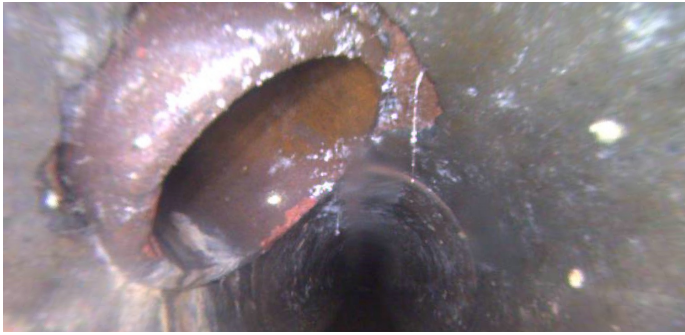
Code: **TBI**  
Description: **Tap Break-in Intruding**

Distance (ft): **53.1**  
Structural Grade: **0**  
O&M Grade: **2**  
Clock Start/From: **11**  
Clock To:  
1st Value: **4.000**  
2nd Value: **1.000**  
Value Percent:  
Continuous Index:  
Within 8" of Joint:  
Remarks:

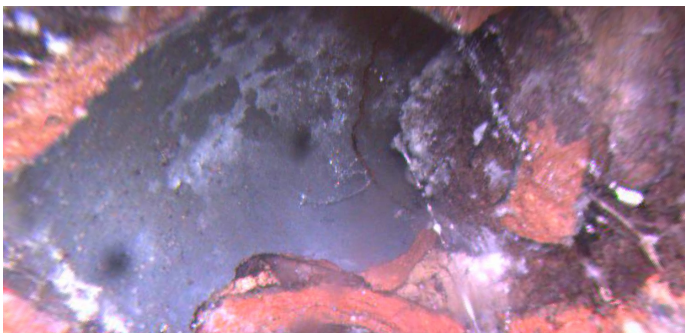
Code: **TBD**  
Description: **Tap Break-in Defective**

Distance (ft): **67.6**  
Structural Grade: **0**  
O&M Grade: **3**  
Clock Start/From: **12**  
Clock To:  
1st Value: **4.000**  
2nd Value:  
Value Percent:  
Continuous Index:  
Within 8" of Joint:  
Remarks: **broken**

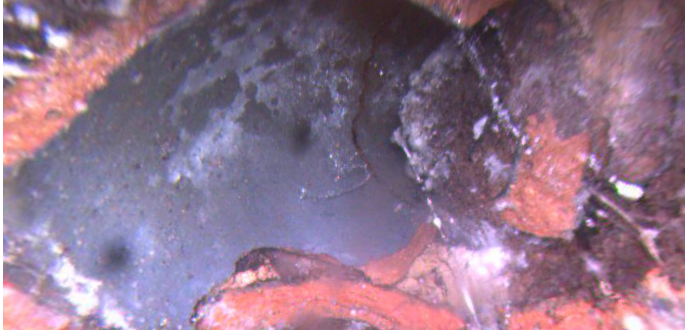
Code: **BSV**  
Description: **Broken Soil Visible**

Distance (ft): **67.6**  
Structural Grade: **5**  
O&M Grade: **0**  
Clock Start/From: **11**  
Clock To:  
1st Value:  
2nd Value:  
Value Percent:  
Continuous Index:  
Within 8" of Joint:  
Remarks:

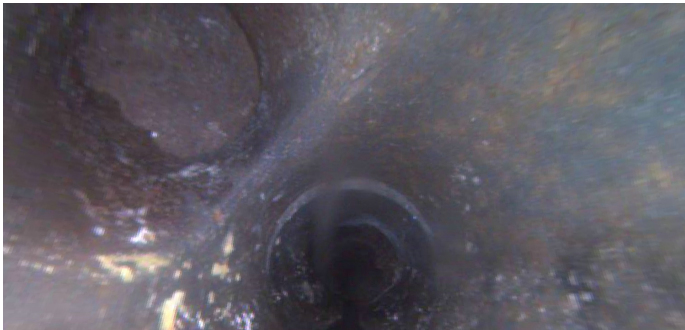
Code: **TFC**  
Description: **Tap Factory Capped**

Distance (ft): **73.2**  
Structural Grade: **0**  
O&M Grade: **0**  
Clock Start/From: **11**  
Clock To:  
1st Value: **4.000**  
2nd Value:  
Value Percent:  
Continuous Index:  
Within 8" of Joint: **YES**  
Remarks:

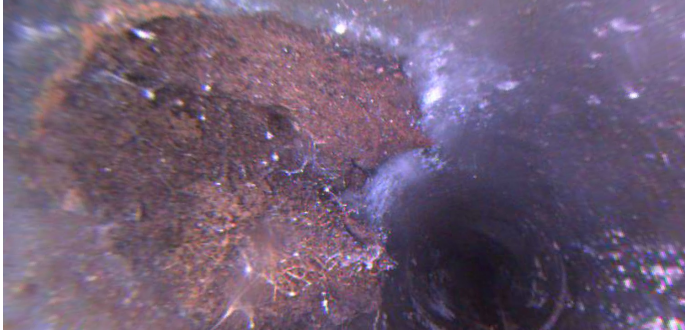
Code: **TFD**  
Description: **Tap Factory Defective**

Distance (ft): **76.0**  
Structural Grade: **0**  
O&M Grade: **2**  
Clock Start/From: **2**  
Clock To:  
1st Value: **4.000**  
2nd Value:  
Value Percent:  
Continuous Index:  
Within 8" of Joint:  
Remarks: **roots**

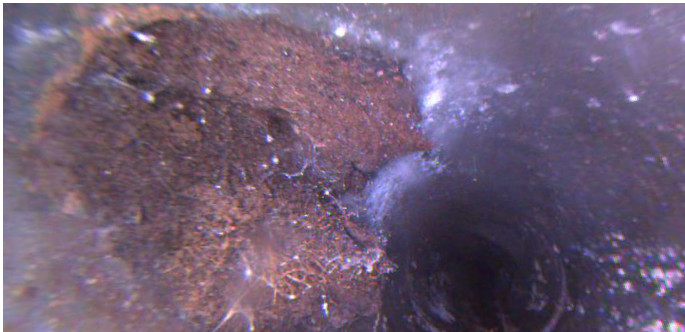
Code: **RML**  
Description: **Roots Medium Lateral**

Distance (ft): **76.0**  
Structural Grade: **0**  
O&M Grade: **3**  
Clock Start/From: **1**  
Clock To: **3**  
1st Value:  
2nd Value:  
Value Percent: **5.000**  
Continuous Index:  
Within 8" of Joint: **NO**  
Remarks:

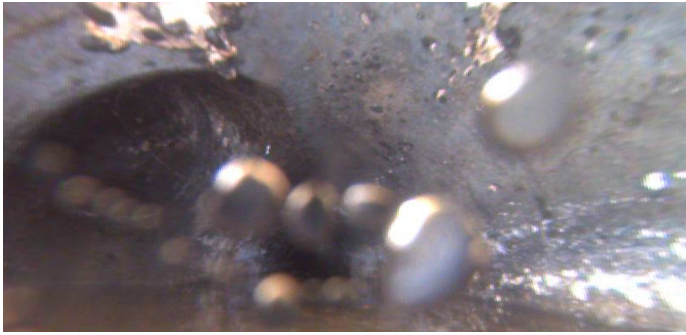
Code: **TF**  
Description: **Tap Factory**

Distance (ft): **89.2**  
Structural Grade: **0**  
O&M Grade: **0**  
Clock Start/From: **10**  
Clock To:  
1st Value: **4.000**  
2nd Value:  
Value Percent:  
Continuous Index:  
Within 8" of Joint:  
Remarks:

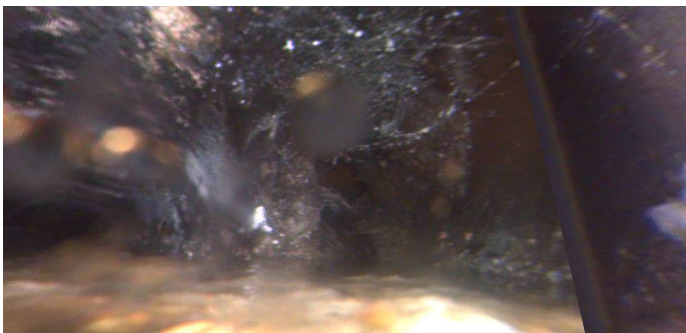
Code: **TF**  
Description: **Tap Factory**

Distance (ft): **91.7**  
Structural Grade: **0**  
O&M Grade: **0**  
Clock Start/From: **2**  
Clock To:  
1st Value: **4.000**  
2nd Value:  
Value Percent:  
Continuous Index:  
Within 8" of Joint: **YES**  
Remarks:

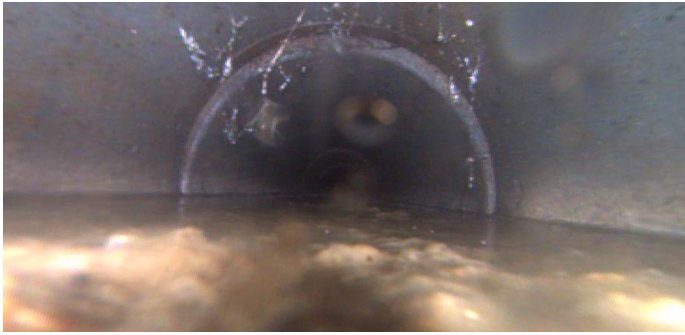
Code: **MSA**  
Description: **Abandoned Survey**

Distance (ft): **108.4**  
Structural Grade: **0**  
O&M Grade: **0**  
Clock Start/From:  
Clock To:  
1st Value:  
2nd Value:  
Value Percent:  
Continuous Index:  
Within 8" of Joint: **NO**  
Remarks: **camera stopped/debris?**

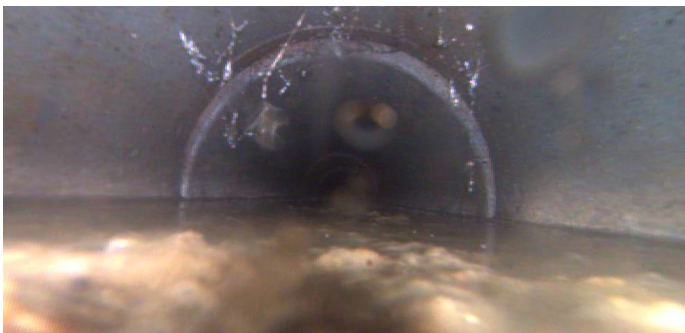
Code: **DSZ**  
Description: **Deposits Settled Other**

Distance (ft): **108.4**  
Structural Grade: **0**  
O&M Grade: **2**  
Clock Start/From: **6**  
Clock To:  
1st Value:  
2nd Value:  
Value Percent: **5.000**  
Continuous Index: **F01**  
Within 8" of Joint: **NO**  
Remarks: **tissue**
