Profile/Photo Observation Report

Date:	04/18/2018	Weather:		Coding:	PACP 6.0
Pipe Length (ft):	259.2	Owner:	NA	Pre Clean:	Not Known
P.O.#:		Surveyor:	Byrd Fitzgerald	PSR:	P-706-008-049
Customer:		Clean Date:	01/01/1900	Shape:	C

Street:	Capitol	Flow Control:	Not Controlled
City:	Hobart, IN	Year Renewed:	
Location:	Light Highway	Tape/Media #:	
Purpose:	Maintenance Related	Dia/Height:	8"
Use:	Sanitary	Material:	VCP
Drain Area:	NA	Lining:	Cured in Place
Category:	NA		
Comment:	debris at 107'.

Location Details:		Direction of Survey:	Upstream
US MH:	M-706-008	DS MH:	M-706-049
		Total Length Surveyed (ft):	108.4

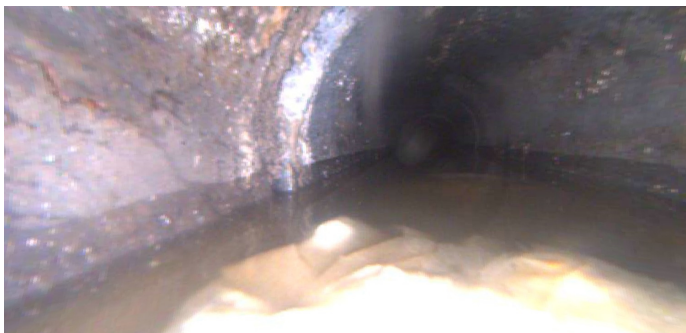
Code: **AMH**
Description: **Manhole**

Distance (ft): **.0**
Structural Grade: **0**
O&M Grade: **0**
Clock Start/From:
Clock To:
1st Value:
2nd Value:
Value Percent:
Continuous Index:
Within 8" of Joint: **NO**
Remarks: **M-706-049**

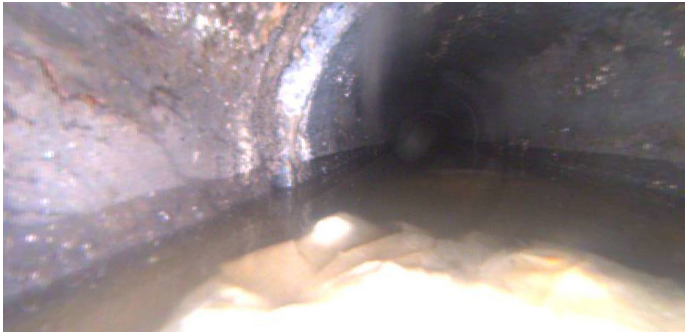
Code:	MWL
Description:	Water Level

Distance (ft):	.0
Structural Grade:	0
O&M Grade:	0
Clock Start/From:	
Clock To:	
1st Value:	
2nd Value:	
Value Percent:	10.000
Continuous Index:	
Within 8" of Joint:	NO
Remarks:

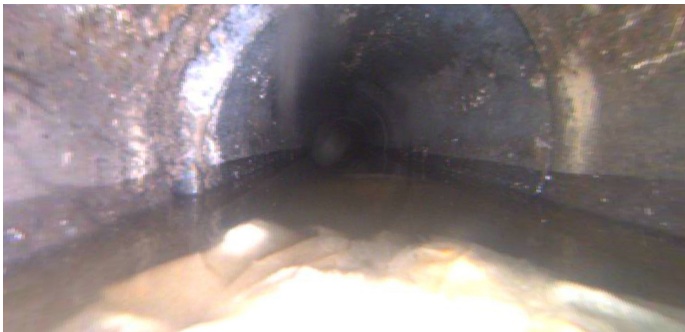
Code:	DSZ
Description:	Deposits Settled Other

Distance (ft):	.0
Structural Grade:	0
O&M Grade:	2
Clock Start/From:	6
Clock To:	
1st Value:	
2nd Value:	
Value Percent:	5.000
Continuous Index:	S01
Within 8" of Joint:	NO
Remarks:	tissue

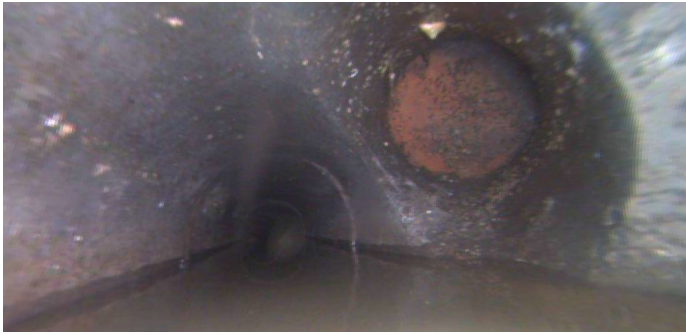
Code: **TFC**
Description: **Tap Factory Capped**

Distance (ft): **2.2**
Structural Grade: **0**
O&M Grade: **0**
Clock Start/From: **2**
Clock To:
1st Value: **4.000**
2nd Value:
Value Percent:
Continuous Index:
Within 8" of Joint:
Remarks:

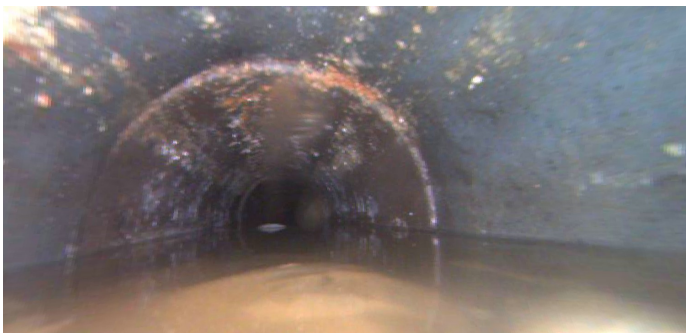
Code: **MWL**
Description: **Water Level**

Distance (ft): **8.7**
Structural Grade: **0**
O&M Grade: **0**
Clock Start/From:
Clock To:
1st Value:
2nd Value:
Value Percent: **25.000**
Continuous Index:
Within 8" of Joint: **NO**
Remarks:

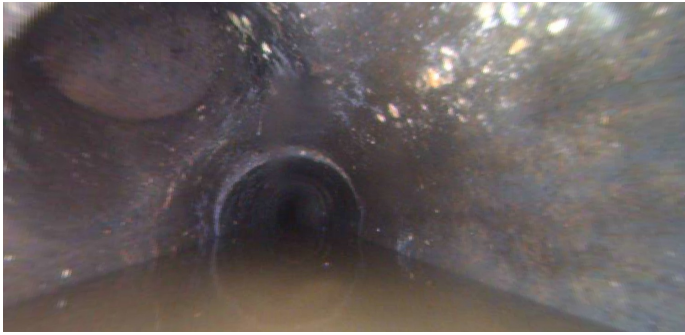
Code: **TFC**
Description: **Tap Factory Capped**

Distance (ft): **26.2**
Structural Grade: **0**
O&M Grade: **0**
Clock Start/From: **11**
Clock To:
1st Value: **4.000**
2nd Value:
Value Percent:
Continuous Index:
Within 8" of Joint: **YES**
Remarks:

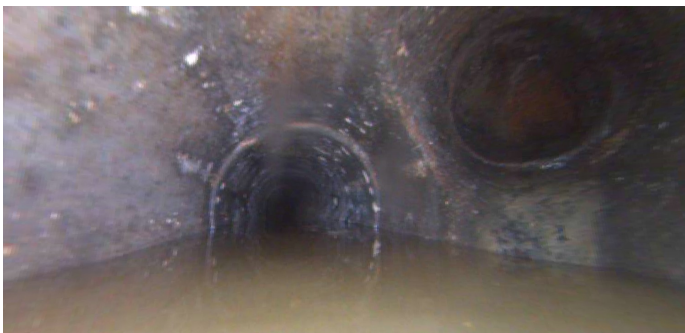
Code: **TF**
Description: **Tap Factory**

Distance (ft): **28.4**
Structural Grade: **0**
O&M Grade: **0**
Clock Start/From: **2**
Clock To:
1st Value: **4.000**
2nd Value:
Value Percent:
Continuous Index:
Within 8" of Joint: **YES**
Remarks:

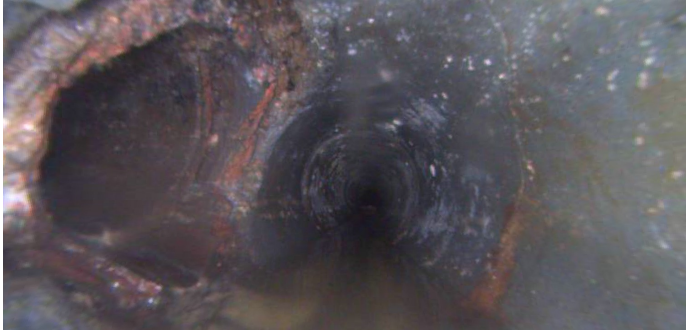
Code: **FC**
Description: **Fracture Circumferential**

Distance (ft): **38.1**
Structural Grade: **2**
O&M Grade: **0**
Clock Start/From: **12**
Clock To: **4**
1st Value:
2nd Value:
Value Percent:
Continuous Index:
Within 8" of Joint:
Remarks:

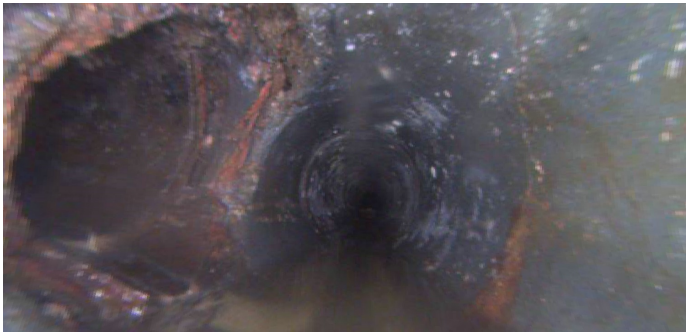
Code: **TB**
Description: **Tap Break-in**

Distance (ft): **38.1**
Structural Grade: **0**
O&M Grade: **0**
Clock Start/From: **9**
Clock To:
1st Value: **6.000**
2nd Value:
Value Percent:
Continuous Index:
Within 8" of Joint:
Remarks:

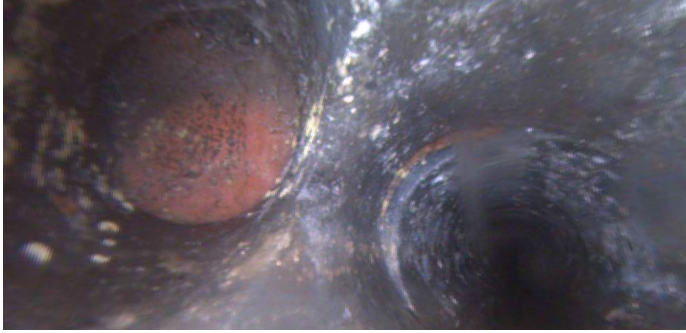
Code: **TFC**
Description: **Tap Factory Capped**

Distance (ft): **49.0**
Structural Grade: **0**
O&M Grade: **0**
Clock Start/From: **10**
Clock To:
1st Value: **4.000**
2nd Value:
Value Percent:
Continuous Index:
Within 8" of Joint: **YES**
Remarks:

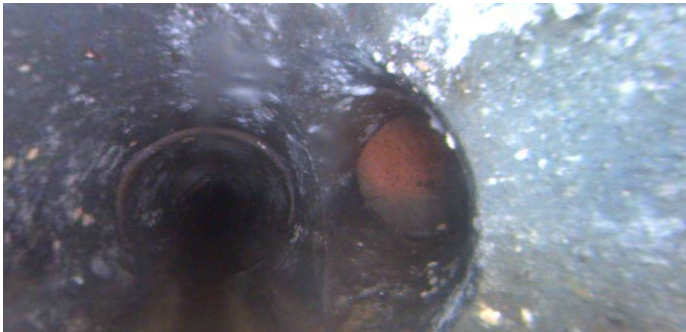
Code: **TFC**
Description: **Tap Factory Capped**

Distance (ft): **50.6**
Structural Grade: **0**
O&M Grade: **0**
Clock Start/From: **3**
Clock To:
1st Value: **4.000**
2nd Value:
Value Percent:
Continuous Index:
Within 8" of Joint:
Remarks:

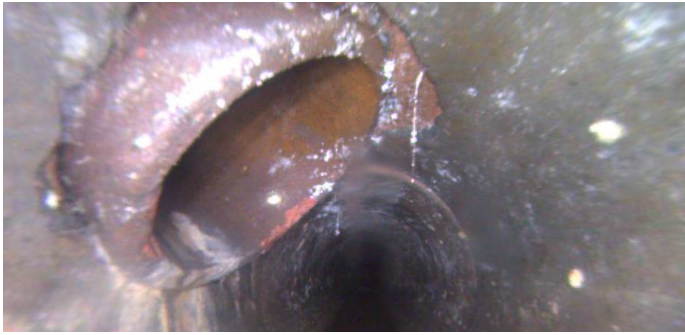
Code: **TBI**
Description: **Tap Break-in Intruding**

Distance (ft): **53.1**
Structural Grade: **0**
O&M Grade: **2**
Clock Start/From: **11**
Clock To:
1st Value: **4.000**
2nd Value: **1.000**
Value Percent:
Continuous Index:
Within 8" of Joint:
Remarks:

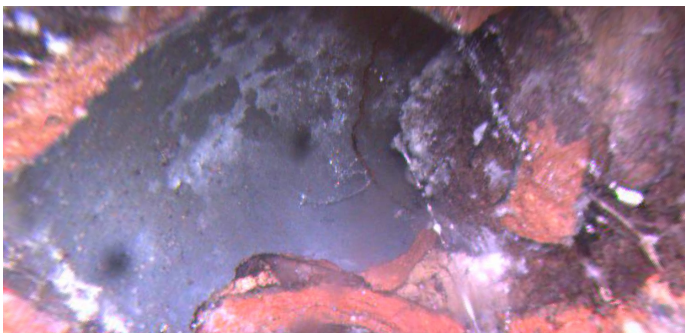
Code: **TBD**
Description: **Tap Break-in Defective**

Distance (ft): **67.6**
Structural Grade: **0**
O&M Grade: **3**
Clock Start/From: **12**
Clock To:
1st Value: **4.000**
2nd Value:
Value Percent:
Continuous Index:
Within 8" of Joint:
Remarks: **broken**

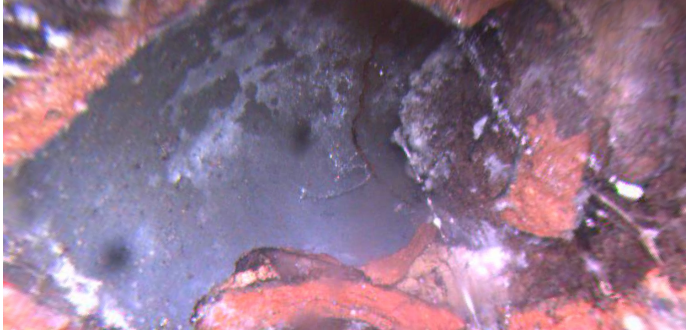
Code: **BSV**
Description: **Broken Soil Visible**

Distance (ft): **67.6**
Structural Grade: **5**
O&M Grade: **0**
Clock Start/From: **11**
Clock To:
1st Value:
2nd Value:
Value Percent:
Continuous Index:
Within 8" of Joint:
Remarks:

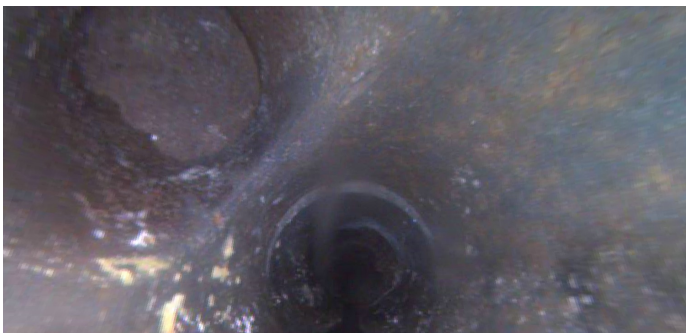
Code: **TFC**
Description: **Tap Factory Capped**

Distance (ft): **73.2**
Structural Grade: **0**
O&M Grade: **0**
Clock Start/From: **11**
Clock To:
1st Value: **4.000**
2nd Value:
Value Percent:
Continuous Index:
Within 8" of Joint: **YES**
Remarks:

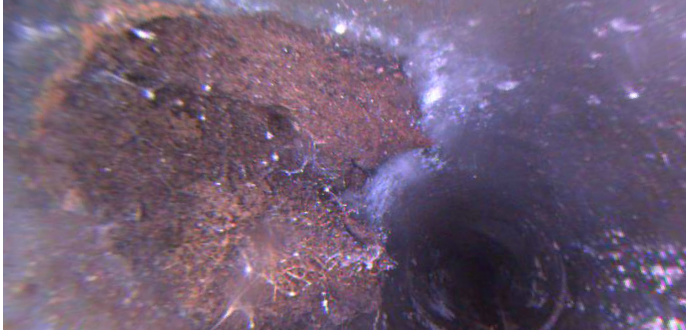
Code: **TFD**
Description: **Tap Factory Defective**

Distance (ft): **76.0**
Structural Grade: **0**
O&M Grade: **2**
Clock Start/From: **2**
Clock To:
1st Value: **4.000**
2nd Value:
Value Percent:
Continuous Index:
Within 8" of Joint:
Remarks: **roots**

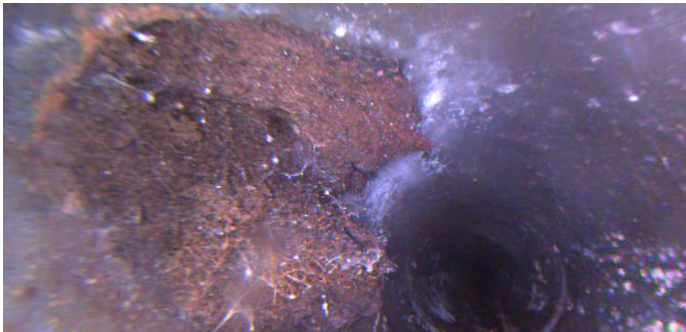
Code: **RML**
Description: **Roots Medium Lateral**

Distance (ft): **76.0**
Structural Grade: **0**
O&M Grade: **3**
Clock Start/From: **1**
Clock To: **3**
1st Value:
2nd Value:
Value Percent: **5.000**
Continuous Index:
Within 8" of Joint: **NO**
Remarks:

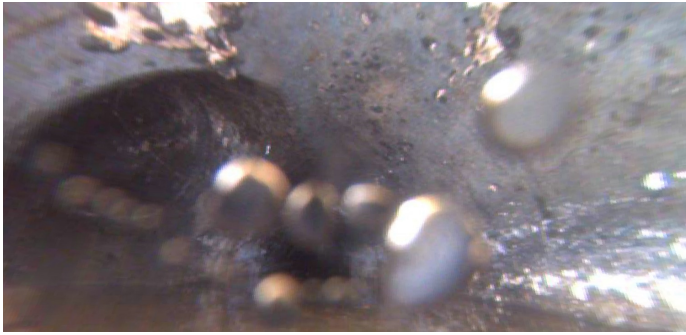
Code: **TF**
Description: **Tap Factory**

Distance (ft): **89.2**
Structural Grade: **0**
O&M Grade: **0**
Clock Start/From: **10**
Clock To:
1st Value: **4.000**
2nd Value:
Value Percent:
Continuous Index:
Within 8" of Joint:
Remarks:

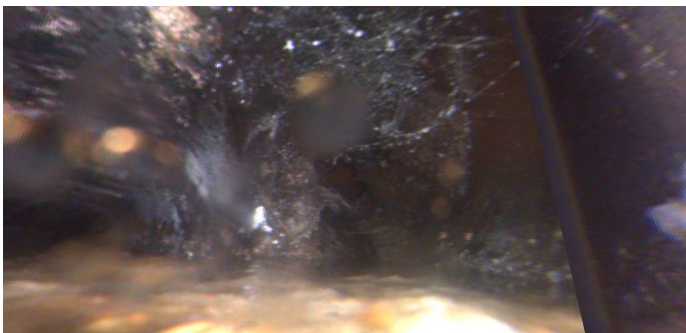
Code: **TF**
Description: **Tap Factory**

Distance (ft): **91.7**
Structural Grade: **0**
O&M Grade: **0**
Clock Start/From: **2**
Clock To:
1st Value: **4.000**
2nd Value:
Value Percent:
Continuous Index:
Within 8" of Joint: **YES**
Remarks:

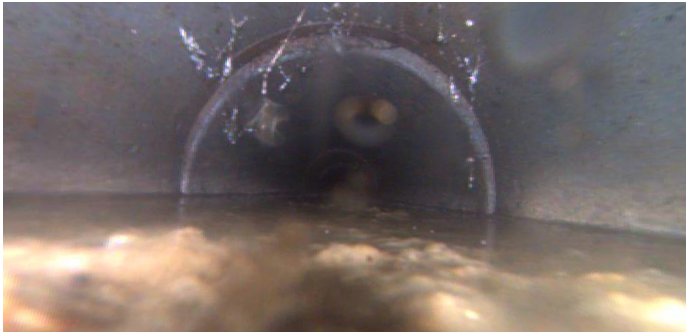
Code: **MSA**
Description: **Abandoned Survey**

Distance (ft): **108.4**
Structural Grade: **0**
O&M Grade: **0**
Clock Start/From:
Clock To:
1st Value:
2nd Value:
Value Percent:
Continuous Index:
Within 8" of Joint: **NO**
Remarks: **camera stopped/debris?**

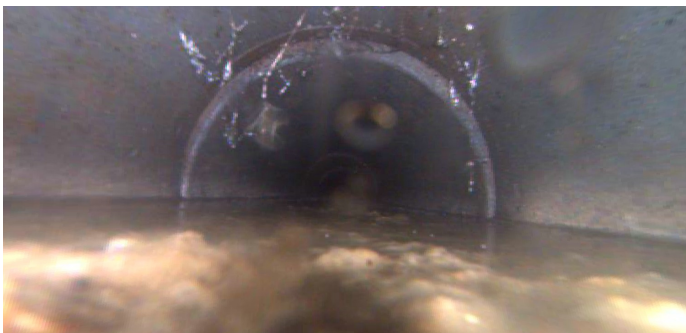
Code: **DSZ**
Description: **Deposits Settled Other**

Distance (ft): **108.4**
Structural Grade: **0**
O&M Grade: **2**
Clock Start/From: **6**
Clock To:
1st Value:
2nd Value:
Value Percent: **5.000**
Continuous Index: **F01**
Within 8" of Joint: **NO**
Remarks: **tissue**
