Profile/Photo Observation Report

Date:	05/01/2018	Weather:		Coding:	PACP 6.0
Pipe Length (ft):		Owner:	City of Hobart	Pre Clean:	Not Known
P.O.#:	275	Surveyor:	B. Helbling	PSR:	P-706-008.1-008
Customer:	City of Hobart	Clean Date:		Shape:	C

Street:	Garfield	Flow Control:	Not Controlled
City:	Hobart, IN	Year Renewed:	
Location:	Light Highway	Tape/Media #:	DEP275
Purpose:	Routine Assessment	Dia/Height:	8"
Use:	Sanitary	Material:	VCP
Drain Area:		Lining:	
Category:	NA		
Comment:	5-21-2018

Location Details:		Direction of Survey:	Downstream
US MH:	M-706-008.1	DS MH:	M-706-008
		Total Length Surveyed (ft):	137.1

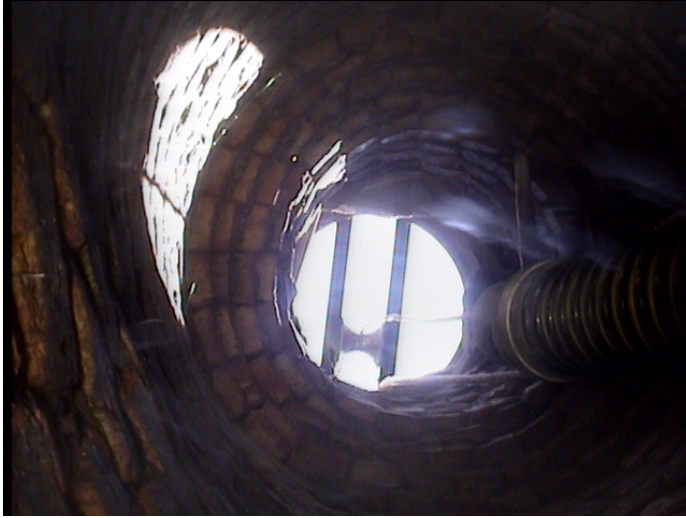
Code: **AMH**
Description: **Manhole**

Distance (ft): **.0**
Structural Grade: **0**
O&M Grade: **0**
Clock Start/From:
Clock To:
1st Value:
2nd Value:
Value Percent:
Continuous Index:
Within 8" of Joint: **NO**
Remarks: **M-706-008.1**

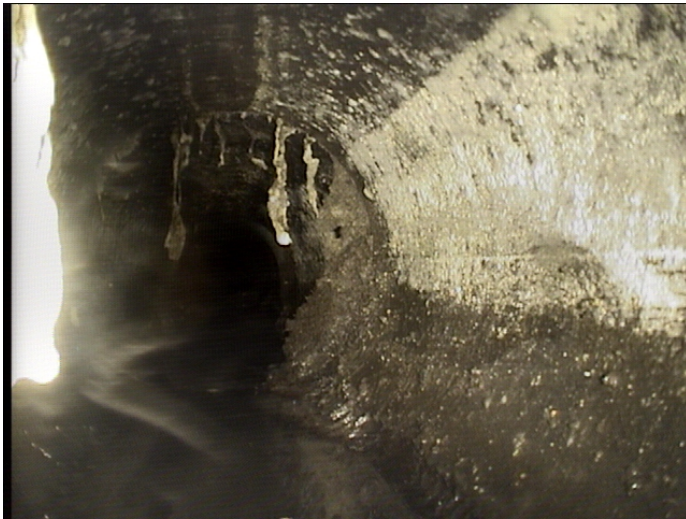
Code: **MWL**
Description: **Water Level**

Distance (ft): **.0**
Structural Grade: **0**
O&M Grade: **0**
Clock Start/From:
Clock To:
1st Value:
2nd Value:
Value Percent: **5.000**
Continuous Index:
Within 8" of Joint: **NO**
Remarks:

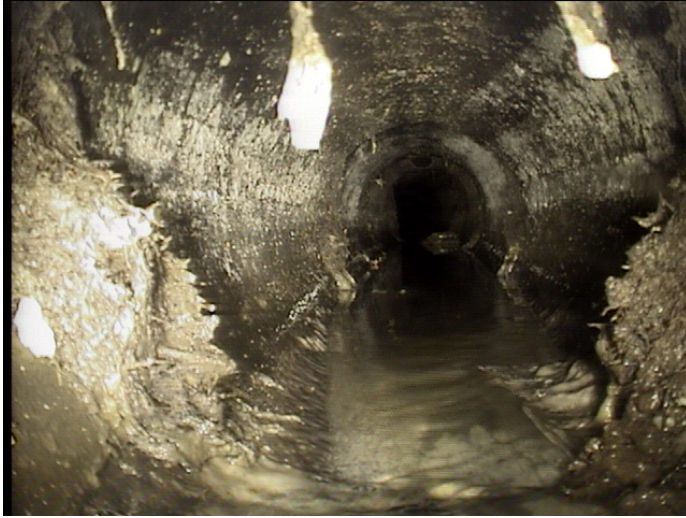
Code: **RFJ**
Description: **Roots Fine Joint**

Distance (ft): **.0**
Structural Grade: **0**
O&M Grade: **1**
Clock Start/From: **7**
Clock To: **5**
1st Value:
2nd Value:
Value Percent:
Continuous Index:
Within 8" of Joint: **YES**
Remarks:

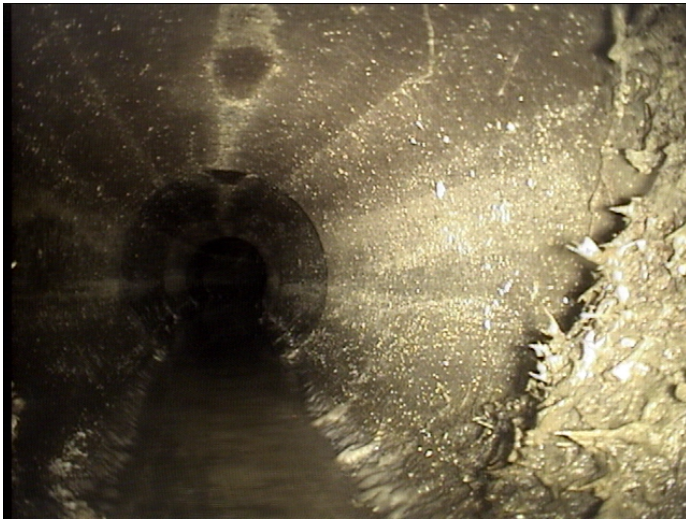
Code: **RFJ**
Description: **Roots Fine Joint**

Distance (ft): **6.7**
Structural Grade: **0**
O&M Grade: **1**
Clock Start/From: **8**
Clock To: **4**
1st Value:
2nd Value:
Value Percent:
Continuous Index:
Within 8" of Joint: **YES**
Remarks:

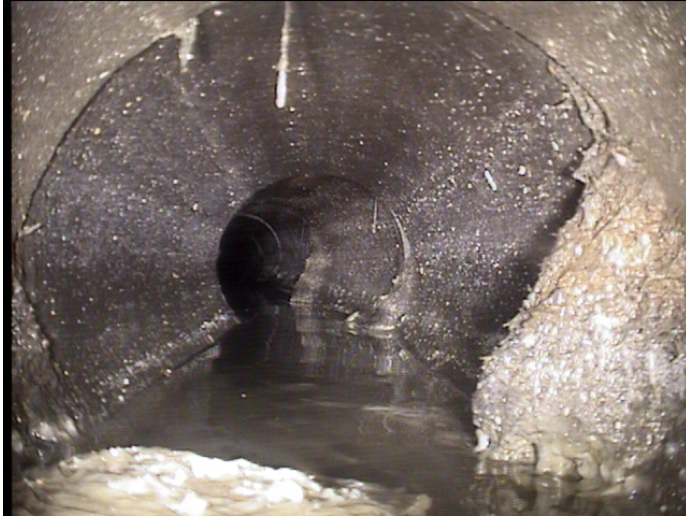
Code: **DSF**
Description: **Deposits Settled Fine**

Distance (ft): **20.9**
Structural Grade: **0**
O&M Grade: **2**
Clock Start/From: **5**
Clock To: **7**
1st Value:
2nd Value:
Value Percent: **5.000**
Continuous Index: **S01**
Within 8" of Joint: **NO**
Remarks:

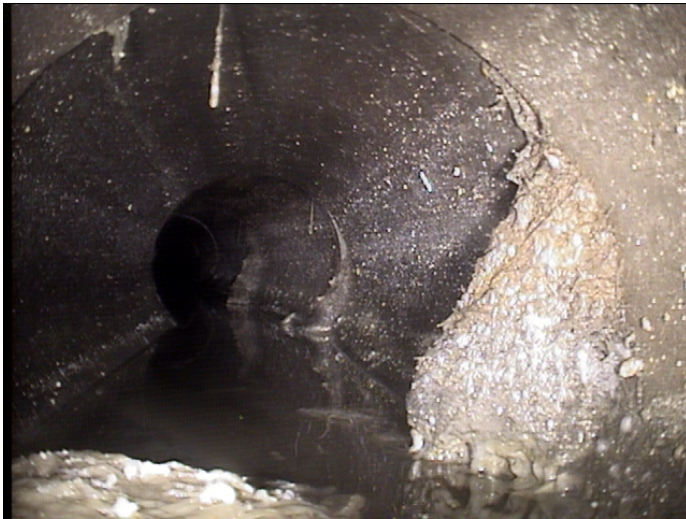
Code: **RMJ**
Description: **Roots Medium Joint**

Distance (ft): **20.9**
Structural Grade: **0**
O&M Grade: **3**
Clock Start/From: **2**
Clock To: **5**
1st Value:
2nd Value:
Value Percent: **5.000**
Continuous Index:
Within 8" of Joint: **YES**
Remarks:

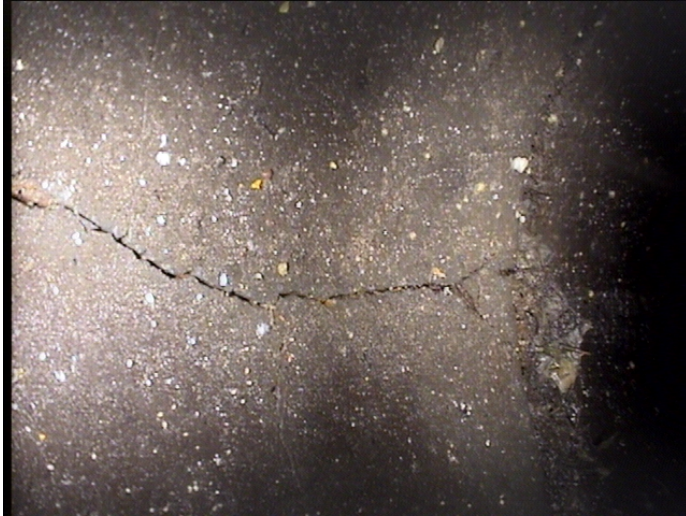
Code: **FL**
Description: **Fracture Longitudinal**

Distance (ft): **25.3**
Structural Grade: **3**
O&M Grade: **0**
Clock Start/From: **9**
Clock To:
1st Value:
2nd Value:
Value Percent:
Continuous Index:
Within 8" of Joint: **NO**
Remarks:

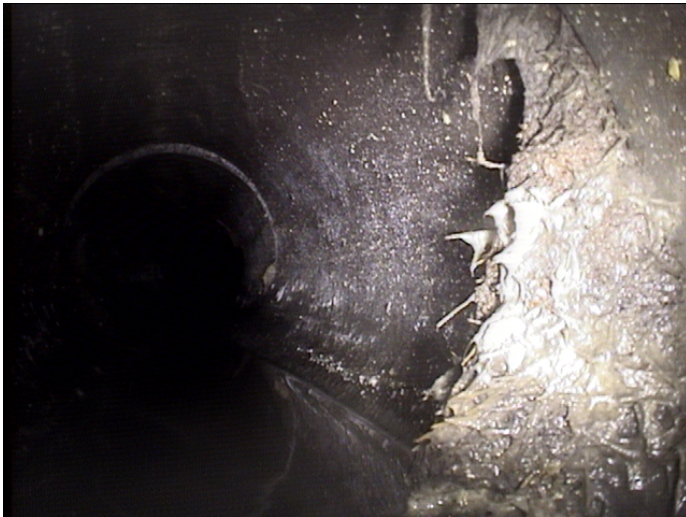
Code: **RFJ**
Description: **Roots Fine Joint**

Distance (ft): **25.3**
Structural Grade: **0**
O&M Grade: **1**
Clock Start/From: **1**
Clock To: **5**
1st Value:
2nd Value:
Value Percent:
Continuous Index:
Within 8" of Joint: **YES**
Remarks:

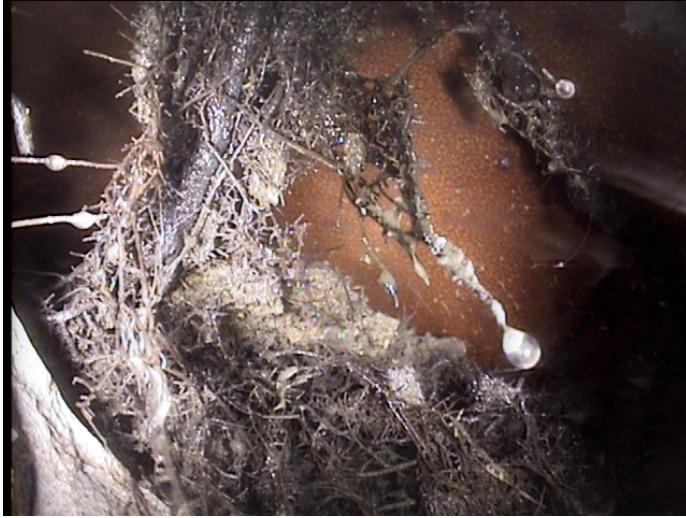
Code: **TBD**
Description: **Tap Break-in Defective**

Distance (ft): **31.4**
Structural Grade: **0**
O&M Grade: **3**
Clock Start/From: **2**
Clock To:
1st Value: **4.000**
2nd Value:
Value Percent:
Continuous Index:
Within 8" of Joint: **NO**
Remarks: **Defective**

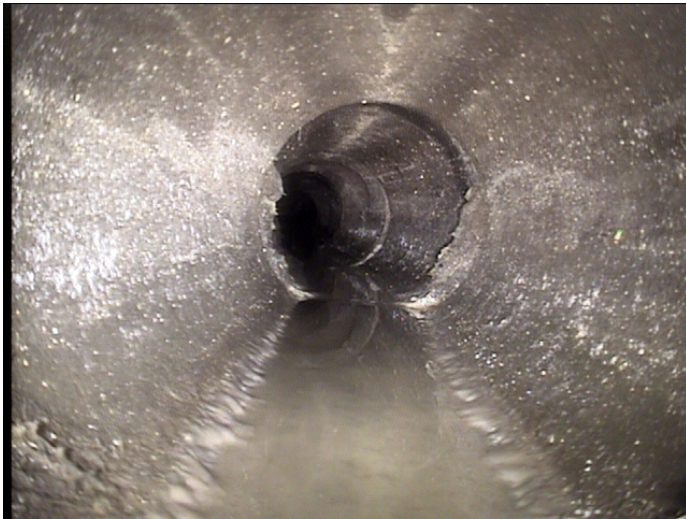
Code: **DSF**
Description: **Deposits Settled Fine**

Distance (ft): **31.4**
Structural Grade: **0**
O&M Grade: **2**
Clock Start/From: **5**
Clock To: **7**
1st Value:
2nd Value:
Value Percent: **5.000**
Continuous Index: **F01**
Within 8" of Joint: **NO**
Remarks:

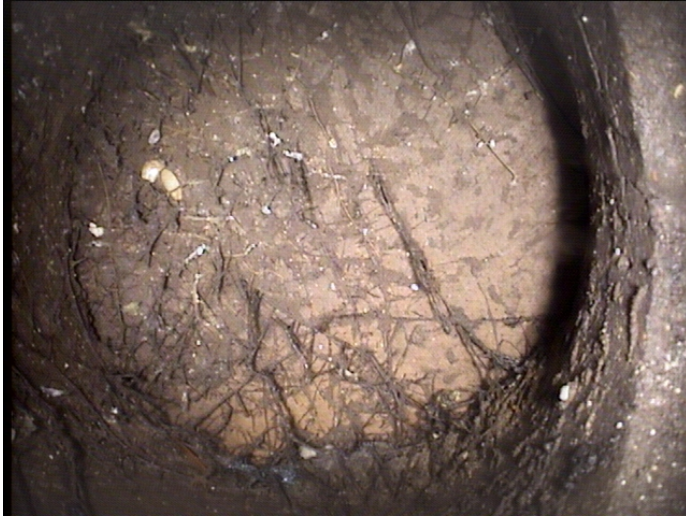
Code: **TFC**
Description: **Tap Factory Capped**

Distance (ft): **36.8**
Structural Grade: **0**
O&M Grade: **0**
Clock Start/From: **2**
Clock To:
1st Value: **4.000**
2nd Value:
Value Percent:
Continuous Index:
Within 8" of Joint: **NO**
Remarks:

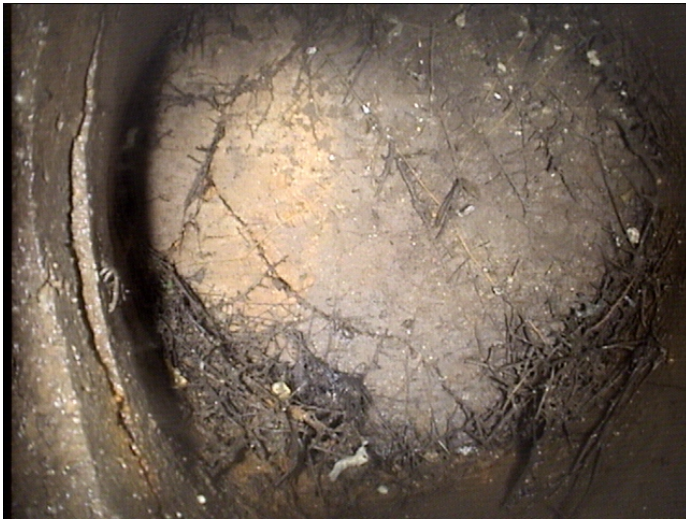
Code: **TFC**
Description: **Tap Factory Capped**

Distance (ft): **38.9**
Structural Grade: **0**
O&M Grade: **0**
Clock Start/From: **11**
Clock To:
1st Value: **4.000**
2nd Value:
Value Percent:
Continuous Index:
Within 8" of Joint: **NO**
Remarks:

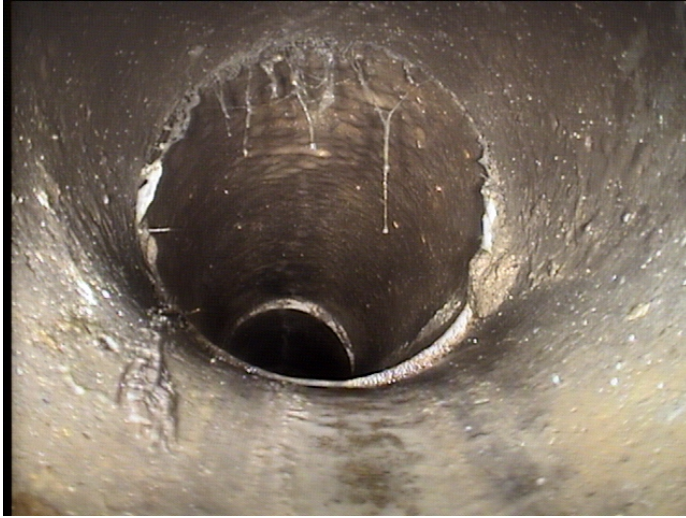
Code: **TF**
Description: **Tap Factory**

Distance (ft): **47.1**
Structural Grade: **0**
O&M Grade: **0**
Clock Start/From: **10**
Clock To:
1st Value: **4.000**
2nd Value:
Value Percent:
Continuous Index:
Within 8" of Joint: **NO**
Remarks:

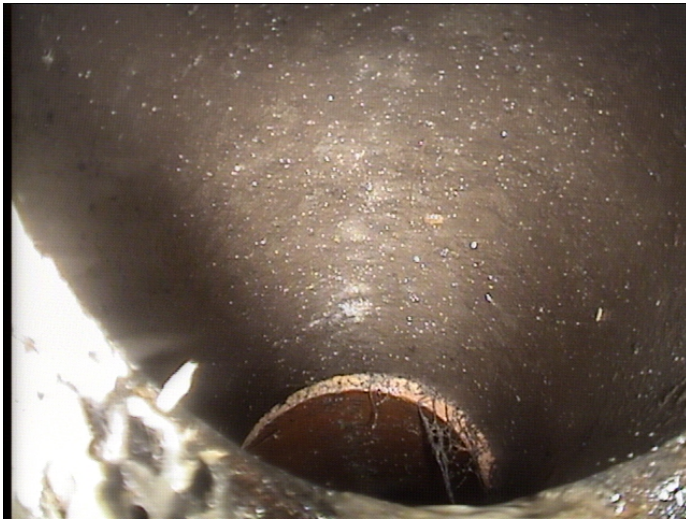
Code: **TB**
Description: **Tap Break-in**

Distance (ft): **49.1**
Structural Grade: **0**
O&M Grade: **0**
Clock Start/From: **2**
Clock To:
1st Value: **4.000**
2nd Value:
Value Percent:
Continuous Index:
Within 8" of Joint: **NO**
Remarks:

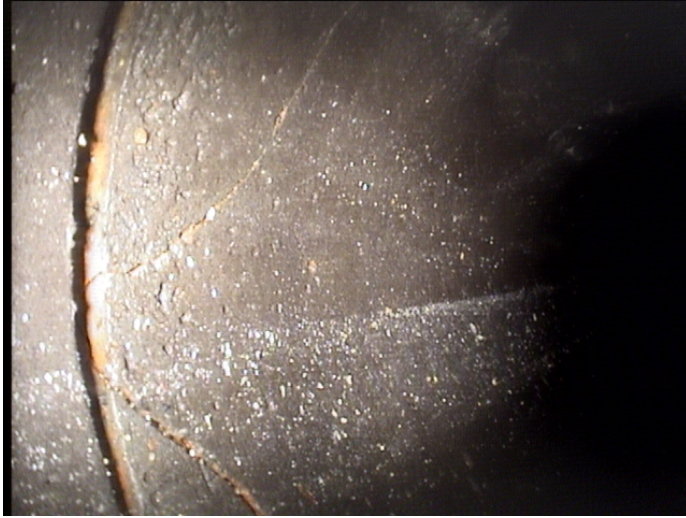
Code:	CM
Description:	Crack Multiple
Distance (ft):	56.2
Structural Grade:	3
O&M Grade:	0
Clock Start/From:	7
Clock To:	11
1st Value:	
2nd Value:	
Value Percent:	
Continuous Index:	
Within 8" of Joint:	NO
Remarks:

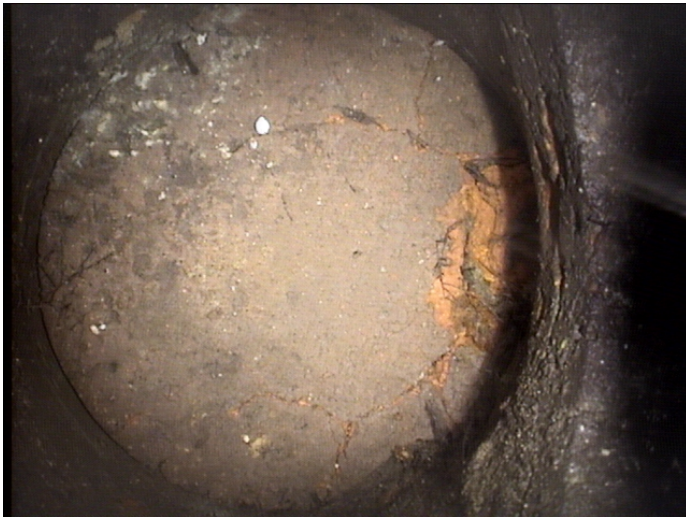
Code:	TFC
Description:	Tap Factory Capped
Distance (ft):	57.4
Structural Grade:	0
O&M Grade:	0
Clock Start/From:	2
Clock To:	
1st Value:	4.000
2nd Value:	
Value Percent:	
Continuous Index:	
Within 8" of Joint:	NO
Remarks:

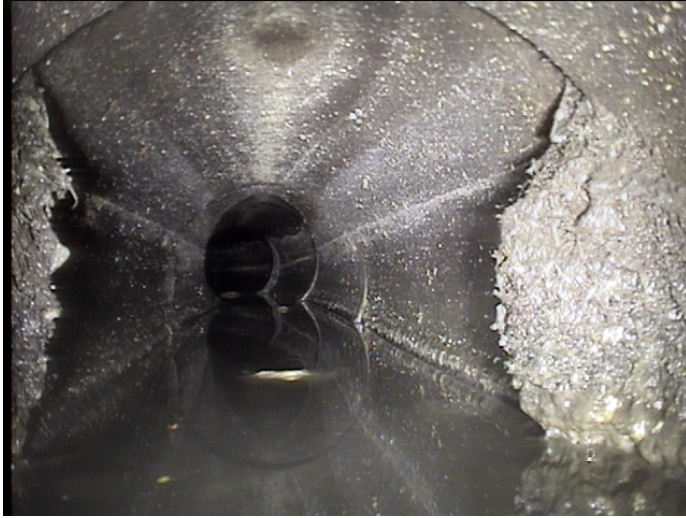
Code: **RMJ**
Description: **Roots Medium Joint**

Distance (ft): **72.0**
Structural Grade: **0**
O&M Grade: **3**
Clock Start/From: **8**
Clock To: **4**
1st Value:
2nd Value:
Value Percent: **10.000**
Continuous Index:
Within 8" of Joint: **YES**
Remarks:

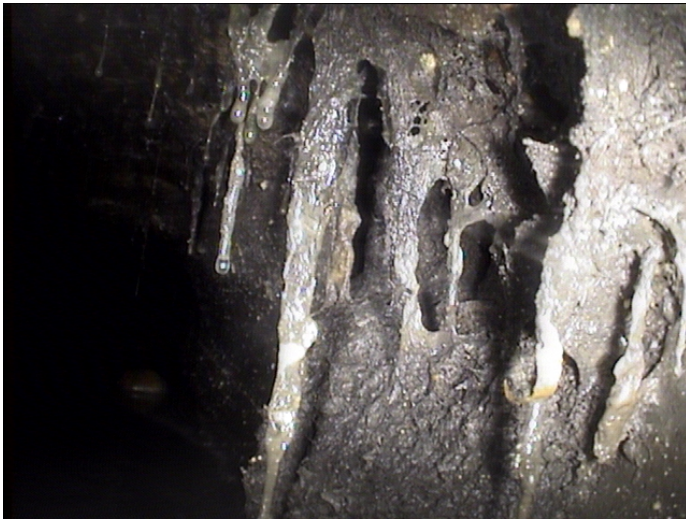
Code: **RFB**
Description: **Roots Fine Barrel**

Distance (ft): **86.2**
Structural Grade: **0**
O&M Grade: **2**
Clock Start/From: **11**
Clock To: **5**
1st Value:
2nd Value:
Value Percent:
Continuous Index:
Within 8" of Joint: **NO**
Remarks:

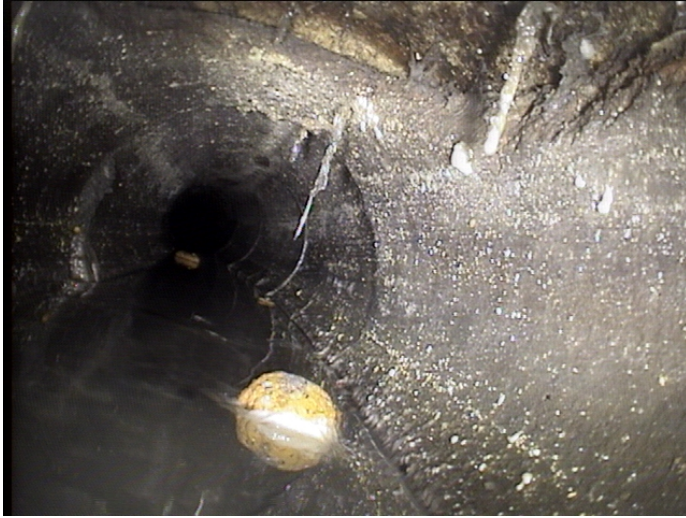
Code: **SAM**
Description: **Surface Aggregate Missing**

Distance (ft): **87.4**
Structural Grade: **4**
O&M Grade: **0**
Clock Start/From: **10**
Clock To: **2**
1st Value:
2nd Value:
Value Percent:
Continuous Index:
Within 8" of Joint: **NO**
Remarks:

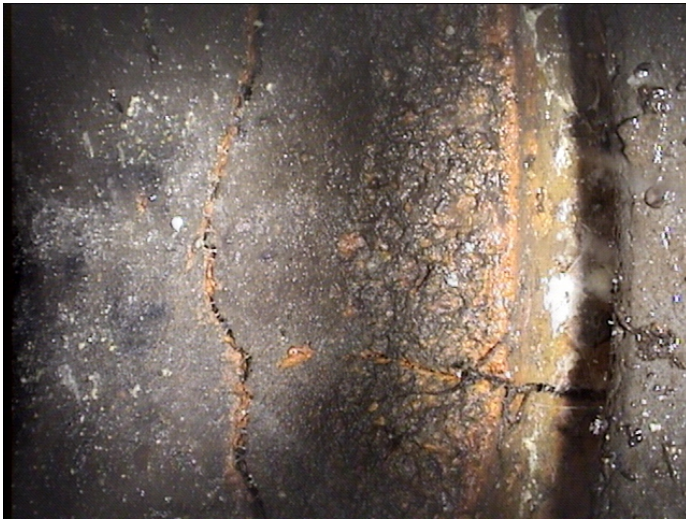
Code: **FM**
Description: **Fracture Multiple**

Distance (ft): **97.2**
Structural Grade: **4**
O&M Grade: **0**
Clock Start/From: **11**
Clock To: **1**
1st Value:
2nd Value:
Value Percent:
Continuous Index:
Within 8" of Joint: **NO**
Remarks:

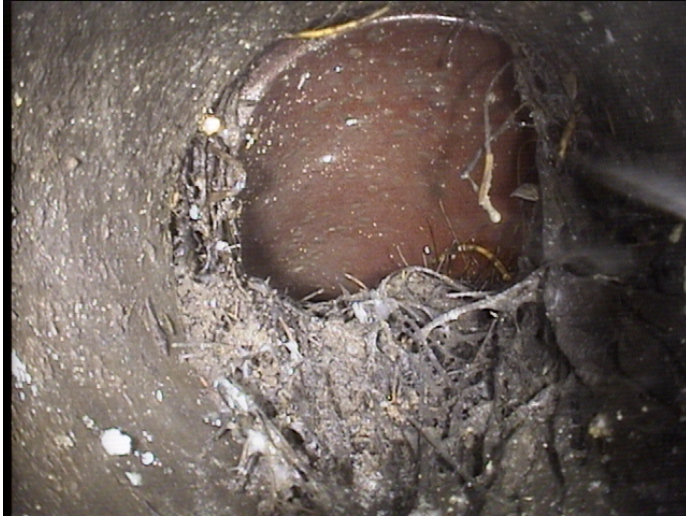
Code: **TFD**
Description: **Tap Factory Defective**

Distance (ft): **98.3**
Structural Grade: **0**
O&M Grade: **2**
Clock Start/From: **2**
Clock To:
1st Value: **4.000**
2nd Value:
Value Percent:
Continuous Index:
Within 8" of Joint: **NO**
Remarks: **Defective**

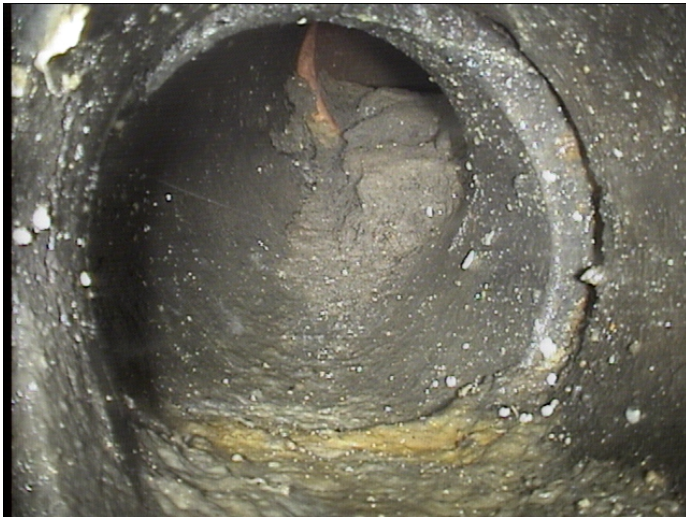
Code: **TF**
Description: **Tap Factory**

Distance (ft): **100.2**
Structural Grade: **0**
O&M Grade: **0**
Clock Start/From: **9**
Clock To:
1st Value: **6.000**
2nd Value:
Value Percent:
Continuous Index:
Within 8" of Joint: **NO**
Remarks:

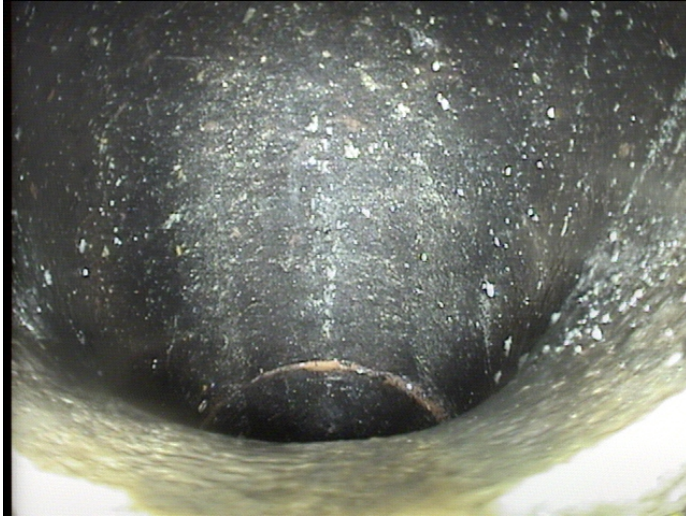
Code: **TF**
Description: **Tap Factory**

Distance (ft): **101.9**
Structural Grade: **0**
O&M Grade: **0**
Clock Start/From: **11**
Clock To:
1st Value: **6.000**
2nd Value:
Value Percent:
Continuous Index:
Within 8" of Joint: **NO**
Remarks:

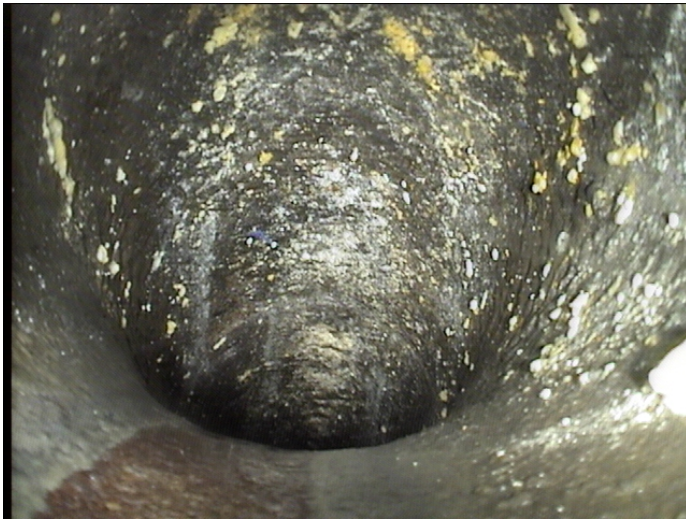
Code: **TF**
Description: **Tap Factory**

Distance (ft): **104.0**
Structural Grade: **0**
O&M Grade: **0**
Clock Start/From: **10**
Clock To:
1st Value: **4.000**
2nd Value:
Value Percent:
Continuous Index:
Within 8" of Joint: **NO**
Remarks:

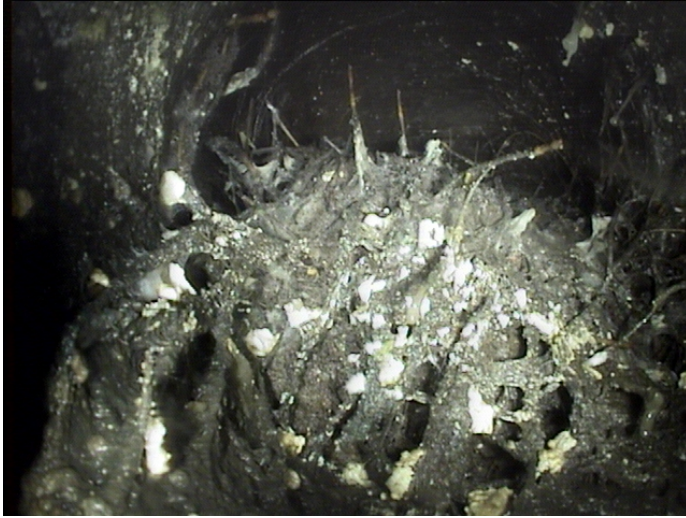
Code: **TFD**
Description: **Tap Factory Defective**

Distance (ft): **108.3**
Structural Grade: **0**
O&M Grade: **2**
Clock Start/From: **10**
Clock To:
1st Value: **4.000**
2nd Value:
Value Percent:
Continuous Index:
Within 8" of Joint: **NO**
Remarks: **Defective**

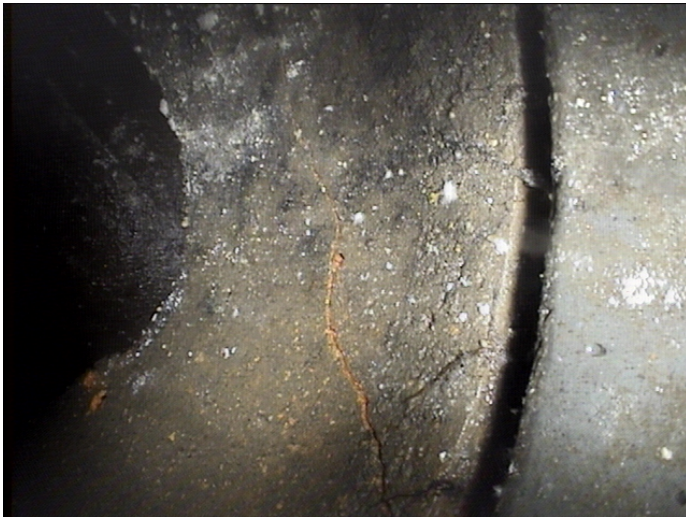
Code: **CL**
Description: **Crack Longitudinal**

Distance (ft): **121.3**
Structural Grade: **2**
O&M Grade: **0**
Clock Start/From: **3**
Clock To:
1st Value:
2nd Value:
Value Percent:
Continuous Index:
Within 8" of Joint: **NO**
Remarks:

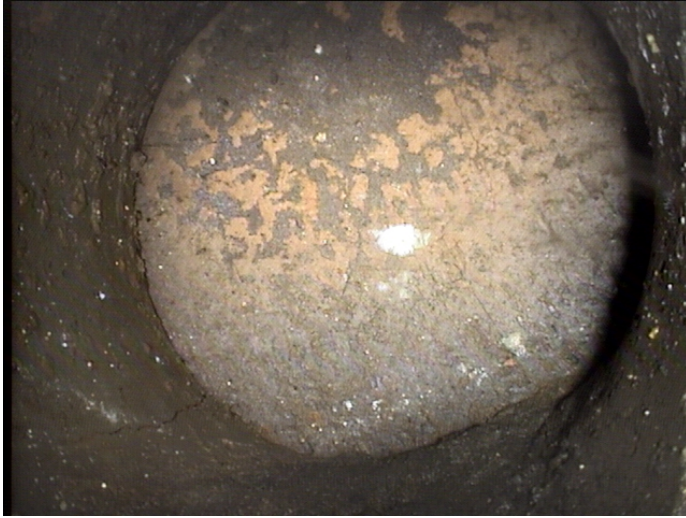
Code: **TFC**
Description: **Tap Factory Capped**

Distance (ft): **122.4**
Structural Grade: **0**
O&M Grade: **0**
Clock Start/From: **2**
Clock To:
1st Value: **4.000**
2nd Value:
Value Percent:
Continuous Index:
Within 8" of Joint: **NO**
Remarks:

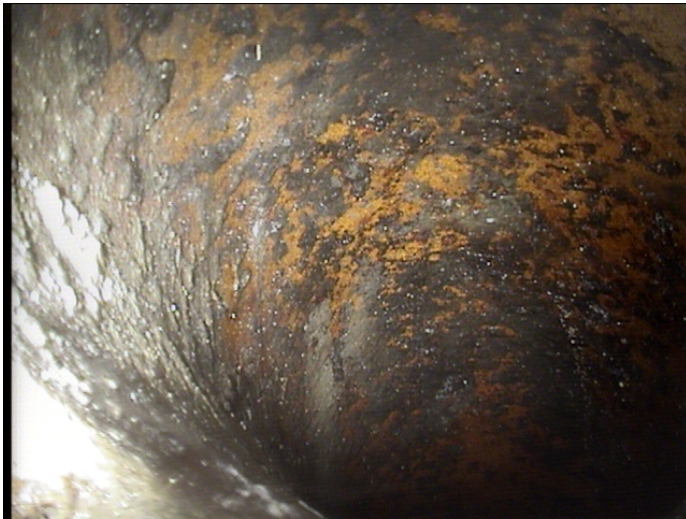
Code: **TB**
Description: **Tap Break-in**

Distance (ft): **128.9**
Structural Grade: **0**
O&M Grade: **0**
Clock Start/From: **2**
Clock To:
1st Value: **4.000**
2nd Value:
Value Percent:
Continuous Index:
Within 8" of Joint: **NO**
Remarks:

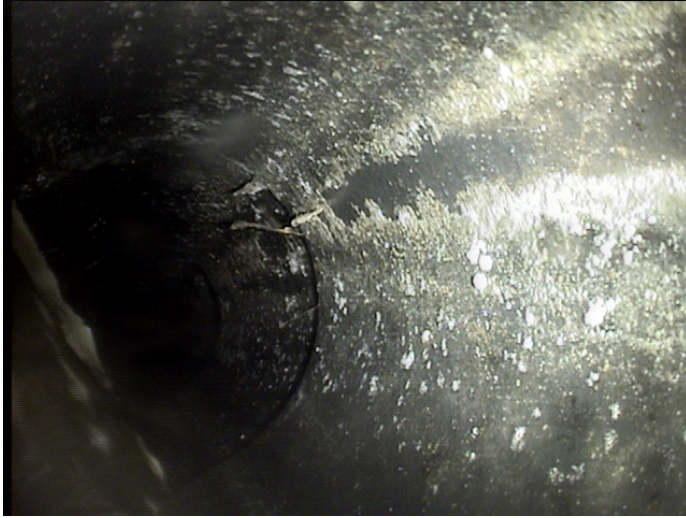
Code: **DSF**
Description: **Deposits Settled Fine**

Distance (ft): **135.3**
Structural Grade: **0**
O&M Grade: **2**
Clock Start/From: **4**
Clock To: **8**
1st Value:
2nd Value:
Value Percent: **5.000**
Continuous Index:
Within 8" of Joint: **NO**
Remarks:

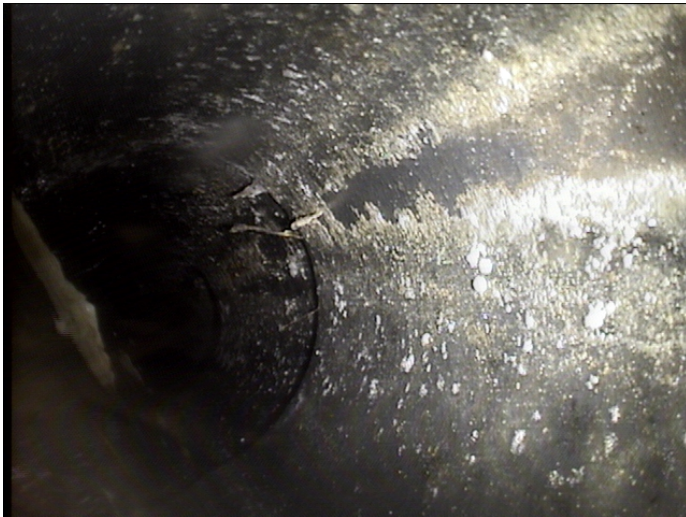
Code: **MWL**
Description: **Water Level**

Distance (ft): **135.3**
Structural Grade: **0**
O&M Grade: **0**
Clock Start/From:
Clock To:
1st Value:
2nd Value:
Value Percent: **30.000**
Continuous Index:
Within 8" of Joint: **NO**
Remarks:

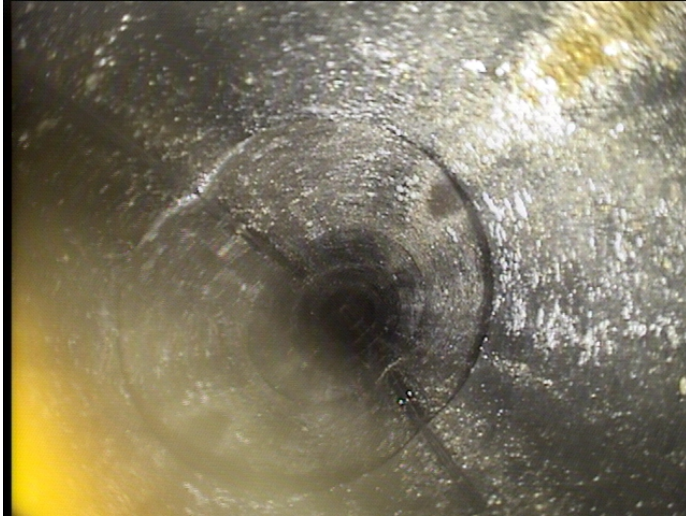
Code:	MSA
Description:	Abandoned Survey
Distance (ft):	136.7
Structural Grade:	0
O&M Grade:	0
Clock Start/From:	
Clock To:	
1st Value:	
2nd Value:	
Value Percent:	
Continuous Index:	
Within 8" of Joint:	NO
Remarks:	Cannot pass debris under flow.
