# Profile/Photo Observation Report

Date:	<b>02/24/2022</b>	Weather:		Coding:	<b>PACP 7.0</b>
Pipe Length (ft):	<b>301.0</b>	Owner:	<b>City of Hobart</b>	Pre Clean:	<b>Heavy Cleaning</b>
P.O.#:	<b>YES502259</b>	Surveyor:	<b>S. Bucklin</b>	PSR:	<b>P-706-008.1-008</b>
Customer:	<b>City of Hobart, IN (Red</b>	Clean Date:	<b>02/19/2022</b>	Shape:	<b>C</b>

Street:	<b>South Garfield Street</b>	Flow Control:	<b>Not Controlled</b>
City:	<b>Hobart, IN</b>	Year Renewed:	
Location:	<b>Local rural streets with light traffic, t</b>	Tape/Media #:	
Purpose:	<b>Routine Assessment</b>	Dia/Height:	<b>8"</b>
Use:	<b>Sanitary Sewage Pipe</b>	Material:	<b>VCP</b>
Drain Area:		Lining:	<b>None</b>
Category:	<b>NA</b>		
Comment:			
Location Details:		Direction of Survey:	<b>Downstream</b>
US MH:	<b>M-706-008.1</b>	DS MH:	<b>M-706-008</b>
		Total Length Surveyed (ft):	<b>300.0</b>

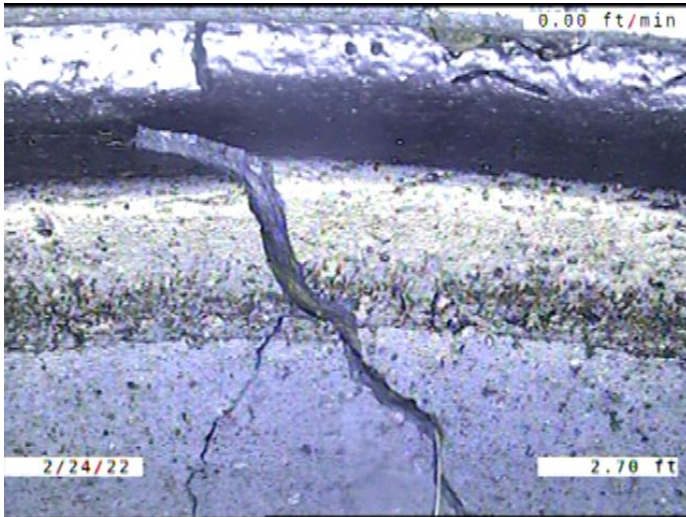
Code: **B**  
Description: **Broken**

Distance (ft): **2.7**  
Structural Grade: **4**  
O&M Grade: **0**  
Clock Start/From: **12**  
Clock To: **12**  
1st Value:  
2nd Value:  
Value Percent:  
Continuous Index:  
Within 8" of Joint: **YES**  
Remarks:

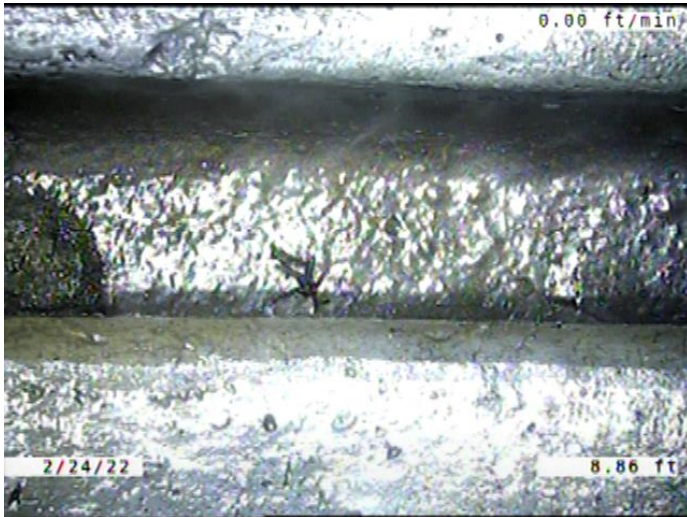
Code: **JAM**  
 Description: **Joint Angular Medium**

Distance (ft): **8.9**  
 Structural Grade: **3**  
 O&M Grade: **0**  
 Clock Start/From:  
 Clock To:  
 1st Value:  
 2nd Value:  
 Value Percent:  
 Continuous Index:  
 Within 8" of Joint: **NO**  
 Remarks:

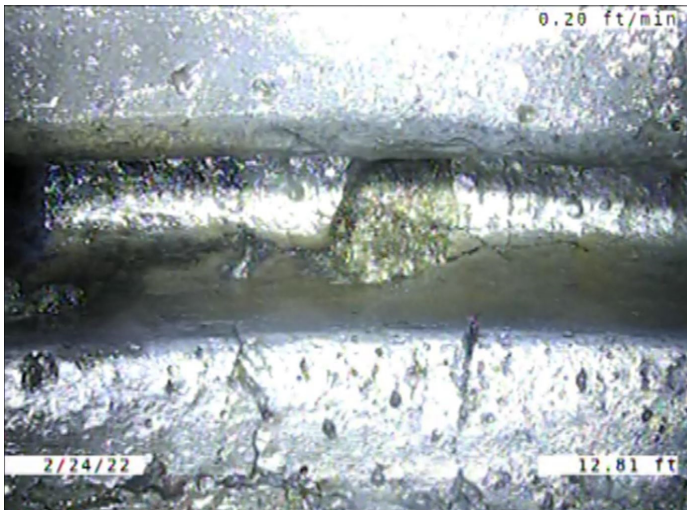
Code: **FM**  
 Description: **Fracture Multiple**

Distance (ft): **12.8**  
 Structural Grade: **4**  
 O&M Grade: **0**  
 Clock Start/From: **8**  
 Clock To: **4**  
 1st Value:  
 2nd Value:  
 Value Percent:  
 Continuous Index: **S14**  
 Within 8" of Joint: **YES**  
 Remarks: **Wandering**

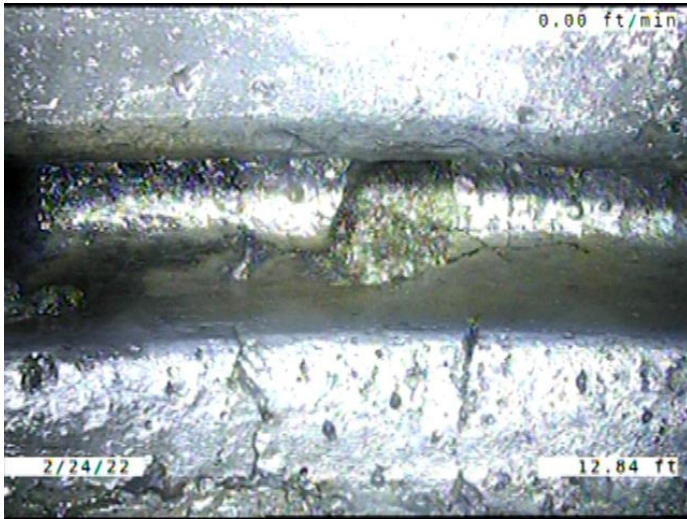
Code: **JAM**  
 Description: **Joint Angular Medium**

Distance (ft): **12.8**  
 Structural Grade: **3**  
 O&M Grade: **0**  
 Clock Start/From:  
 Clock To:  
 1st Value:  
 2nd Value:  
 Value Percent:  
 Continuous Index:  
 Within 8" of Joint: **NO**  
 Remarks:

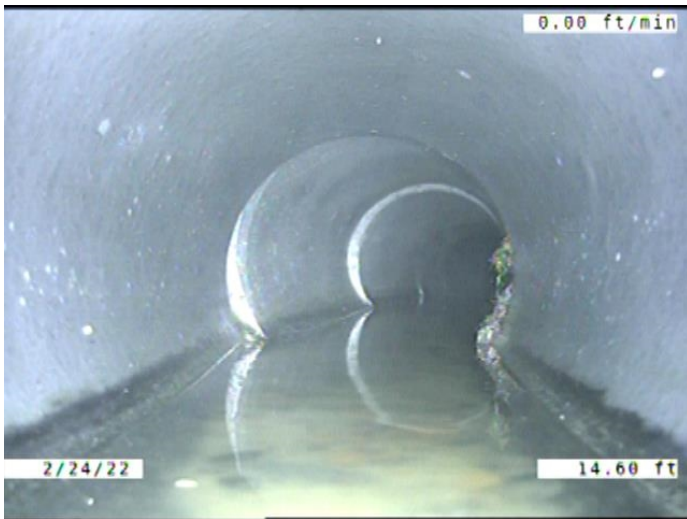
Code: **LR**  
 Description: **Line Right**

Distance (ft): **14.6**  
 Structural Grade: **0**  
 O&M Grade: **1**  
 Clock Start/From:  
 Clock To:  
 1st Value:  
 2nd Value:  
 Value Percent: **10.000**  
 Continuous Index:  
 Within 8" of Joint: **NO**  
 Remarks:

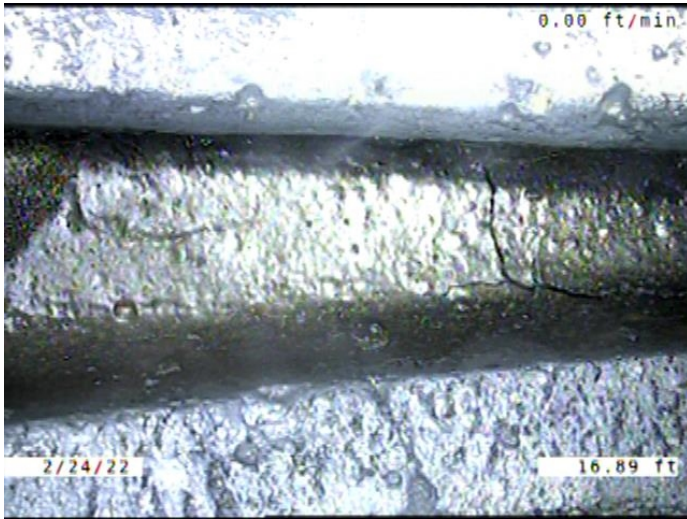
Code: **JAM**  
Description: **Joint Angular Medium**

Distance (ft): **16.9**  
Structural Grade: **3**  
O&M Grade: **0**  
Clock Start/From:  
Clock To:  
1st Value:  
2nd Value:  
Value Percent:  
Continuous Index:  
Within 8" of Joint: **NO**  
Remarks:

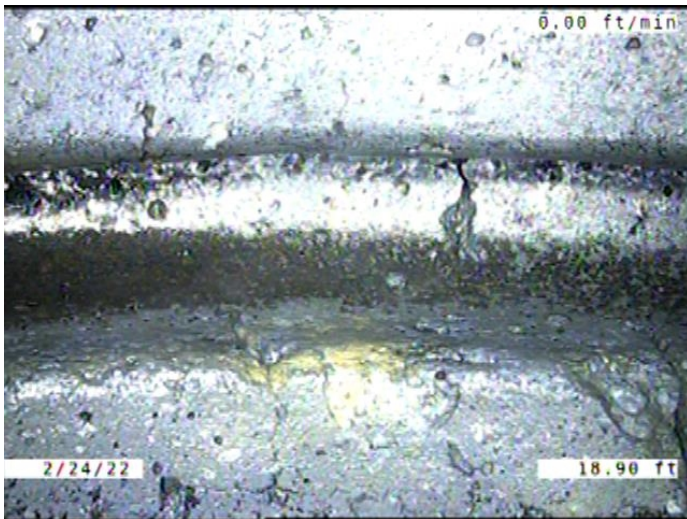
Code: **JAM**  
Description: **Joint Angular Medium**

Distance (ft): **18.9**  
Structural Grade: **3**  
O&M Grade: **0**  
Clock Start/From:  
Clock To:  
1st Value:  
2nd Value:  
Value Percent:  
Continuous Index:  
Within 8" of Joint: **NO**  
Remarks:

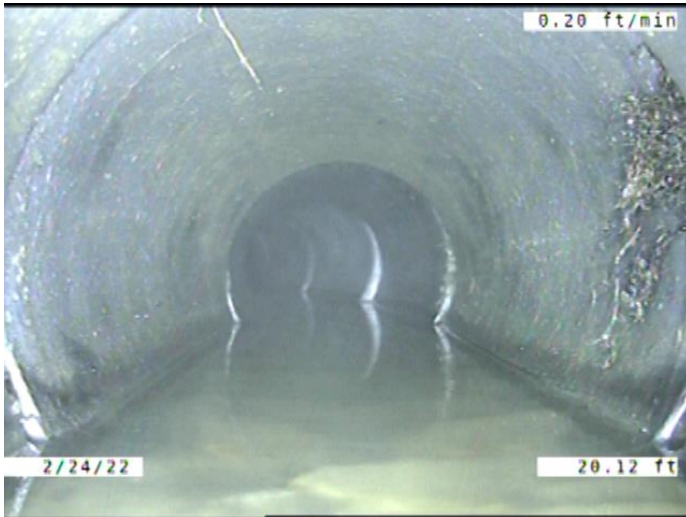
Code: **DSF**  
 Description: **Deposits Settled Fine**

Distance (ft): **20.1**  
 Structural Grade: **0**  
 O&M Grade: **2**  
 Clock Start/From: **5**  
 Clock To: **7**  
 1st Value:  
 2nd Value:  
 Value Percent: **5.000**  
 Continuous Index: **S03**  
 Within 8" of Joint: **YES**  
 Remarks:

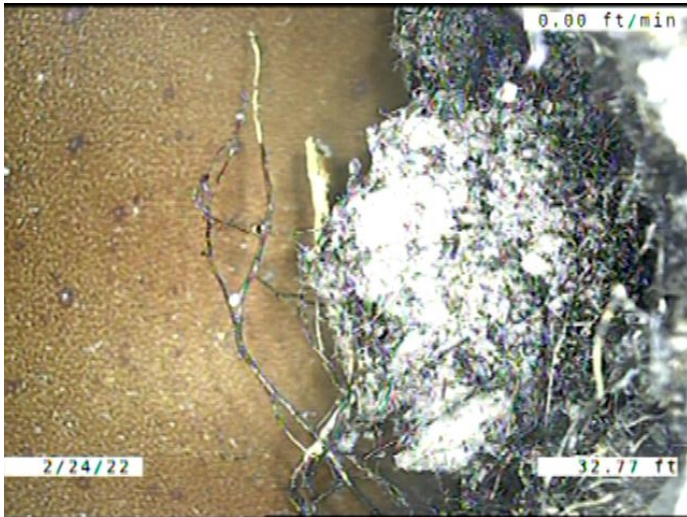
Code: **TBI**  
 Description: **Tap Break-in Intruding**

Distance (ft): **32.8**  
 Structural Grade: **0**  
 O&M Grade: **2**  
 Clock Start/From: **1**  
 Clock To:  
 1st Value: **6.000**  
 2nd Value: **2.000**  
 Value Percent:  
 Continuous Index:  
 Within 8" of Joint: **YES**  
 Remarks:

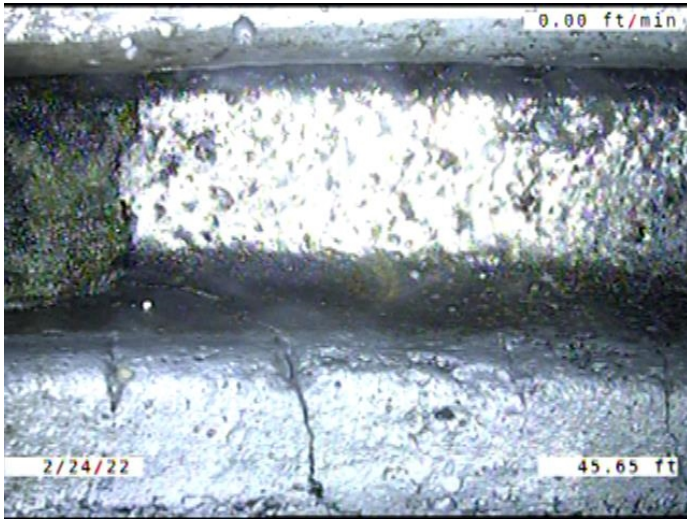
Code: **JAL**  
 Description: **Joint Angular Large**

Distance (ft): **45.6**  
 Structural Grade: **4**  
 O&M Grade: **0**  
 Clock Start/From:  
 Clock To:  
 1st Value:  
 2nd Value:  
 Value Percent:  
 Continuous Index:  
 Within 8" of Joint: **NO**  
 Remarks:

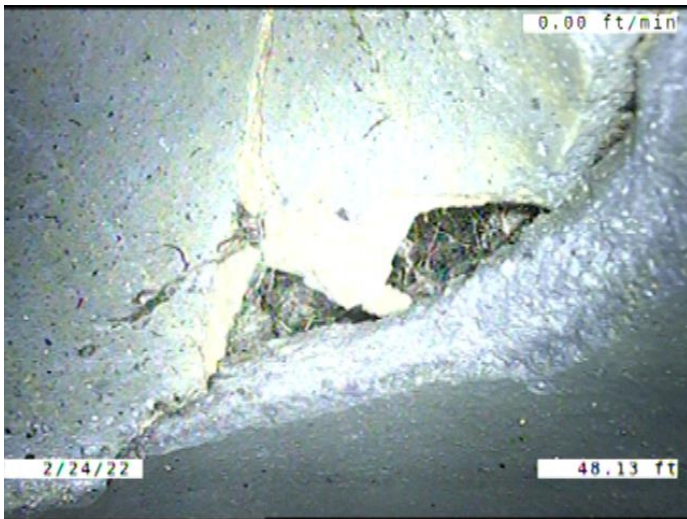
Code: **SSS**  
 Description: **Surface Damage Surface Spalling**

Distance (ft): **48.1**  
 Structural Grade: **2**  
 O&M Grade: **0**  
 Clock Start/From: **8**  
 Clock To: **11**  
 1st Value:  
 2nd Value:  
 Value Percent:  
 Continuous Index:  
 Within 8" of Joint: **YES**  
 Remarks:

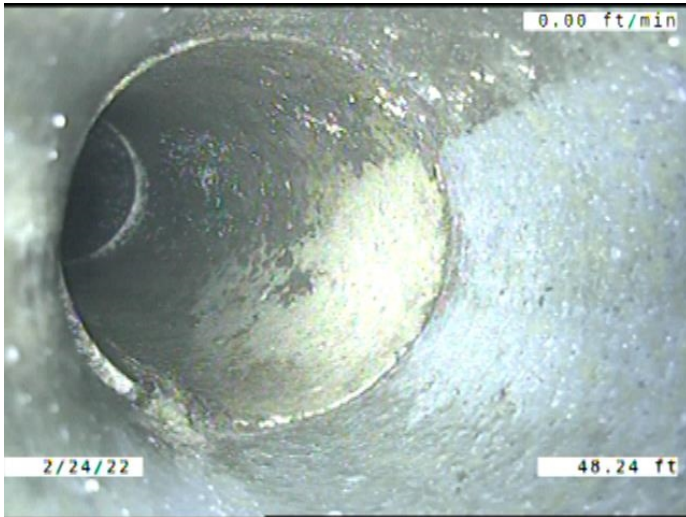
Code: **TBI**  
Description: **Tap Break-in Intruding**

Distance (ft): **48.2**  
Structural Grade: **0**  
O&M Grade: **2**  
Clock Start/From: **10**  
Clock To:  
1st Value: **6.000**  
2nd Value: **1.000**  
Value Percent:  
Continuous Index:  
Within 8" of Joint: **YES**  
Remarks:

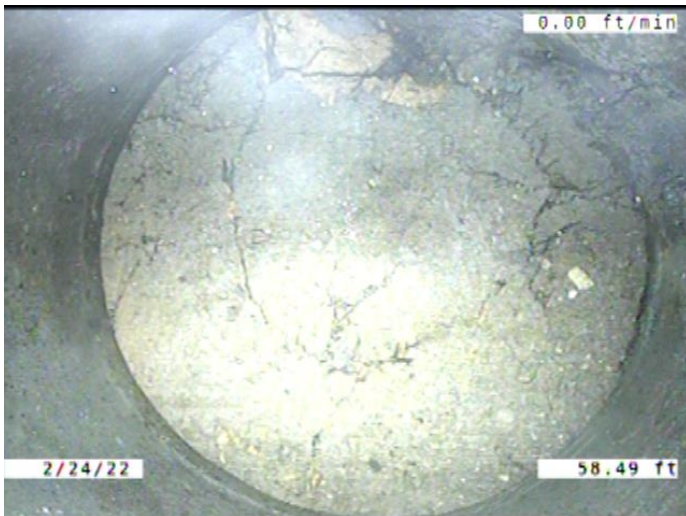
Code: **TFD**  
Description: **Tap Factory Defective**

Distance (ft): **58.5**  
Structural Grade: **0**  
O&M Grade: **3**  
Clock Start/From: **2**  
Clock To:  
1st Value: **6.000**  
2nd Value:  
Value Percent:  
Continuous Index:  
Within 8" of Joint: **YES**  
Remarks: **CAPPED. CAP BROKEN. ROOTS GROWING AROUND IT AND THROU**

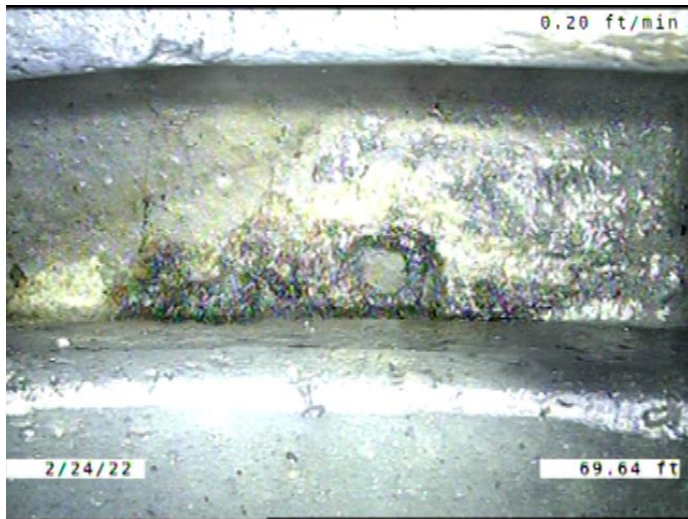
Code: **JAL**  
Description: **Joint Angular Large**

Distance (ft): **69.6**  
Structural Grade: **4**  
O&M Grade: **0**  
Clock Start/From:  
Clock To:  
1st Value:  
2nd Value:  
Value Percent:  
Continuous Index:  
Within 8" of Joint: **NO**  
Remarks:

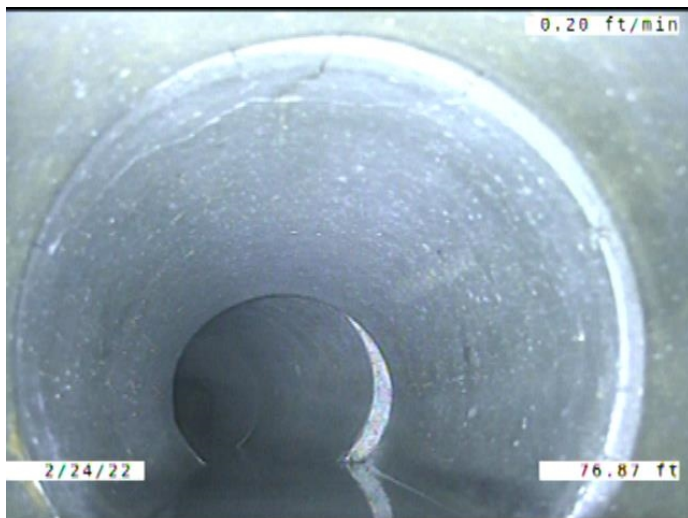
Code: **LL**  
Description: **Line Left**

Distance (ft): **76.9**  
Structural Grade: **0**  
O&M Grade: **2**  
Clock Start/From:  
Clock To:  
1st Value:  
2nd Value:  
Value Percent: **15.000**  
Continuous Index:  
Within 8" of Joint: **NO**  
Remarks:

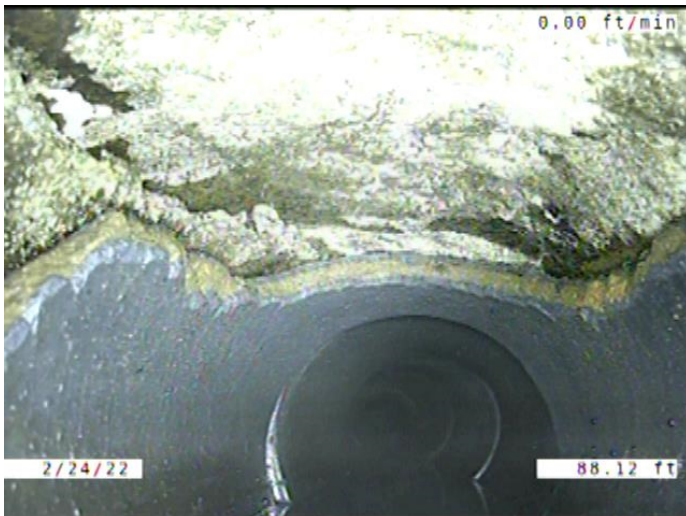
Code: **RPP**  
Description: **Point Repair Patch**

Distance (ft): **88.1**  
Structural Grade: **0**  
O&M Grade: **0**  
Clock Start/From: **9**  
Clock To: **4**  
1st Value:  
2nd Value:  
Value Percent:  
Continuous Index:  
Within 8" of Joint: **YES**  
Remarks: **LOOKS TO HAVE BEEN REPAIRED**

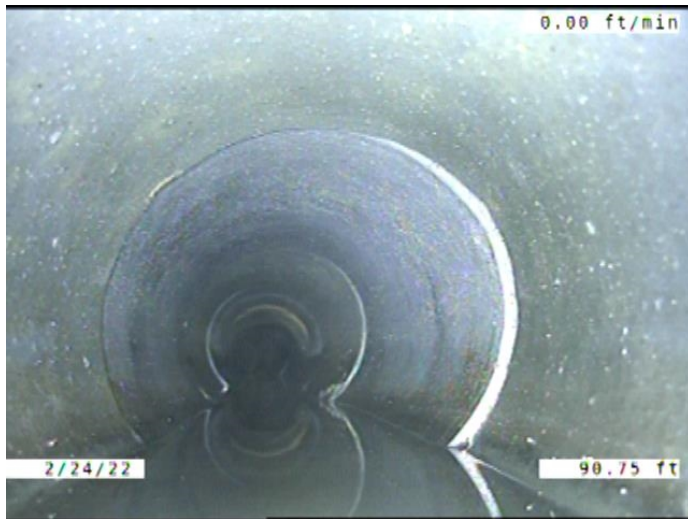
Code: **MWLS**  
 Description: **Miscellaneous Water Level Sag**

Distance (ft): **90.7**  
 Structural Grade: **2**  
 O&M Grade: **0**  
 Clock Start/From:  
 Clock To:  
 1st Value:  
 2nd Value:  
 Value Percent: **10.000**  
 Continuous Index:  
 Within 8" of Joint: **NO**  
 Remarks:

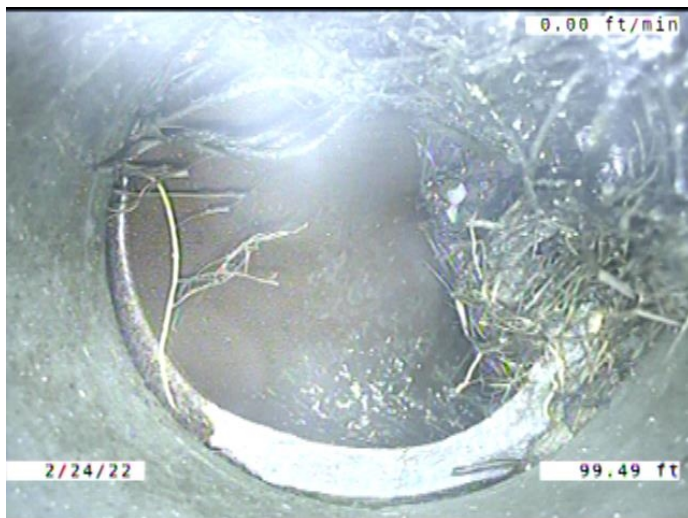
Code: **TF**  
 Description: **Tap Factory**

Distance (ft): **99.5**  
 Structural Grade: **0**  
 O&M Grade: **0**  
 Clock Start/From: **2**  
 Clock To:  
 1st Value: **6.000**  
 2nd Value:  
 Value Percent:  
 Continuous Index:  
 Within 8" of Joint: **YES**  
 Remarks: **ROOTS GROWING FROM THE MAIN TO SERVICE CONNECTION**

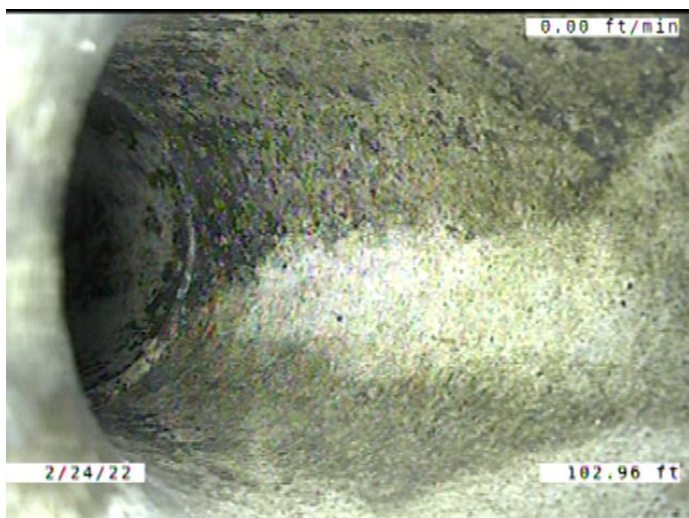
Code: **TBI**  
 Description: **Tap Break-in Intruding**

Distance (ft): **103.0**  
 Structural Grade: **0**  
 O&M Grade: **2**  
 Clock Start/From: **11**  
 Clock To:  
 1st Value: **6.000**  
 2nd Value: **1.000**  
 Value Percent:  
 Continuous Index:  
 Within 8" of Joint: **YES**  
 Remarks:

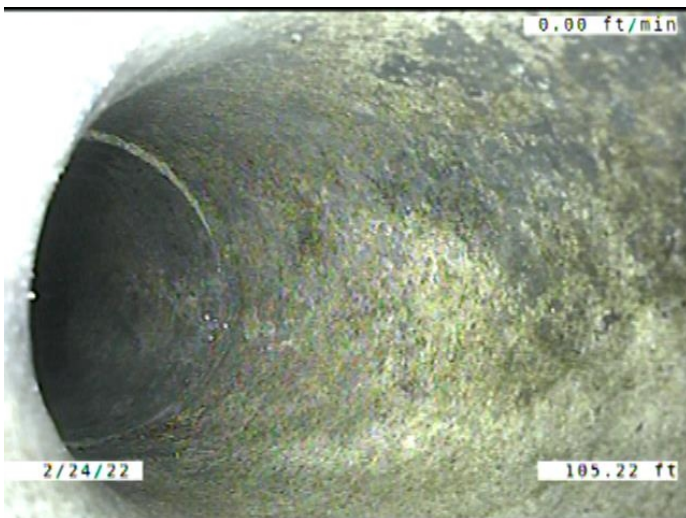
Code: **TBI**  
Description: **Tap Break-in Intruding**

Distance (ft): **105.2**  
Structural Grade: **0**  
O&M Grade: **2**  
Clock Start/From: **11**  
Clock To:  
1st Value: **6.000**  
2nd Value: **1.000**  
Value Percent:  
Continuous Index:  
Within 8" of Joint: **YES**  
Remarks:

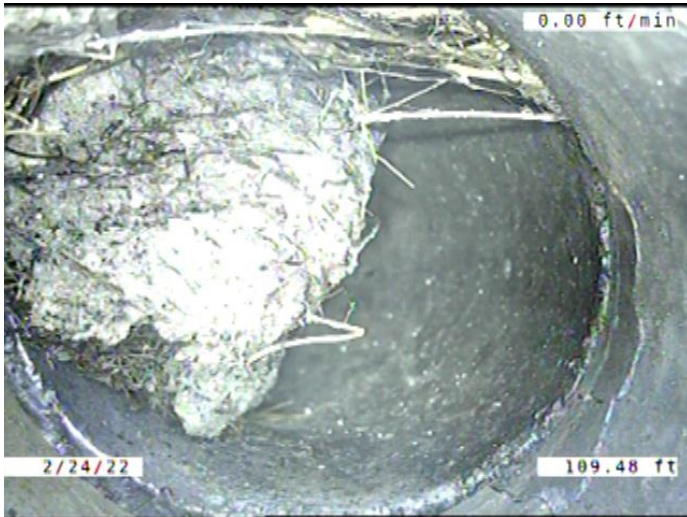
Code:	<b>TF</b>
Description:	<b>Tap Factory</b>
Distance (ft):	<b>109.5</b>
Structural Grade:	<b>0</b>
O&M Grade:	<b>0</b>
Clock Start/From:	<b>11</b>
Clock To:	
1st Value:	<b>6.000</b>
2nd Value:	
Value Percent:	
Continuous Index:	
Within 8" of Joint:	<b>YES</b>
Remarks:	<b>80% PLUGGED WITH ROOTS</b>

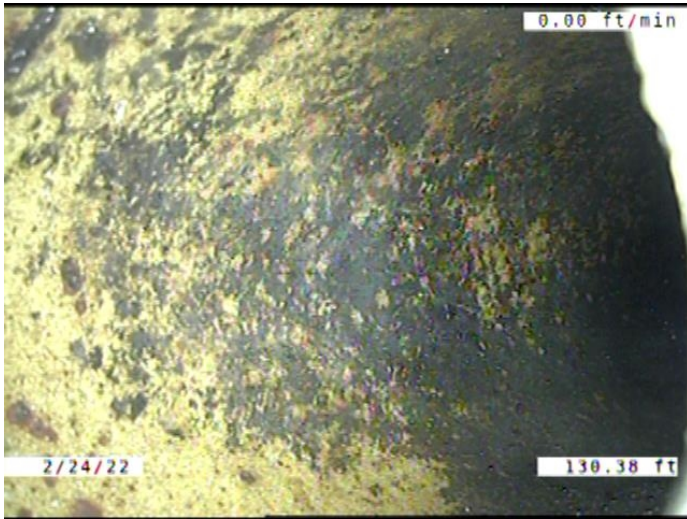
Code: **TBI**  
 Description: **Tap Break-in Intruding**

Distance (ft): **130.4**  
 Structural Grade: **0**  
 O&M Grade: **2**  
 Clock Start/From: **1**  
 Clock To:  
 1st Value: **6.000**  
 2nd Value: **1.000**  
 Value Percent:  
 Continuous Index:  
 Within 8" of Joint: **YES**  
 Remarks:

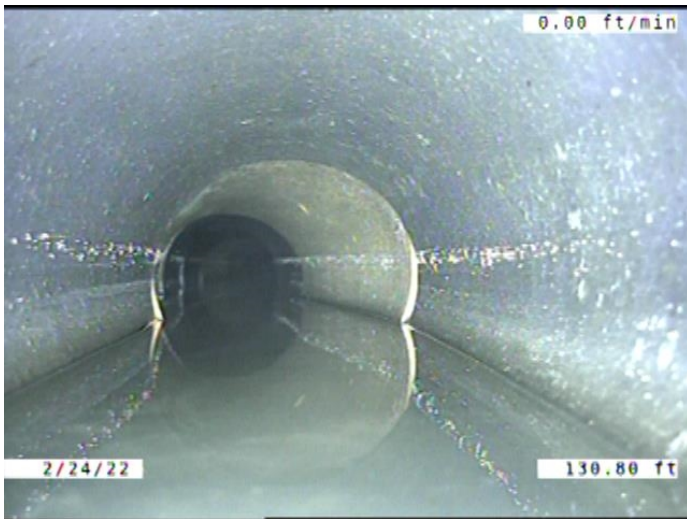
Code: **MWLS**  
 Description: **Miscellaneous Water Level Sag**

Distance (ft): **130.8**  
 Structural Grade: **2**  
 O&M Grade: **0**  
 Clock Start/From:  
 Clock To:  
 1st Value:  
 2nd Value:  
 Value Percent: **15.000**  
 Continuous Index: **F04**  
 Within 8" of Joint: **NO**  
 Remarks:

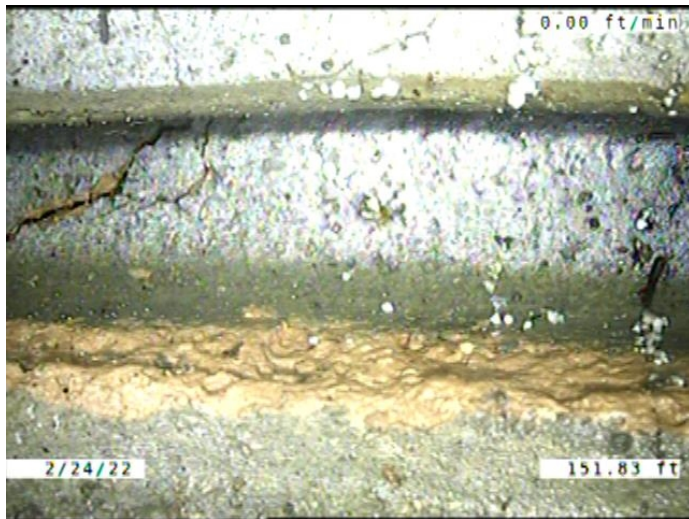
Code: **JAL**  
 Description: **Joint Angular Large**

Distance (ft): **151.8**  
 Structural Grade: **4**  
 O&M Grade: **0**  
 Clock Start/From:  
 Clock To:  
 1st Value:  
 2nd Value:  
 Value Percent:  
 Continuous Index:  
 Within 8" of Joint: **NO**  
 Remarks:

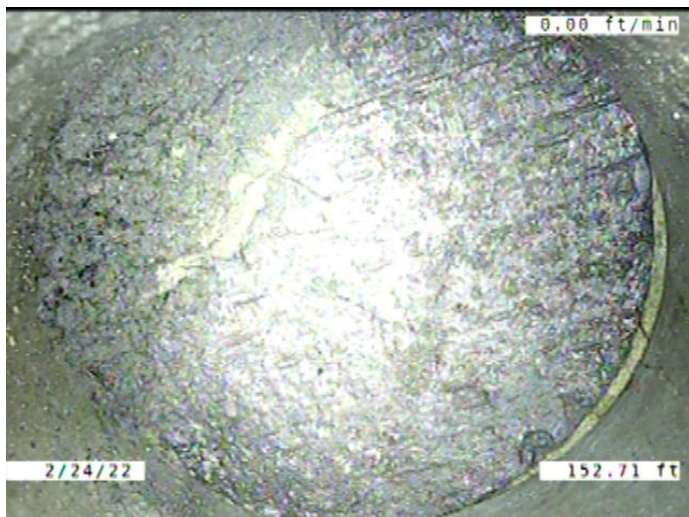
Code: **TFC**  
 Description: **Tap Factory Capped**

Distance (ft): **152.7**  
 Structural Grade: **0**  
 O&M Grade: **0**  
 Clock Start/From: **11**  
 Clock To:  
 1st Value: **6.000**  
 2nd Value:  
 Value Percent:  
 Continuous Index:  
 Within 8" of Joint: **YES**  
 Remarks: **ROOTS GROWING AROUND THE CAP**

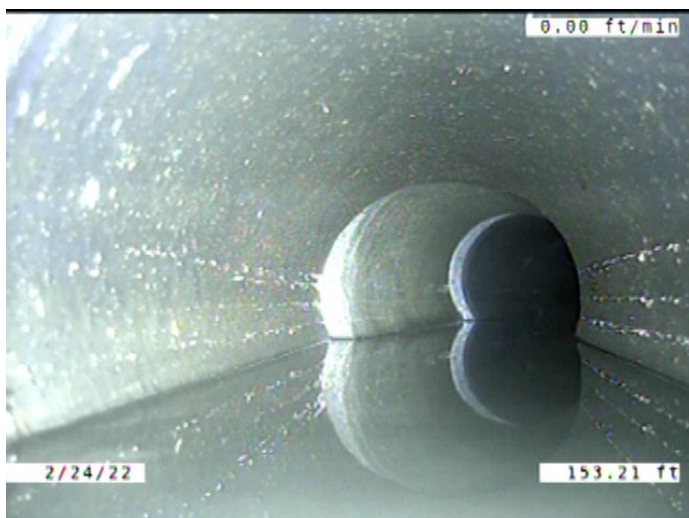
Code: **LR**  
 Description: **Line Right**

Distance (ft): **153.2**  
 Structural Grade: **0**  
 O&M Grade: **4**  
 Clock Start/From:  
 Clock To:  
 1st Value:  
 2nd Value:  
 Value Percent: **25.000**  
 Continuous Index: **S05**  
 Within 8" of Joint: **NO**  
 Remarks:

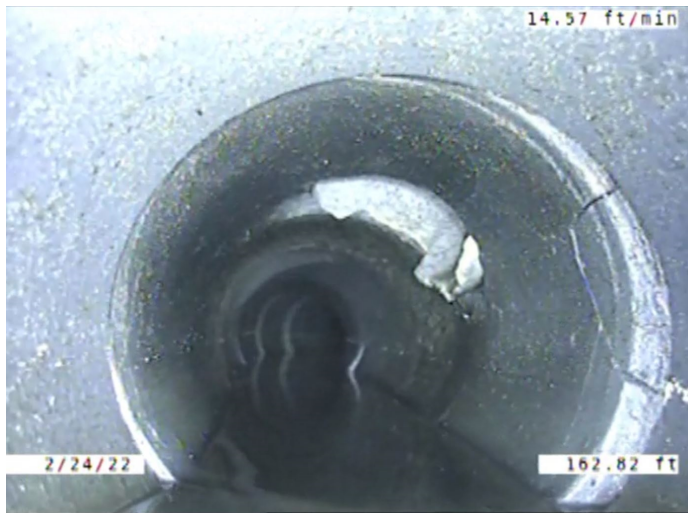
Code: **B**  
 Description: **Broken**

Distance (ft): **162.8**  
 Structural Grade: **4**  
 O&M Grade: **0**  
 Clock Start/From: **12**  
 Clock To: **3**  
 1st Value:  
 2nd Value:  
 Value Percent:  
 Continuous Index:  
 Within 8" of Joint: **YES**  
 Remarks:

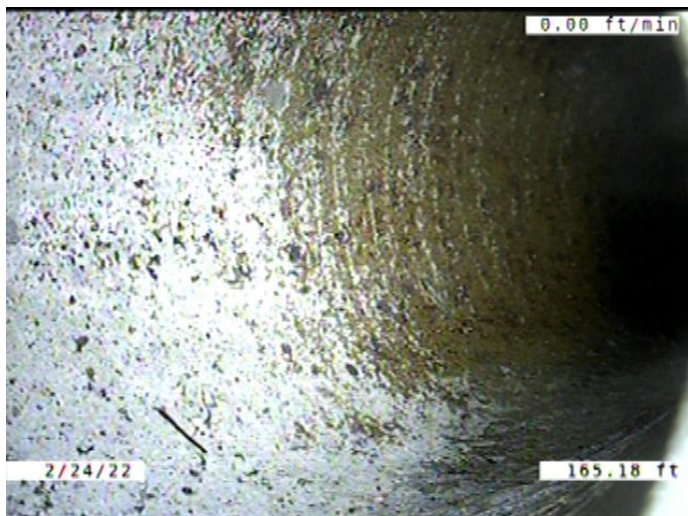
Code: **TBI**  
 Description: **Tap Break-in Intruding**

Distance (ft): **165.2**  
 Structural Grade: **0**  
 O&M Grade: **2**  
 Clock Start/From: **1**  
 Clock To:  
 1st Value: **6.000**  
 2nd Value: **1.000**  
 Value Percent:  
 Continuous Index:  
 Within 8" of Joint: **YES**  
 Remarks: **CONSTANTLY RUNNING WATER**

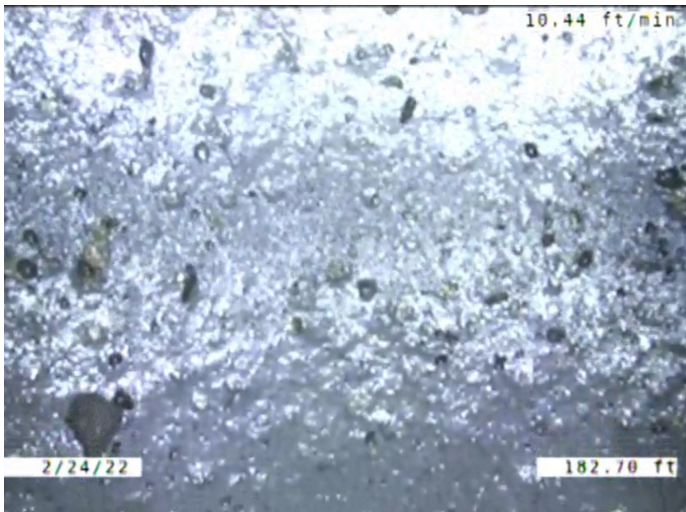
Code: **FM**  
Description: **Fracture Multiple**

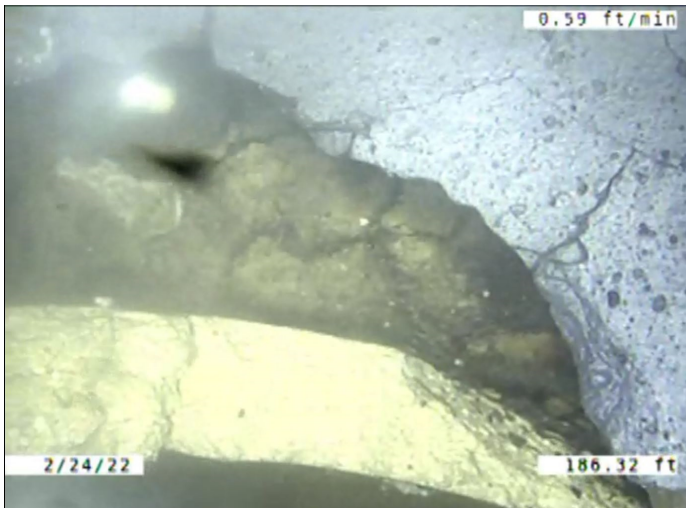
Code:	<b>FM</b>
Description:	<b>Fracture Multiple</b>
Distance (ft):	<b>186.3</b>
Structural Grade:	<b>4</b>
O&M Grade:	<b>0</b>
Clock Start/From:	<b>10</b>
Clock To:	<b>2</b>
1st Value:	
2nd Value:	
Value Percent:	
Continuous Index:	<b>S15</b>
Within 8" of Joint:	<b>NO</b>
Remarks:	<b>Visible through water. Wandering</b>

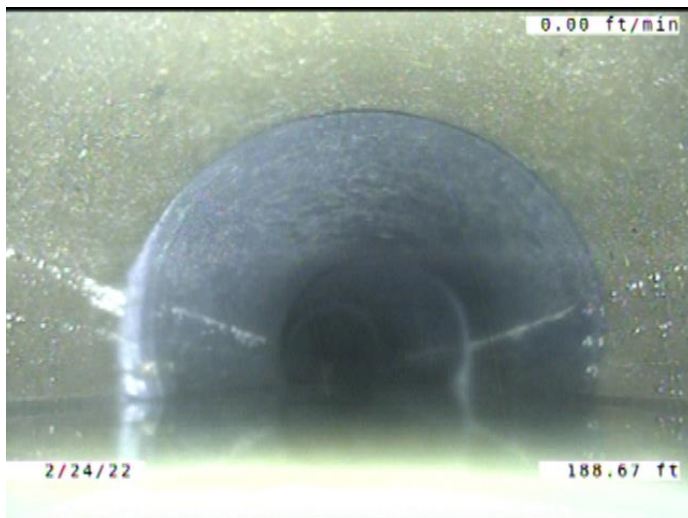
Code: **MCU**  
Description: **Miscellaneous Camera Underwater**

Distance (ft): **188.7**  
Structural Grade: **0**  
O&M Grade: **4**  
Clock Start/From:  
Clock To:  
1st Value:  
2nd Value:  
Value Percent:  
Continuous Index: **F11**  
Within 8" of Joint: **NO**  
Remarks:

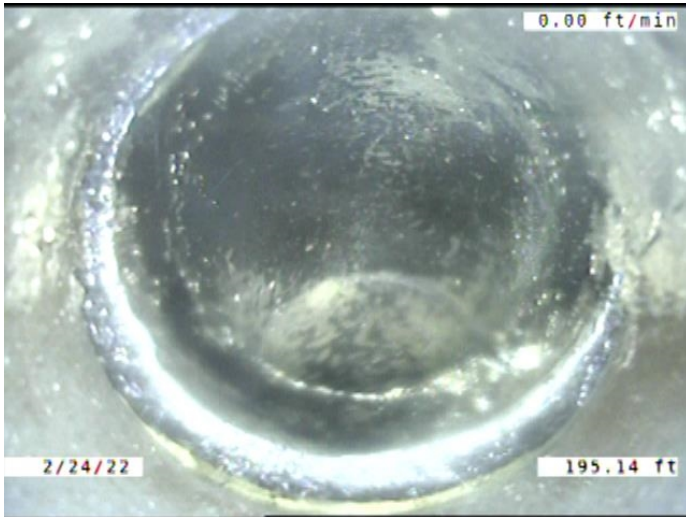
Code: **TFD**  
Description: **Tap Factory Defective**

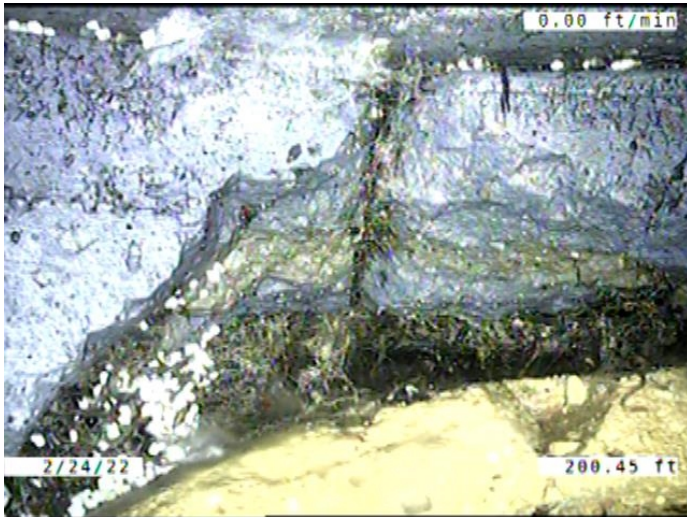
Code:	<b>SSS</b>
Description:	<b>Surface Damage Surface Spalling</b>
Distance (ft):	<b>200.4</b>
Structural Grade:	<b>2</b>
O&M Grade:	<b>0</b>
Clock Start/From:	<b>9</b>
Clock To:	<b>12</b>
1st Value:	
2nd Value:	
Value Percent:	
Continuous Index:	
Within 8" of Joint:	<b>YES</b>
Remarks:

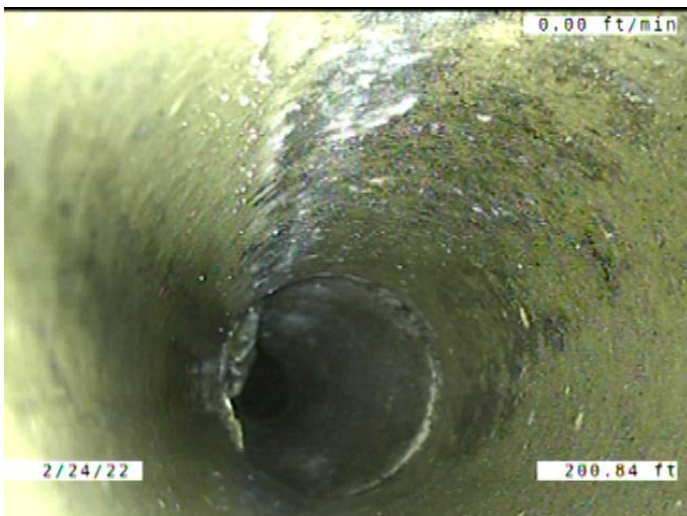
Code:	<b>TBI</b>
Description:	<b>Tap Break-in Intruding</b>
Distance (ft):	<b>200.8</b>
Structural Grade:	<b>0</b>
O&M Grade:	<b>2</b>
Clock Start/From:	<b>10</b>
Clock To:	
1st Value:	<b>6.000</b>
2nd Value:	<b>1.000</b>
Value Percent:	
Continuous Index:	
Within 8" of Joint:	<b>YES</b>
Remarks:

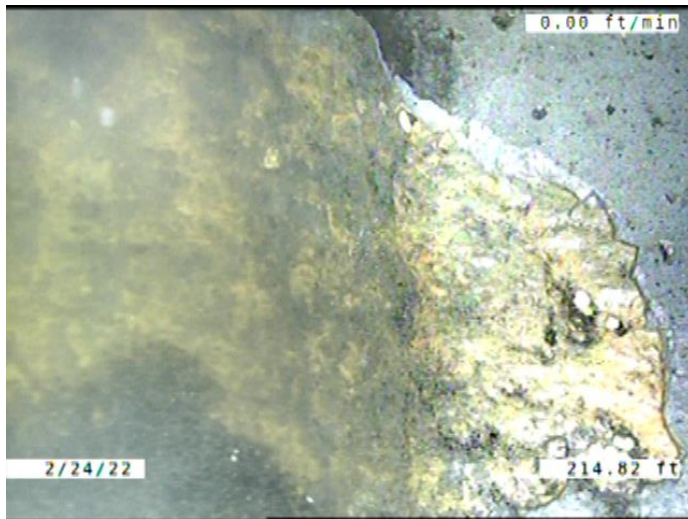
Code: **SSS**  
 Description: **Surface Damage Surface Spalling**

Distance (ft): **214.8**  
 Structural Grade: **2**  
 O&M Grade: **0**  
 Clock Start/From: **4**  
 Clock To: **5**  
 1st Value:  
 2nd Value:  
 Value Percent:  
 Continuous Index:  
 Within 8" of Joint: **YES**  
 Remarks:

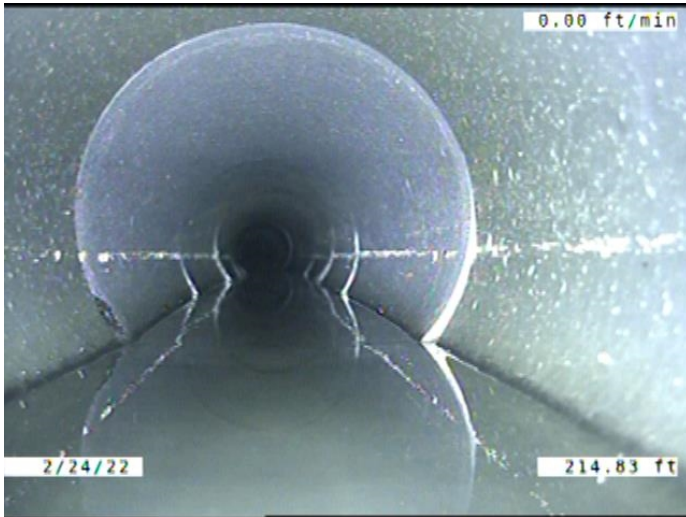
Code: **LL**  
Description: **Line Left**

Distance (ft): **214.8**  
Structural Grade: **0**  
O&M Grade: **2**  
Clock Start/From:  
Clock To:  
1st Value:  
2nd Value:  
Value Percent: **15.000**  
Continuous Index: **F09**  
Within 8" of Joint: **NO**  
Remarks:

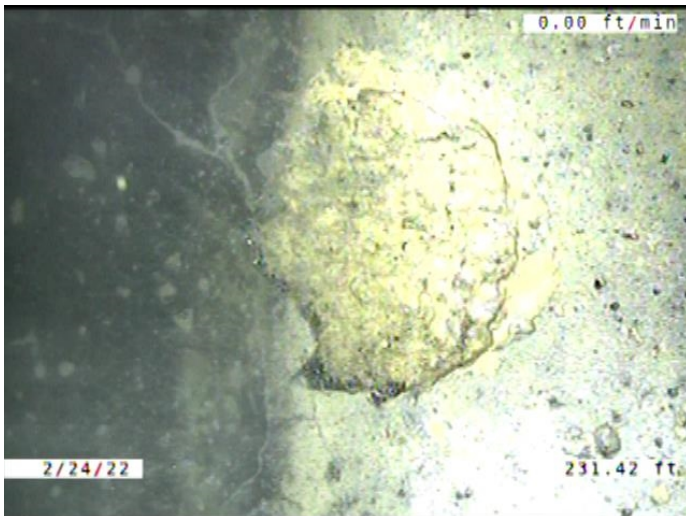
Code: **SSS**  
Description: **Surface Damage Surface Spalling**

Distance (ft): **231.4**  
Structural Grade: **2**  
O&M Grade: **0**  
Clock Start/From: **5**  
Clock To:  
1st Value:  
2nd Value:  
Value Percent:  
Continuous Index:  
Within 8" of Joint: **NO**  
Remarks:

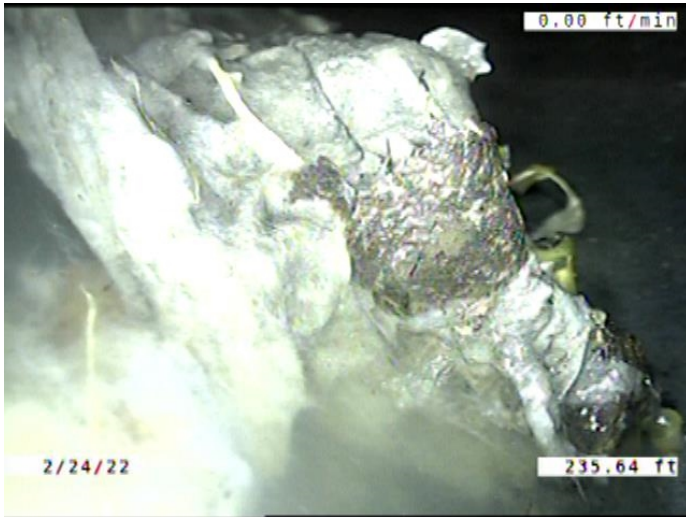
Code: **OBZ**  
 Description: **Obstruction Other**

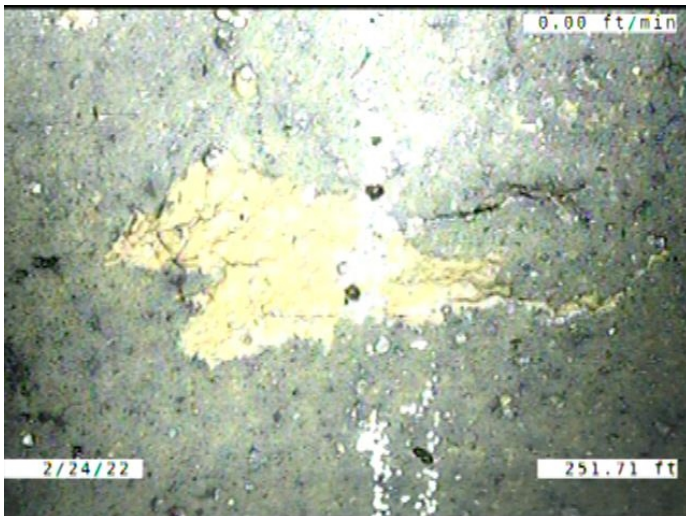
Code:	<b>SSS</b>
Description:	<b>Surface Damage Surface Spalling</b>
Distance (ft):	<b>251.7</b>
Structural Grade:	<b>2</b>
O&M Grade:	<b>0</b>
Clock Start/From:	<b>9</b>
Clock To:	<b>10</b>
1st Value:	
2nd Value:	
Value Percent:	
Continuous Index:	
Within 8" of Joint:	<b>NO</b>
Remarks:

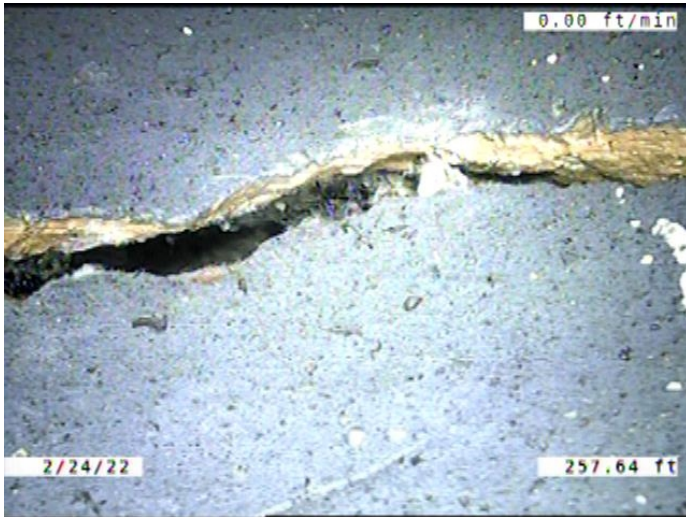
Code: **BVV**  
 Description: **Broken Void Visible**

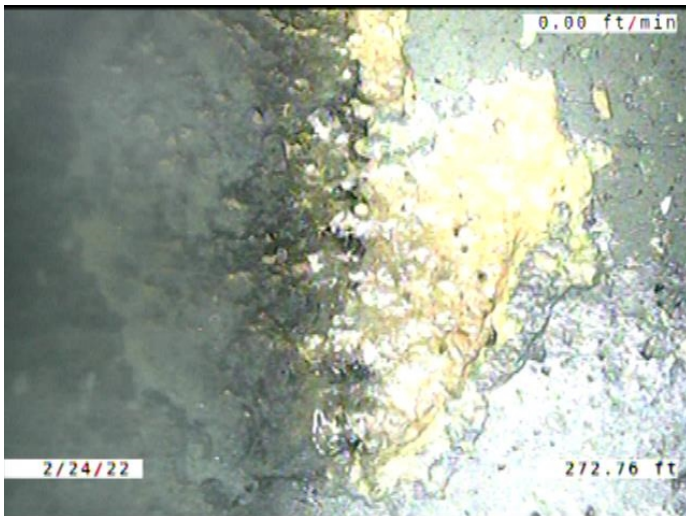
Code: **SSS**  
Description: **Surface Damage Surface Spalling**

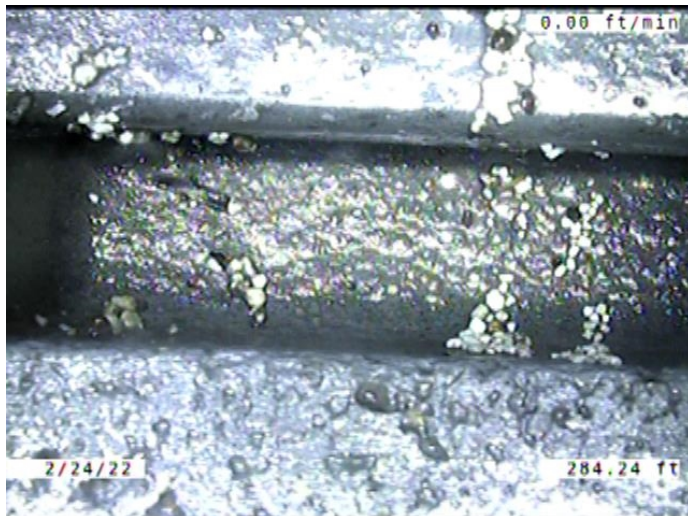
Code: **JAL**  
 Description: **Joint Angular Large**

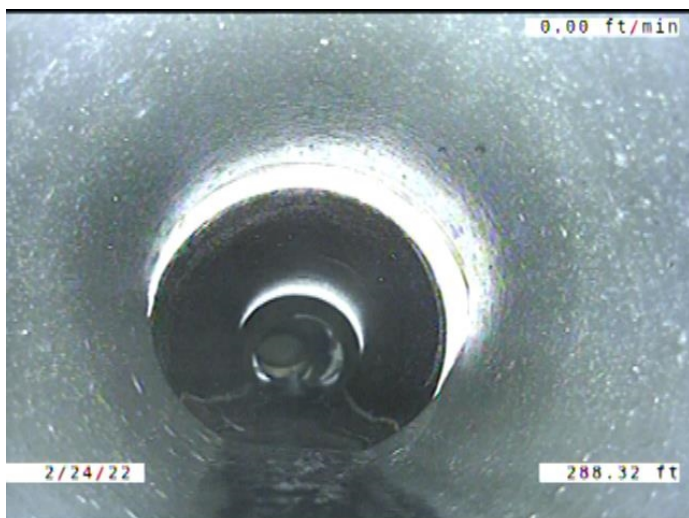
Code: **LD**  
 Description: **Line Down**

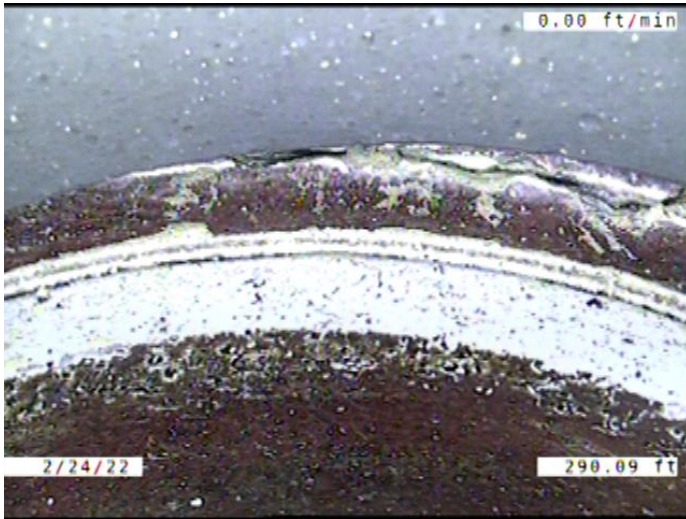
Code: **JOMD**  
 Description: **Joint Offset Medium Defective**

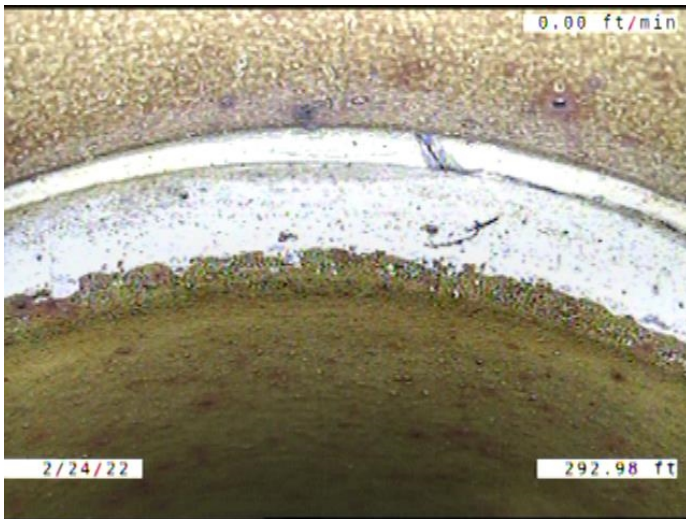
Code: **JOM**  
 Description: **Joint Offset Medium**

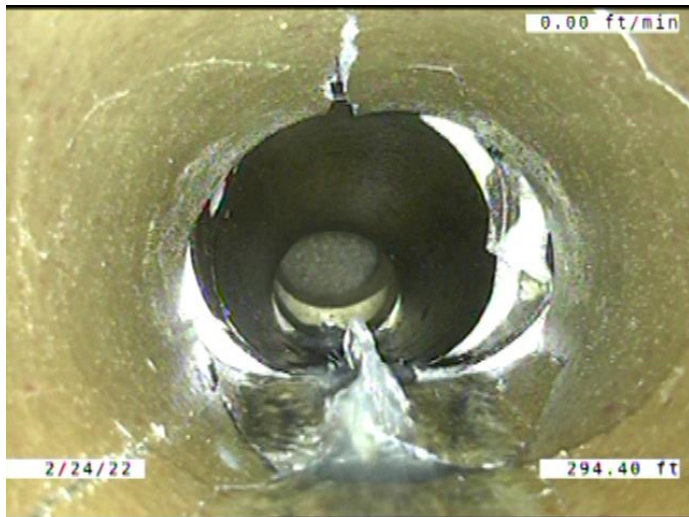
Code: **DR**  
 Description: **Deformed Rigid**

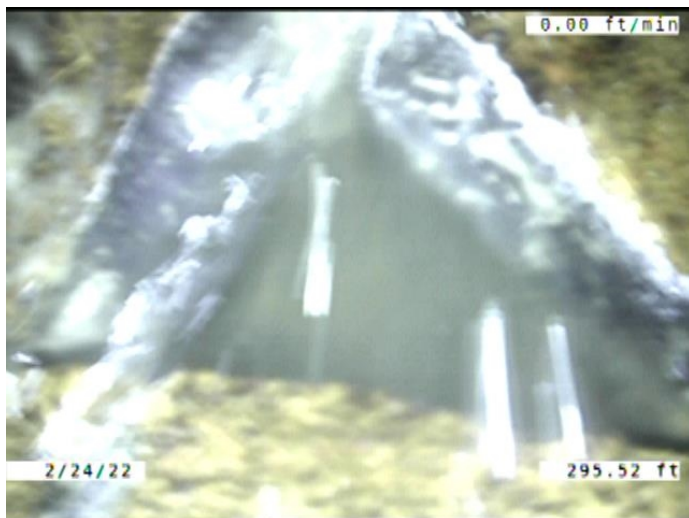
Code: **H**  
 Description: **Hole**

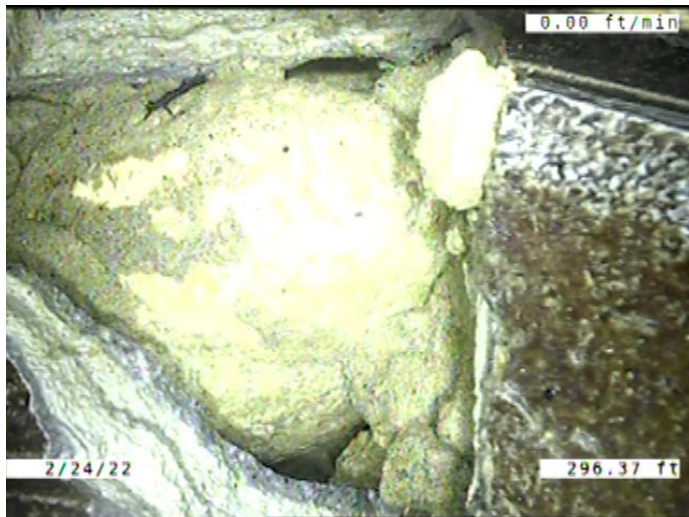
Code: **HVV**  
 Description: **Hole Void Visible**

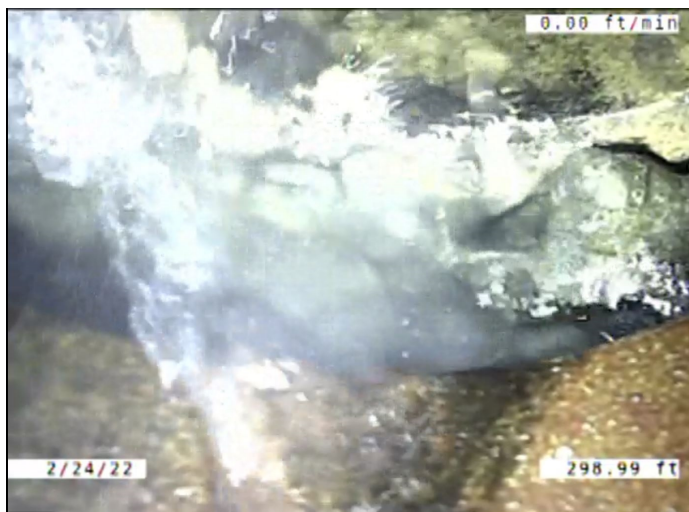
Code: **FM**  
 Description: **Fracture Multiple**

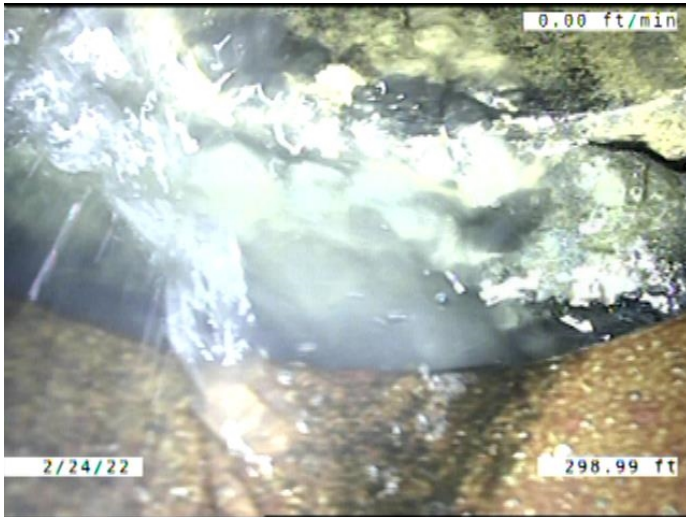
Code: **JOMD**  
 Description: **Joint Offset Medium Defective**

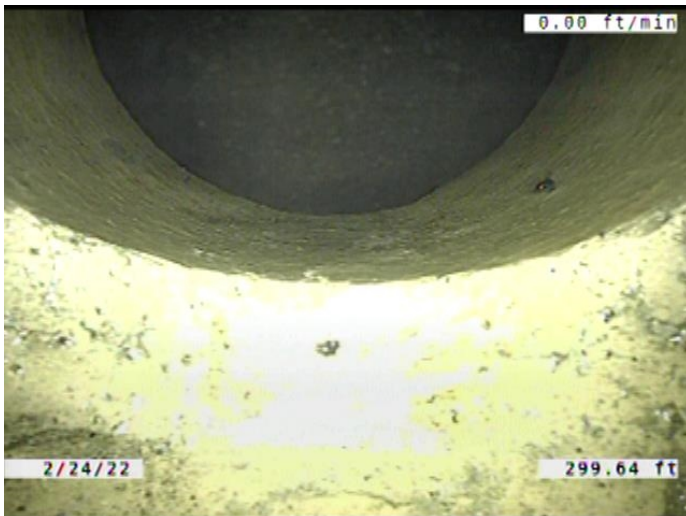
Code: **DSF**  
 Description: **Deposits Settled Fine**
