Profile/Photo Observation Report

| P.O.#: | | Surveyor: | Byrd Fitzgerald | PSR: | P-706-008.2-008.1 |

| Street: | Capitol | Flow Control: | Not Controlled |
| City: | Hobart, IN | Year Renewed: | |

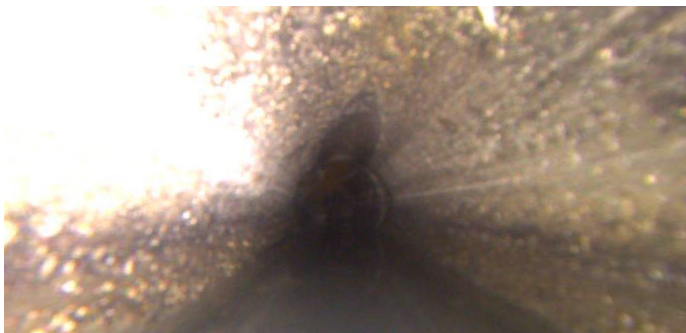
| Position | Code | Observation | Video (sec) | Grade |
|---|---|---|---|---|
| .0 | DAGS | Deposits Attached Grease | 10 | M 2 |

Code: **DAGS**
 Description: **Deposits Attached Grease**

Distance (ft): **.0**
 Structural Grade: **0**
 O&M Grade: **2**
 Clock Start/From: **8**
 Clock To: **4**
 1st Value:
 2nd Value:
 Value Percent: **10.000**
 Continuous Index:
 Within 8" of Joint: **NO**
 Remarks:

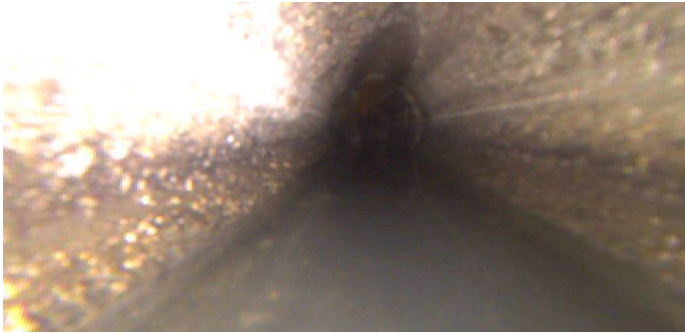
| Code: | AMH |
| Description: | Manhole |

| Remarks: | M-706-008.1 |

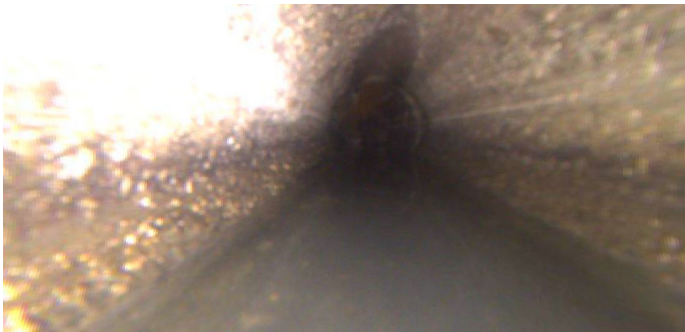
| Code: | MWL |
| Description: | Water Level |

| Value Percent: | 5.000 |

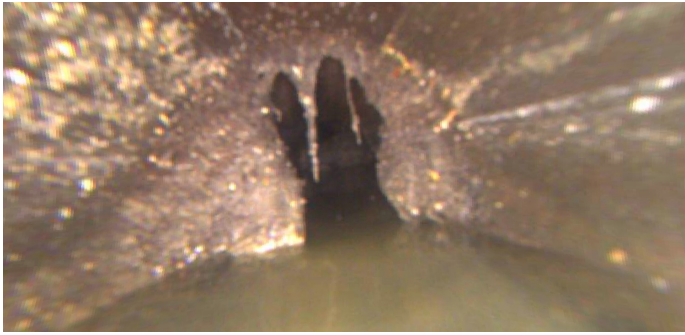
| Comment: | Roots at 4'. | | |

| Position | Code | Observation | Video (sec) | Grade |
|---|---|---|---|---|
| 4.4 | RBJ | Roots Ball Joint | 53 | M 4 |

Code: **RBJ**
Description: **Roots Ball Joint**

Distance (ft): **4.4**
Structural Grade: **0**
O&M Grade: **4**
Clock Start/From: **7**
Clock To: **5**
1st Value:
2nd Value:
Value Percent: **55.000**
Continuous Index:
Within 8" of Joint: **YES**
Remarks:

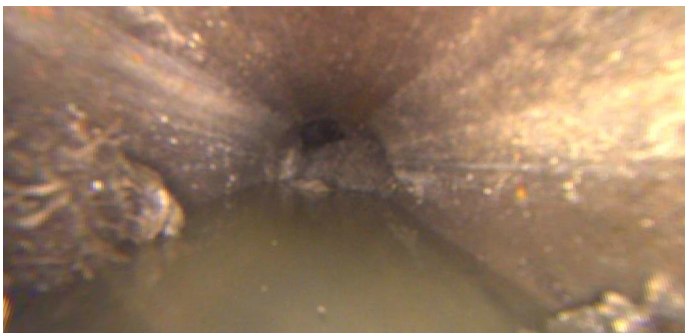
| Position | Code | Observation | Video (sec) | Grade |
|---|---|---|---|---|
| 5.3 | MSA | Abandoned Survey | 66 | NA |

Code: **MSA**
Description: **Abandoned Survey**

Distance (ft): **5.3**
Structural Grade: **0**
O&M Grade: **0**
Clock Start/From:
Clock To:
1st Value:
2nd Value:
Value Percent:
Continuous Index:
Within 8" of Joint: **NO**
Remarks: **rbj**
