Profile/Photo Observation Report

Date:	04/18/2018	Weather:		Coding:	PACP 6.0
Pipe Length (ft):	219.3	Owner:	NA	Pre Clean:	Not Known
P.O.#:		Surveyor:	Byrd Fitzgerald	PSR:	P-706-008.2-008.1
Customer:		Clean Date:	01/01/1900	Shape:	C

Street:	Capitol	Flow Control:	Not Controlled
City:	Hobart, IN	Year Renewed:	
Location:	Light Highway	Tape/Media #:	
Purpose:	Maintenance Related	Dia/Height:	8"
Use:	Sanitary	Material:	VCP
Drain Area:	NA	Lining:	Cured in Place
Category:	NA		
Comment:	roots at 1'.

Location Details:		Direction of Survey:	Upstream
US MH:	M-706-008.1	DS MH:	M-706-008.2
		Total Length Surveyed (ft):	2.5

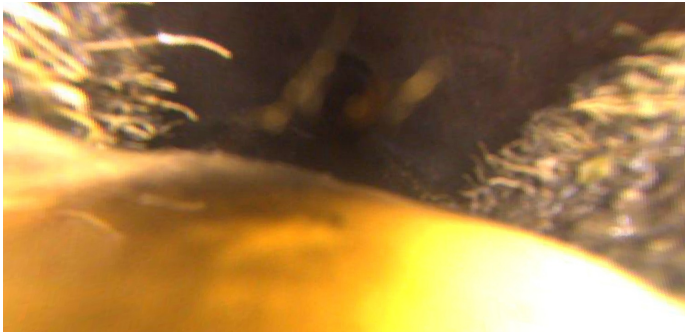
Code:	MWL
Description:	Water Level

Distance (ft):	.0
Structural Grade:	0
O&M Grade:	0
Clock Start/From:	
Clock To:	
1st Value:	
2nd Value:	
Value Percent:	5.000
Continuous Index:	
Within 8" of Joint:	NO
Remarks:

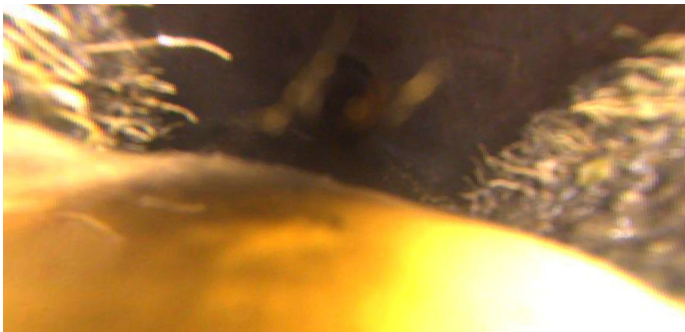
Code:	RBJ
Description:	Roots Ball Joint

Distance (ft):	.0
Structural Grade:	0
O&M Grade:	4
Clock Start/From:	7
Clock To:	5
1st Value:	
2nd Value:	
Value Percent:	55.000
Continuous Index:	
Within 8" of Joint:	YES
Remarks:

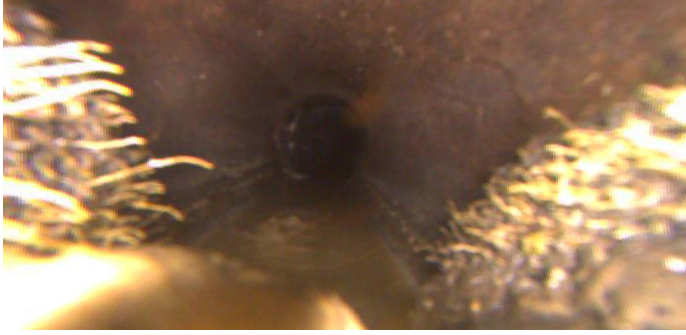
Code:	MSA
Description:	Abandoned Survey
Distance (ft):	2.5
Structural Grade:	0
O&M Grade:	0
Clock Start/From:	
Clock To:	
1st Value:	
2nd Value:	
Value Percent:	
Continuous Index:	
Within 8" of Joint:	NO
Remarks:	rbj
