Profile/Photo Observation Report

Date:	04/14/2018	Weather:		Coding:	PACP 6.0
Pipe Length (ft):	127.7	Owner:	NA	Pre Clean:	Not Known
P.O.#:		Surveyor:	Jen Costello	PSR:	P-706-008.3-008.2
Customer:		Clean Date:	01/01/1900	Shape:	C

Street:	GARFIELD ST & E 9TH ST	Flow Control:	Not Controlled
City:	Hobart, IN	Year Renewed:	
Location:	Light Highway	Tape/Media #:	
Purpose:	Maintenance Related	Dia/Height:	8"
Use:	Sanitary	Material:	VCP
Drain Area:	NA	Lining:	Cured in Place
Category:	NA		
Comment:	roots at 110'-flow incorrect.

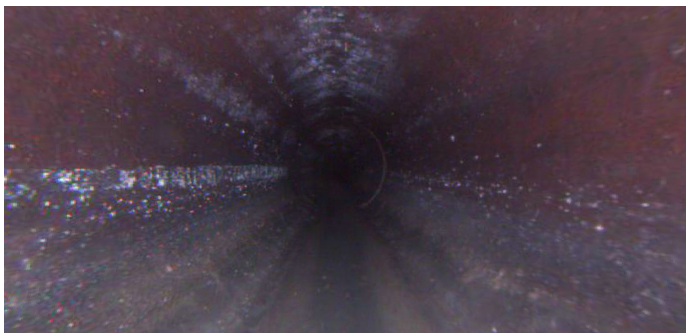
Code: **AMH**
Description: **Manhole**

Distance (ft): **.0**
Structural Grade: **0**
O&M Grade: **0**
Clock Start/From:
Clock To:
1st Value:
2nd Value:
Value Percent:
Continuous Index:
Within 8" of Joint: **NO**
Remarks: **M-706-008.3**

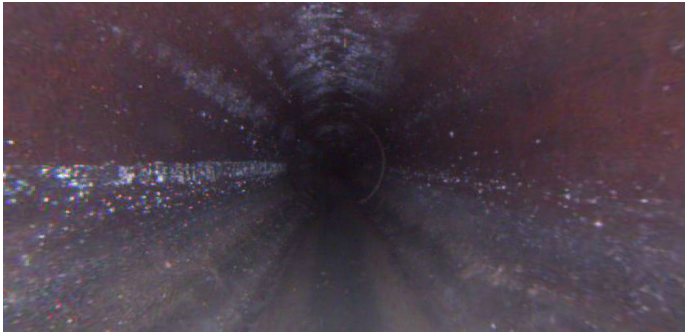
Code:	MWL
Description:	Water Level

Distance (ft):	.0
Structural Grade:	0
O&M Grade:	0
Clock Start/From:	
Clock To:	
1st Value:	
2nd Value:	
Value Percent:	5.000
Continuous Index:	
Within 8" of Joint:	NO
Remarks:

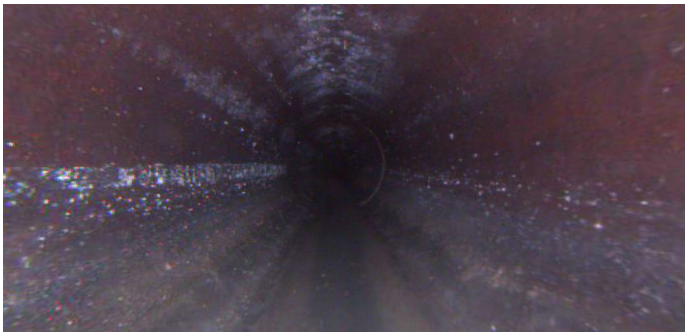
Code:	DAGS
Description:	Deposits Attached Grease

Distance (ft):	.0
Structural Grade:	0
O&M Grade:	2
Clock Start/From:	7
Clock To:	5
1st Value:	
2nd Value:	
Value Percent:	5.000
Continuous Index:	S01
Within 8" of Joint:	NO
Remarks:

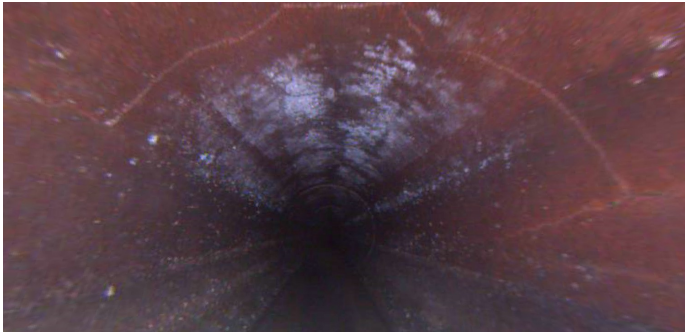
Code: **FM**
Description: **Fracture Multiple**

Distance (ft): **4.4**
Structural Grade: **4**
O&M Grade: **0**
Clock Start/From: **9**
Clock To: **3**
1st Value:
2nd Value:
Value Percent:
Continuous Index:
Within 8" of Joint:
Remarks:

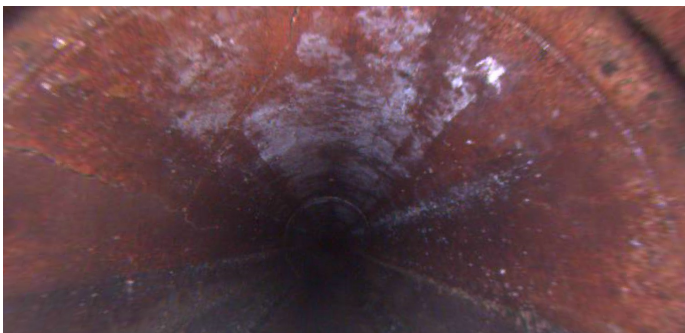
Code: **FM**
Description: **Fracture Multiple**

Distance (ft): **6.3**
Structural Grade: **4**
O&M Grade: **0**
Clock Start/From: **10**
Clock To: **12**
1st Value:
2nd Value:
Value Percent:
Continuous Index: **S02**
Within 8" of Joint: **YES**
Remarks:

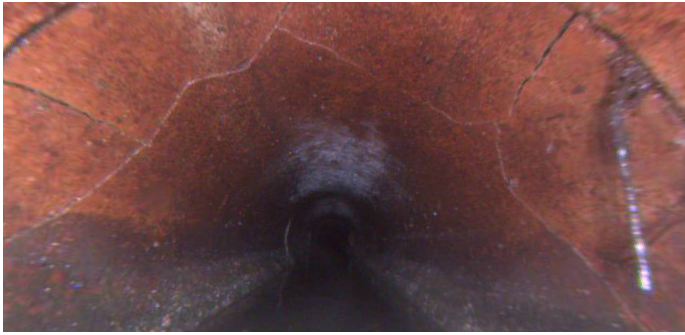
Code: **RFJ**
Description: **Roots Fine Joint**

Distance (ft): **53.0**
Structural Grade: **0**
O&M Grade: **1**
Clock Start/From: **2**
Clock To:
1st Value:
2nd Value:
Value Percent:
Continuous Index:
Within 8" of Joint: **YES**
Remarks:

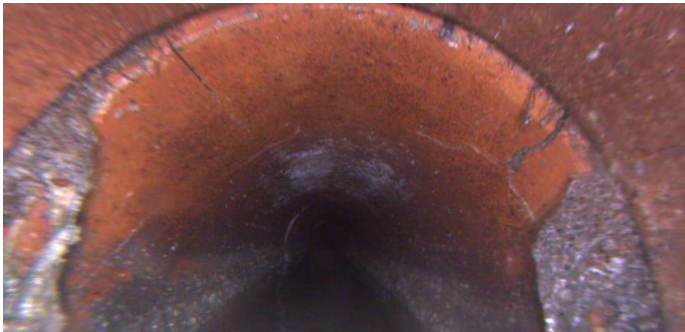
Code: **RMJ**
Description: **Roots Medium Joint**

Distance (ft): **56.8**
Structural Grade: **0**
O&M Grade: **3**
Clock Start/From: **8**
Clock To: **4**
1st Value:
2nd Value:
Value Percent: **5.000**
Continuous Index:
Within 8" of Joint: **YES**
Remarks:

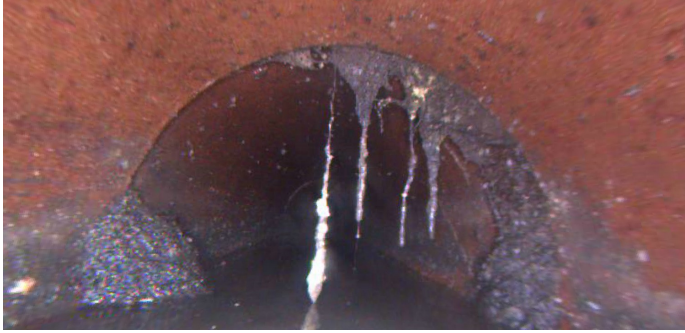
Code: **RMJ**
Description: **Roots Medium Joint**

Distance (ft): **66.3**
Structural Grade: **0**
O&M Grade: **3**
Clock Start/From: **8**
Clock To: **4**
1st Value:
2nd Value:
Value Percent: **10.000**
Continuous Index: **S03**
Within 8" of Joint: **YES**
Remarks:

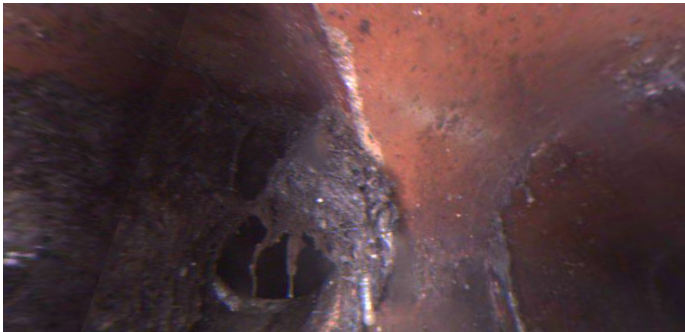
Code: **TFD**
Description: **Tap Factory Defective**

Distance (ft): **71.4**
Structural Grade: **0**
O&M Grade: **2**
Clock Start/From: **3**
Clock To:
1st Value: **4.000**
2nd Value:
Value Percent:
Continuous Index:
Within 8" of Joint:
Remarks: **roots**

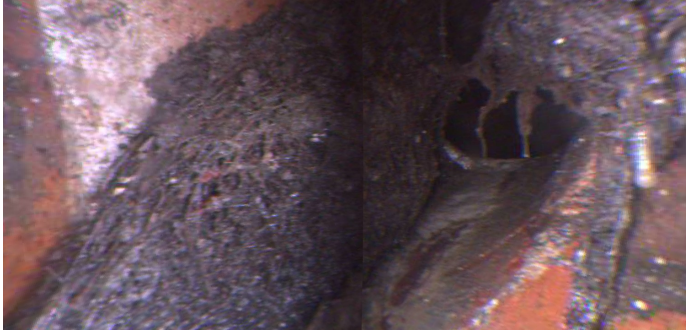
Code: **RML**
Description: **Roots Medium Lateral**

Distance (ft): **71.4**
Structural Grade: **0**
O&M Grade: **3**
Clock Start/From: **2**
Clock To: **4**
1st Value:
2nd Value:
Value Percent: **10.000**
Continuous Index:
Within 8" of Joint: **NO**
Remarks:

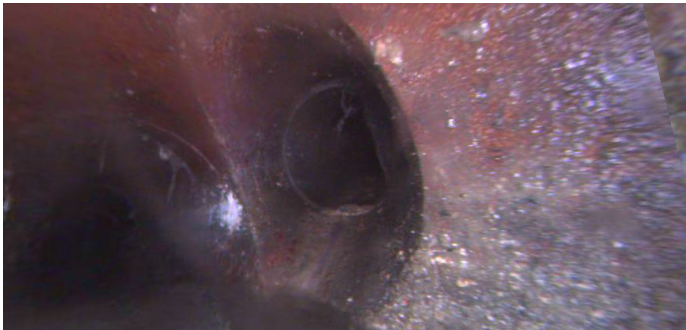
Code: **TF**
Description: **Tap Factory**

Distance (ft): **74.1**
Structural Grade: **0**
O&M Grade: **0**
Clock Start/From: **9**
Clock To:
1st Value: **4.000**
2nd Value:
Value Percent:
Continuous Index:
Within 8" of Joint:
Remarks:

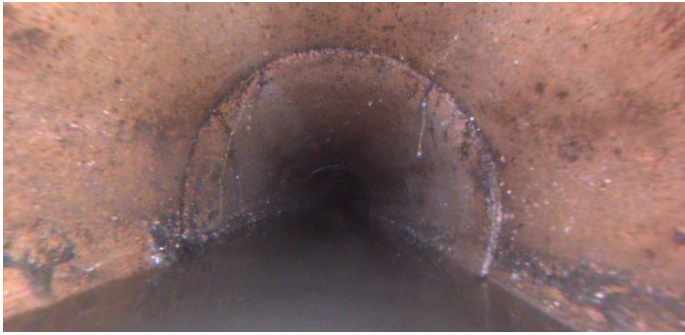
Code: **RMJ**
Description: **Roots Medium Joint**

Distance (ft): **89.6**
Structural Grade: **0**
O&M Grade: **3**
Clock Start/From: **8**
Clock To: **4**
1st Value:
2nd Value:
Value Percent: **10.000**
Continuous Index: **F03**
Within 8" of Joint: **YES**
Remarks:

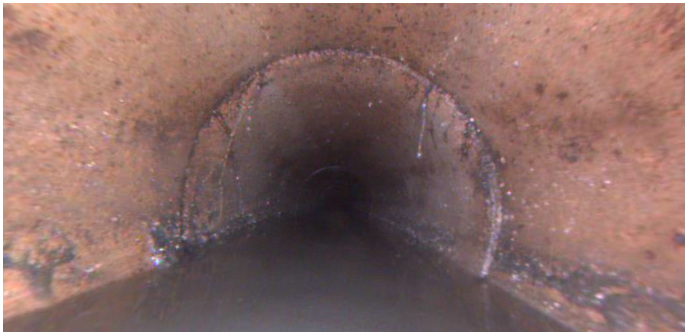
Code: **RFJ**
Description: **Roots Fine Joint**

Distance (ft): **89.6**
Structural Grade: **0**
O&M Grade: **1**
Clock Start/From: **8**
Clock To: **4**
1st Value:
2nd Value:
Value Percent:
Continuous Index: **S04**
Within 8" of Joint: **YES**
Remarks:

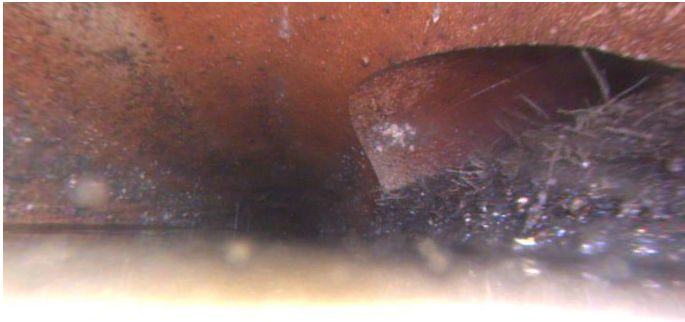
Code: **TFD**
Description: **Tap Factory Defective**

Distance (ft): **107.9**
Structural Grade: **0**
O&M Grade: **2**
Clock Start/From: **3**
Clock To:
1st Value: **4.000**
2nd Value:
Value Percent:
Continuous Index:
Within 8" of Joint:
Remarks: **roots**

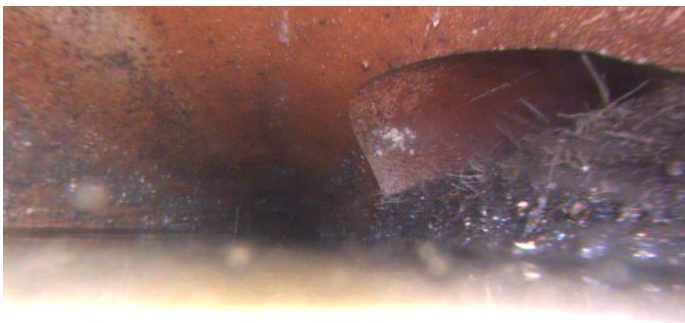
Code: **RML**
Description: **Roots Medium Lateral**

Distance (ft): **107.9**
Structural Grade: **0**
O&M Grade: **3**
Clock Start/From: **3**
Clock To:
1st Value:
2nd Value:
Value Percent: **10.000**
Continuous Index:
Within 8" of Joint: **NO**
Remarks:

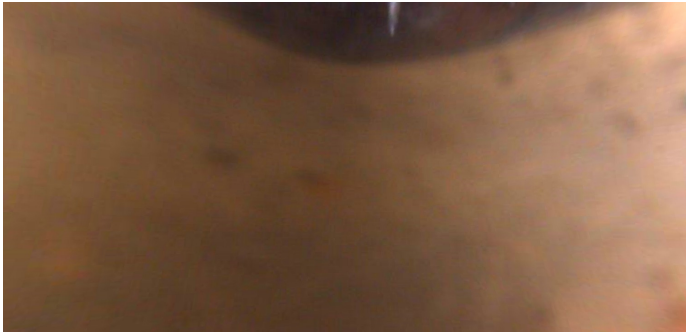
Code: **MWL**
Description: **Water Level**

Distance (ft): **111.5**
Structural Grade: **0**
O&M Grade: **0**
Clock Start/From:
Clock To:
1st Value:
2nd Value:
Value Percent: **100.000**
Continuous Index:
Within 8" of Joint: **NO**
Remarks:

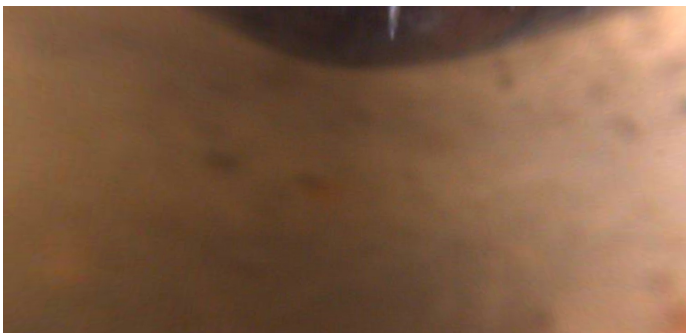
Code: **RFJ**
Description: **Roots Fine Joint**

Distance (ft): **111.5**
Structural Grade: **0**
O&M Grade: **1**
Clock Start/From: **8**
Clock To: **4**
1st Value:
2nd Value:
Value Percent:
Continuous Index: **F04**
Within 8" of Joint: **YES**
Remarks:

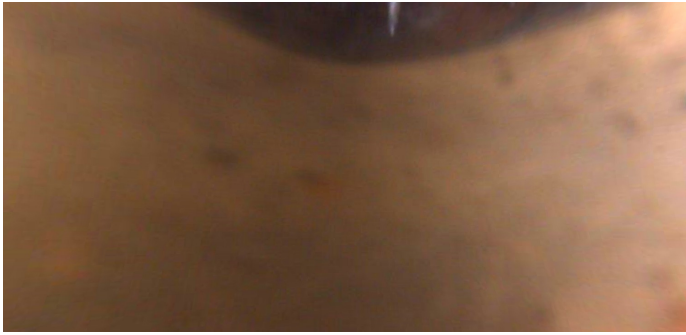
Code: **FM**
Description: **Fracture Multiple**

Distance (ft): **111.5**
Structural Grade: **4**
O&M Grade: **0**
Clock Start/From: **10**
Clock To: **12**
1st Value:
2nd Value:
Value Percent:
Continuous Index: **F02**
Within 8" of Joint: **YES**
Remarks:

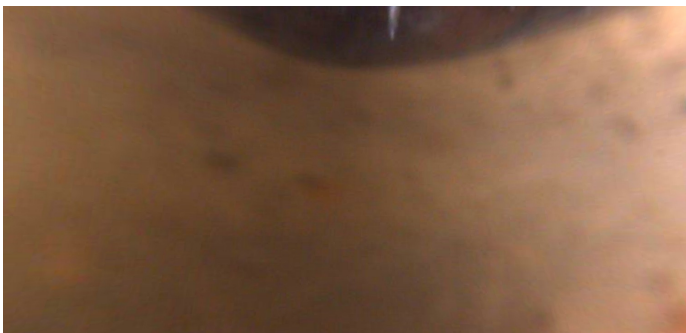
Code: **DAGS**
Description: **Deposits Attached Grease**

Distance (ft): **111.5**
Structural Grade: **0**
O&M Grade: **2**
Clock Start/From: **7**
Clock To: **5**
1st Value:
2nd Value:
Value Percent: **5.000**
Continuous Index: **F01**
Within 8" of Joint: **NO**
Remarks:

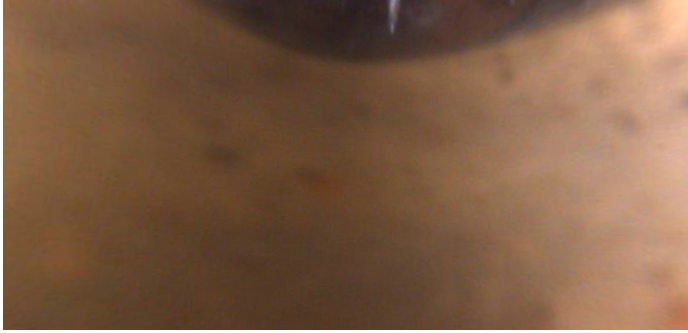
Code:	MSA
Description:	Abandoned Survey
Distance (ft):	111.5
Structural Grade:	0
O&M Grade:	0
Clock Start/From:	
Clock To:	
1st Value:	
2nd Value:	
Value Percent:	
Continuous Index:	
Within 8" of Joint:	NO
Remarks:	under water
