Profile/Photo Observation Report

Date:	04/14/2018	Weather:		Coding:	PACP 6.0
Pipe Length (ft):	127.7	Owner:	NA	Pre Clean:	Not Known
P.O.#:		Surveyor:	Jen Costello	PSR:	P-706-008.3-008.2
Customer:		Clean Date:	01/01/1900	Shape:	C

Street:	Capitol	Flow Control:	Not Controlled
City:	Hobart, IN	Year Renewed:	
Location:	Light Highway	Tape/Media #:	
Purpose:	Maintenance Related	Dia/Height:	8"
Use:	Sanitary	Material:	VCP
Drain Area:	NA	Lining:	Cured in Place
Category:	NA		
Comment:	roots at 110'-flow incorrect.

Location Details:		Direction of Survey:	Upstream
US MH:	M-706-008.2	DS MH:	M-706-008.3
		Total Length Surveyed (ft):	111.5

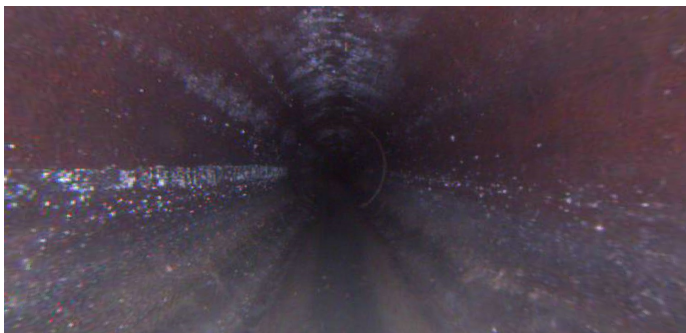
Code: **AMH**
Description: **Manhole**

Distance (ft): **.0**
Structural Grade: **0**
O&M Grade: **0**
Clock Start/From:
Clock To:
1st Value:
2nd Value:
Value Percent:
Continuous Index:
Within 8" of Joint: **NO**
Remarks: **M-706-008.3**

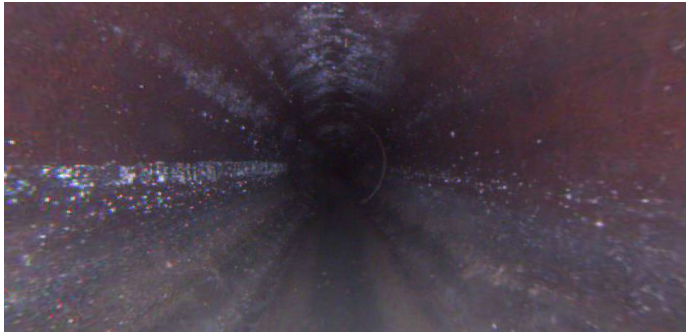
Code:	MWL
Description:	Water Level

Distance (ft):	.0
Structural Grade:	0
O&M Grade:	0
Clock Start/From:	
Clock To:	
1st Value:	
2nd Value:	
Value Percent:	5.000
Continuous Index:	
Within 8" of Joint:	NO
Remarks:

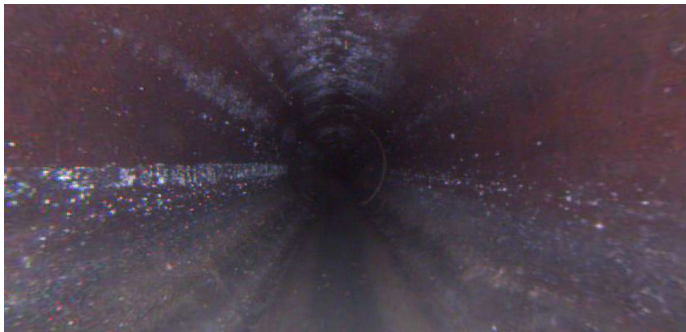
Code:	DAGS
Description:	Deposits Attached Grease

Distance (ft):	.0
Structural Grade:	0
O&M Grade:	2
Clock Start/From:	7
Clock To:	5
1st Value:	
2nd Value:	
Value Percent:	5.000
Continuous Index:	S01
Within 8" of Joint:	NO
Remarks:

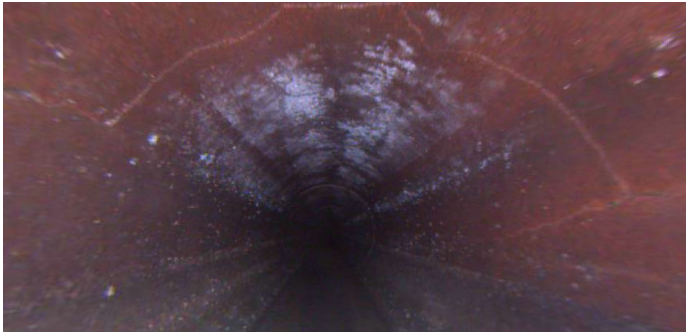
Code: **FM**
Description: **Fracture Multiple**

Distance (ft): **4.4**
Structural Grade: **4**
O&M Grade: **0**
Clock Start/From: **9**
Clock To: **3**
1st Value:
2nd Value:
Value Percent:
Continuous Index:
Within 8" of Joint:
Remarks:

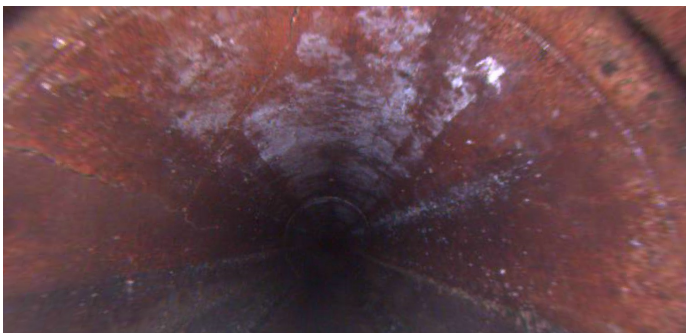
Code: **FM**
Description: **Fracture Multiple**

Distance (ft): **6.3**
Structural Grade: **4**
O&M Grade: **0**
Clock Start/From: **10**
Clock To: **12**
1st Value:
2nd Value:
Value Percent:
Continuous Index: **S02**
Within 8" of Joint: **YES**
Remarks:

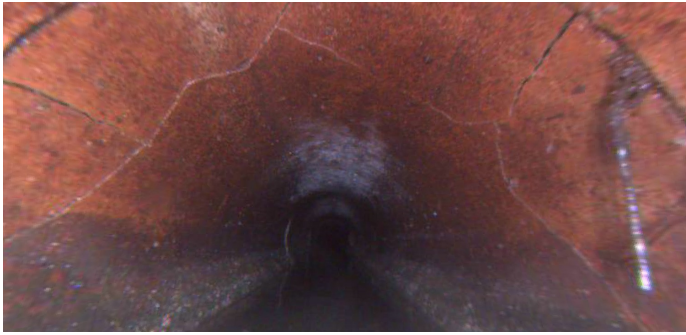
Code: **RFJ**
Description: **Roots Fine Joint**

Distance (ft): **53.0**
Structural Grade: **0**
O&M Grade: **1**
Clock Start/From: **2**
Clock To:
1st Value:
2nd Value:
Value Percent:
Continuous Index:
Within 8" of Joint: **YES**
Remarks:

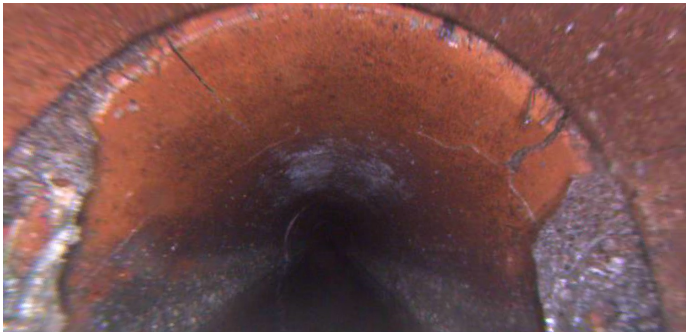
Code: **RMJ**
Description: **Roots Medium Joint**

Distance (ft): **56.8**
Structural Grade: **0**
O&M Grade: **3**
Clock Start/From: **8**
Clock To: **4**
1st Value:
2nd Value:
Value Percent: **5.000**
Continuous Index:
Within 8" of Joint: **YES**
Remarks:

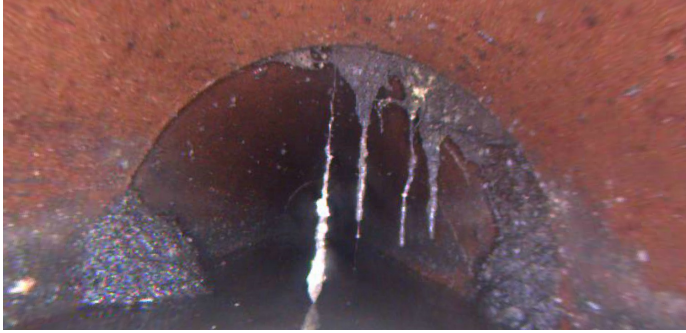
Code: **RMJ**
Description: **Roots Medium Joint**

Distance (ft): **66.3**
Structural Grade: **0**
O&M Grade: **3**
Clock Start/From: **8**
Clock To: **4**
1st Value:
2nd Value:
Value Percent: **10.000**
Continuous Index: **S03**
Within 8" of Joint: **YES**
Remarks:

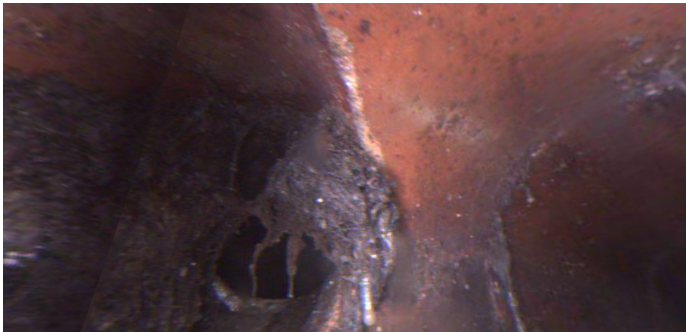
Code: **TFD**
Description: **Tap Factory Defective**

Distance (ft): **71.4**
Structural Grade: **0**
O&M Grade: **2**
Clock Start/From: **3**
Clock To:
1st Value: **4.000**
2nd Value:
Value Percent:
Continuous Index:
Within 8" of Joint:
Remarks: **roots**

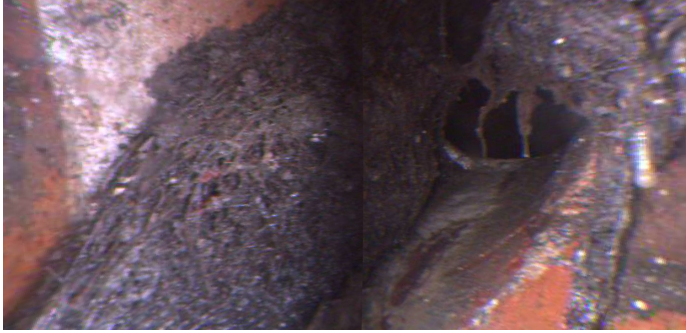
Code: **RML**
Description: **Roots Medium Lateral**

Distance (ft): **71.4**
Structural Grade: **0**
O&M Grade: **3**
Clock Start/From: **2**
Clock To: **4**
1st Value:
2nd Value:
Value Percent: **10.000**
Continuous Index:
Within 8" of Joint: **NO**
Remarks:

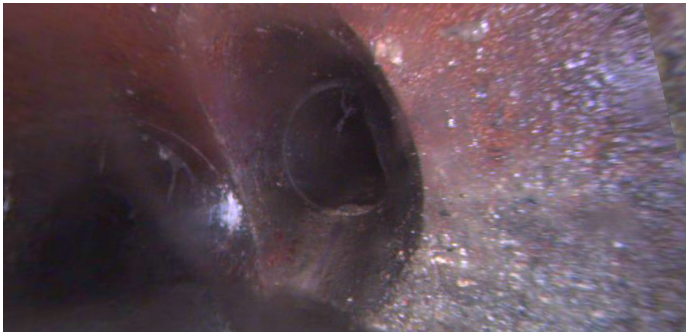
Code: **TF**
Description: **Tap Factory**

Distance (ft): **74.1**
Structural Grade: **0**
O&M Grade: **0**
Clock Start/From: **9**
Clock To:
1st Value: **4.000**
2nd Value:
Value Percent:
Continuous Index:
Within 8" of Joint:
Remarks:

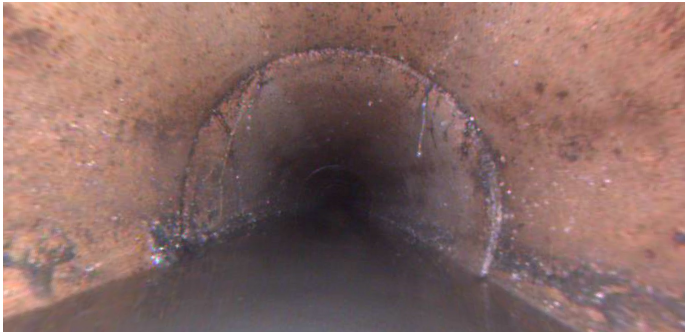
Code: **RMJ**
Description: **Roots Medium Joint**

Distance (ft): **89.6**
Structural Grade: **0**
O&M Grade: **3**
Clock Start/From: **8**
Clock To: **4**
1st Value:
2nd Value:
Value Percent: **10.000**
Continuous Index: **F03**
Within 8" of Joint: **YES**
Remarks:

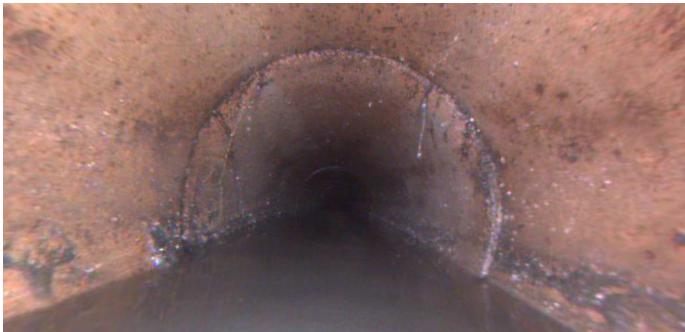
Code: **RFJ**
Description: **Roots Fine Joint**

Distance (ft): **89.6**
Structural Grade: **0**
O&M Grade: **1**
Clock Start/From: **8**
Clock To: **4**
1st Value:
2nd Value:
Value Percent:
Continuous Index: **S04**
Within 8" of Joint: **YES**
Remarks:

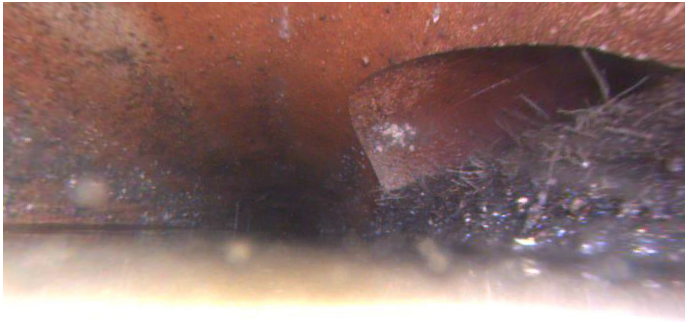
Code: **TFD**
Description: **Tap Factory Defective**

Distance (ft): **107.9**
Structural Grade: **0**
O&M Grade: **2**
Clock Start/From: **3**
Clock To:
1st Value: **4.000**
2nd Value:
Value Percent:
Continuous Index:
Within 8" of Joint:
Remarks: **roots**

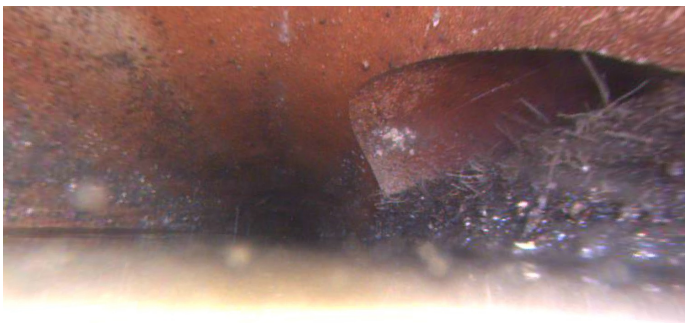
Code: **RML**
Description: **Roots Medium Lateral**

Distance (ft): **107.9**
Structural Grade: **0**
O&M Grade: **3**
Clock Start/From: **3**
Clock To:
1st Value:
2nd Value:
Value Percent: **10.000**
Continuous Index:
Within 8" of Joint: **NO**
Remarks:

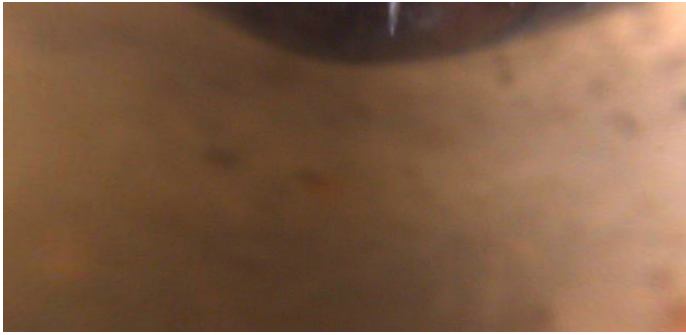
Code: **MWL**
Description: **Water Level**

Distance (ft): **111.5**
Structural Grade: **0**
O&M Grade: **0**
Clock Start/From:
Clock To:
1st Value:
2nd Value:
Value Percent: **100.000**
Continuous Index:
Within 8" of Joint: **NO**
Remarks:

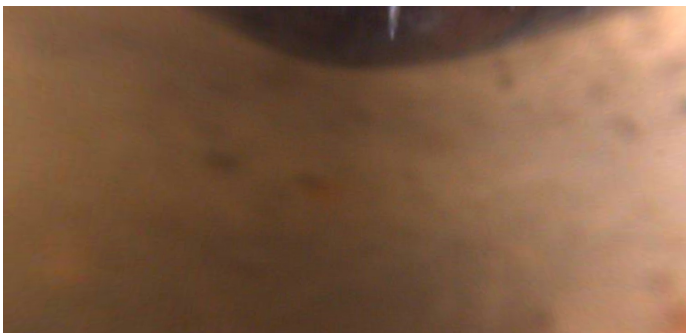
Code: **RFJ**
Description: **Roots Fine Joint**

Distance (ft): **111.5**
Structural Grade: **0**
O&M Grade: **1**
Clock Start/From: **8**
Clock To: **4**
1st Value:
2nd Value:
Value Percent:
Continuous Index: **F04**
Within 8" of Joint: **YES**
Remarks:

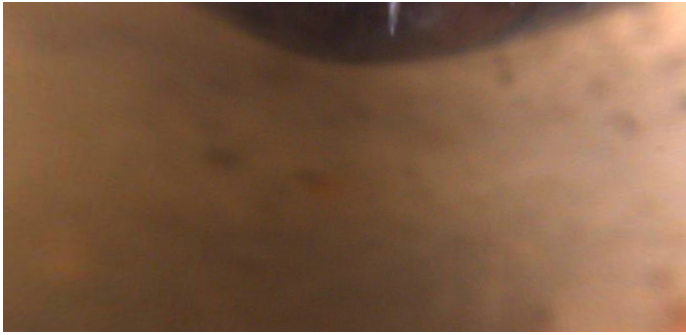
Code: **FM**
Description: **Fracture Multiple**

Distance (ft): **111.5**
Structural Grade: **4**
O&M Grade: **0**
Clock Start/From: **10**
Clock To: **12**
1st Value:
2nd Value:
Value Percent:
Continuous Index: **F02**
Within 8" of Joint: **YES**
Remarks:

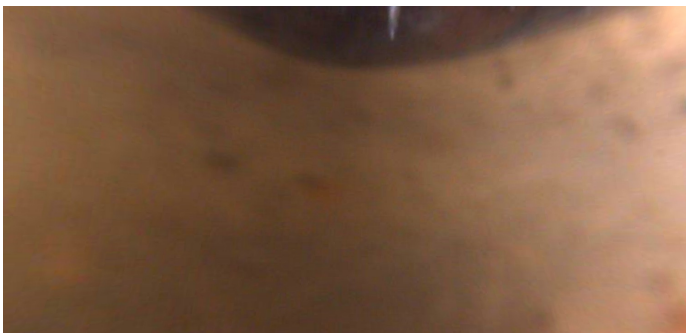
Code: **DAGS**
Description: **Deposits Attached Grease**

Distance (ft): **111.5**
Structural Grade: **0**
O&M Grade: **2**
Clock Start/From: **7**
Clock To: **5**
1st Value:
2nd Value:
Value Percent: **5.000**
Continuous Index: **F01**
Within 8" of Joint: **NO**
Remarks:

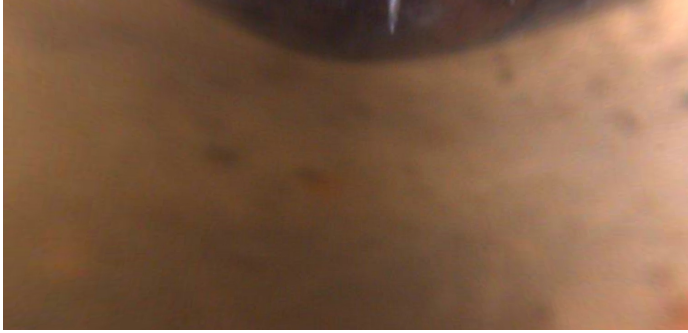
Code:	MSA
Description:	Abandoned Survey
Distance (ft):	111.5
Structural Grade:	0
O&M Grade:	0
Clock Start/From:	
Clock To:	
1st Value:	
2nd Value:	
Value Percent:	
Continuous Index:	
Within 8" of Joint:	NO
Remarks:	under water
