## Profile/Photo Observation Report

Street:	<b>GARFIELD ST &amp; E 9TH ST</b>	Flow Control:	<b>Not Controlled</b>
City:	<b>Hobart, IN</b>	Year Renewed:	
Location:	<b>Light Highway</b>	Tape/Media #:	
Purpose:	<b>Maintenance Related</b>	Dia/Height:	<b>10"</b>
Use:	<b>Sanitary</b>	Material:	<b>VCP</b>
Drain Area:	<b>NA</b>	Lining:	<b>Cured in Place</b>
Category:	<b>NA</b>		
Comment:	<b>Reverse setup. clogged with debris at 10'.</b>		
Location Details:		Direction of Survey:	<b>Downstream</b>
US MH:	<b>M-706-008.2</b>	DS MH:	<b>M-706-008.3</b>
		Total Length Surveyed (ft):	<b>11.3</b>

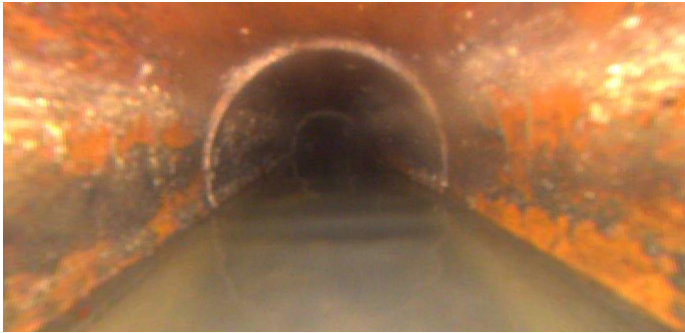
Code:	<b>MWL</b>
Description:	<b>Water Level</b>

Distance (ft):	<b>.0</b>
Structural Grade:	<b>0</b>
O&M Grade:	<b>0</b>
Clock Start/From:	
Clock To:	
1st Value:	
2nd Value:	
Value Percent:	<b>5.000</b>
Continuous Index:	
Within 8" of Joint:	<b>NO</b>
Remarks:

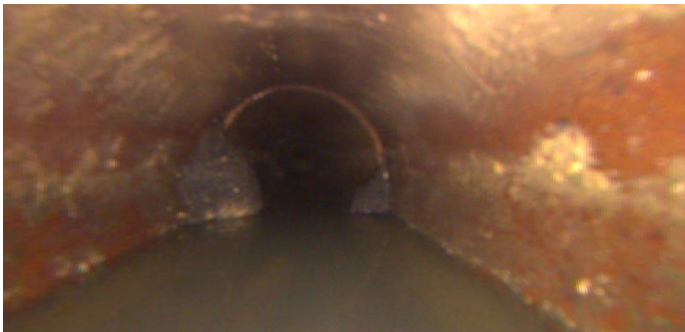
Code:	<b>RMJ</b>
Description:	<b>Roots Medium Joint</b>

Distance (ft):	<b>4.3</b>
Structural Grade:	<b>0</b>
O&M Grade:	<b>3</b>
Clock Start/From:	<b>7</b>
Clock To:	<b>5</b>
1st Value:	
2nd Value:	
Value Percent:	<b>15.000</b>
Continuous Index:	<b>S01</b>
Within 8" of Joint:	<b>YES</b>
Remarks:

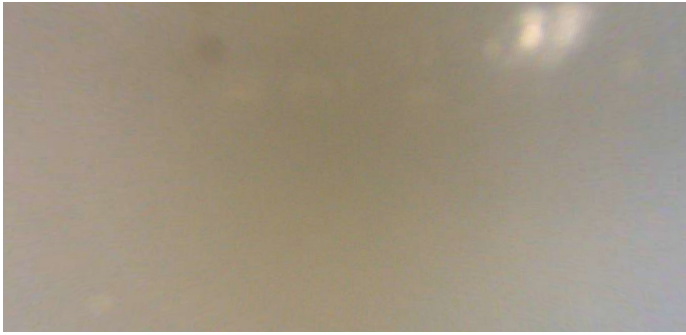
Code: **MWLS**  
Description: **Water Level Sag**

Distance (ft): **10.4**  
Structural Grade: **2**  
O&M Grade: **3**  
Clock Start/From:  
Clock To:  
1st Value:  
2nd Value:  
Value Percent: **10.000**  
Continuous Index:  
Within 8" of Joint: **NO**  
Remarks:
