Profile/Photo Observation Report

Date:	04/15/2018	Weather:		Coding:	PACP 6.0
Pipe Length (ft):	127.7	Owner:	NA	Pre Clean:	Not Known
P.O.#:		Surveyor:	Selasie Honu	PSR:	P-706-008.3-008.2
Customer:		Clean Date:	01/01/1900	Shape:	C

Street:	Capitol	Flow Control:	Not Controlled
City:	Hobart, IN	Year Renewed:	
Location:	Light Highway	Tape/Media #:	
Purpose:	Maintenance Related	Dia/Height:	10"
Use:	Sanitary	Material:	VCP
Drain Area:	NA	Lining:	Cured in Place
Category:	NA		
Comment:	Reverse setup. clogged with debris at 10'.

Location Details:		Direction of Survey:	Downstream
US MH:	M-706-008.2	DS MH:	M-706-008.3
		Total Length Surveyed (ft):	11.3

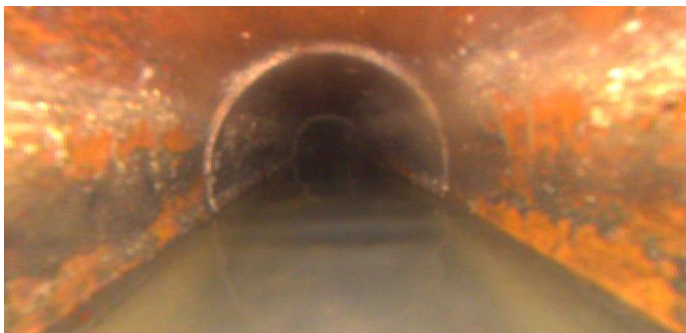
Code: **AMH**
 Description: **Manhole**

Distance (ft): **.0**
 Structural Grade: **0**
 O&M Grade: **0**
 Clock Start/From:
 Clock To:
 1st Value:
 2nd Value:
 Value Percent:
 Continuous Index:
 Within 8" of Joint: **NO**
 Remarks: **M-706-008.2**

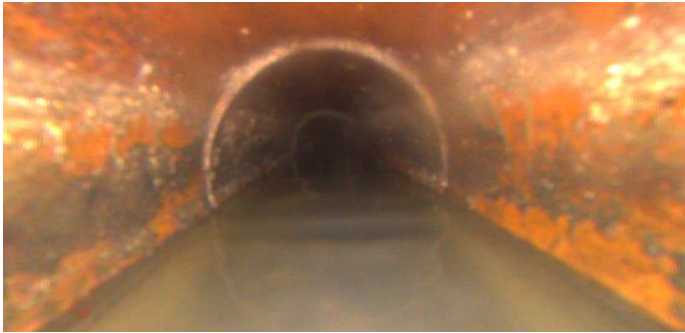
Code:	MWL
Description:	Water Level

Distance (ft):	.0
Structural Grade:	0
O&M Grade:	0
Clock Start/From:	
Clock To:	
1st Value:	
2nd Value:	
Value Percent:	5.000
Continuous Index:	
Within 8" of Joint:	NO
Remarks:

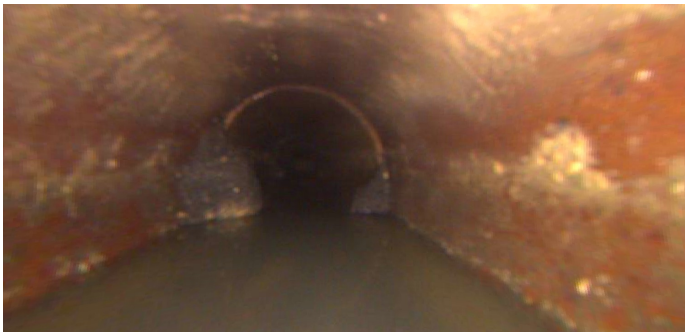
Code:	RMJ
Description:	Roots Medium Joint

Distance (ft):	4.3
Structural Grade:	0
O&M Grade:	3
Clock Start/From:	7
Clock To:	5
1st Value:	
2nd Value:	
Value Percent:	15.000
Continuous Index:	S01
Within 8" of Joint:	YES
Remarks:
