Profile/Photo Observation Report

Date:	04/14/2018	Weather:		Coding:	PACP 6.0
Pipe Length (ft):	222.5	Owner:	NA	Pre Clean:	Not Known
P.O.#:		Surveyor:	Jen Costello	PSR:	P-706-008.6-008.3
Customer:		Clean Date:	01/01/1900	Shape:	C

Street:	GARFIELD ST	Flow Control:	Not Controlled
City:	Hobart, IN	Year Renewed:	
Location:	Light Highway	Tape/Media #:	
Purpose:	Maintenance Related	Dia/Height:	8"
Use:	Sanitary	Material:	VCP
Drain Area:	NA	Lining:	Cured in Place
Category:	NA		
Comment:	heavy soft debris at 70'. flow incorrect.		
Location Details:		Direction of Survey:	Upstream
US MH:	M-706-008.3	DS MH:	M-706-008.6
		Total Length Surveyed (ft):	71.8

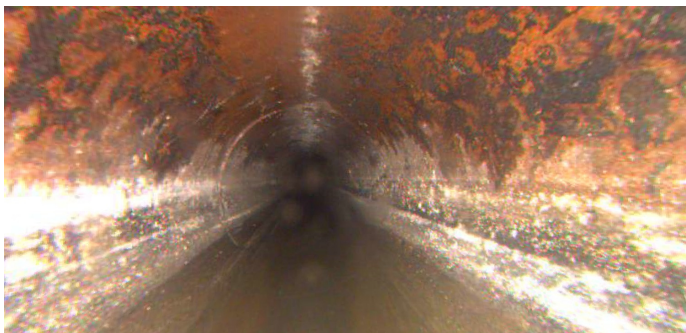
Code: **AMH**
Description: **Manhole**

Distance (ft): **.0**
Structural Grade: **0**
O&M Grade: **0**
Clock Start/From:
Clock To:
1st Value:
2nd Value:
Value Percent:
Continuous Index:
Within 8" of Joint: **NO**
Remarks: **M-706-008.6**

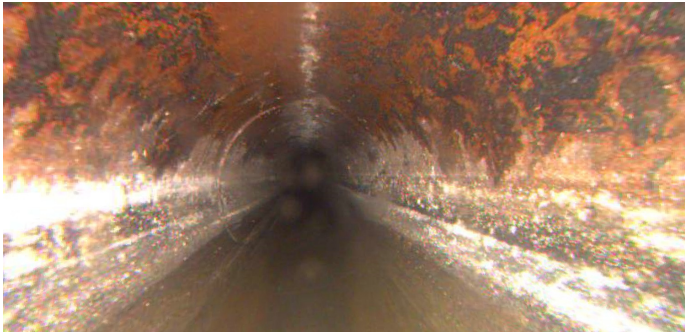
Code:	MWL
Description:	Water Level

Distance (ft):	.0
Structural Grade:	0
O&M Grade:	0
Clock Start/From:	
Clock To:	
1st Value:	
2nd Value:	
Value Percent:	10.000
Continuous Index:	
Within 8" of Joint:	NO
Remarks:

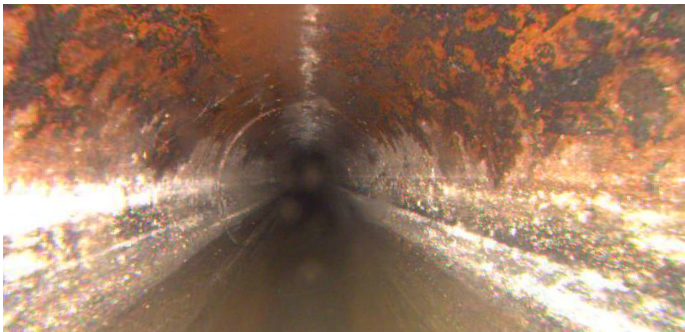
Code:	DAE
Description:	Deposits Attached Encrustation

Distance (ft):	.0
Structural Grade:	0
O&M Grade:	2
Clock Start/From:	8
Clock To:	4
1st Value:	
2nd Value:	
Value Percent:	5.000
Continuous Index:	S01
Within 8" of Joint:	NO
Remarks:

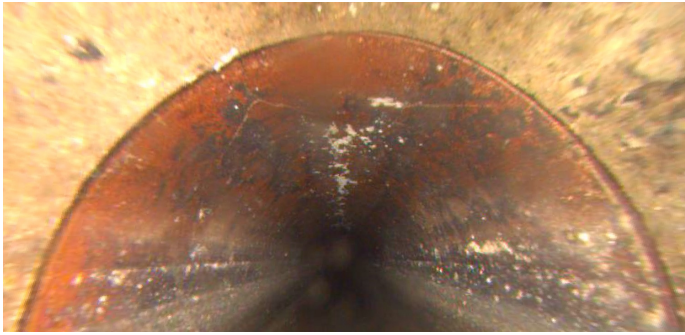
Code: **CM**
Description: **Crack Multiple**

Distance (ft): **5.5**
Structural Grade: **3**
O&M Grade: **0**
Clock Start/From: **10**
Clock To: **2**
1st Value:
2nd Value:
Value Percent:
Continuous Index:
Within 8" of Joint: **YES**
Remarks:

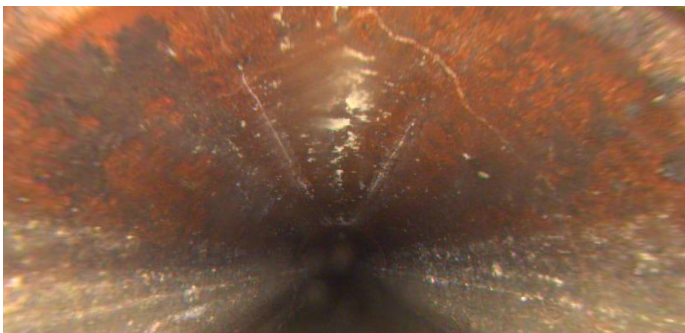
Code: **CM**
Description: **Crack Multiple**

Distance (ft): **9.6**
Structural Grade: **3**
O&M Grade: **0**
Clock Start/From: **12**
Clock To: **3**
1st Value:
2nd Value:
Value Percent:
Continuous Index:
Within 8" of Joint: **YES**
Remarks:

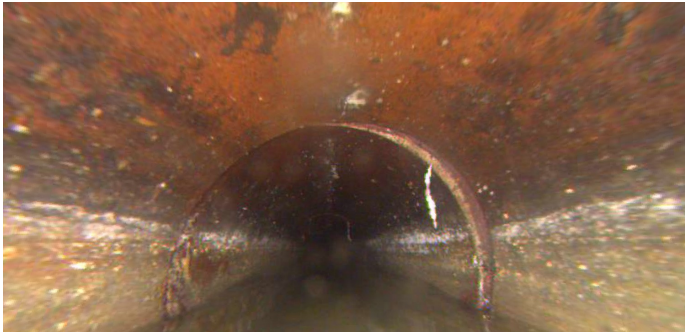
Code: **RFJ**
Description: **Roots Fine Joint**

Distance (ft): **15.1**
Structural Grade: **0**
O&M Grade: **1**
Clock Start/From: **8**
Clock To: **4**
1st Value:
2nd Value:
Value Percent:
Continuous Index:
Within 8" of Joint: **YES**
Remarks:

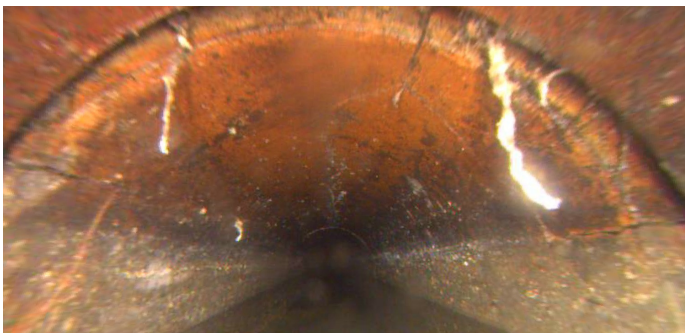
Code: **FM**
Description: **Fracture Multiple**

Distance (ft): **17.4**
Structural Grade: **4**
O&M Grade: **0**
Clock Start/From: **8**
Clock To: **4**
1st Value:
2nd Value:
Value Percent:
Continuous Index:
Within 8" of Joint: **YES**
Remarks:

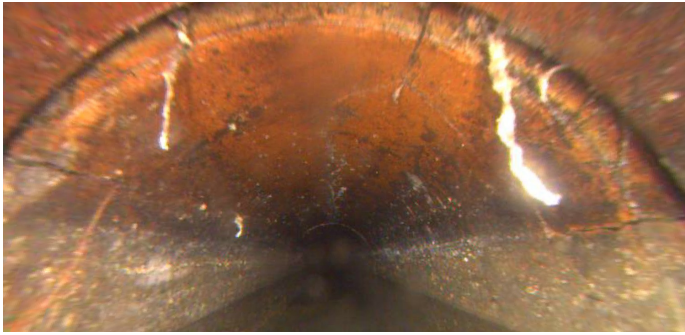
Code: **RFJ**
Description: **Roots Fine Joint**

Distance (ft): **17.4**
Structural Grade: **0**
O&M Grade: **1**
Clock Start/From: **8**
Clock To: **4**
1st Value:
2nd Value:
Value Percent:
Continuous Index:
Within 8" of Joint: **YES**
Remarks:

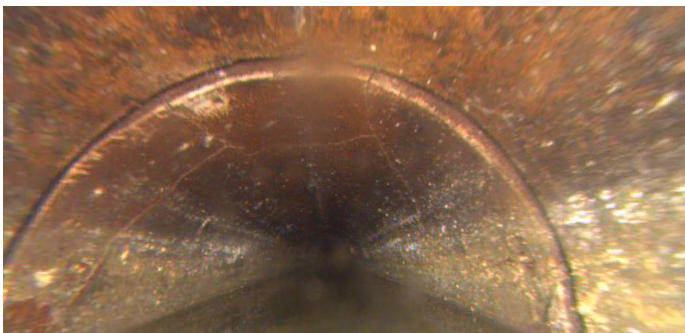
Code: **FM**
Description: **Fracture Multiple**

Distance (ft): **19.3**
Structural Grade: **4**
O&M Grade: **0**
Clock Start/From: **8**
Clock To: **4**
1st Value:
2nd Value:
Value Percent:
Continuous Index:
Within 8" of Joint: **YES**
Remarks:

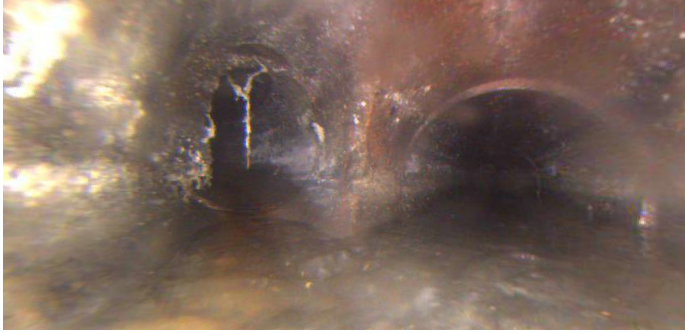
Code: **TFA**
Description: **Tap Factory Active**

Distance (ft): **22.8**
Structural Grade: **0**
O&M Grade: **0**
Clock Start/From: **3**
Clock To:
1st Value: **4.000**
2nd Value:
Value Percent:
Continuous Index:
Within 8" of Joint:
Remarks:

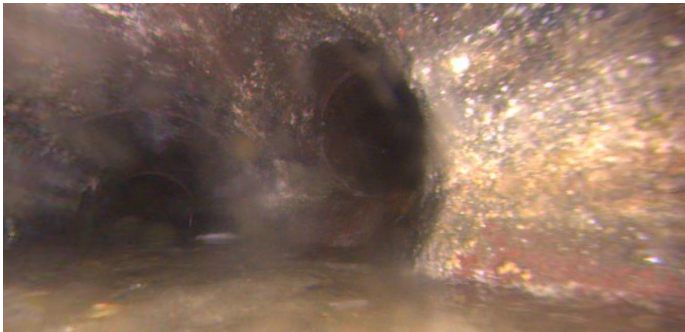
Code: **TFA**
Description: **Tap Factory Active**

Distance (ft): **25.0**
Structural Grade: **0**
O&M Grade: **0**
Clock Start/From: **9**
Clock To:
1st Value: **4.000**
2nd Value:
Value Percent:
Continuous Index:
Within 8" of Joint:
Remarks:

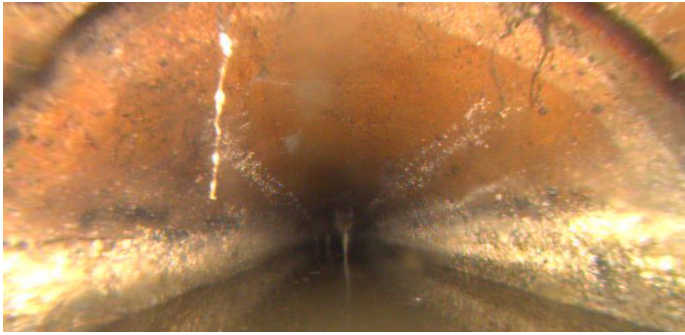
Code: **RFJ**
Description: **Roots Fine Joint**

Distance (ft): **27.5**
Structural Grade: **0**
O&M Grade: **1**
Clock Start/From: **8**
Clock To: **4**
1st Value:
2nd Value:
Value Percent:
Continuous Index: **S02**
Within 8" of Joint: **YES**
Remarks:

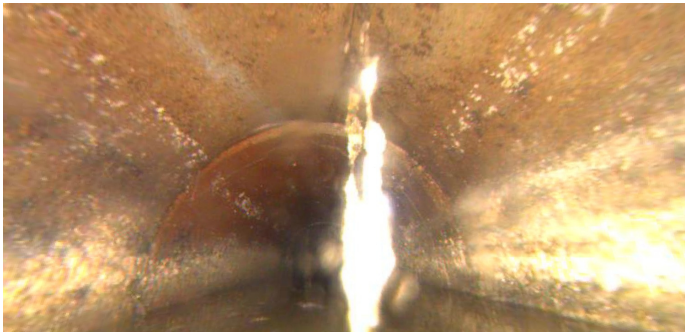
Code: **RMB**
Description: **Roots Medium Barrel**

Distance (ft): **29.1**
Structural Grade: **0**
O&M Grade: **4**
Clock Start/From: **12**
Clock To:
1st Value:
2nd Value:
Value Percent: **5.000**
Continuous Index:
Within 8" of Joint: **NO**
Remarks:

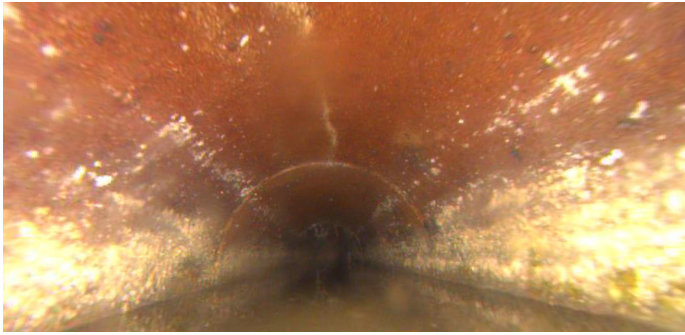
Code: **FL**
Description: **Fracture Longitudinal**

Distance (ft): **32.8**
Structural Grade: **3**
O&M Grade: **0**
Clock Start/From: **12**
Clock To:
1st Value:
2nd Value:
Value Percent:
Continuous Index:
Within 8" of Joint: **YES**
Remarks:

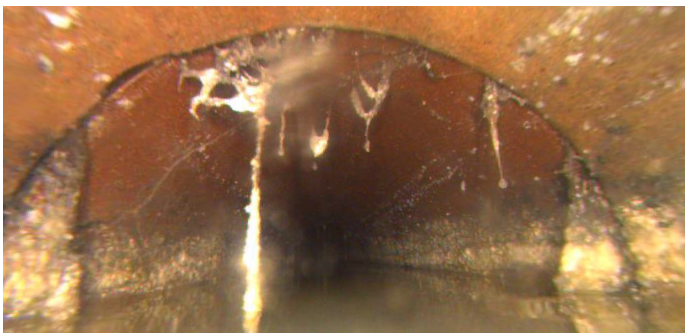
Code: **FM**
Description: **Fracture Multiple**

Distance (ft): **37.4**
Structural Grade: **4**
O&M Grade: **0**
Clock Start/From: **8**
Clock To: **4**
1st Value:
2nd Value:
Value Percent:
Continuous Index: **S03**
Within 8" of Joint: **YES**
Remarks:

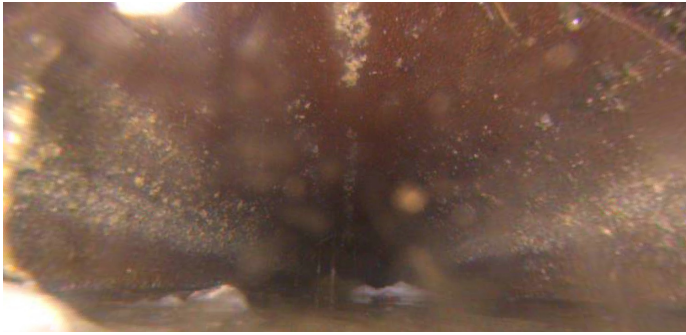
Code: **MGO**
Description: **General Observation**

Distance (ft): **55.8**
Structural Grade: **0**
O&M Grade: **0**
Clock Start/From:
Clock To:
1st Value:
2nd Value:
Value Percent:
Continuous Index:
Within 8" of Joint: **NO**
Remarks: **REAR CAMERA**

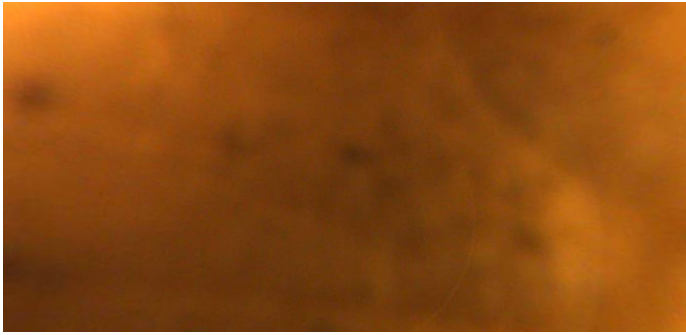
Code: **MWL**
Description: **Water Level**

Distance (ft): **71.8**
Structural Grade: **0**
O&M Grade: **0**
Clock Start/From:
Clock To:
1st Value:
2nd Value:
Value Percent: **100.000**
Continuous Index:
Within 8" of Joint: **NO**
Remarks:

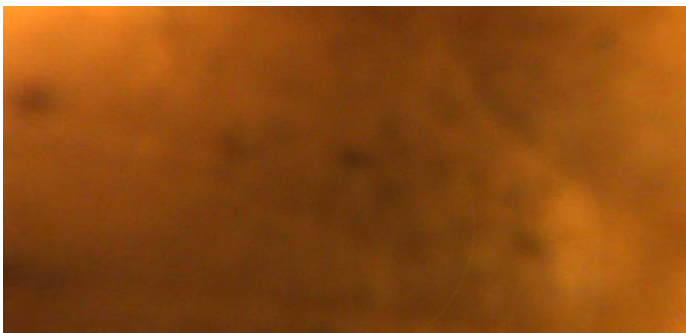
Code: **MCU**
Description: **Camera Underwater**

Distance (ft): **71.8**
Structural Grade: **0**
O&M Grade: **4**
Clock Start/From:
Clock To:
1st Value:
2nd Value:
Value Percent:
Continuous Index:
Within 8" of Joint: **NO**
Remarks:

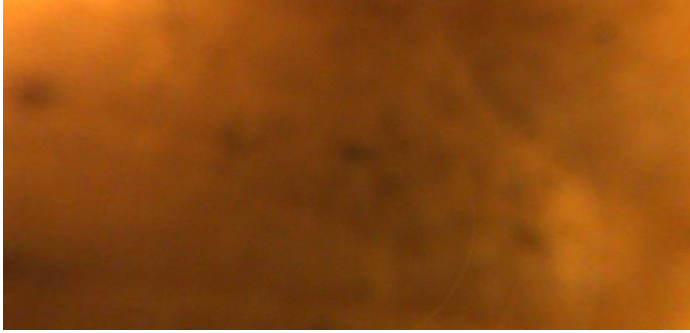
Code:	MSA
Description:	Abandoned Survey
Distance (ft):	71.8
Structural Grade:	0
O&M Grade:	0
Clock Start/From:	
Clock To:	
1st Value:	
2nd Value:	
Value Percent:	
Continuous Index:	
Within 8" of Joint:	NO
Remarks:	MCU
