Profile/Photo Observation Report

Date:	04/14/2018	Weather:		Coding:	PACP 6.0
Pipe Length (ft):	222.5	Owner:	NA	Pre Clean:	Not Known
P.O.#:		Surveyor:	Jen Costello	PSR:	P-706-008.6-008.3
Customer:		Clean Date:	01/01/1900	Shape:	C

Street:	Capitol	Flow Control:	Not Controlled
City:	Hobart, IN	Year Renewed:	
Location:	Light Highway	Tape/Media #:	
Purpose:	Maintenance Related	Dia/Height:	8"
Use:	Sanitary	Material:	VCP
Drain Area:	NA	Lining:	Cured in Place
Category:	NA		
Comment:	heavy soft debris at 70'. flow incorrect.

Location Details:		Direction of Survey:	Upstream
US MH:	M-706-008.3	DS MH:	M-706-008.6
		Total Length Surveyed (ft):	71.8

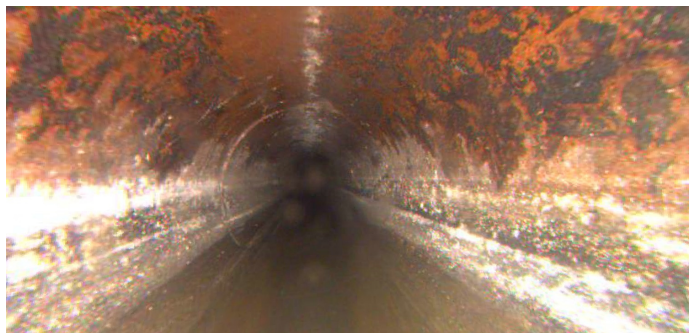
Code: **AMH**
Description: **Manhole**

Distance (ft): **.0**
Structural Grade: **0**
O&M Grade: **0**
Clock Start/From:
Clock To:
1st Value:
2nd Value:
Value Percent:
Continuous Index:
Within 8" of Joint: **NO**
Remarks: **M-706-008.6**

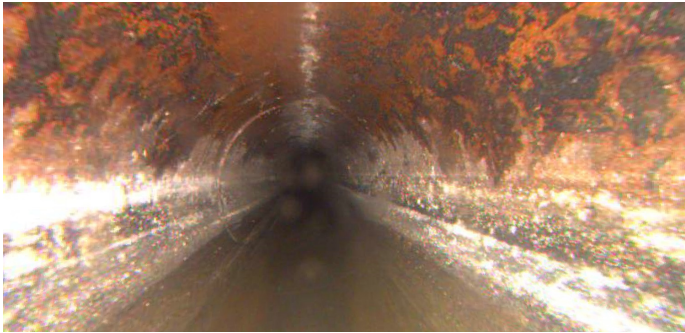
Code:	MWL
Description:	Water Level

Distance (ft):	.0
Structural Grade:	0
O&M Grade:	0
Clock Start/From:	
Clock To:	
1st Value:	
2nd Value:	
Value Percent:	10.000
Continuous Index:	
Within 8" of Joint:	NO
Remarks:

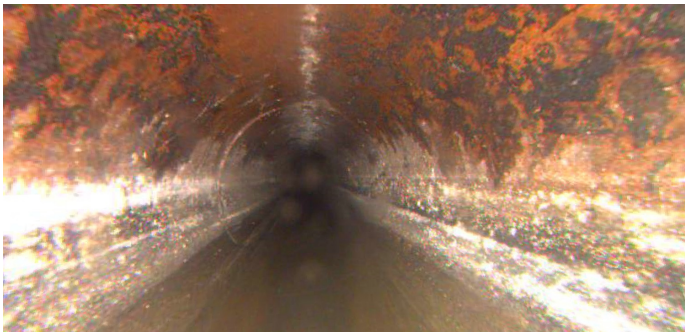
Code:	DAE
Description:	Deposits Attached Encrustation

Distance (ft):	.0
Structural Grade:	0
O&M Grade:	2
Clock Start/From:	8
Clock To:	4
1st Value:	
2nd Value:	
Value Percent:	5.000
Continuous Index:	S01
Within 8" of Joint:	NO
Remarks:

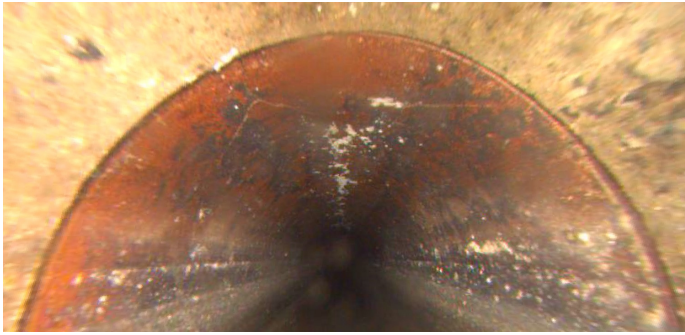
Code: **CM**
Description: **Crack Multiple**

Distance (ft): **5.5**
Structural Grade: **3**
O&M Grade: **0**
Clock Start/From: **10**
Clock To: **2**
1st Value:
2nd Value:
Value Percent:
Continuous Index:
Within 8" of Joint: **YES**
Remarks:

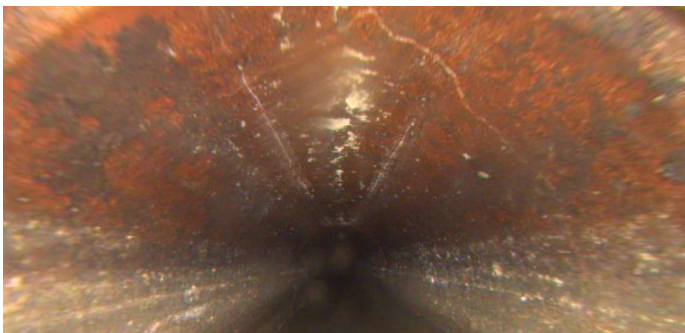
Code: **CM**
Description: **Crack Multiple**

Distance (ft): **9.6**
Structural Grade: **3**
O&M Grade: **0**
Clock Start/From: **12**
Clock To: **3**
1st Value:
2nd Value:
Value Percent:
Continuous Index:
Within 8" of Joint: **YES**
Remarks:

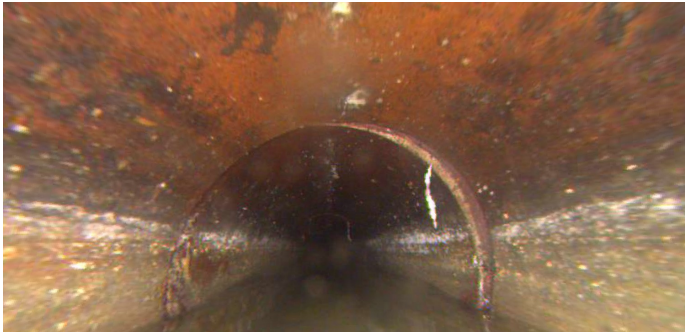
Code: **RFJ**
Description: **Roots Fine Joint**

Distance (ft): **15.1**
Structural Grade: **0**
O&M Grade: **1**
Clock Start/From: **8**
Clock To: **4**
1st Value:
2nd Value:
Value Percent:
Continuous Index:
Within 8" of Joint: **YES**
Remarks:

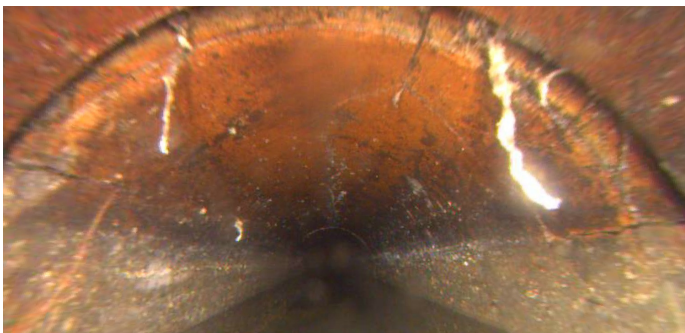
Code: **FM**
Description: **Fracture Multiple**

Distance (ft): **17.4**
Structural Grade: **4**
O&M Grade: **0**
Clock Start/From: **8**
Clock To: **4**
1st Value:
2nd Value:
Value Percent:
Continuous Index:
Within 8" of Joint: **YES**
Remarks:

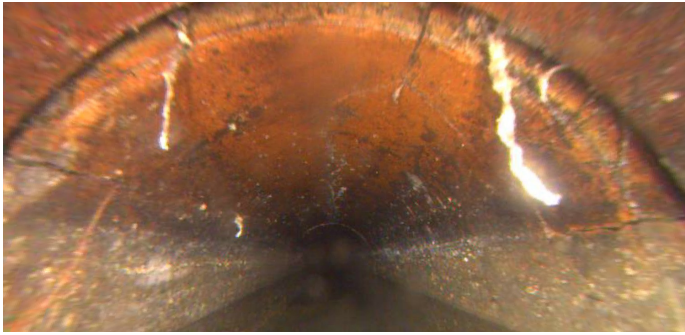
Code: **RFJ**
Description: **Roots Fine Joint**

Distance (ft): **17.4**
Structural Grade: **0**
O&M Grade: **1**
Clock Start/From: **8**
Clock To: **4**
1st Value:
2nd Value:
Value Percent:
Continuous Index:
Within 8" of Joint: **YES**
Remarks:

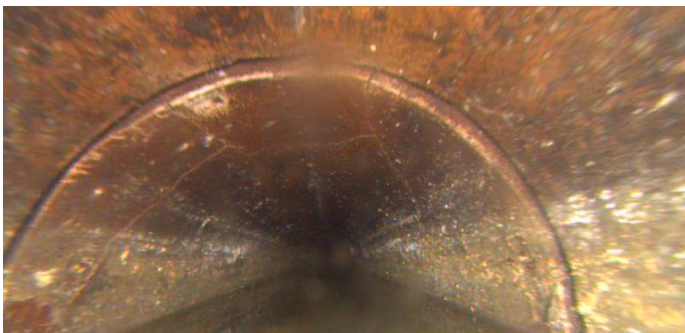
Code: **FM**
Description: **Fracture Multiple**

Distance (ft): **19.3**
Structural Grade: **4**
O&M Grade: **0**
Clock Start/From: **8**
Clock To: **4**
1st Value:
2nd Value:
Value Percent:
Continuous Index:
Within 8" of Joint: **YES**
Remarks:

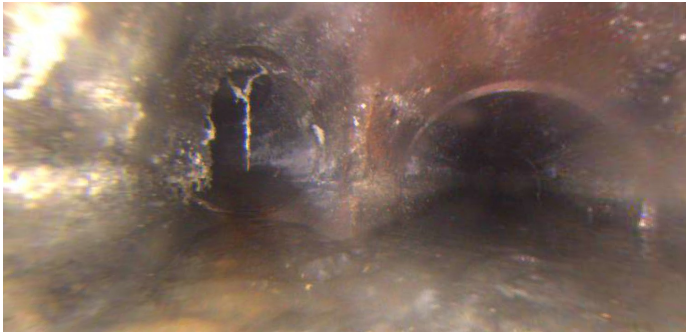
Code: **TFA**
Description: **Tap Factory Active**

Distance (ft): **22.8**
Structural Grade: **0**
O&M Grade: **0**
Clock Start/From: **3**
Clock To:
1st Value: **4.000**
2nd Value:
Value Percent:
Continuous Index:
Within 8" of Joint:
Remarks:

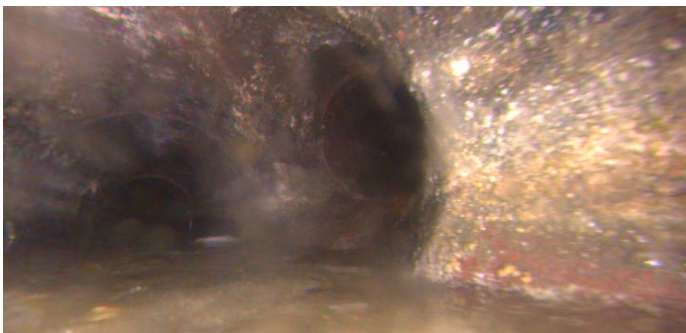
Code: **TFA**
Description: **Tap Factory Active**

Distance (ft): **25.0**
Structural Grade: **0**
O&M Grade: **0**
Clock Start/From: **9**
Clock To:
1st Value: **4.000**
2nd Value:
Value Percent:
Continuous Index:
Within 8" of Joint:
Remarks:

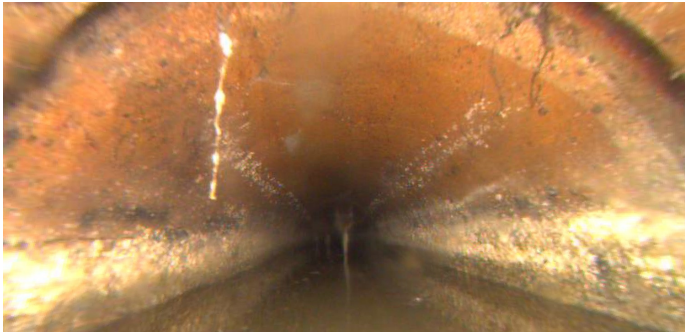
Code: **RFJ**
Description: **Roots Fine Joint**

Distance (ft): **27.5**
Structural Grade: **0**
O&M Grade: **1**
Clock Start/From: **8**
Clock To: **4**
1st Value:
2nd Value:
Value Percent:
Continuous Index: **S02**
Within 8" of Joint: **YES**
Remarks:

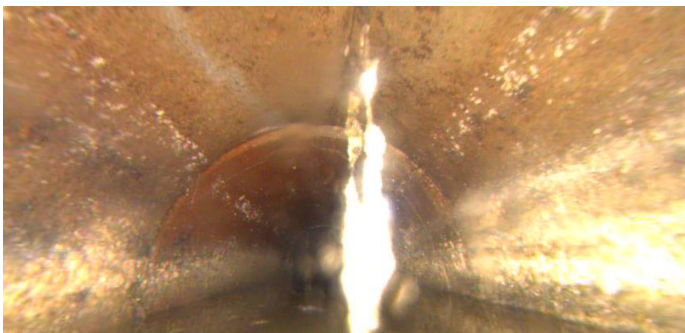
Code: **RMB**
Description: **Roots Medium Barrel**

Distance (ft): **29.1**
Structural Grade: **0**
O&M Grade: **4**
Clock Start/From: **12**
Clock To:
1st Value:
2nd Value:
Value Percent: **5.000**
Continuous Index:
Within 8" of Joint: **NO**
Remarks:

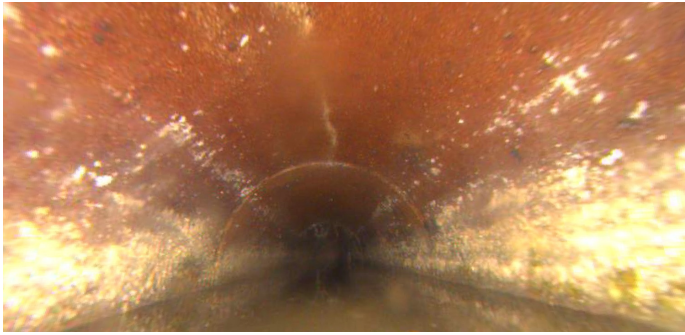
Code: **FL**
Description: **Fracture Longitudinal**

Distance (ft): **32.8**
Structural Grade: **3**
O&M Grade: **0**
Clock Start/From: **12**
Clock To:
1st Value:
2nd Value:
Value Percent:
Continuous Index:
Within 8" of Joint: **YES**
Remarks:

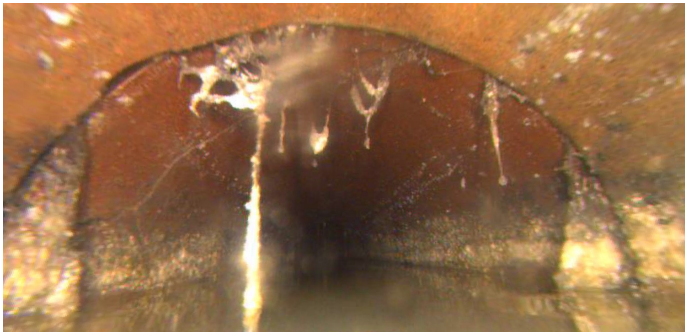
Code: **FM**
Description: **Fracture Multiple**

Distance (ft): **37.4**
Structural Grade: **4**
O&M Grade: **0**
Clock Start/From: **8**
Clock To: **4**
1st Value:
2nd Value:
Value Percent:
Continuous Index: **S03**
Within 8" of Joint: **YES**
Remarks:

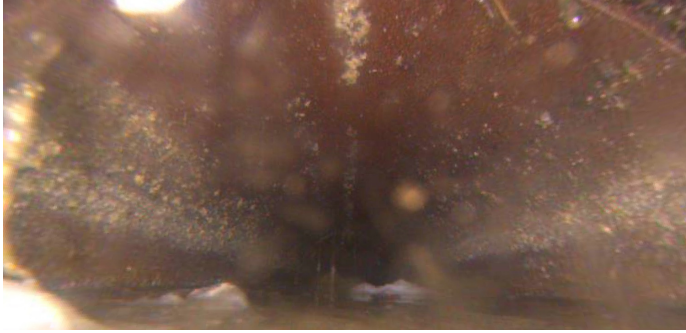
Code: **MGO**
Description: **General Observation**

Distance (ft): **55.8**
Structural Grade: **0**
O&M Grade: **0**
Clock Start/From:
Clock To:
1st Value:
2nd Value:
Value Percent:
Continuous Index:
Within 8" of Joint: **NO**
Remarks: **REAR CAMERA**

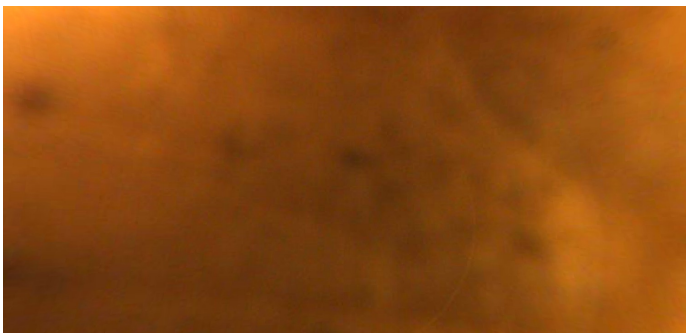
Code: **DAE**
Description: **Deposits Attached Encrustation**

Distance (ft): **71.8**
Structural Grade: **0**
O&M Grade: **2**
Clock Start/From: **8**
Clock To: **4**
1st Value:
2nd Value:
Value Percent: **5.000**
Continuous Index: **F01**
Within 8" of Joint: **NO**
Remarks:

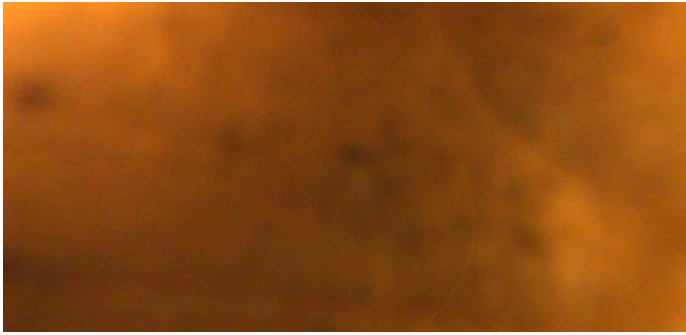
Code: **MWL**
Description: **Water Level**

Distance (ft): **71.8**
Structural Grade: **0**
O&M Grade: **0**
Clock Start/From:
Clock To:
1st Value:
2nd Value:
Value Percent: **100.000**
Continuous Index:
Within 8" of Joint: **NO**
Remarks:

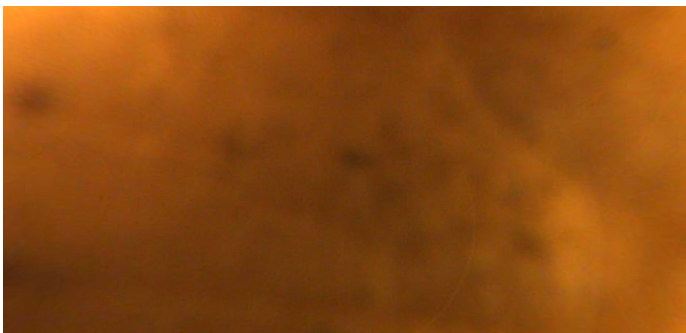
Code: **MCU**
Description: **Camera Underwater**

Distance (ft): **71.8**
Structural Grade: **0**
O&M Grade: **4**
Clock Start/From:
Clock To:
1st Value:
2nd Value:
Value Percent:
Continuous Index:
Within 8" of Joint: **NO**
Remarks:

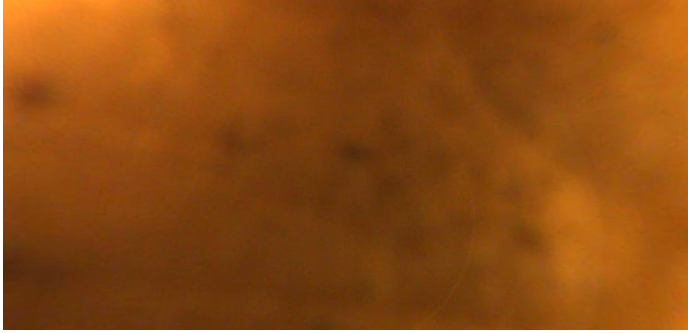
Code:	MSA
Description:	Abandoned Survey
Distance (ft):	71.8
Structural Grade:	0
O&M Grade:	0
Clock Start/From:	
Clock To:	
1st Value:	
2nd Value:	
Value Percent:	
Continuous Index:	
Within 8" of Joint:	NO
Remarks:	MCU
