Profile/Photo Observation Report

Date:	04/14/2018	Weather:		Coding:	PACP 6.0
Pipe Length (ft):	222.5	Owner:	NA	Pre Clean:	Not Known
P.O.#:		Surveyor:	Jen Costello	PSR:	P-706-008.6-008.3
Customer:		Clean Date:	01/01/1900	Shape:	C

Street:	GARFIELD ST	Flow Control:	Not Controlled
City:	Hobart, IN	Year Renewed:	
Location:	Light Highway	Tape/Media #:	
Purpose:	Maintenance Related	Dia/Height:	8"
Use:	Sanitary	Material:	VCP
Drain Area:	NA	Lining:	Cured in Place
Category:	NA		
Comment:	reverse setup.flow incorrect. roots at 41'.		
Location Details:		Direction of Survey:	Downstream
US MH:	M-706-008.3	DS MH:	M-706-008.6
		Total Length Surveyed (ft):	42.4

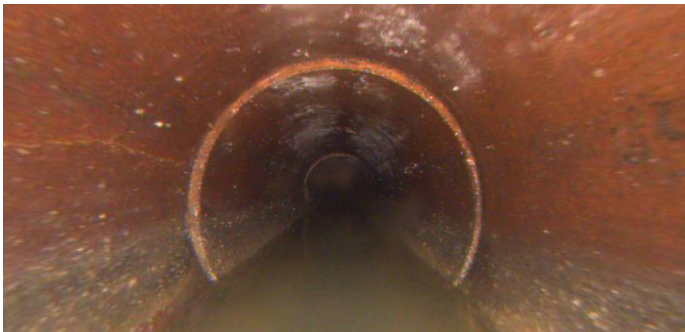
Code:	FL
Description:	Fracture Longitudinal

Distance (ft):	1.6
Structural Grade:	3
O&M Grade:	0
Clock Start/From:	9
Clock To:	
1st Value:	
2nd Value:	
Value Percent:	
Continuous Index:	
Within 8" of Joint:	YES
Remarks:

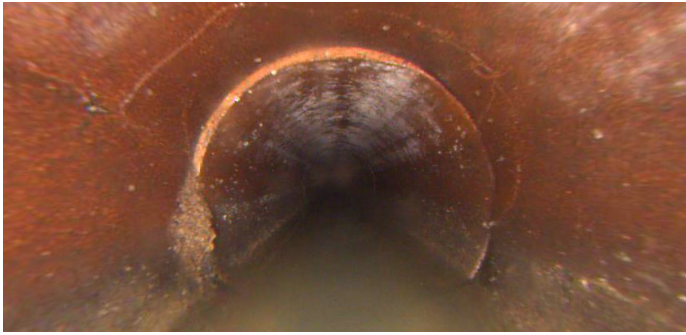
Code: **FM**
Description: **Fracture Multiple**

Distance (ft): **3.5**
Structural Grade: **4**
O&M Grade: **0**
Clock Start/From: **8**
Clock To: **4**
1st Value:
2nd Value:
Value Percent:
Continuous Index:
Within 8" of Joint: **YES**
Remarks:

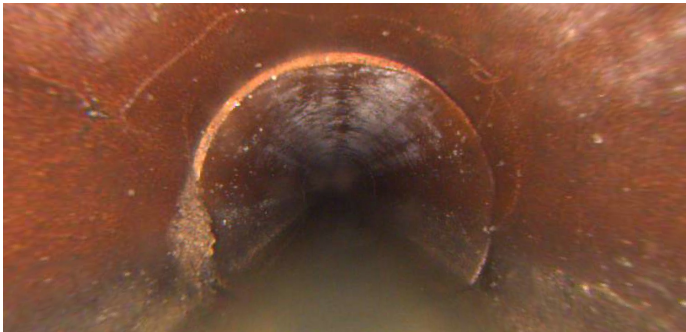
Code: **DAZ**
Description: **Deposits Attached Other**

Distance (ft): **3.5**
Structural Grade: **0**
O&M Grade: **2**
Clock Start/From: **8**
Clock To: **9**
1st Value:
2nd Value:
Value Percent: **5.000**
Continuous Index:
Within 8" of Joint: **YES**
Remarks:

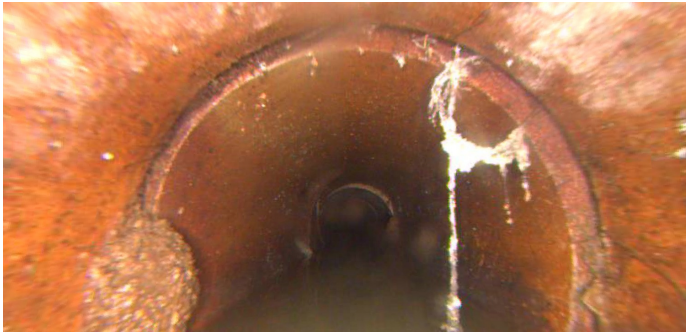
Code: **RFJ**
Description: **Roots Fine Joint**

Distance (ft): **9.6**
Structural Grade: **0**
O&M Grade: **1**
Clock Start/From: **8**
Clock To: **4**
1st Value:
2nd Value:
Value Percent:
Continuous Index: **S01**
Within 8" of Joint: **YES**
Remarks:

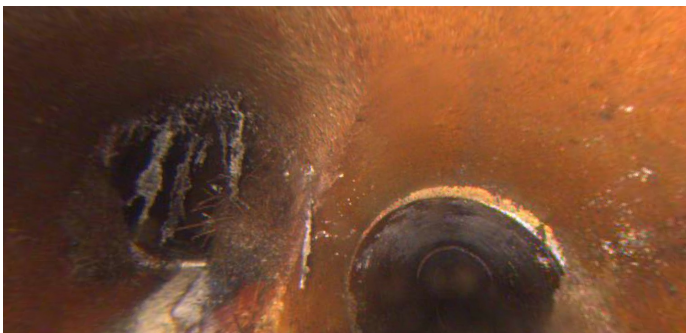
Code: **TFD**
Description: **Tap Factory Defective**

Distance (ft): **11.1**
Structural Grade: **0**
O&M Grade: **2**
Clock Start/From: **9**
Clock To:
1st Value: **4.000**
2nd Value:
Value Percent:
Continuous Index:
Within 8" of Joint:
Remarks: **ROOTS**

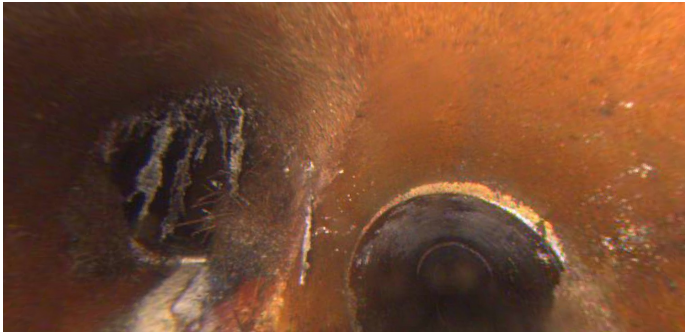
Code: **RFL**
Description: **Roots Fine Lateral**

Distance (ft): **11.1**
Structural Grade: **0**
O&M Grade: **1**
Clock Start/From: **9**
Clock To:
1st Value:
2nd Value:
Value Percent:
Continuous Index:
Within 8" of Joint: **NO**
Remarks:

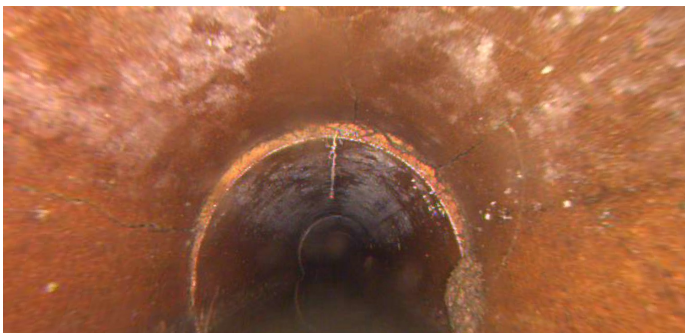
Code: **FM**
Description: **Fracture Multiple**

Distance (ft): **13.4**
Structural Grade: **4**
O&M Grade: **0**
Clock Start/From: **8**
Clock To: **4**
1st Value:
2nd Value:
Value Percent:
Continuous Index: **S03**
Within 8" of Joint: **YES**
Remarks:

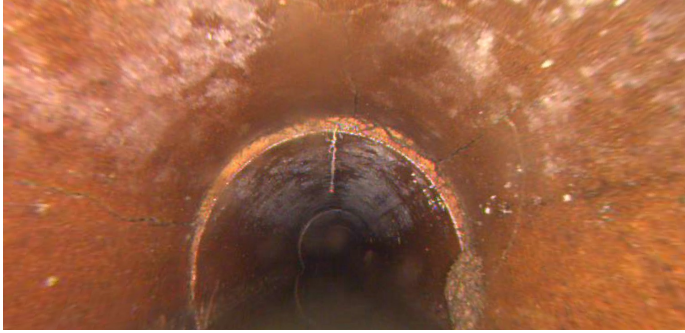
Code: **DAZ**
Description: **Deposits Attached Other**

Distance (ft): **13.4**
Structural Grade: **0**
O&M Grade: **2**
Clock Start/From: **8**
Clock To: **4**
1st Value:
2nd Value:
Value Percent: **5.000**
Continuous Index: **S02**
Within 8" of Joint: **YES**
Remarks:

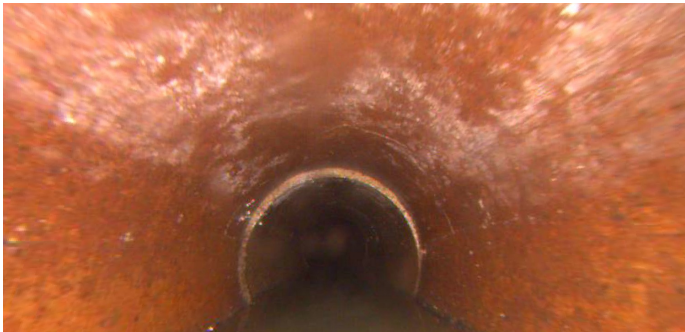
Code: **DAZ**
Description: **Deposits Attached Other**

Distance (ft): **24.9**
Structural Grade: **0**
O&M Grade: **2**
Clock Start/From: **8**
Clock To: **4**
1st Value:
2nd Value:
Value Percent: **5.000**
Continuous Index: **F02**
Within 8" of Joint: **YES**
Remarks:

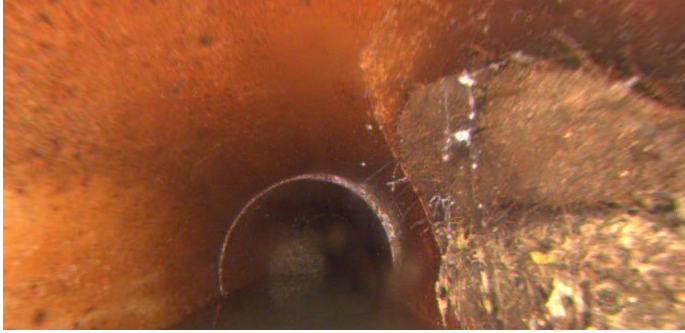
Code: **TFD**
Description: **Tap Factory Defective**

Distance (ft): **36.8**
Structural Grade: **0**
O&M Grade: **2**
Clock Start/From: **2**
Clock To:
1st Value: **4.000**
2nd Value:
Value Percent:
Continuous Index:
Within 8" of Joint:
Remarks: **ROOTS**

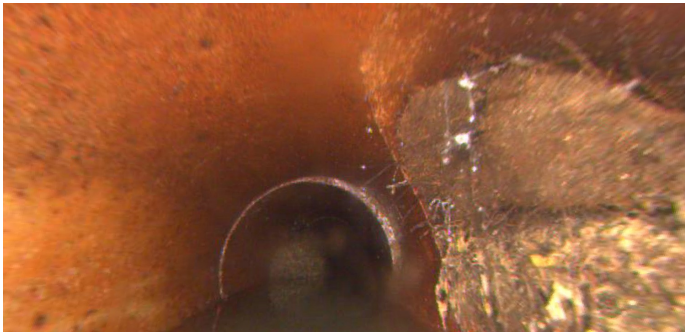
Code: **RML**
Description: **Roots Medium Lateral**

Distance (ft): **36.8**
Structural Grade: **0**
O&M Grade: **3**
Clock Start/From: **2**
Clock To: **4**
1st Value:
2nd Value:
Value Percent: **10.000**
Continuous Index:
Within 8" of Joint: **NO**
Remarks:

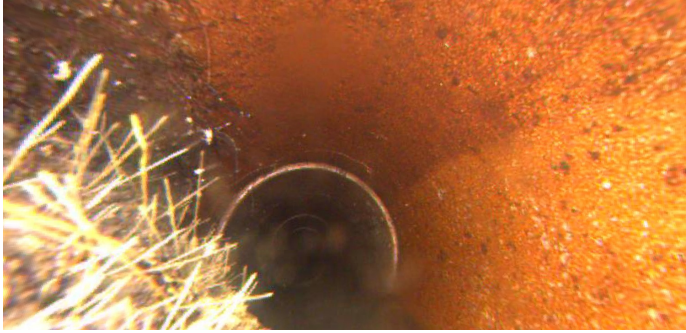
Code: **TFD**
Description: **Tap Factory Defective**

Distance (ft): **38.9**
Structural Grade: **0**
O&M Grade: **2**
Clock Start/From: **9**
Clock To:
1st Value: **4.000**
2nd Value:
Value Percent:
Continuous Index:
Within 8" of Joint:
Remarks: **ROOTS**

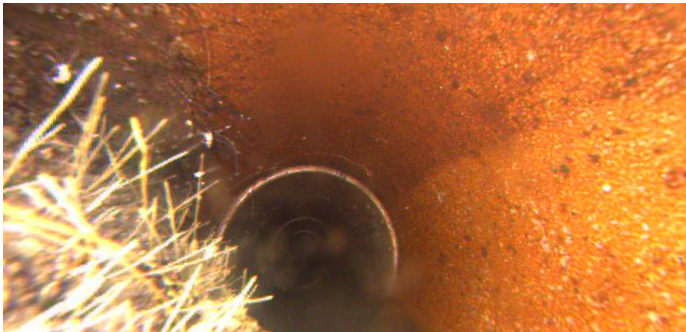
Code: **RML**
Description: **Roots Medium Lateral**

Distance (ft): **38.9**
Structural Grade: **0**
O&M Grade: **3**
Clock Start/From: **6**
Clock To: **9**
1st Value:
2nd Value:
Value Percent: **20.000**
Continuous Index:
Within 8" of Joint: **NO**
Remarks:

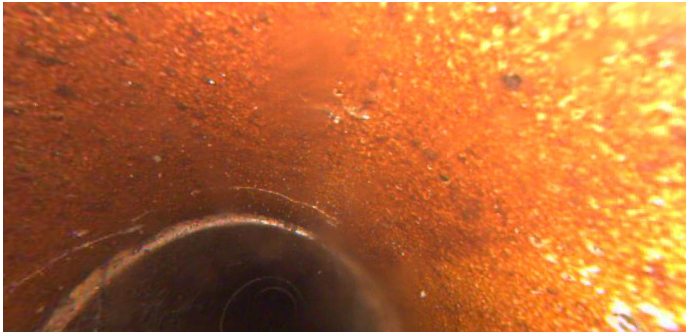
Code: **RFJ**
Description: **Roots Fine Joint**

Distance (ft): **42.4**
Structural Grade: **0**
O&M Grade: **1**
Clock Start/From: **8**
Clock To: **4**
1st Value:
2nd Value:
Value Percent:
Continuous Index: **F01**
Within 8" of Joint: **YES**
Remarks:

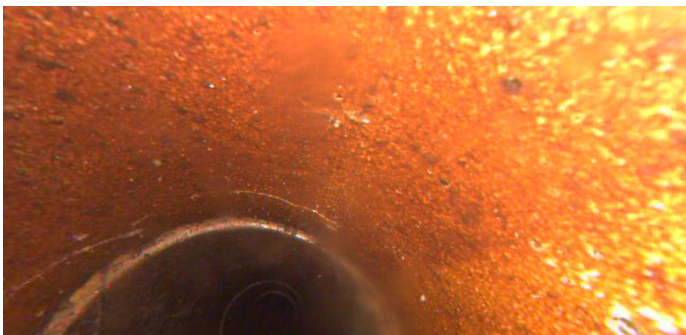
Code: **FM**
Description: **Fracture Multiple**

Distance (ft): **42.4**
Structural Grade: **4**
O&M Grade: **0**
Clock Start/From: **8**
Clock To: **4**
1st Value:
2nd Value:
Value Percent:
Continuous Index: **F03**
Within 8" of Joint: **YES**
Remarks:

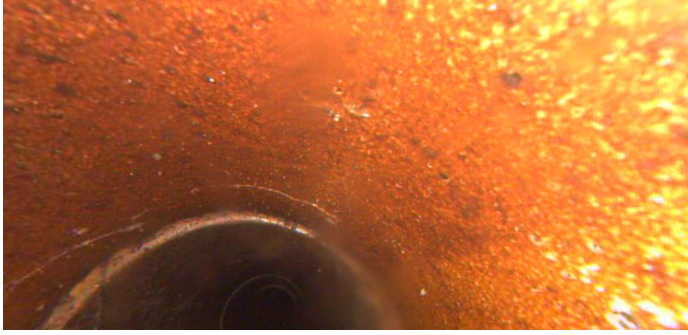
Code:	MSA
Description:	Abandoned Survey
Distance (ft):	42.4
Structural Grade:	0
O&M Grade:	0
Clock Start/From:	
Clock To:	
1st Value:	
2nd Value:	
Value Percent:	
Continuous Index:	
Within 8" of Joint:	NO
Remarks:	ROOTS
