Profile/Photo Observation Report

Date:	04/14/2018	Weather:		Coding:	PACP 6.0
Pipe Length (ft):	222.5	Owner:	NA	Pre Clean:	Not Known
P.O.#:		Surveyor:	Jen Costello	PSR:	P-706-008.6-008.3
Customer:		Clean Date:	01/01/1900	Shape:	C

Street:	Capitol	Flow Control:	Not Controlled
City:	Hobart, IN	Year Renewed:	
Location:	Light Highway	Tape/Media #:	
Purpose:	Maintenance Related	Dia/Height:	8"
Use:	Sanitary	Material:	VCP
Drain Area:	NA	Lining:	Cured in Place
Category:	NA		
Comment:	reverse setup.flow incorrect. roots at 41'.		
Location Details:		Direction of Survey:	Downstream
US MH:	M-706-008.3	DS MH:	M-706-008.6
		Total Length Surveyed (ft):	42.4

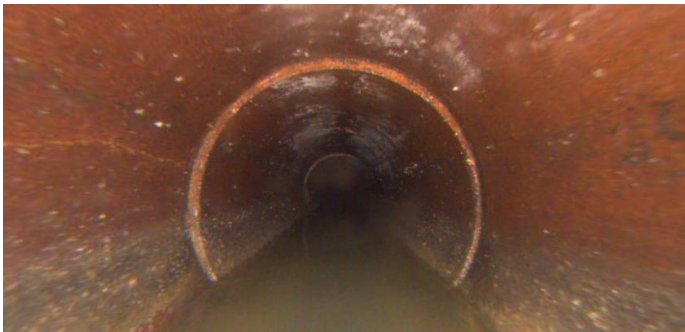
Code:	FL
Description:	Fracture Longitudinal

Distance (ft):	1.6
Structural Grade:	3
O&M Grade:	0
Clock Start/From:	9
Clock To:	
1st Value:	
2nd Value:	
Value Percent:	
Continuous Index:	
Within 8" of Joint:	YES
Remarks:

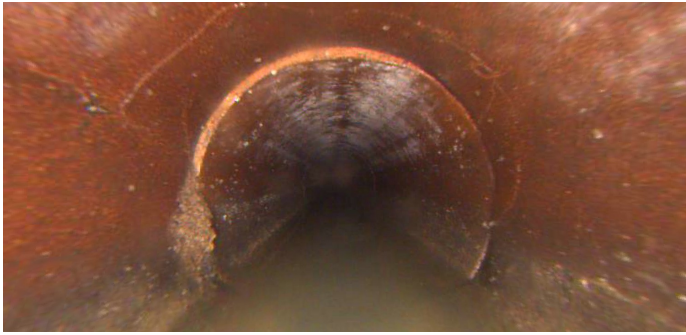
Code: **FM**
Description: **Fracture Multiple**

Distance (ft): **3.5**
Structural Grade: **4**
O&M Grade: **0**
Clock Start/From: **8**
Clock To: **4**
1st Value:
2nd Value:
Value Percent:
Continuous Index:
Within 8" of Joint: **YES**
Remarks:

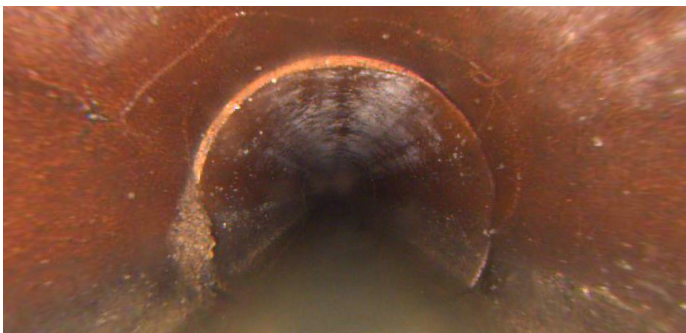
Code: **DAZ**
Description: **Deposits Attached Other**

Distance (ft): **3.5**
Structural Grade: **0**
O&M Grade: **2**
Clock Start/From: **8**
Clock To: **9**
1st Value:
2nd Value:
Value Percent: **5.000**
Continuous Index:
Within 8" of Joint: **YES**
Remarks:

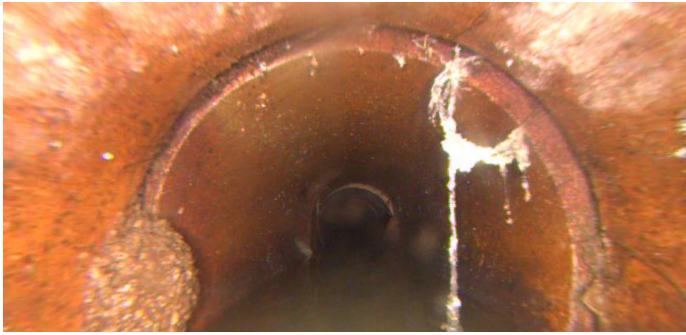
Code: **RFJ**
Description: **Roots Fine Joint**

Distance (ft): **9.6**
Structural Grade: **0**
O&M Grade: **1**
Clock Start/From: **8**
Clock To: **4**
1st Value:
2nd Value:
Value Percent:
Continuous Index: **S01**
Within 8" of Joint: **YES**
Remarks:

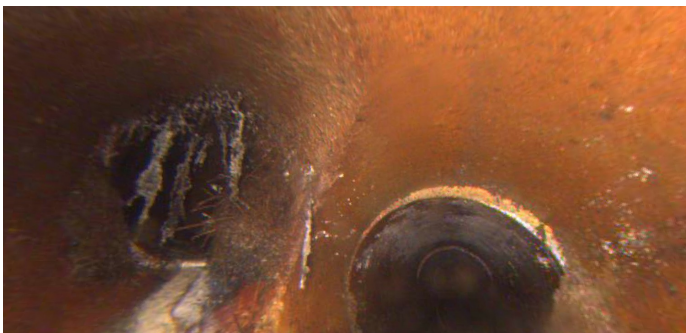
Code: **TFD**
Description: **Tap Factory Defective**

Distance (ft): **11.1**
Structural Grade: **0**
O&M Grade: **2**
Clock Start/From: **9**
Clock To:
1st Value: **4.000**
2nd Value:
Value Percent:
Continuous Index:
Within 8" of Joint:
Remarks: **ROOTS**

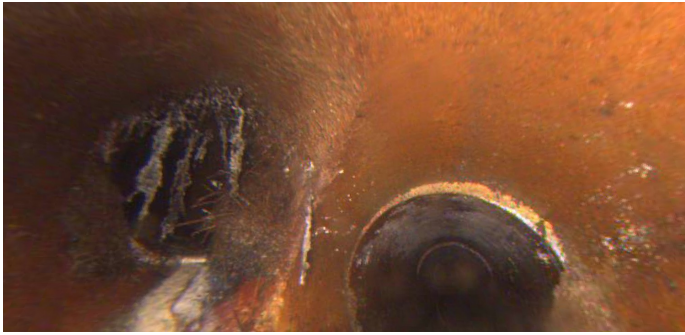
Code: **RFL**
Description: **Roots Fine Lateral**

Distance (ft): **11.1**
Structural Grade: **0**
O&M Grade: **1**
Clock Start/From: **9**
Clock To:
1st Value:
2nd Value:
Value Percent:
Continuous Index:
Within 8" of Joint: **NO**
Remarks:

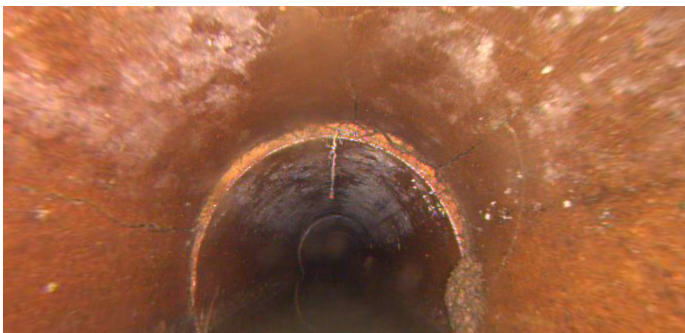
Code: **FM**
Description: **Fracture Multiple**

Distance (ft): **13.4**
Structural Grade: **4**
O&M Grade: **0**
Clock Start/From: **8**
Clock To: **4**
1st Value:
2nd Value:
Value Percent:
Continuous Index: **S03**
Within 8" of Joint: **YES**
Remarks:

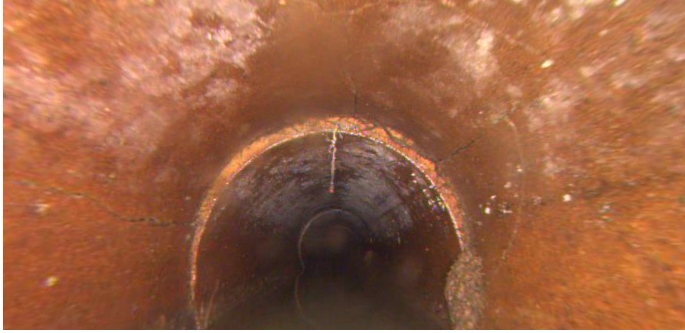
Code: **DAZ**
Description: **Deposits Attached Other**

Distance (ft): **13.4**
Structural Grade: **0**
O&M Grade: **2**
Clock Start/From: **8**
Clock To: **4**
1st Value:
2nd Value:
Value Percent: **5.000**
Continuous Index: **S02**
Within 8" of Joint: **YES**
Remarks:

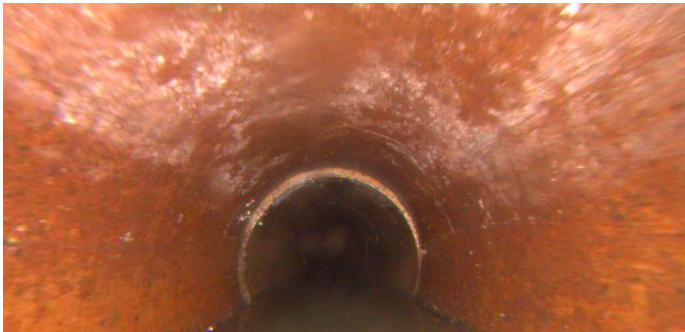
Code: **DAZ**
Description: **Deposits Attached Other**

Distance (ft): **24.9**
Structural Grade: **0**
O&M Grade: **2**
Clock Start/From: **8**
Clock To: **4**
1st Value:
2nd Value:
Value Percent: **5.000**
Continuous Index: **F02**
Within 8" of Joint: **YES**
Remarks:

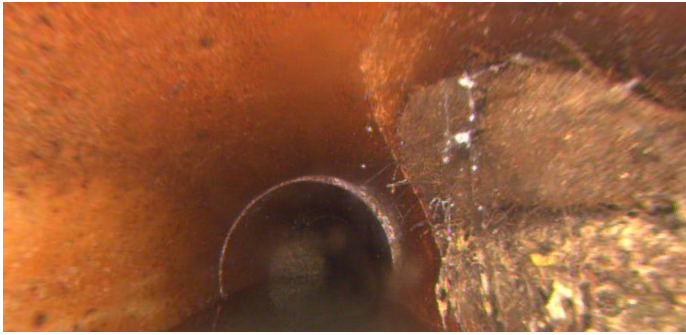
Code: **TFD**
Description: **Tap Factory Defective**

Distance (ft): **36.8**
Structural Grade: **0**
O&M Grade: **2**
Clock Start/From: **2**
Clock To:
1st Value: **4.000**
2nd Value:
Value Percent:
Continuous Index:
Within 8" of Joint:
Remarks: **ROOTS**

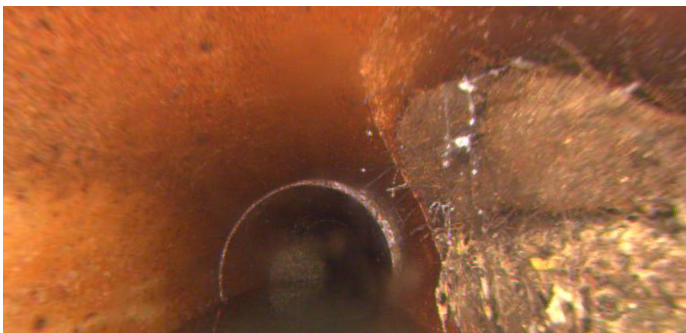
Code: **RML**
Description: **Roots Medium Lateral**

Distance (ft): **36.8**
Structural Grade: **0**
O&M Grade: **3**
Clock Start/From: **2**
Clock To: **4**
1st Value:
2nd Value:
Value Percent: **10.000**
Continuous Index:
Within 8" of Joint: **NO**
Remarks:

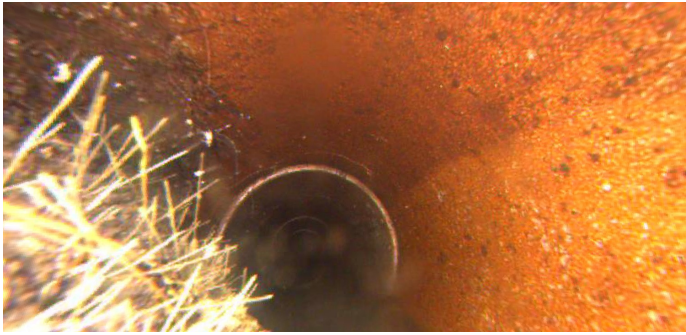
Code: **TFD**
Description: **Tap Factory Defective**

Distance (ft): **38.9**
Structural Grade: **0**
O&M Grade: **2**
Clock Start/From: **9**
Clock To:
1st Value: **4.000**
2nd Value:
Value Percent:
Continuous Index:
Within 8" of Joint:
Remarks: **ROOTS**

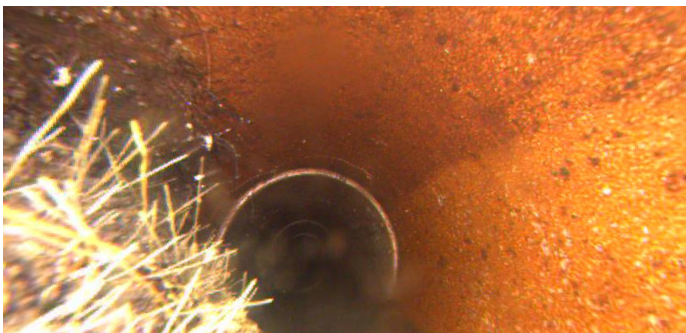
Code: **RML**
Description: **Roots Medium Lateral**

Distance (ft): **38.9**
Structural Grade: **0**
O&M Grade: **3**
Clock Start/From: **6**
Clock To: **9**
1st Value:
2nd Value:
Value Percent: **20.000**
Continuous Index:
Within 8" of Joint: **NO**
Remarks:

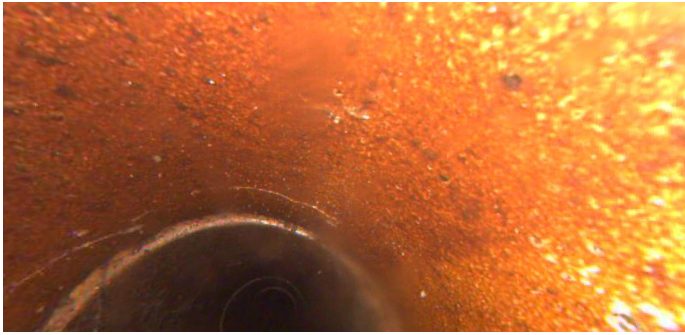
Code: **RFJ**
Description: **Roots Fine Joint**

Distance (ft): **42.4**
Structural Grade: **0**
O&M Grade: **1**
Clock Start/From: **8**
Clock To: **4**
1st Value:
2nd Value:
Value Percent:
Continuous Index: **F01**
Within 8" of Joint: **YES**
Remarks:

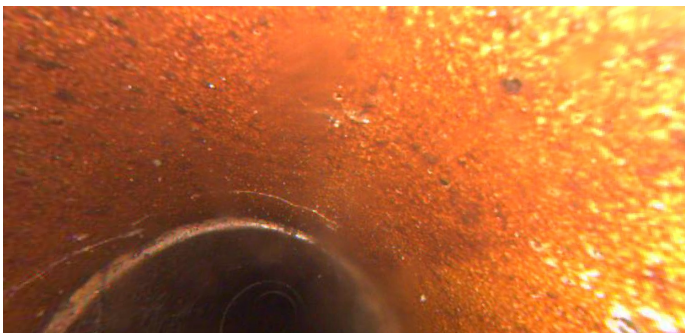
Code: **FM**
Description: **Fracture Multiple**

Distance (ft): **42.4**
Structural Grade: **4**
O&M Grade: **0**
Clock Start/From: **8**
Clock To: **4**
1st Value:
2nd Value:
Value Percent:
Continuous Index: **F03**
Within 8" of Joint: **YES**
Remarks:

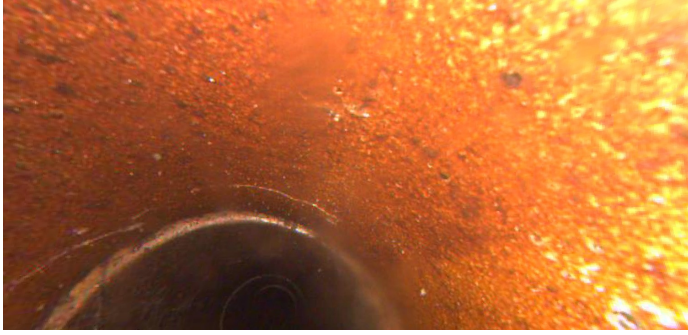
Code:	MSA
Description:	Abandoned Survey
Distance (ft):	42.4
Structural Grade:	0
O&M Grade:	0
Clock Start/From:	
Clock To:	
1st Value:	
2nd Value:	
Value Percent:	
Continuous Index:	
Within 8" of Joint:	NO
Remarks:	ROOTS
