Profile/Photo Observation Report

Date:	05/07/2018	Weather:		Coding:	PACP 6.0
Pipe Length (ft):		Owner:	City of Hobart	Pre Clean:	No Pre-Cleaning
P.O.#:	610	Surveyor:	M. Pielacha	PSR:	P-706-008.5-008.4
Customer:	City of Hobart	Clean Date:		Shape:	C

Street:	9th Street	Flow Control:	Not Controlled
City:	Hobart, IN	Year Renewed:	
Location:	Light Highway	Tape/Media #:	DEP 610
Purpose:	Routine Assessment	Dia/Height:	6"
Use:	Sanitary	Material:	VCP
Drain Area:		Lining:	
Category:	NA		
Comment:	5-21-2018

Location Details:		Direction of Survey:	Upstream
US MH:	M-706-008.4	DS MH:	M-706-008.5
		Total Length Surveyed (ft):	71.5

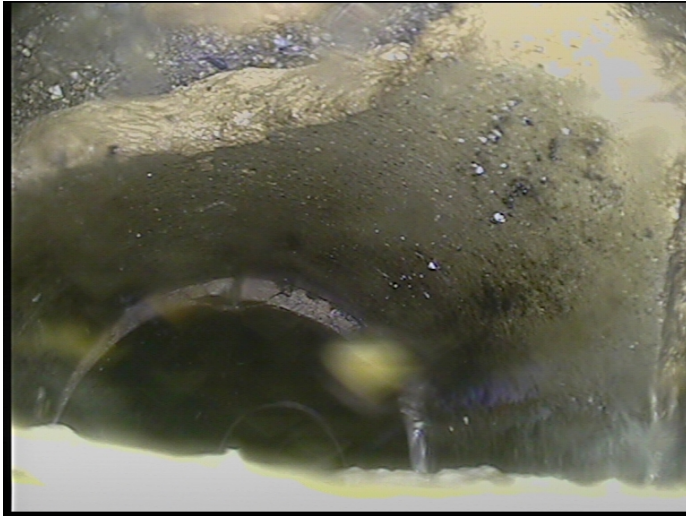
Code: **MWL**
Description: **Water Level**

Distance (ft): **.0**
Structural Grade: **0**
O&M Grade: **0**
Clock Start/From:
Clock To:
1st Value:
2nd Value:
Value Percent: **30.000**
Continuous Index:
Within 8" of Joint: **NO**
Remarks:

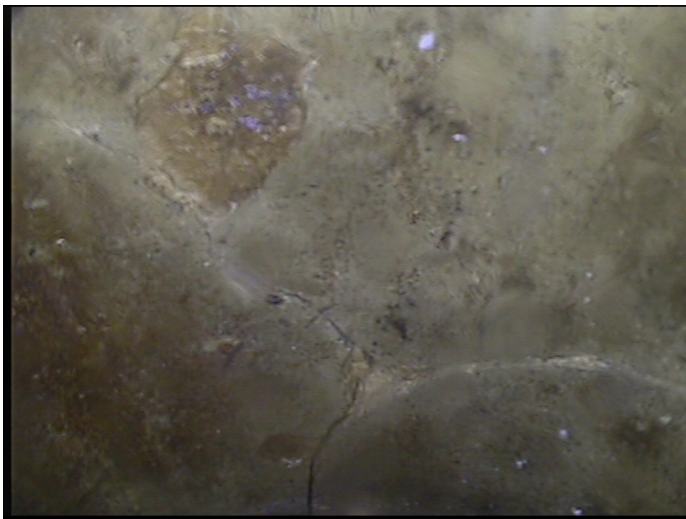
Code: **CM**
Description: **Crack Multiple**

Distance (ft): **12.4**
Structural Grade: **3**
O&M Grade: **0**
Clock Start/From: **11**
Clock To: **2**
1st Value:
2nd Value:
Value Percent:
Continuous Index:
Within 8" of Joint: **YES**
Remarks:

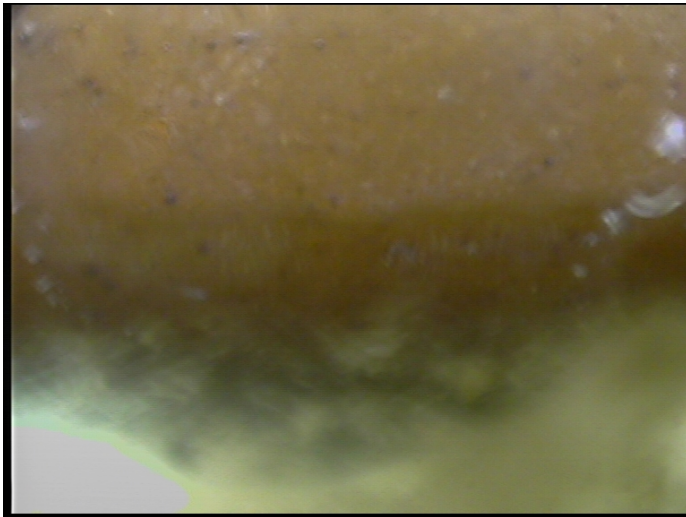
Code: **MWL**
Description: **Water Level**

Distance (ft): **24.5**
Structural Grade: **0**
O&M Grade: **0**
Clock Start/From:
Clock To:
1st Value:
2nd Value:
Value Percent: **60.000**
Continuous Index:
Within 8" of Joint: **NO**
Remarks:

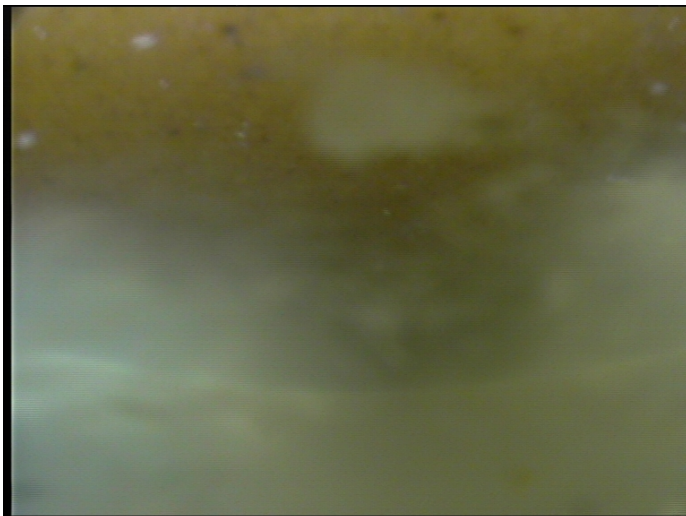
Code: **MCU**
Description: **Camera Underwater**

Distance (ft): **45.3**
Structural Grade: **0**
O&M Grade: **4**
Clock Start/From:
Clock To:
1st Value:
2nd Value:
Value Percent:
Continuous Index: **S01**
Within 8" of Joint: **NO**
Remarks:

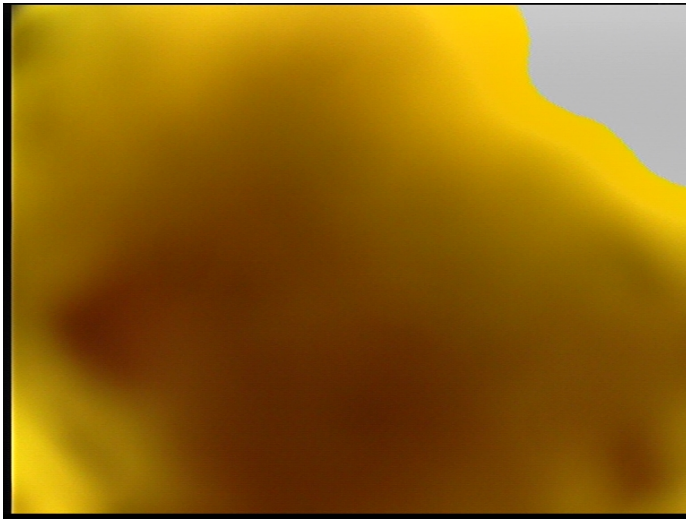
Code: **MCU**
Description: **Camera Underwater**

Distance (ft): **69.3**
Structural Grade: **0**
O&M Grade: **4**
Clock Start/From:
Clock To:
1st Value:
2nd Value:
Value Percent:
Continuous Index: **F01**
Within 8" of Joint: **NO**
Remarks:

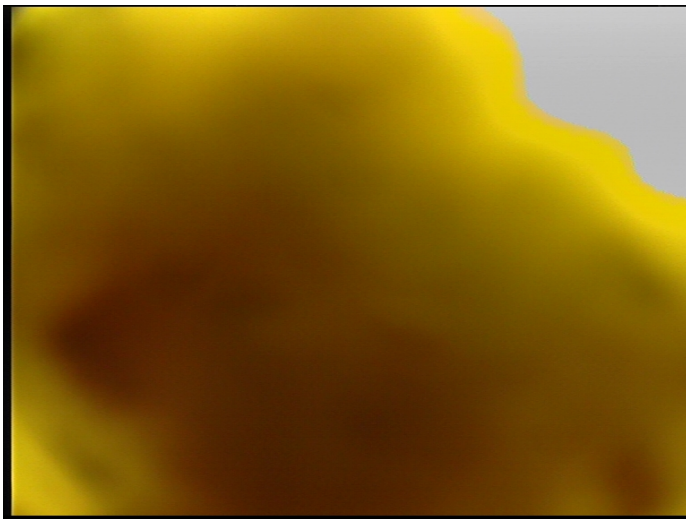
Code: **MSA**
Description: **Abandoned Survey**

Distance (ft): **69.3**
Structural Grade: **0**
O&M Grade: **0**
Clock Start/From:
Clock To:
1st Value:
2nd Value:
Value Percent:
Continuous Index:
Within 8" of Joint: **NO**
Remarks: **underwater. debris.**
